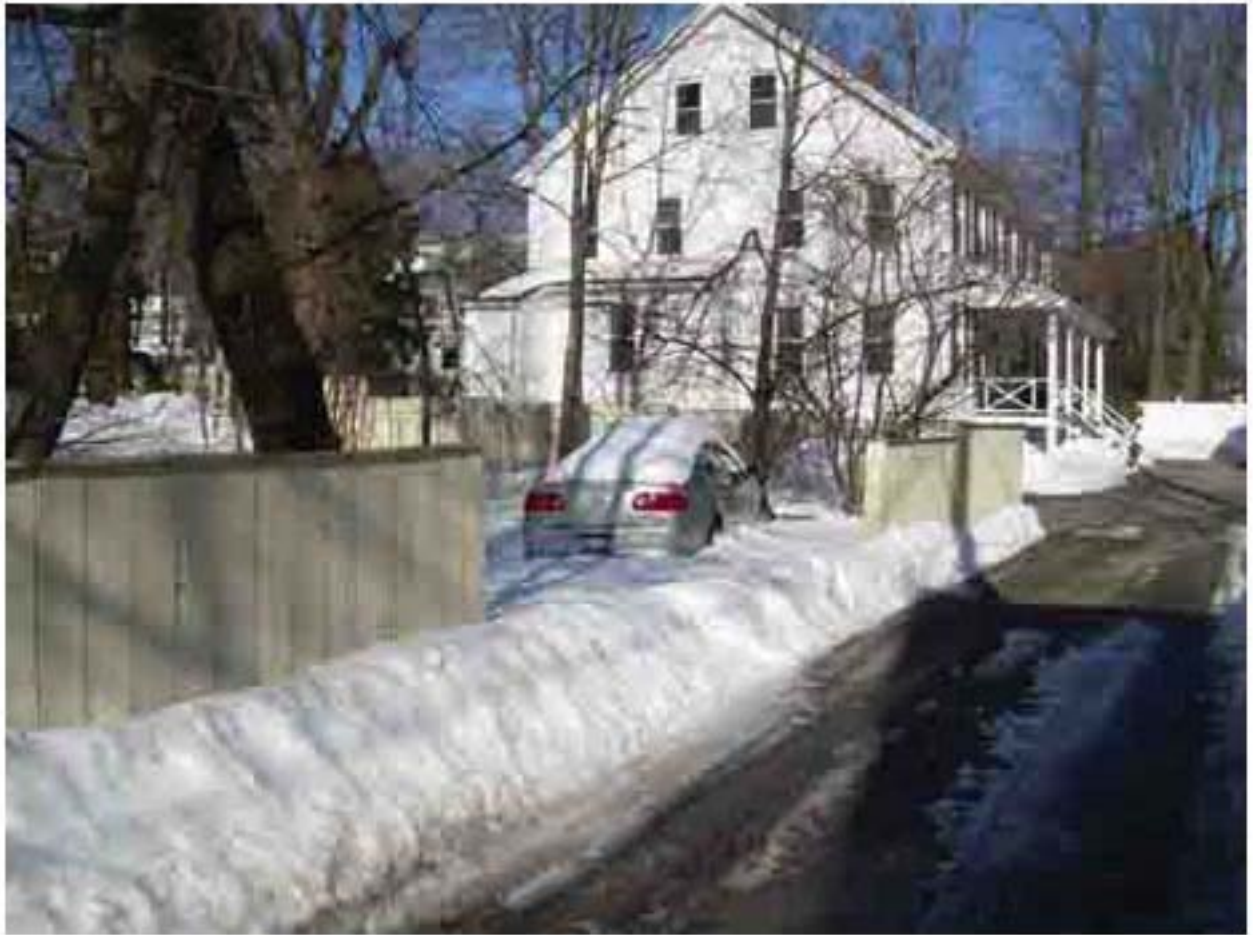
1A- Existing stained wood board fence along Columbus Place

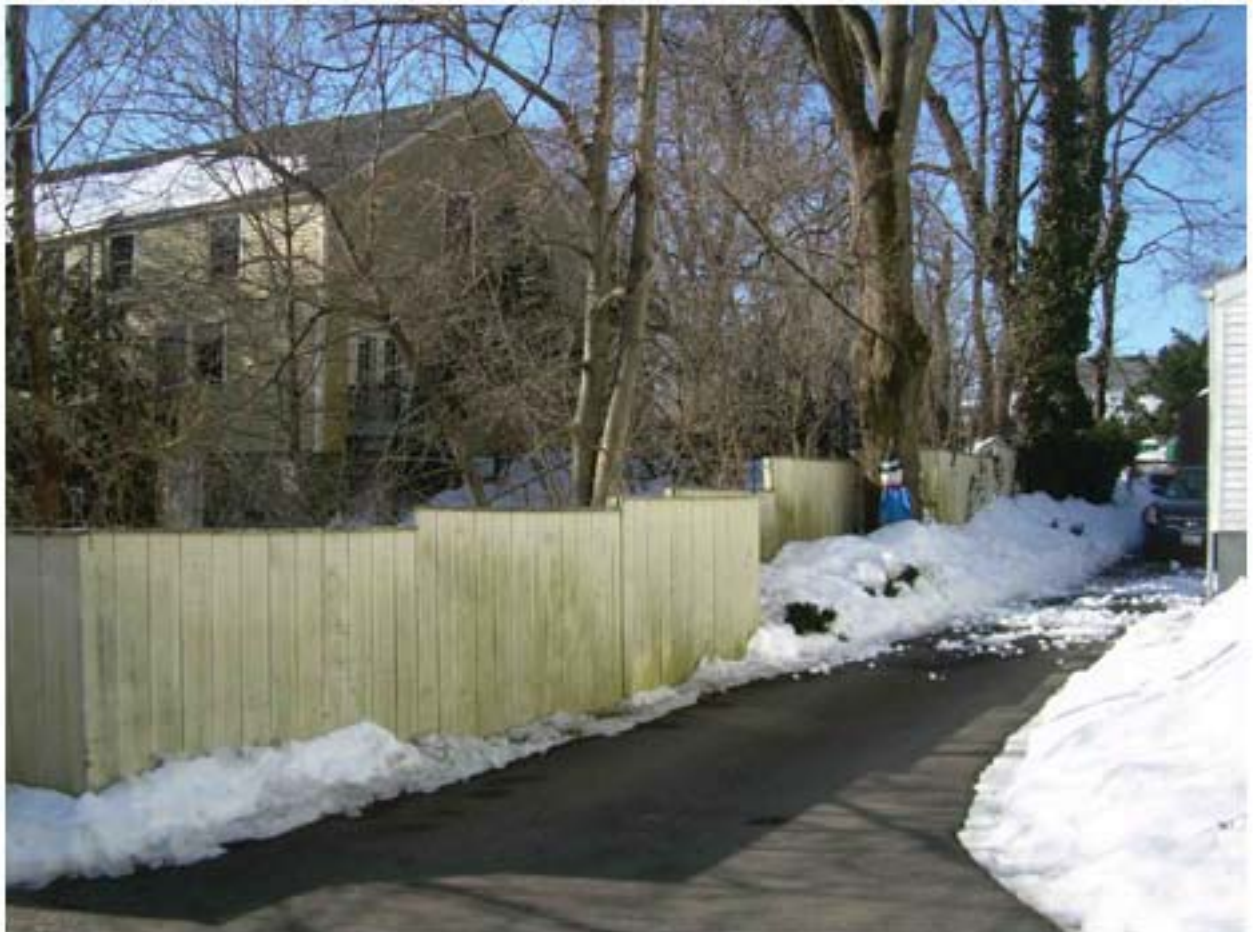
1B- Existing stained wood board fence at rear of north side of barn

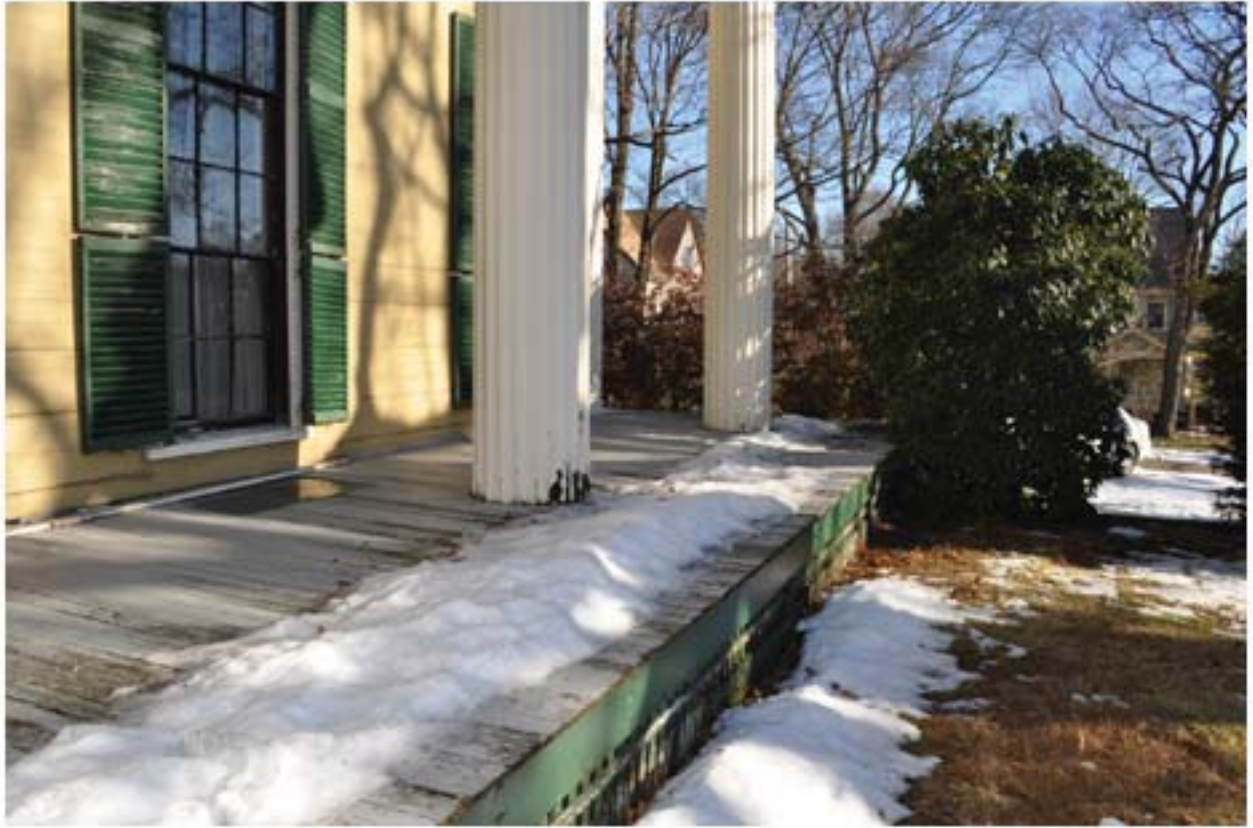
2A- Existing extended wood decking on south side of house

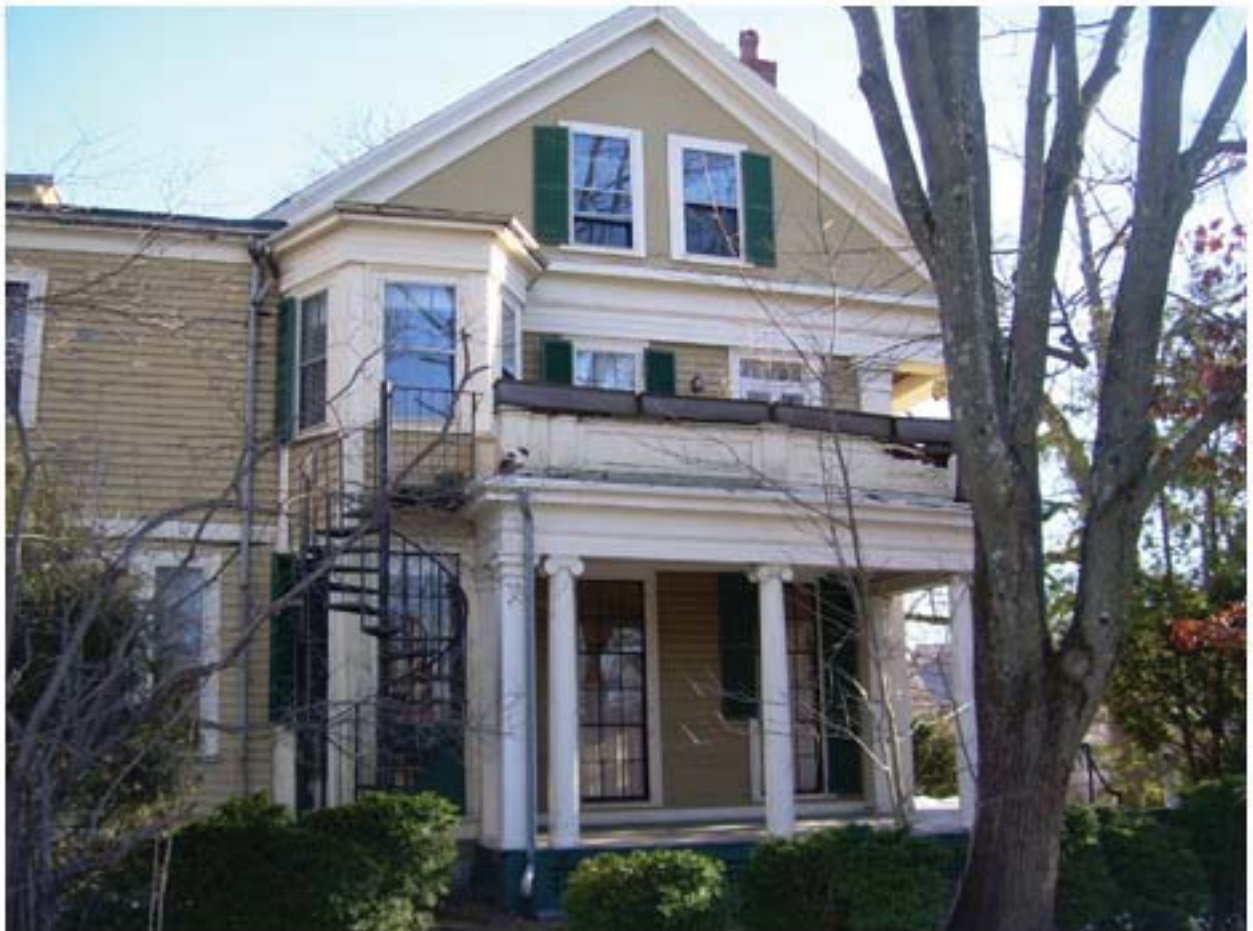
2B- Existing extended wrap around porch on west side of house

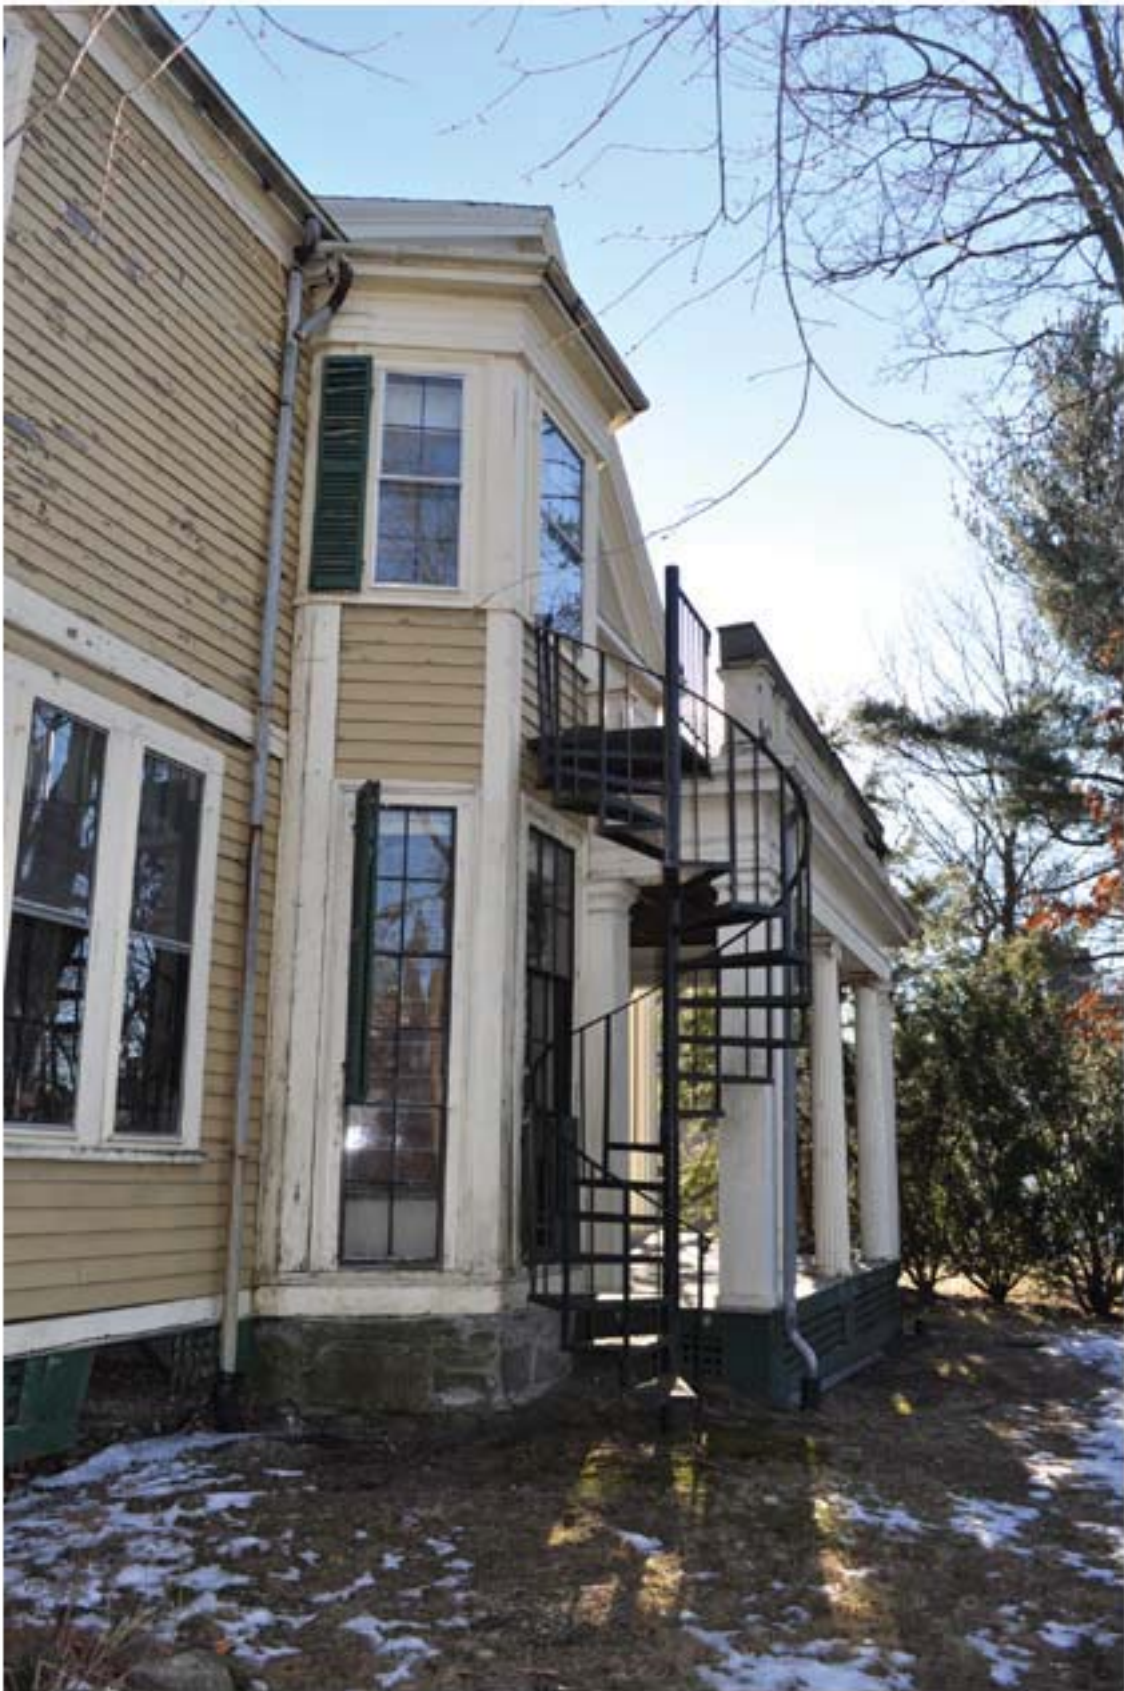
2C- Existing extended wrap around porch on west side of house

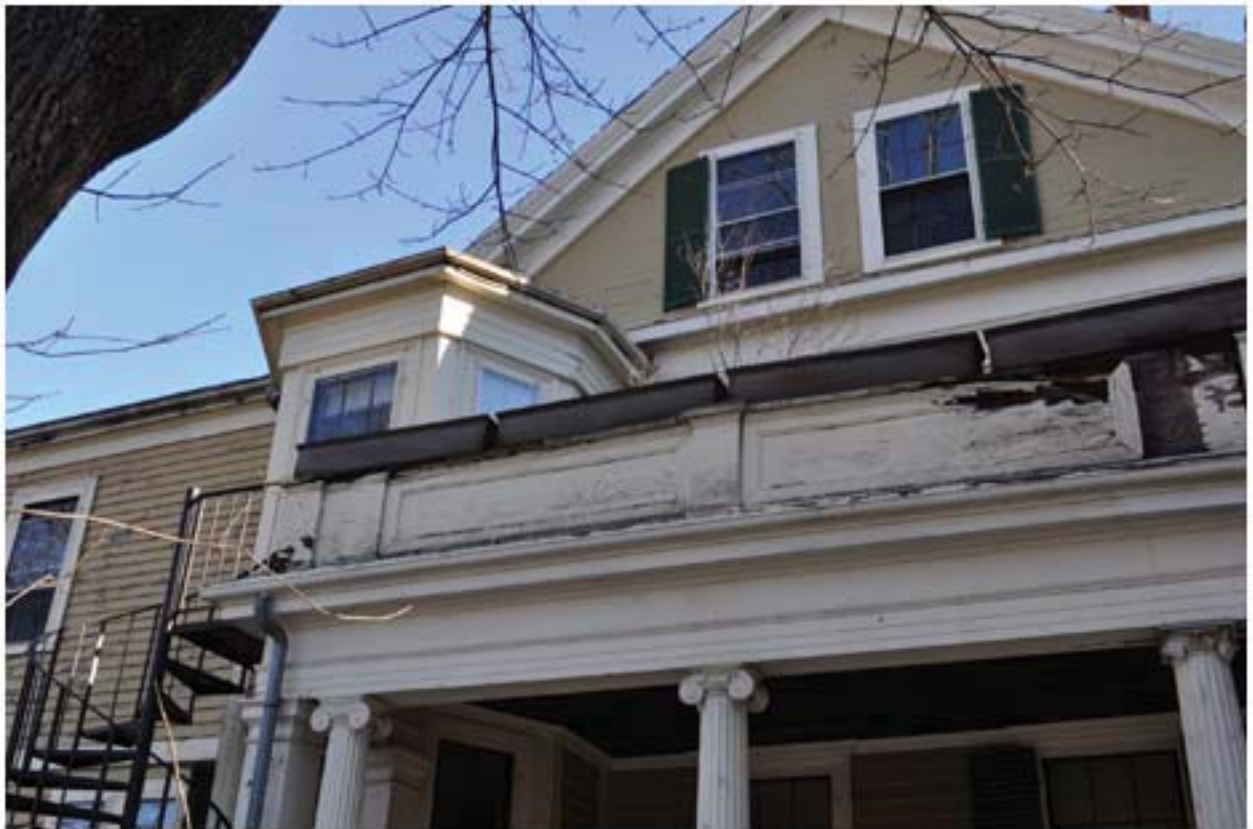
3A- Existing deteriorated one story porch on west side of house

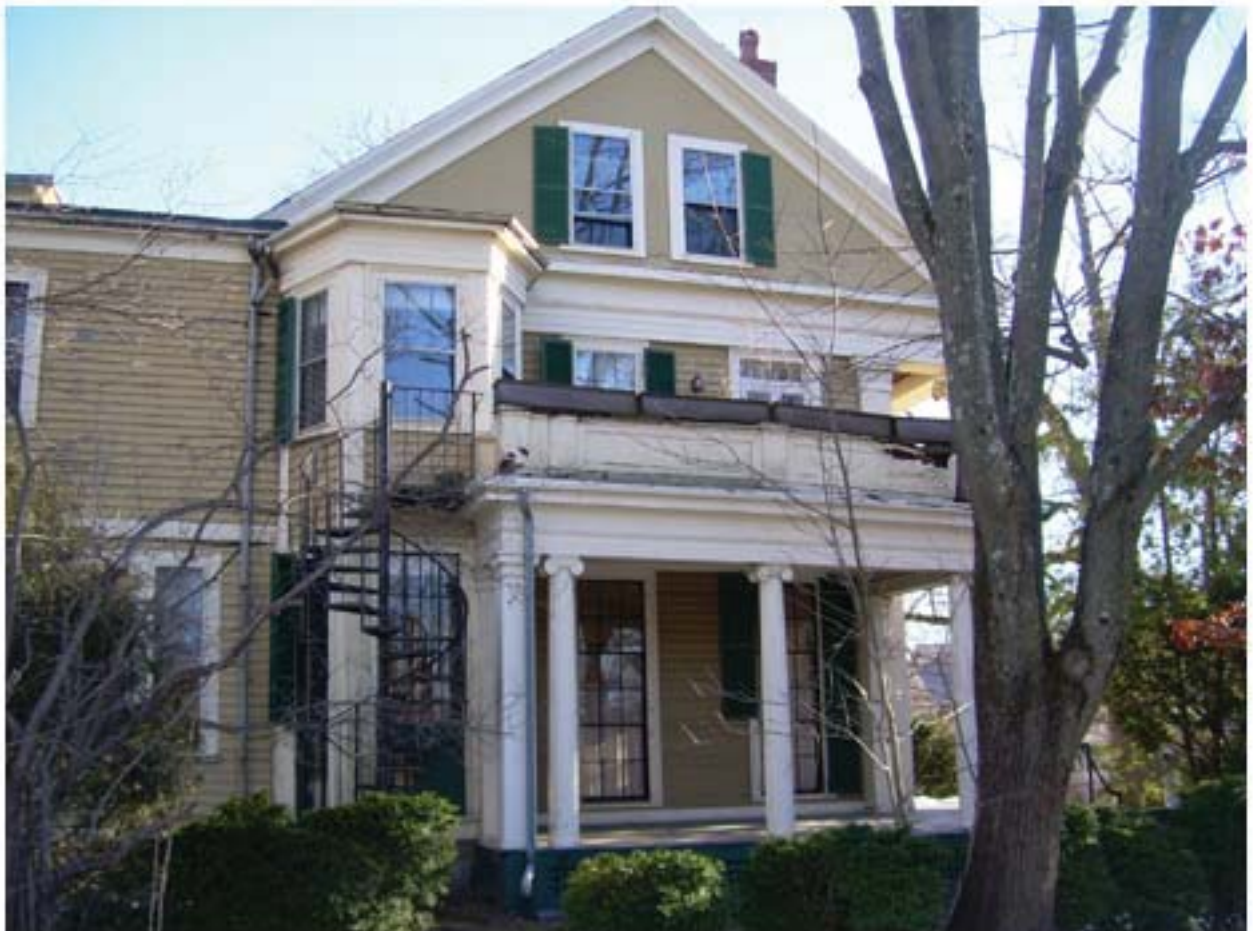
3B- Existing deteriorated one story porch on west side of house

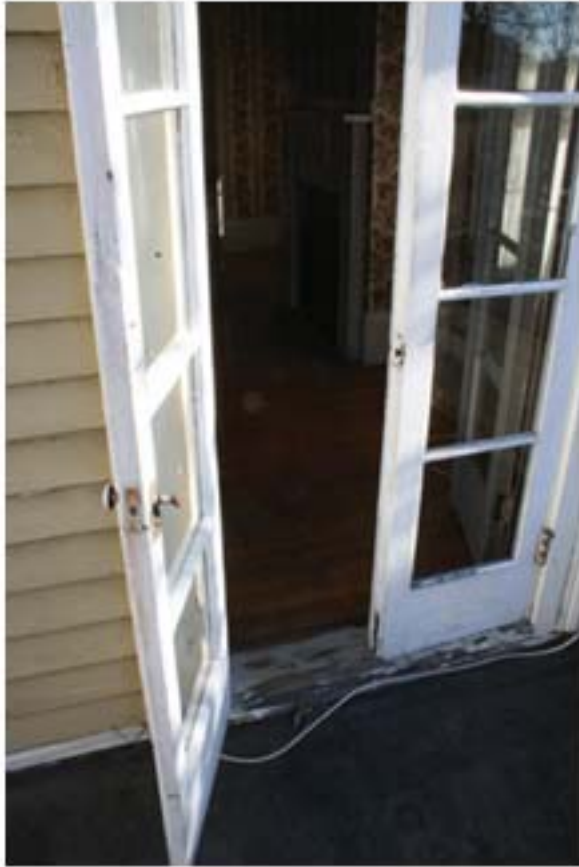
4A- Existing French casement window on second floor of west side of house

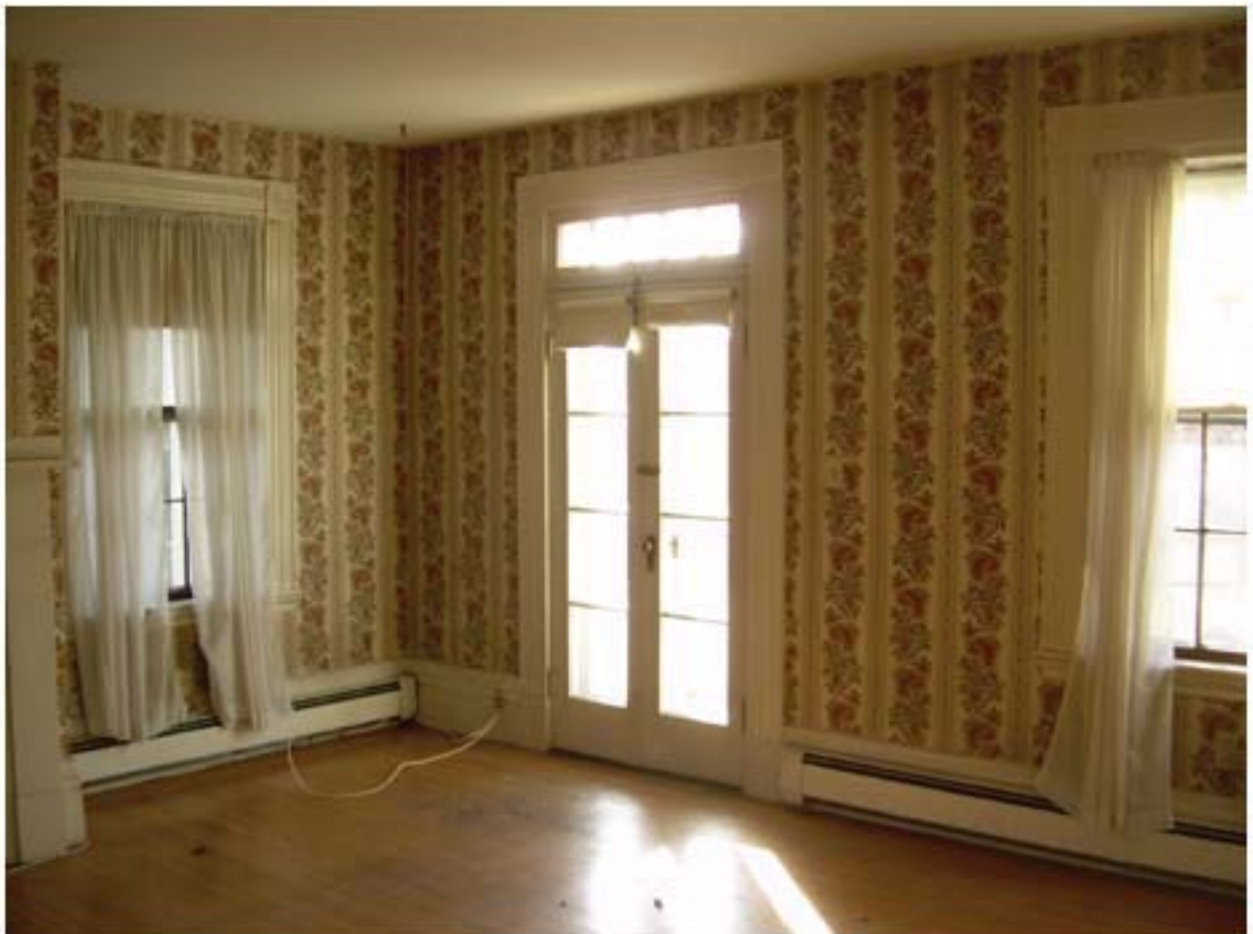
4A (Interior)- Existing French casement window on second floor

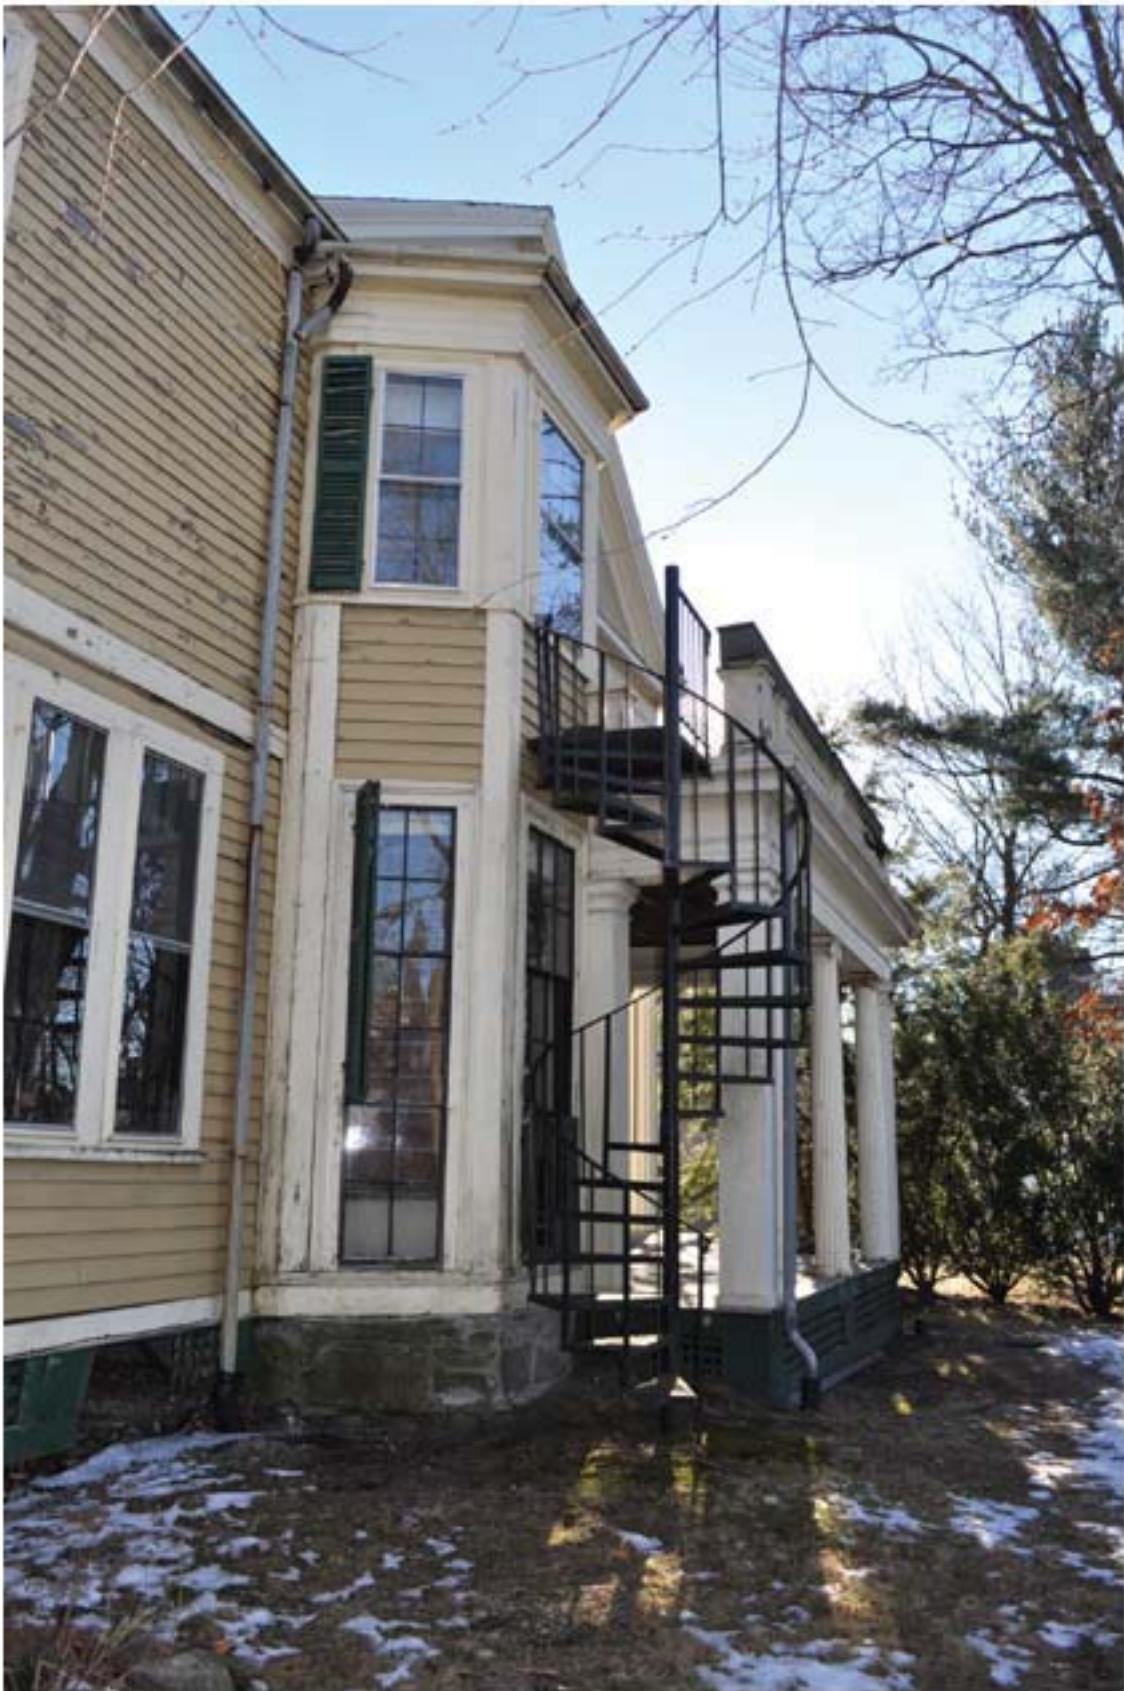
5A- Existing iron spiral stairway for one story porch on west side of house

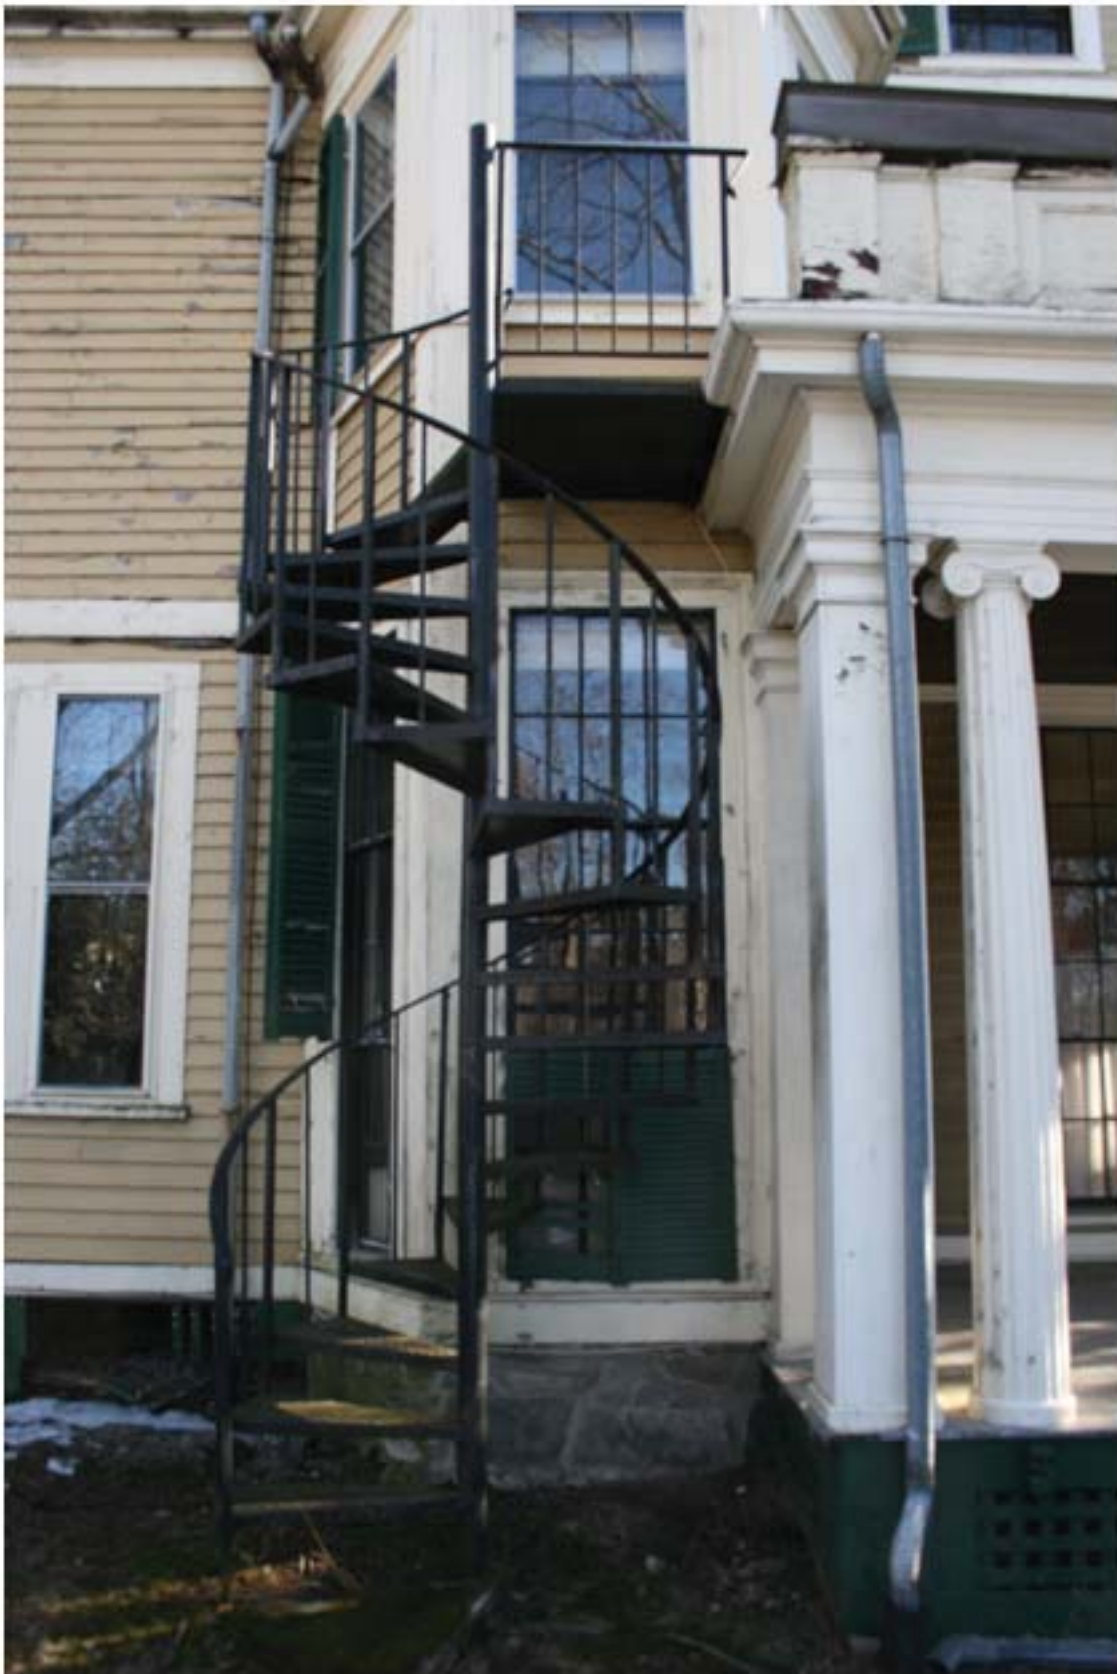
5B- Existing iron spiral stairway for one story porch on west side of house

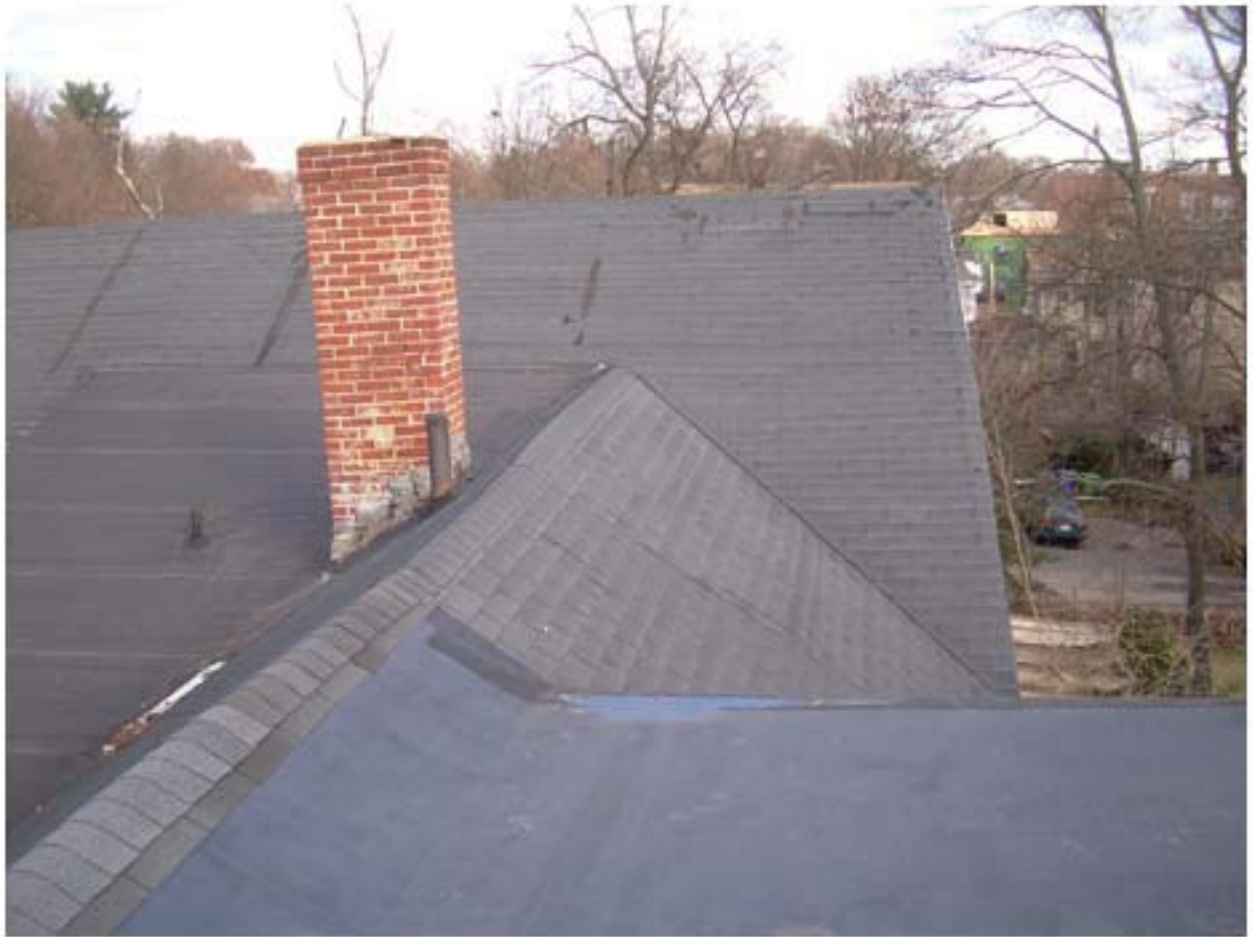
6A- Existing barn chimney

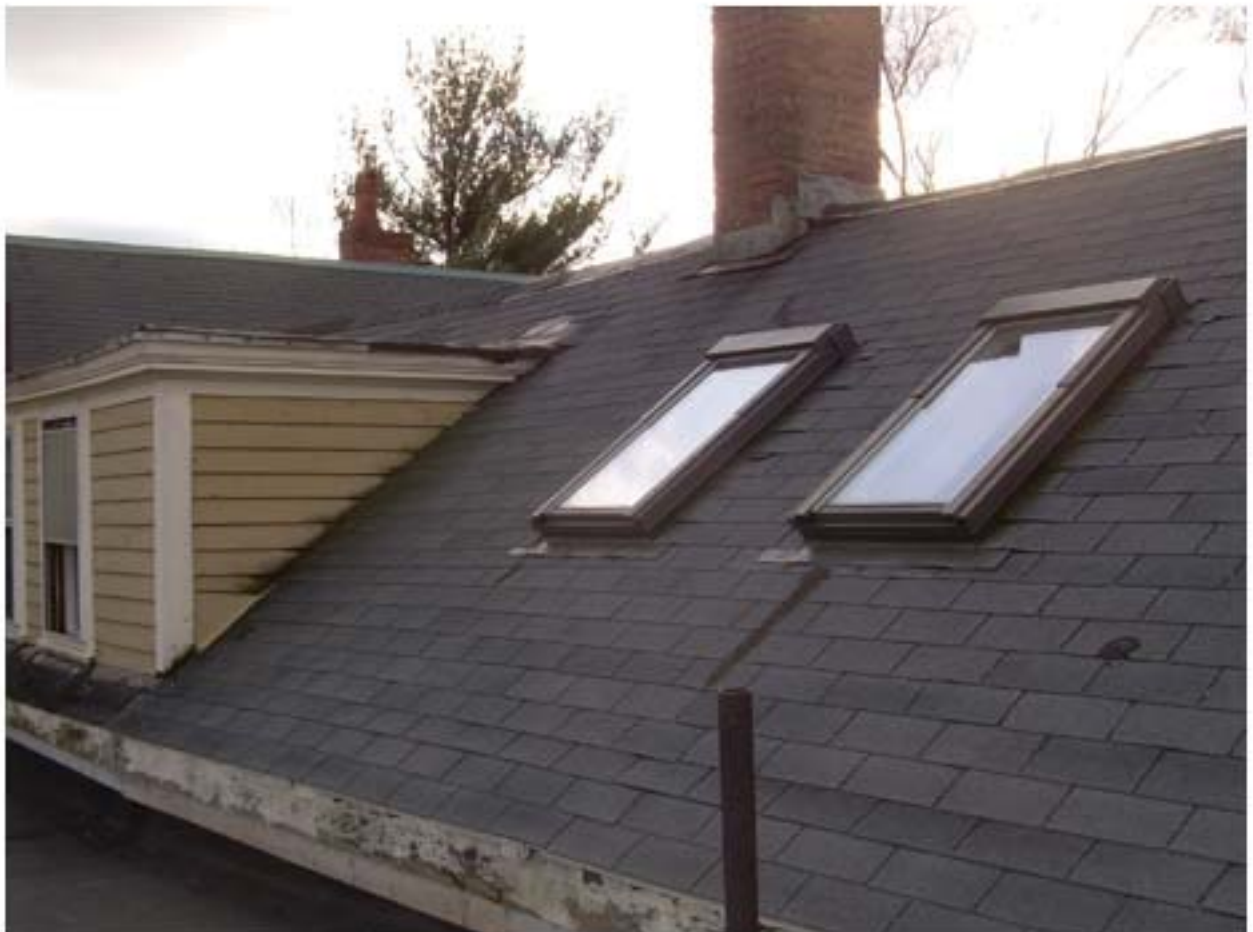
6B- Existing house chimney

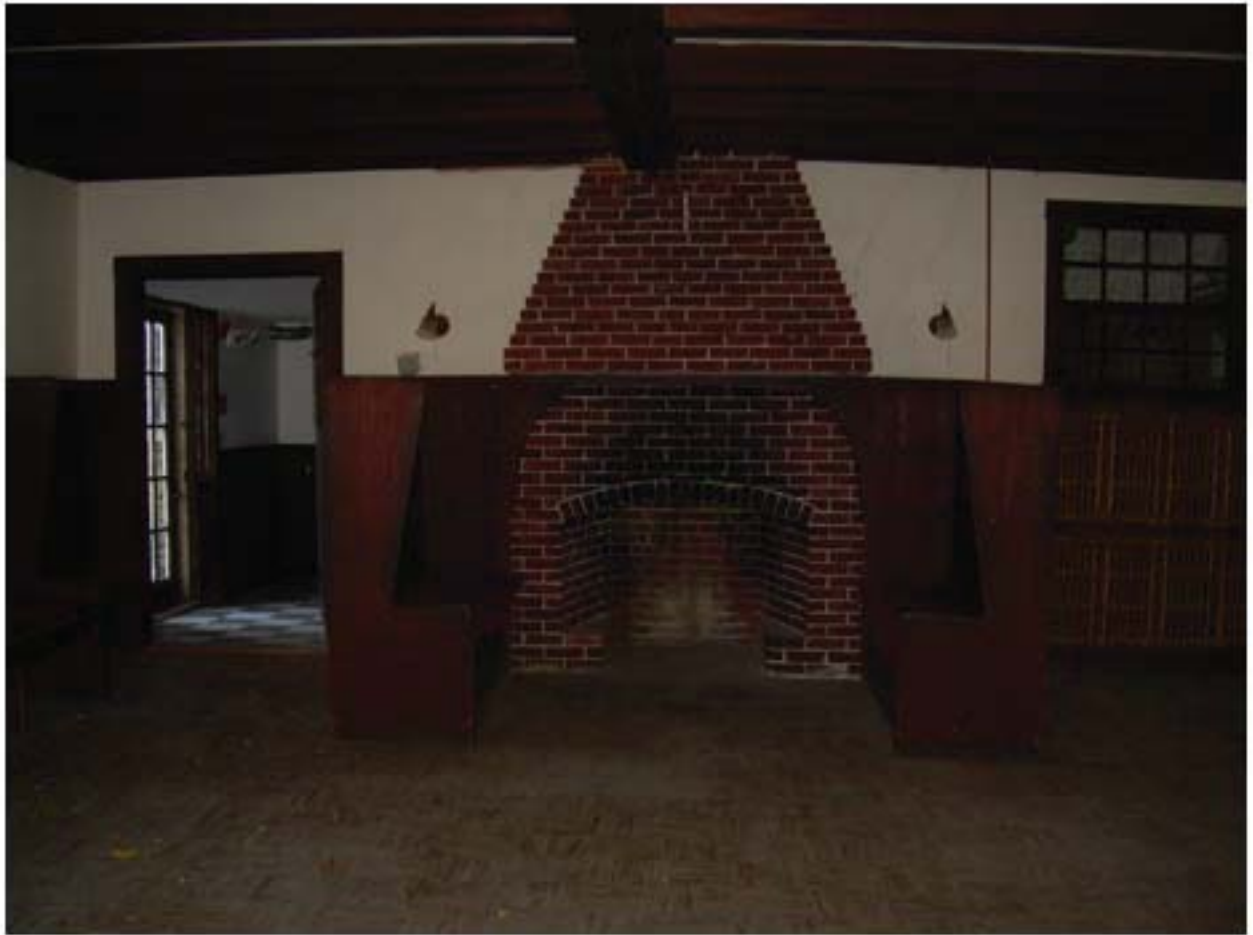
6A (Interior)- Existing barn chimney

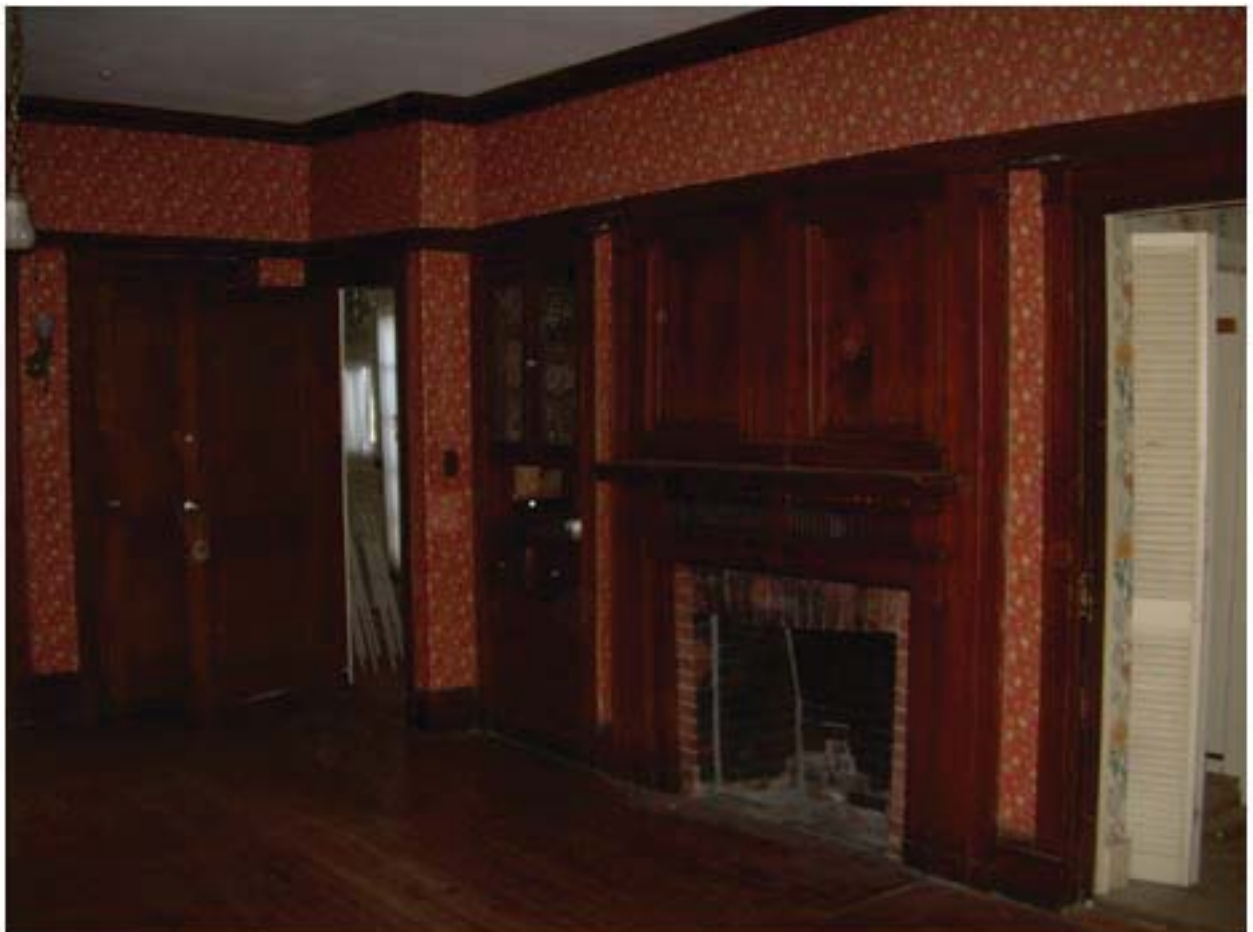
6B (Interior)- Existing house chimney

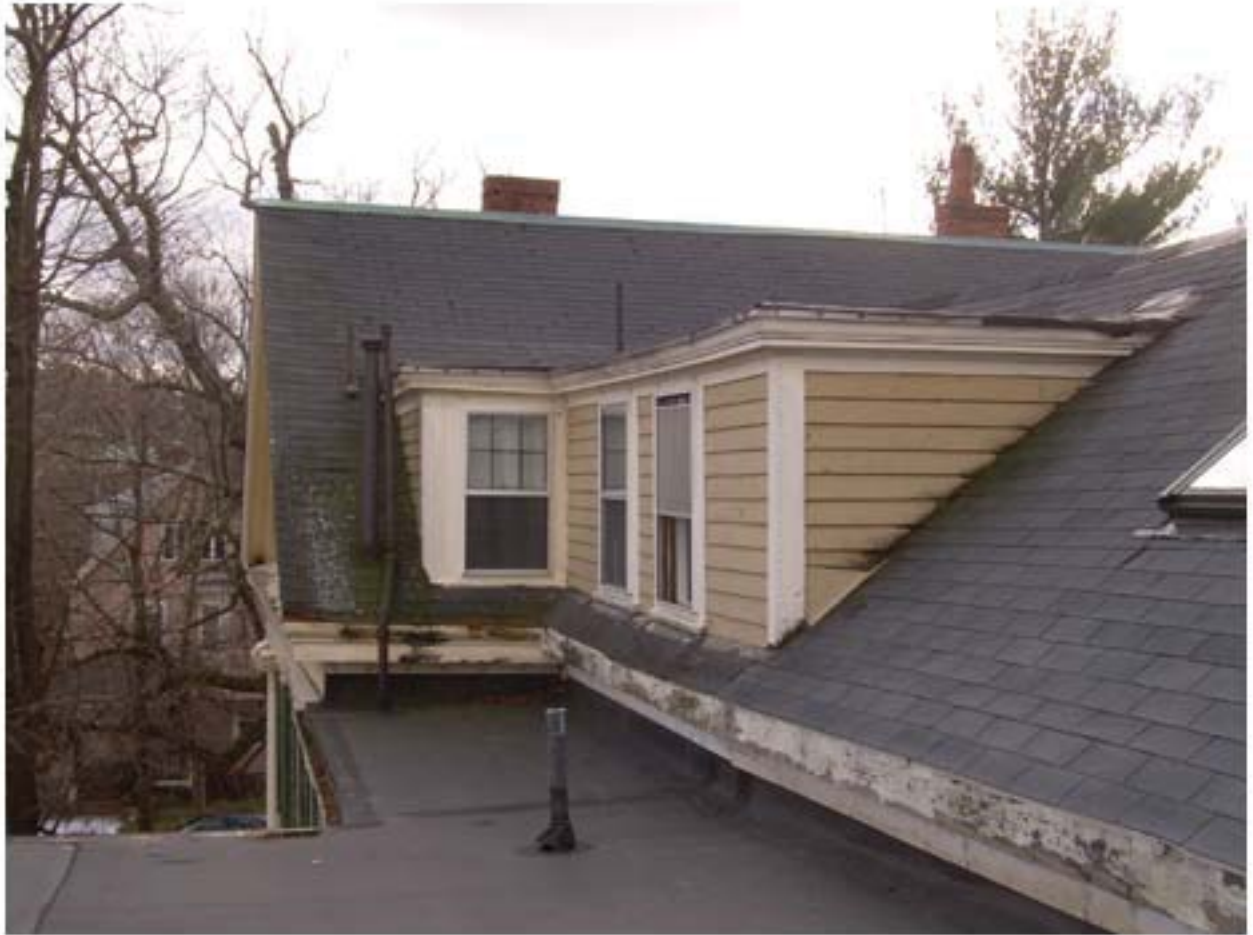
6C- Existing house chimneys

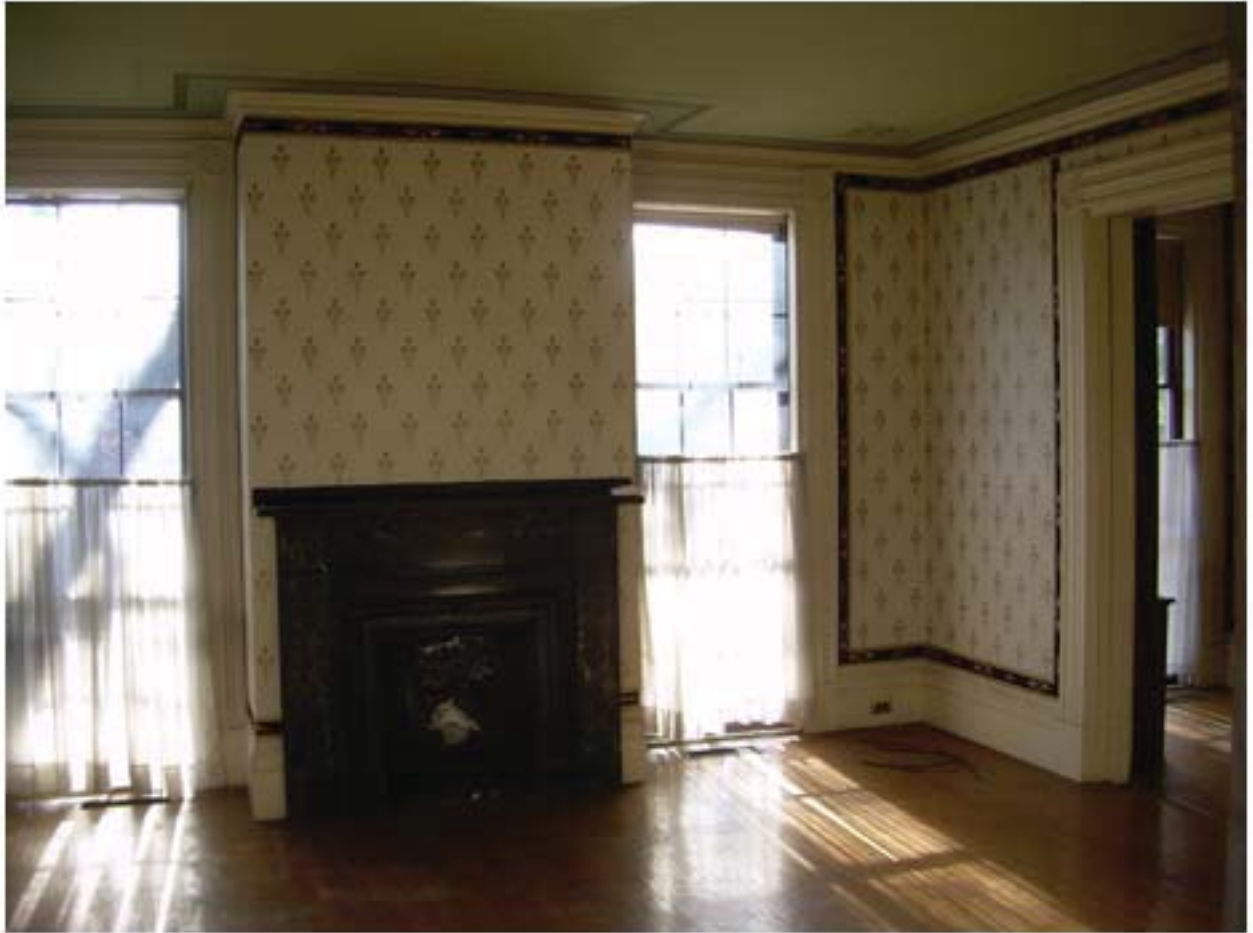
6C&D (Interior)- Existing house chimney

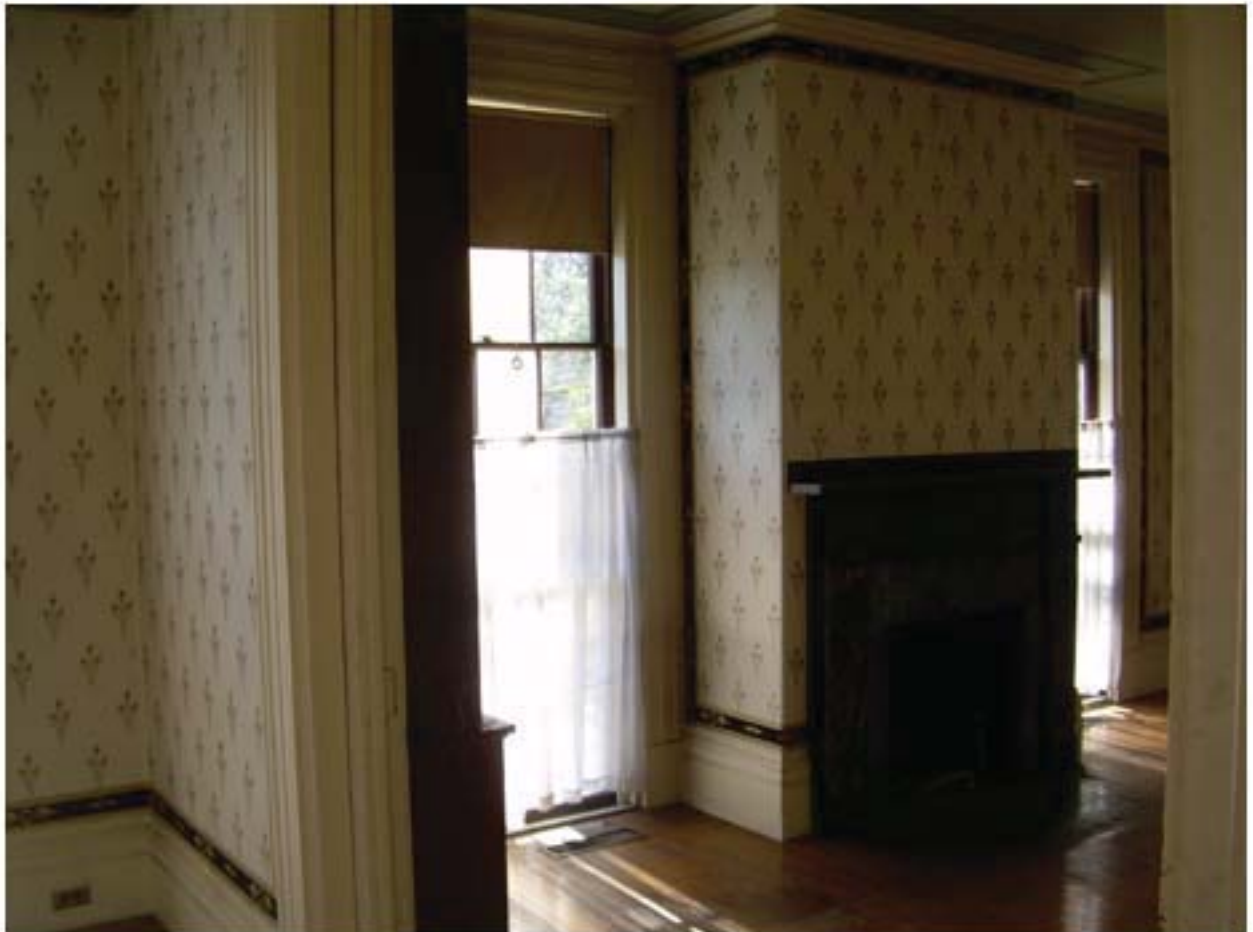
6C&D (Interior)- Existing house chimney
