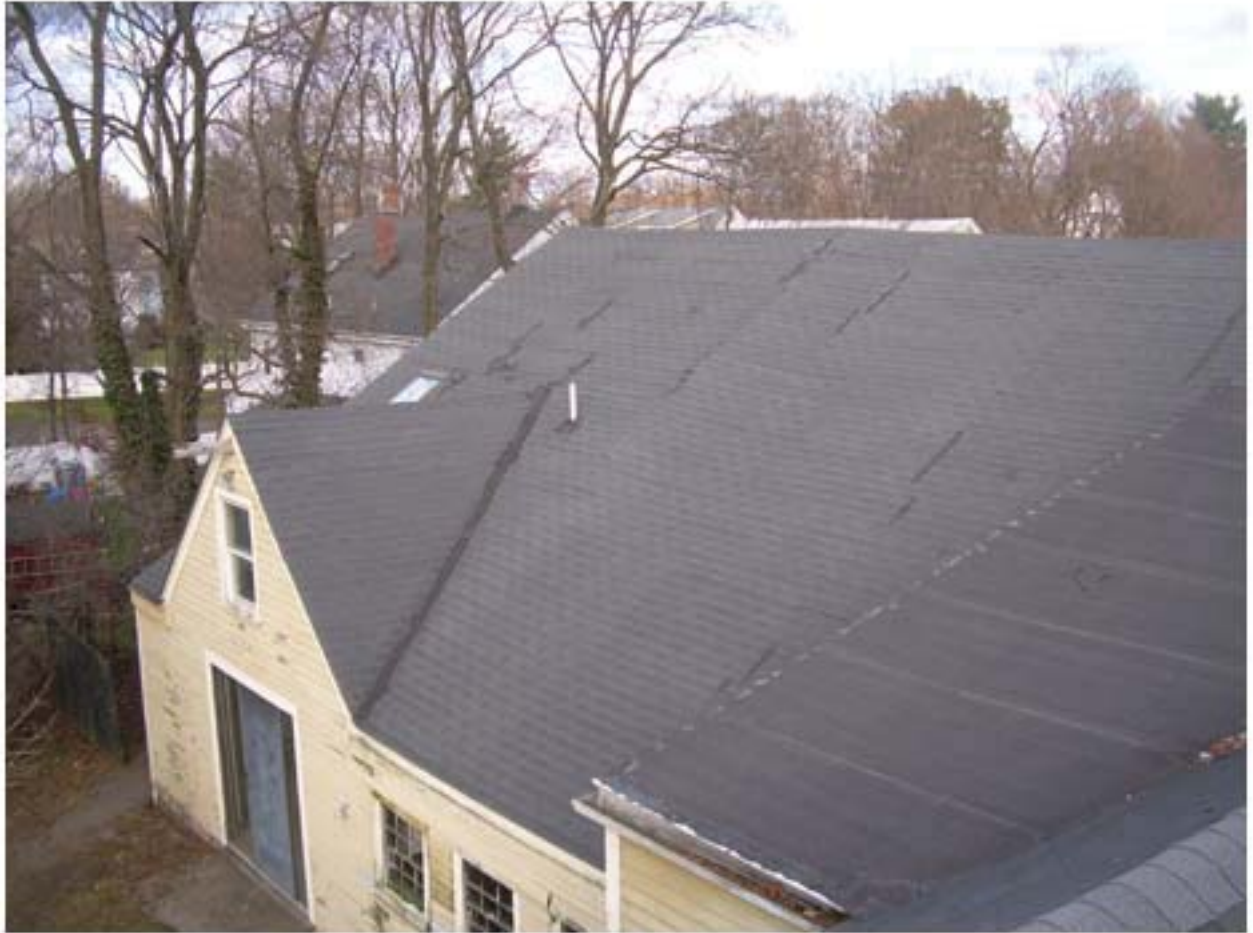
7A- Existing barn sloped gable roof with common three tab black asphalt shingles

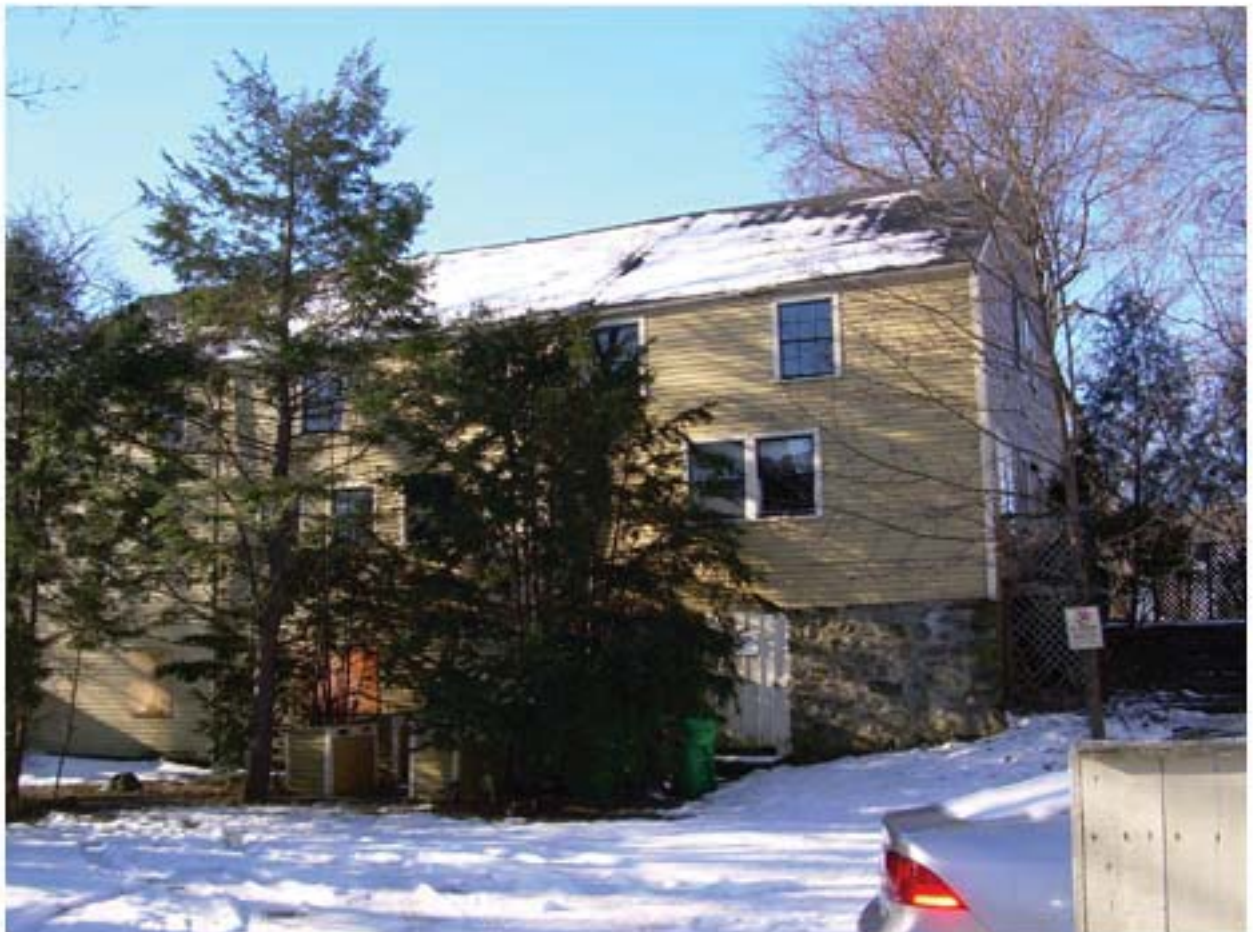
7B- Existing barn sloped gable roof with common three tab black asphalt shingles

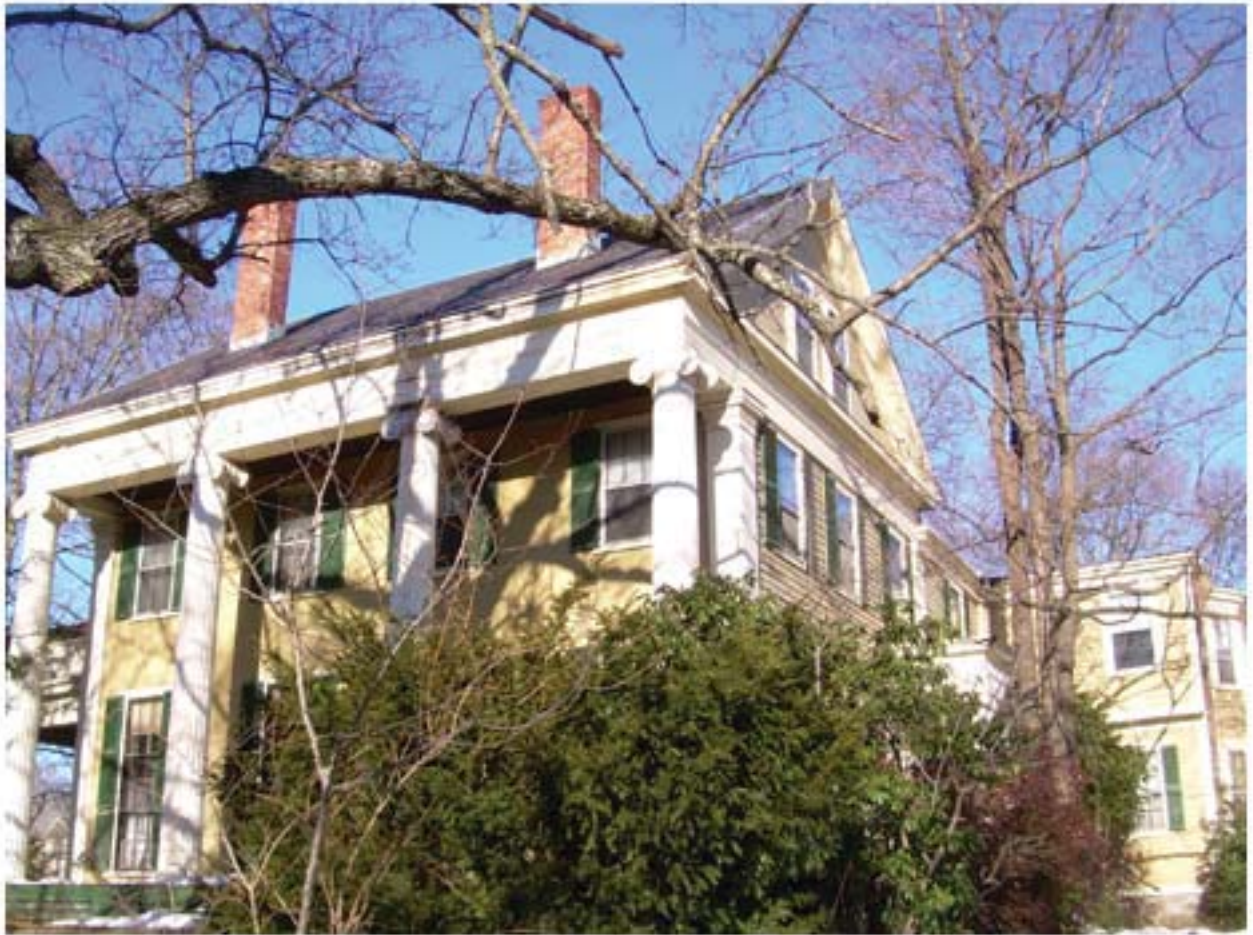
7C- Existing house sloped gable roof with common three tab black asphalt shingles

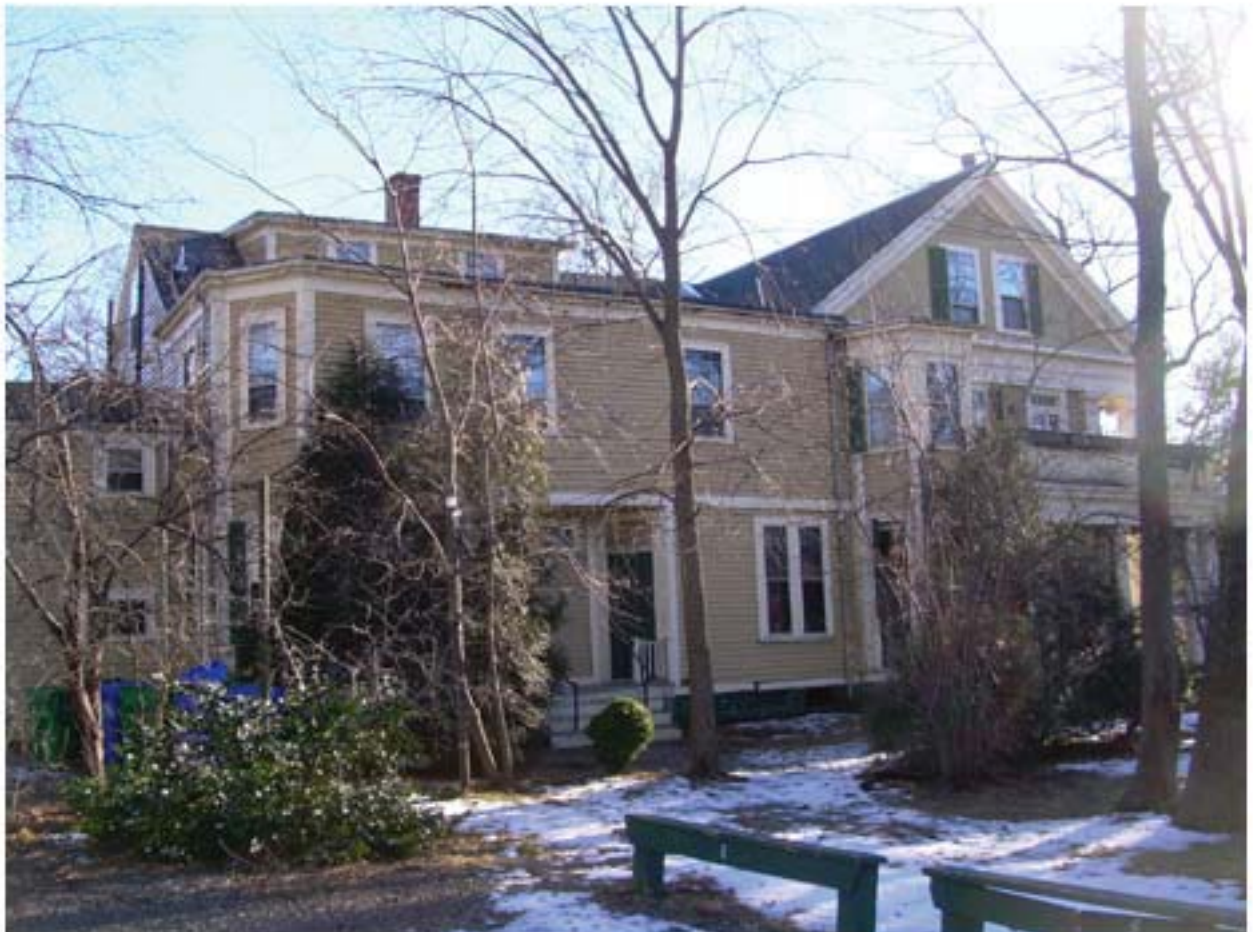
7D- Existing house sloped gable roofs with common three tab black asphalt shingles

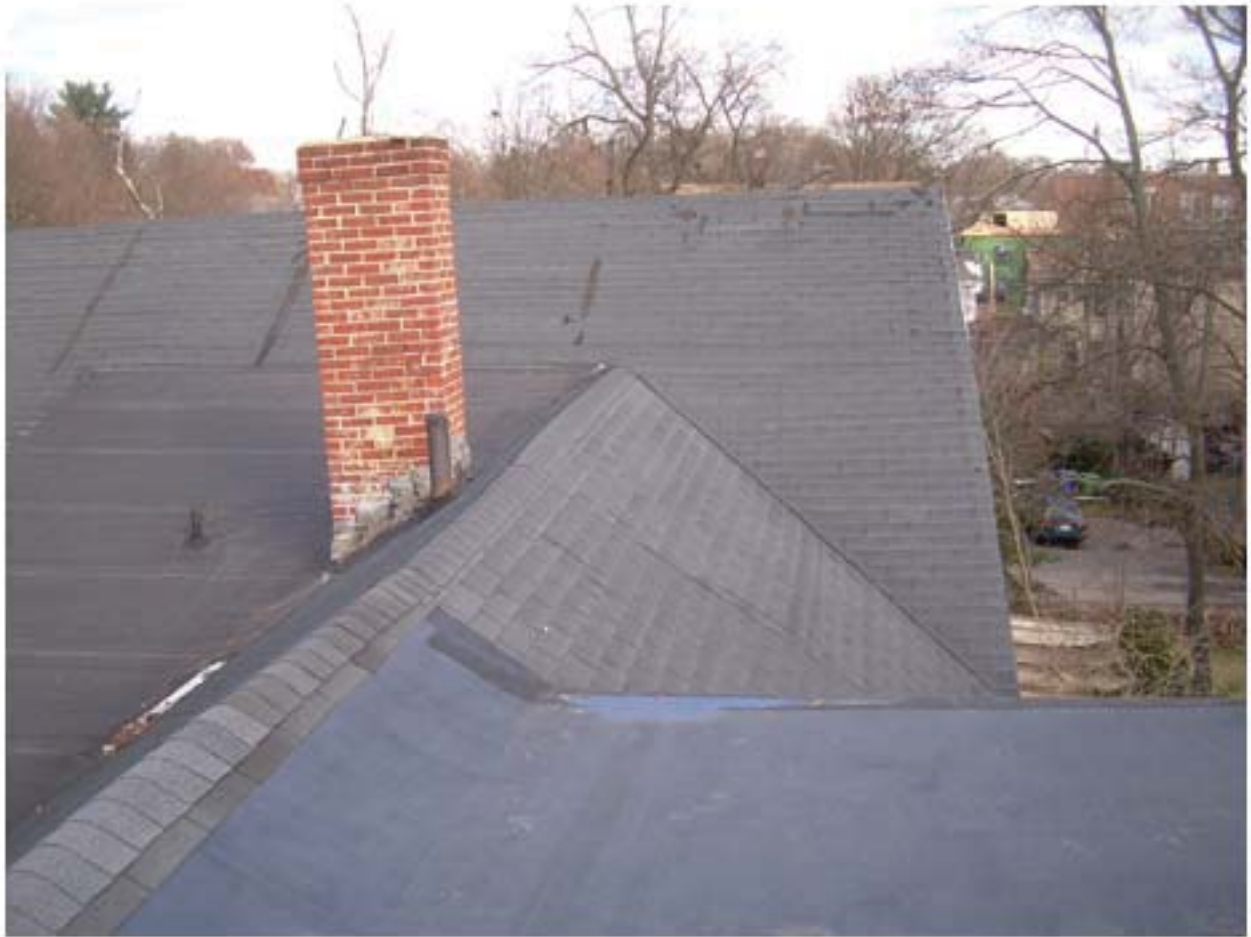
8A- Existing upper flat roof covered with black EPDM membrane roofing

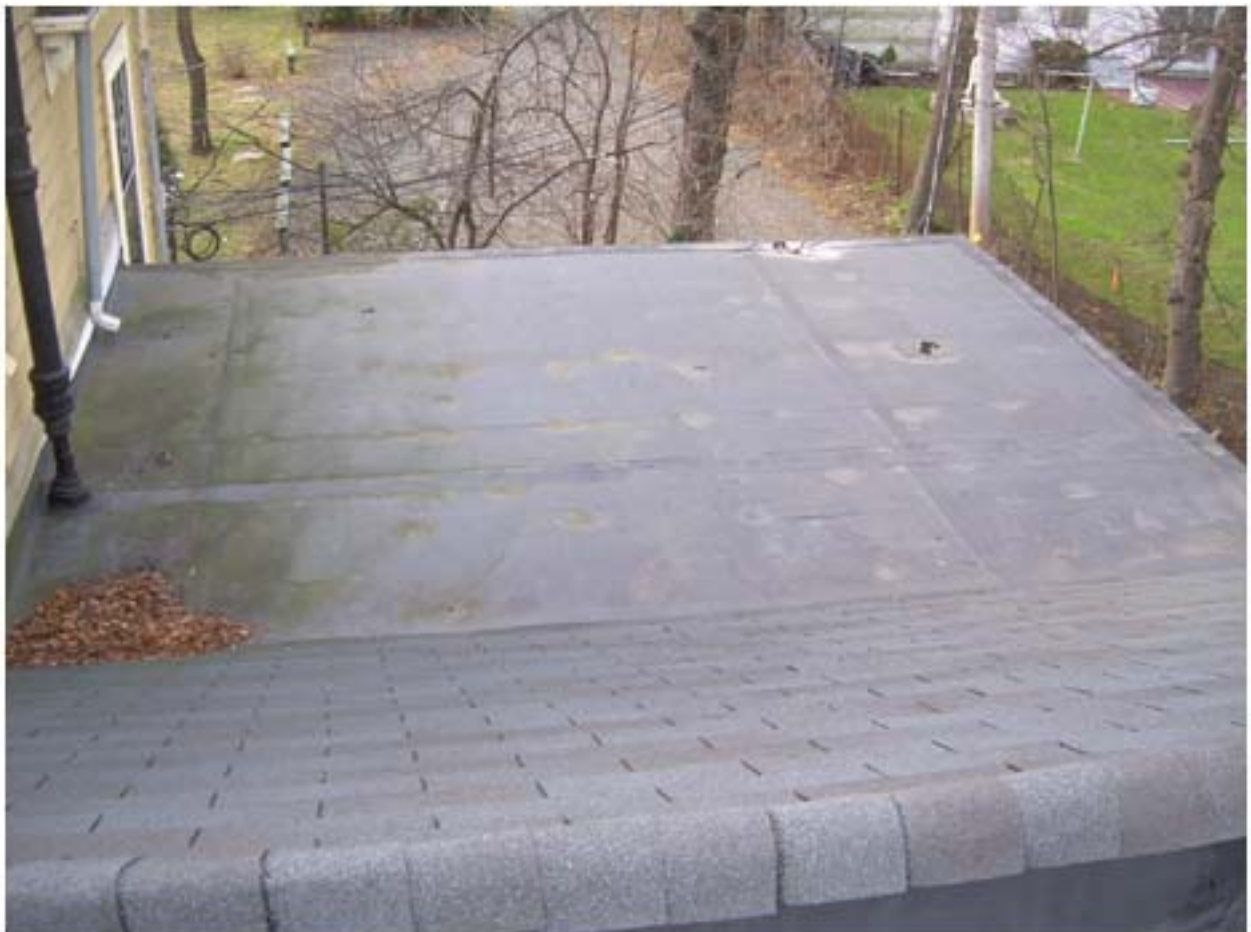
8B- Existing lower flat roof covered with black EPDM membrane roofing

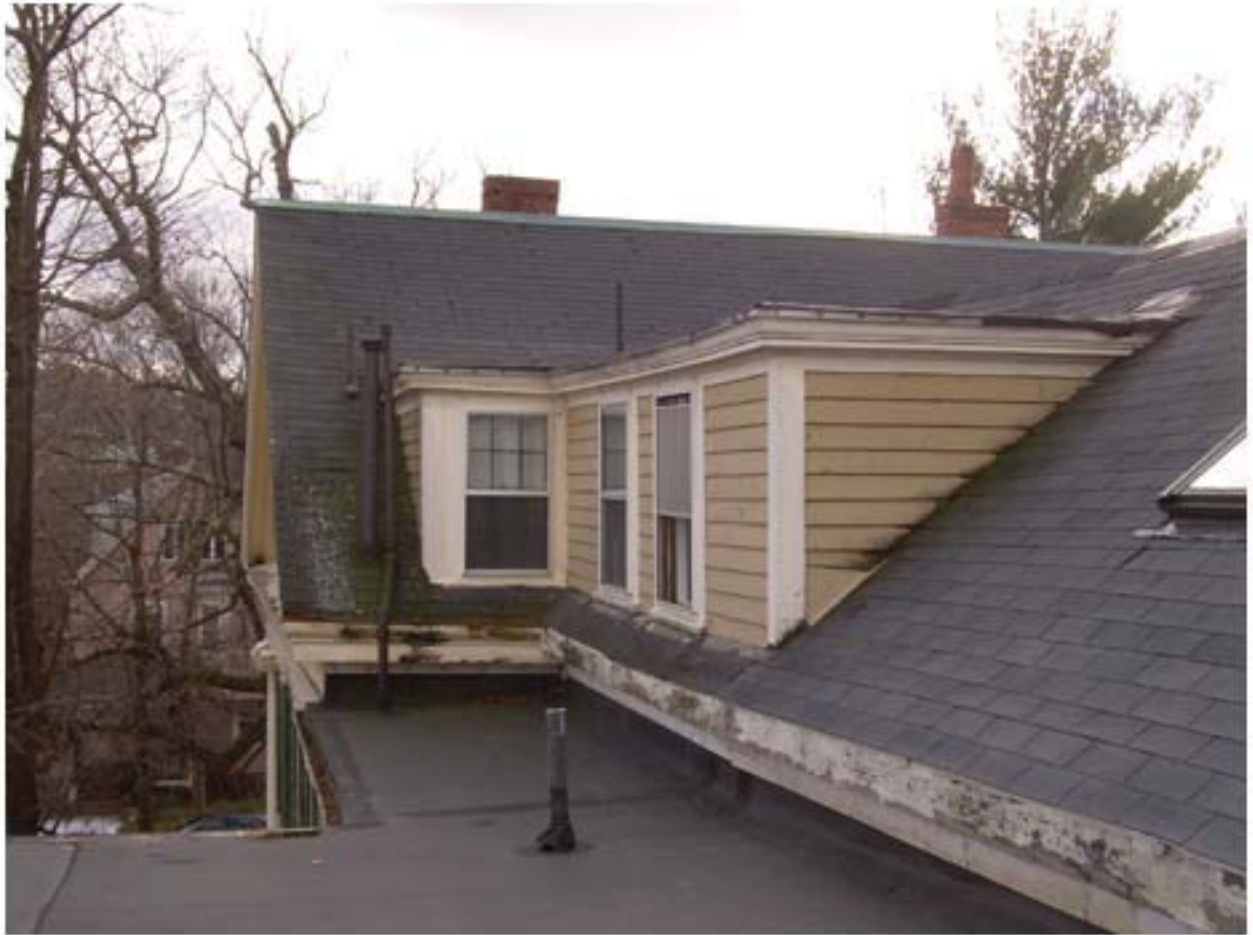
8C- Existing upper flat roof covered with black EPDM membrane roofing

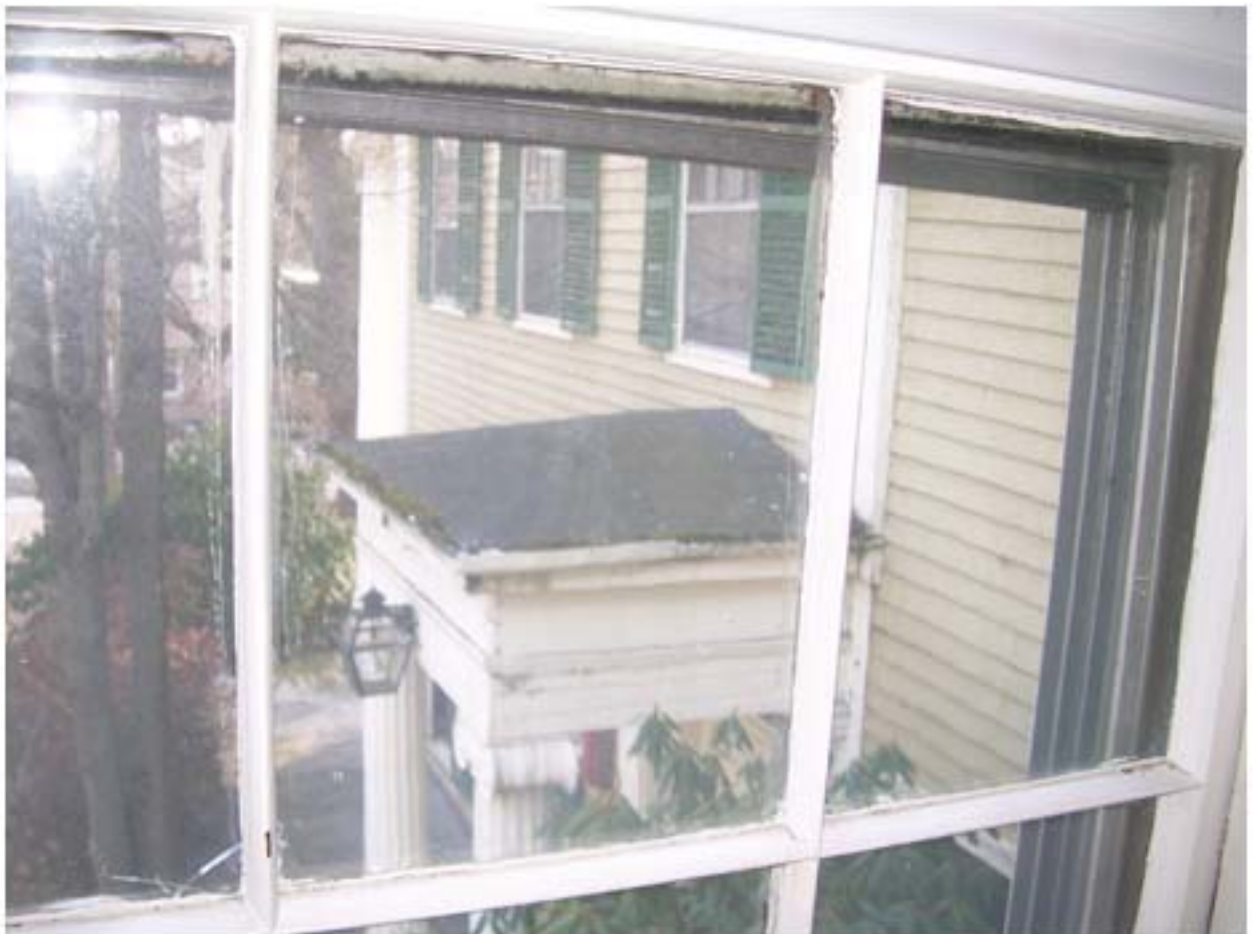
9B- Existing east porch low sloped hot mopped asphalt roof

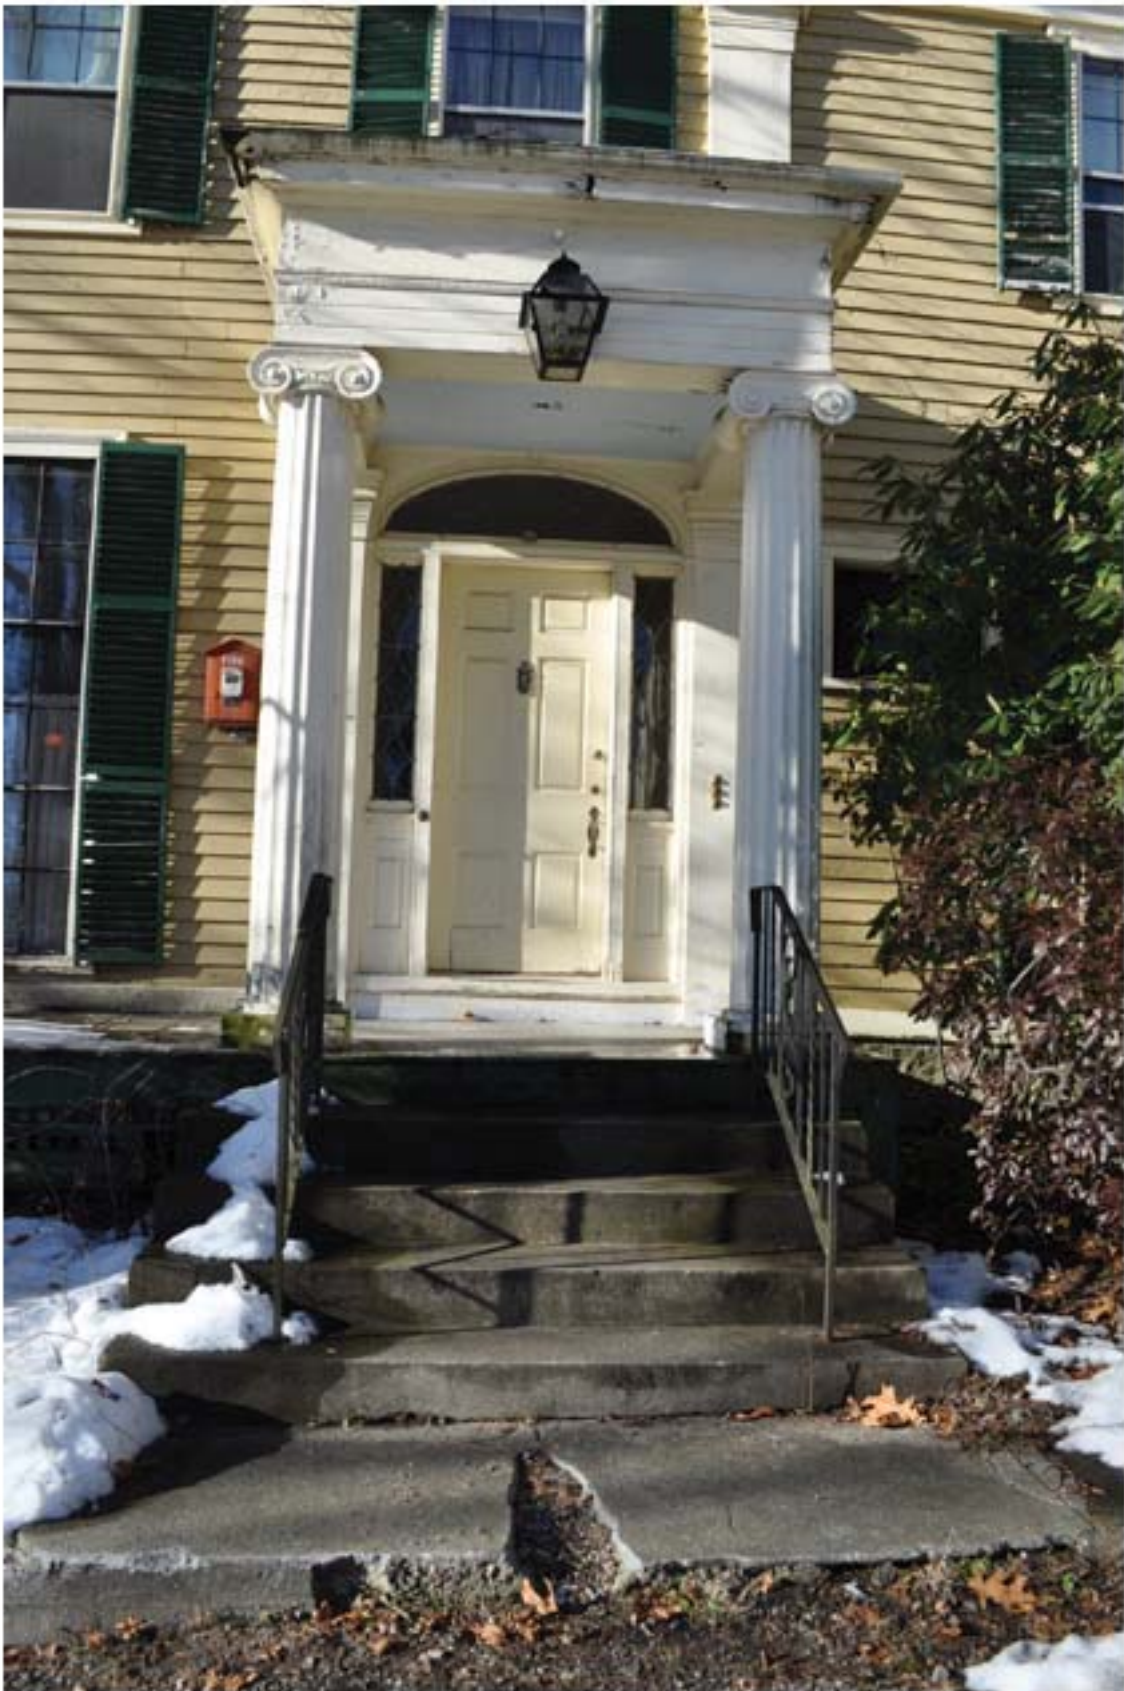
9C- Existing east porch and low sloped hot mopped asphalt roof

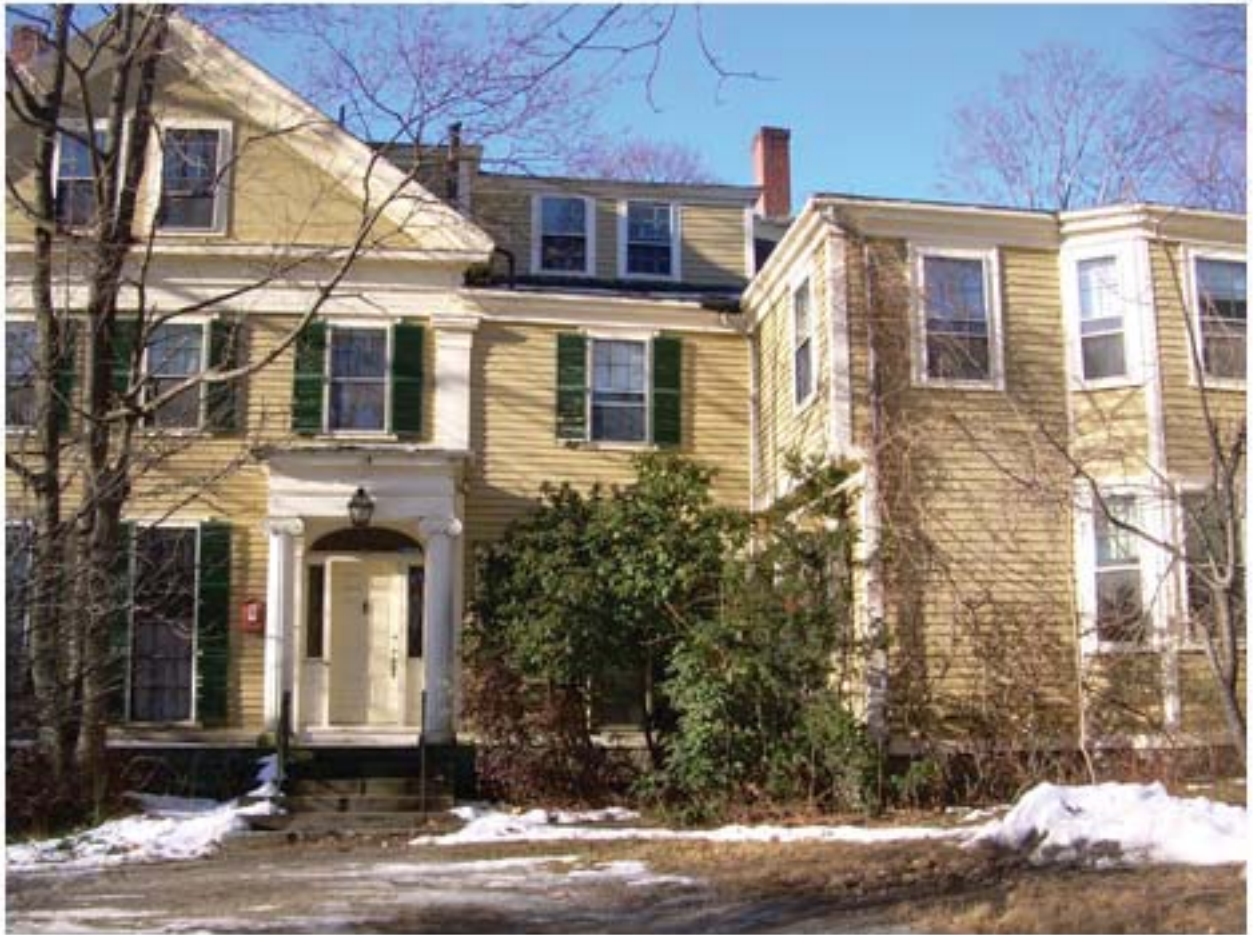
10A- Existing east entrance porch and house cornice

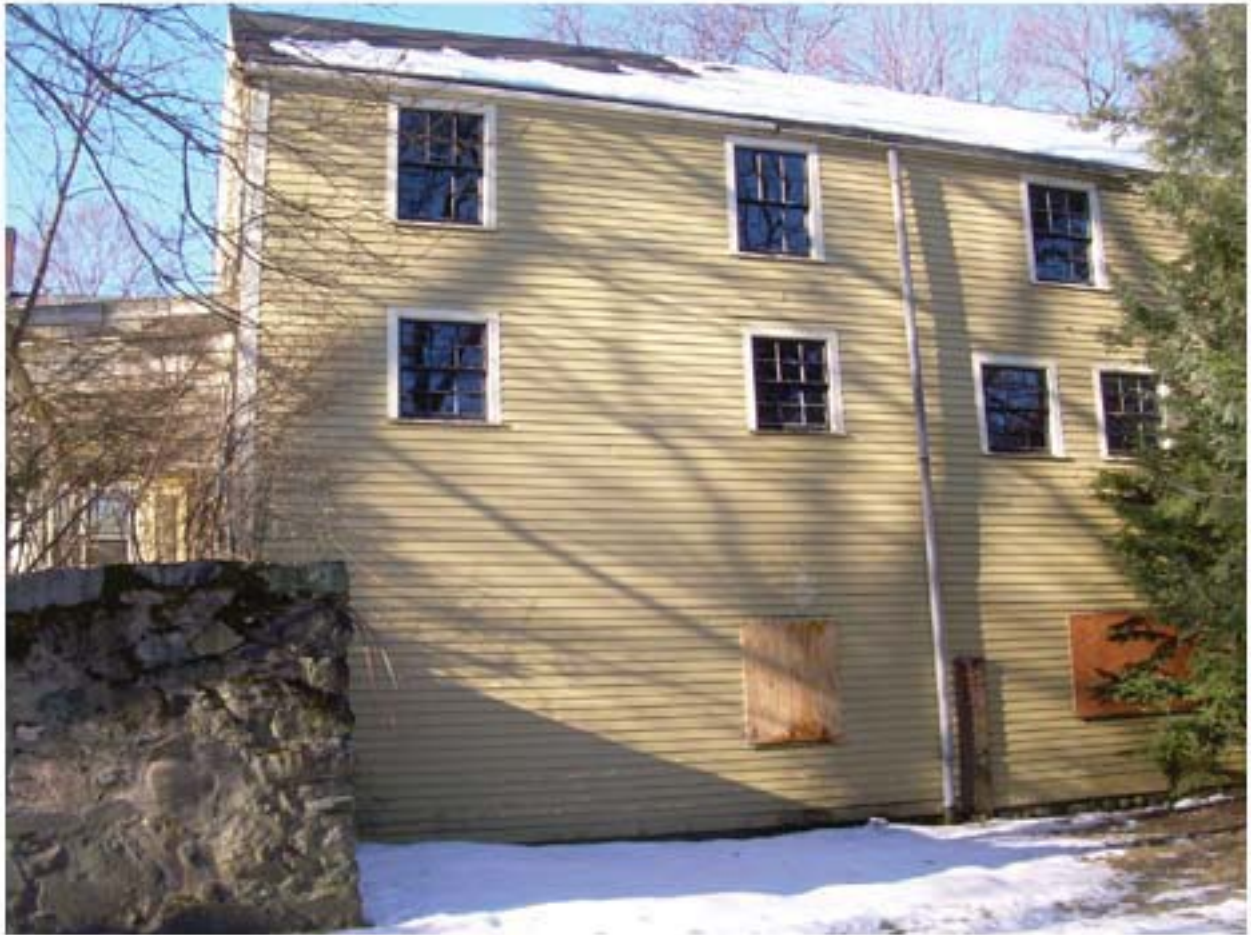
11A- Existing east side of barn

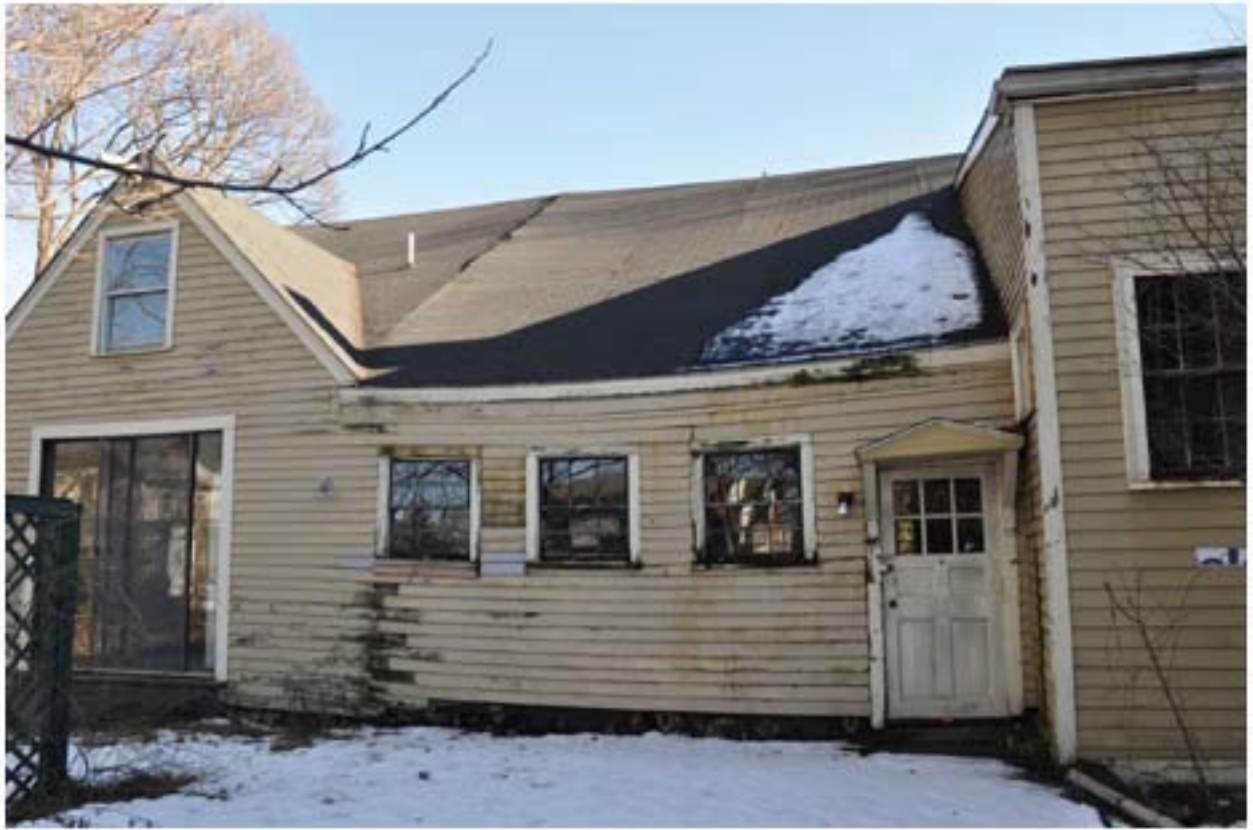
11C- Existing west side of barn with missing and rotted components

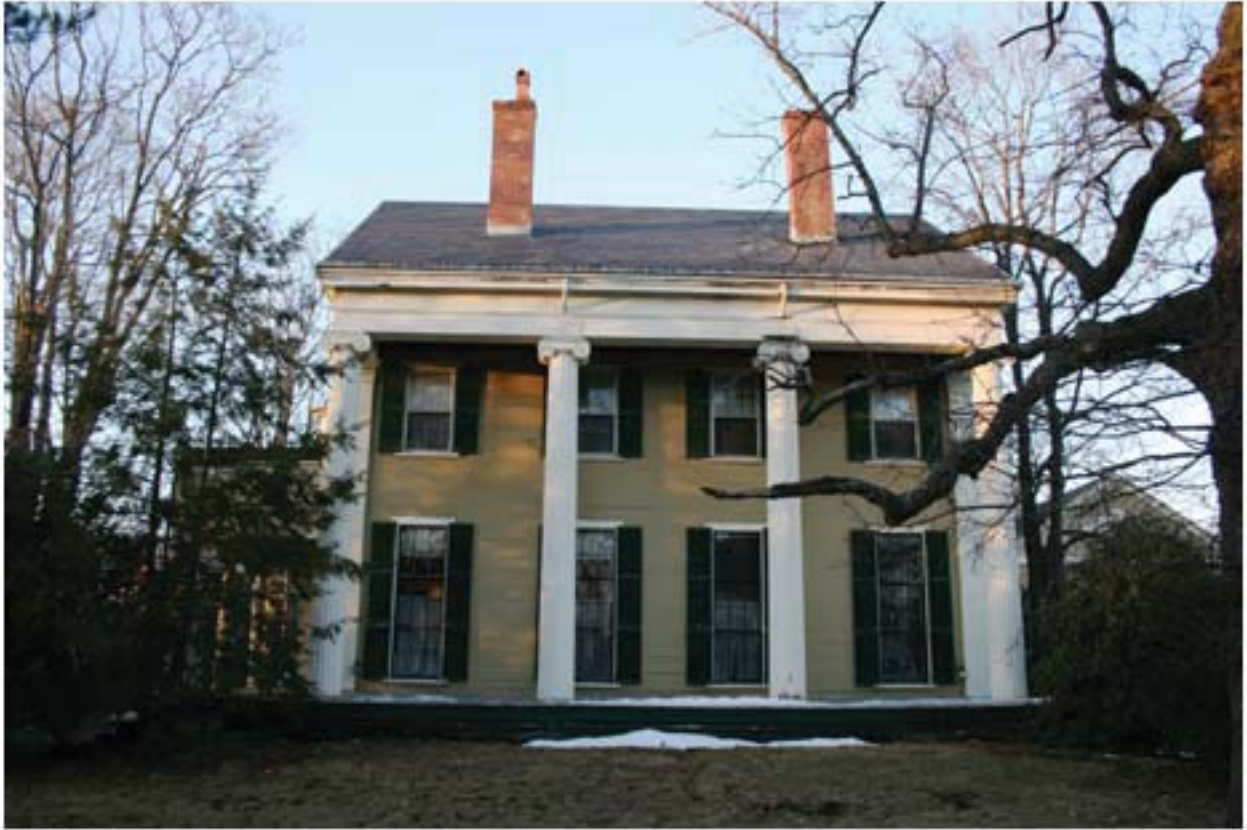
12A- Existing monumental ionic columns on south side of building

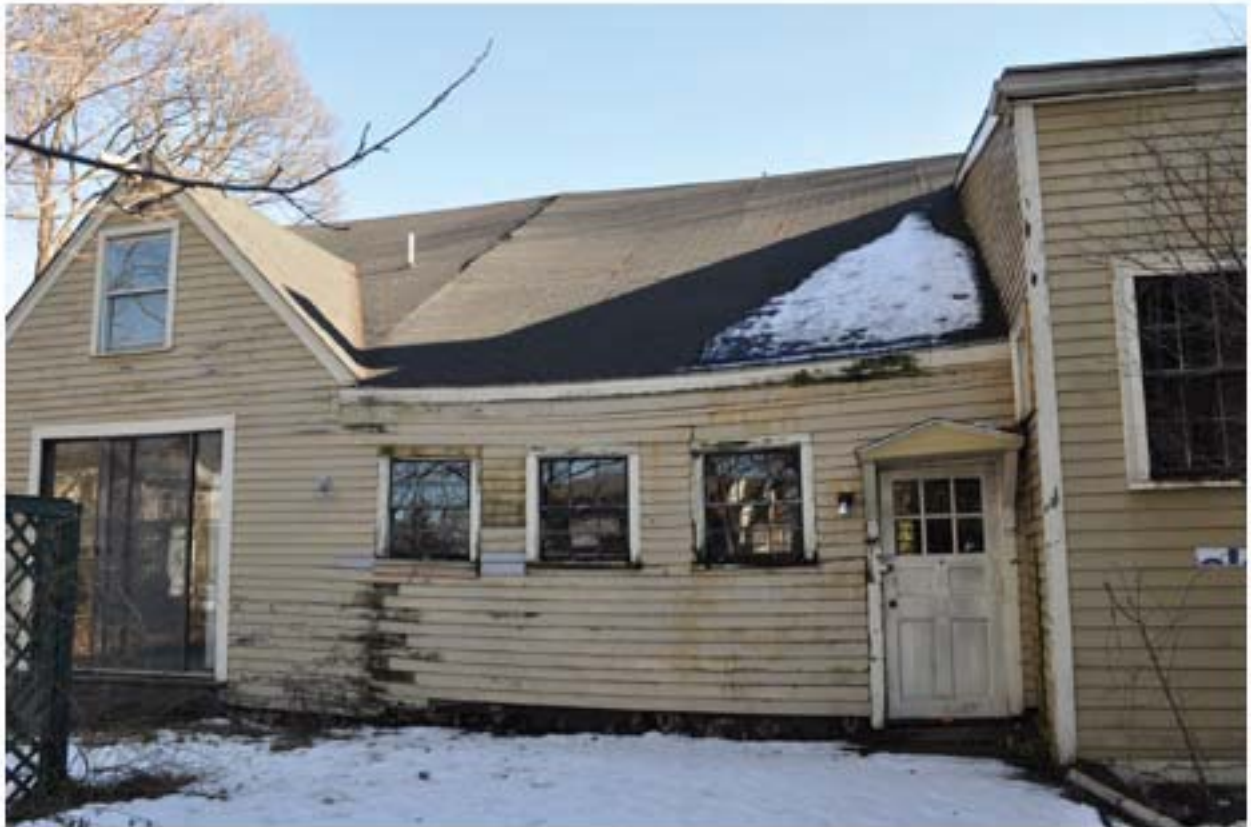
13A- Existing siding and water damage on west side of barn

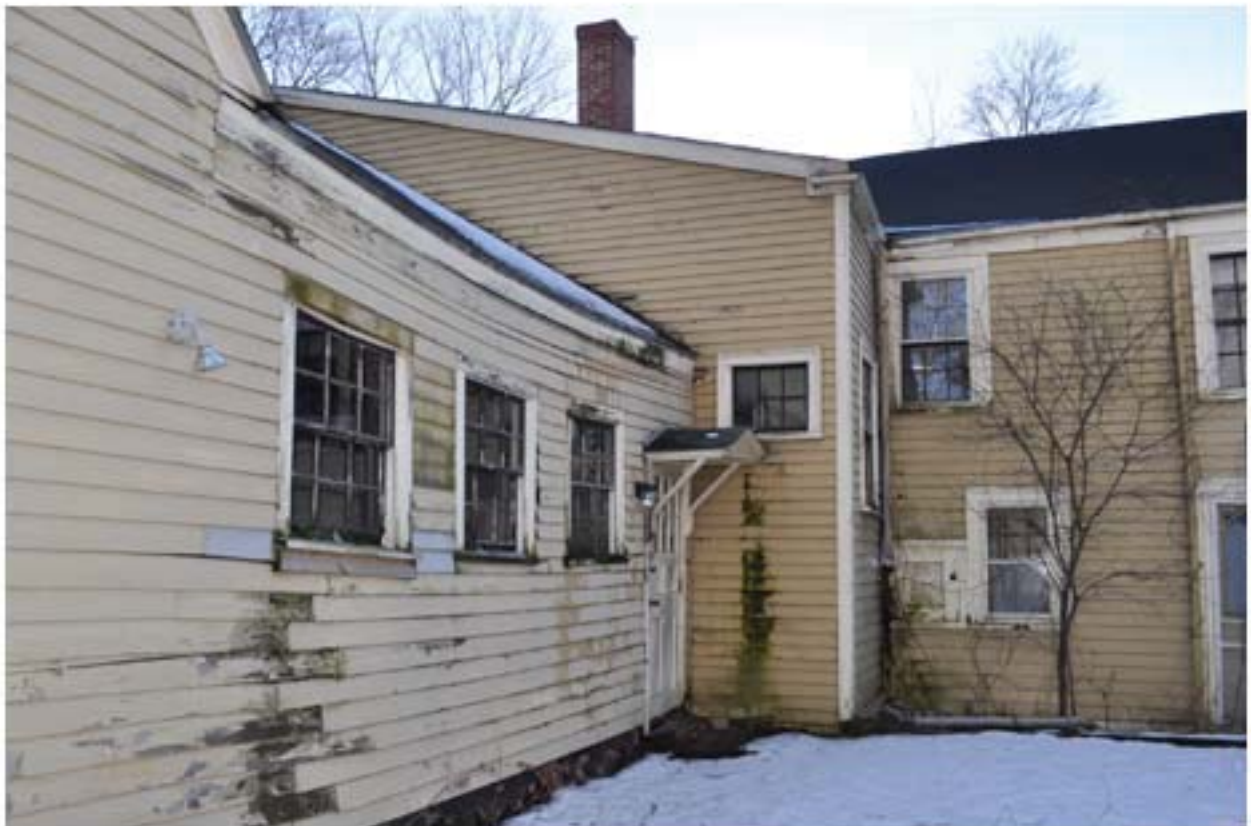
13B- Existing siding and water damage on west side of barn and north side of house

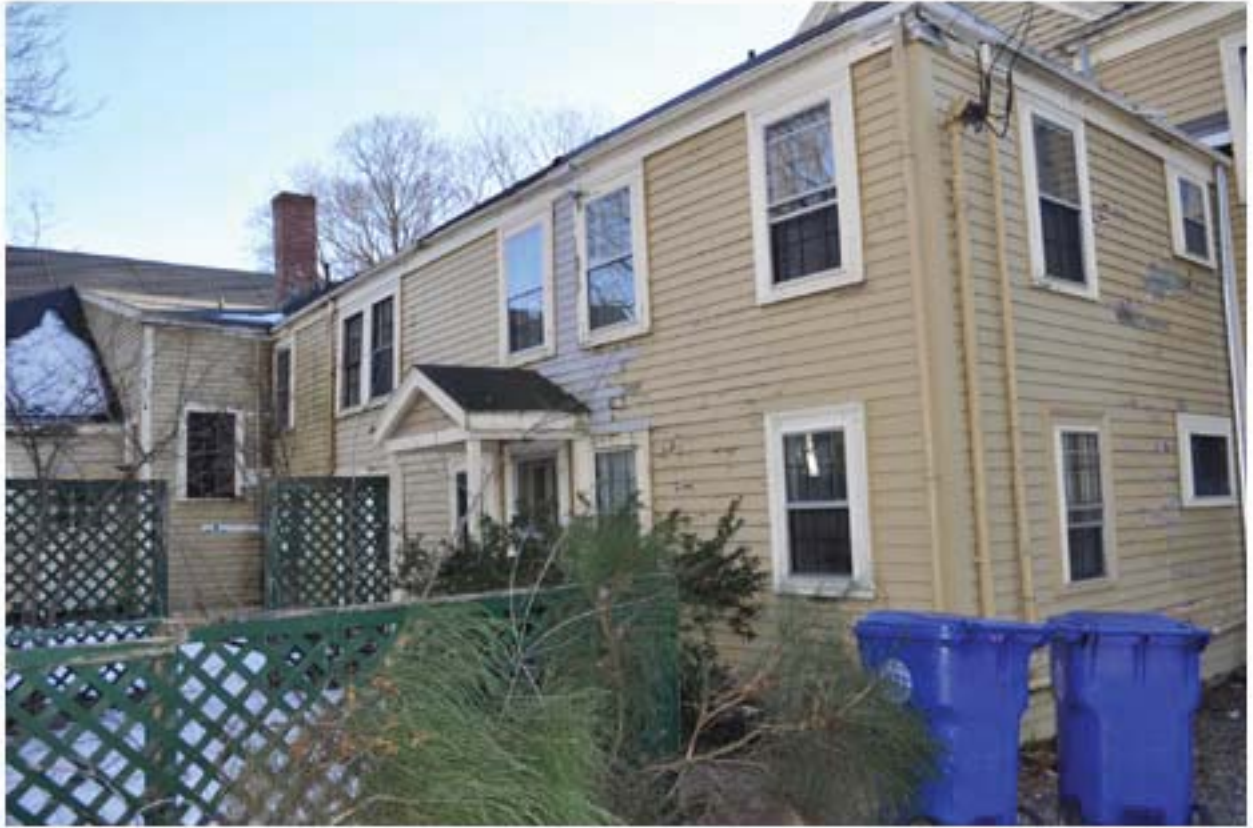
13C- Existing siding on south and west side of house

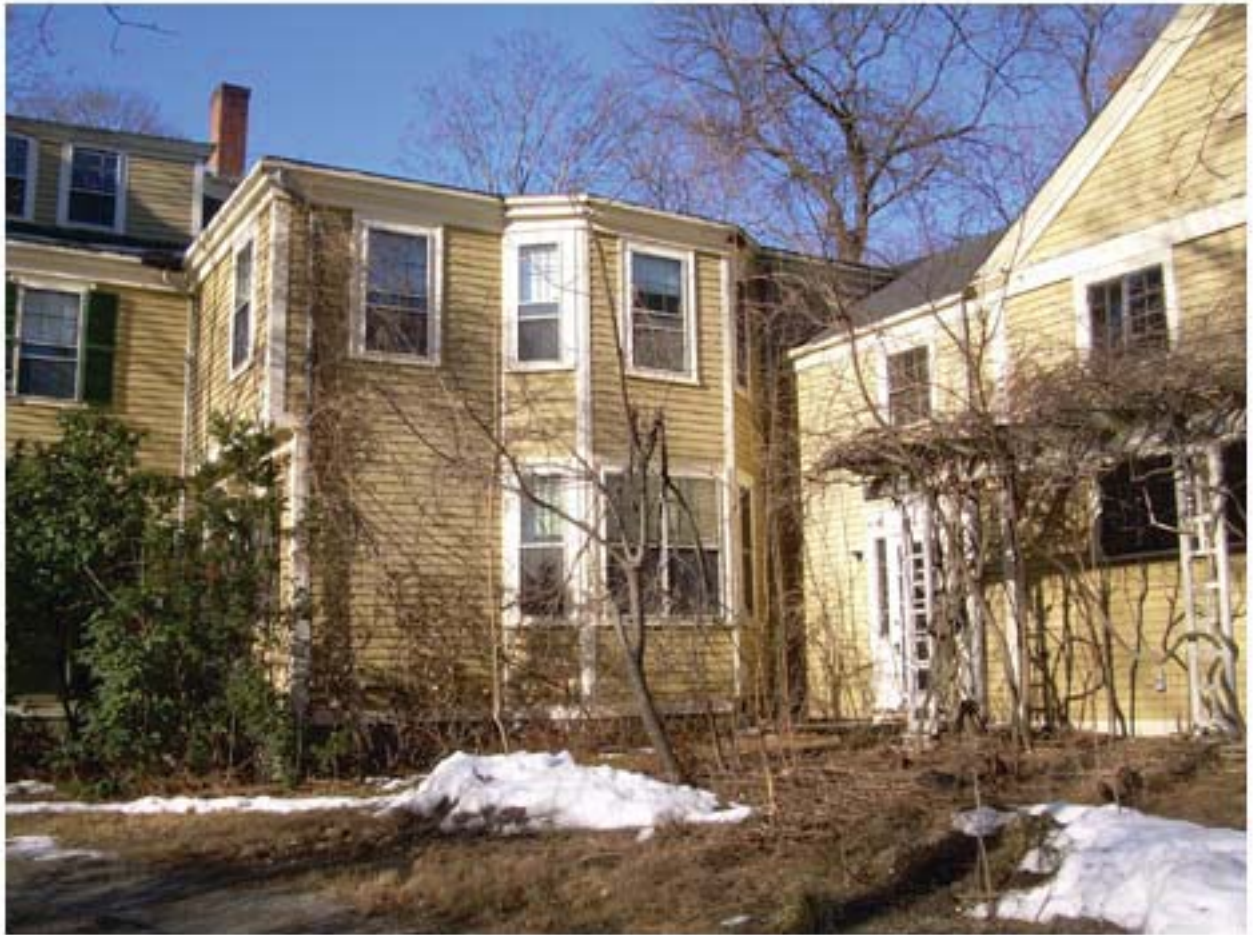
14A- Existing double hung wood windows on east side of house and south side of barn

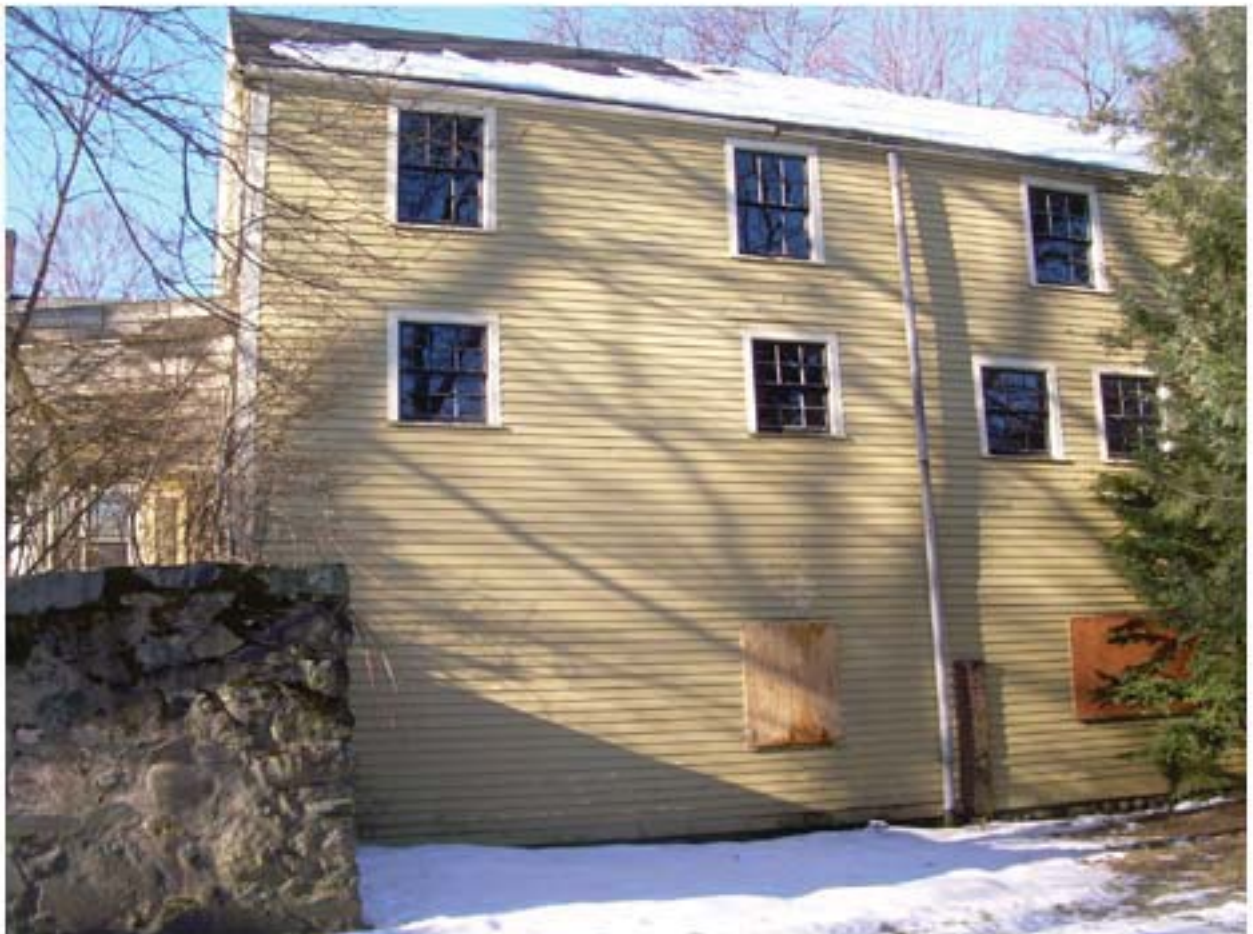
14B- Existing double hung wood windows on east side of barn

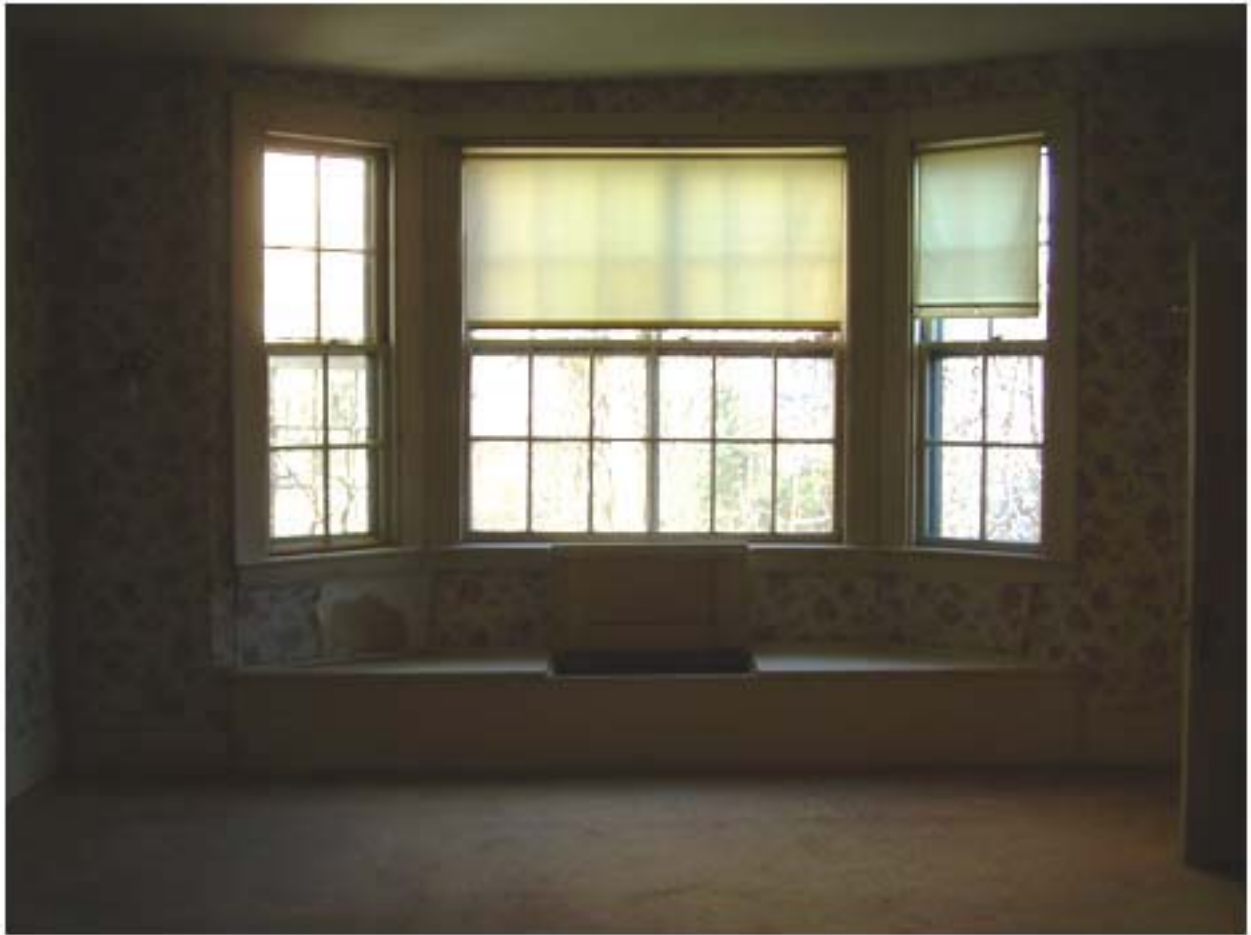
14A (Interior)- Existing double hung wood windows on first floor of east side of house
