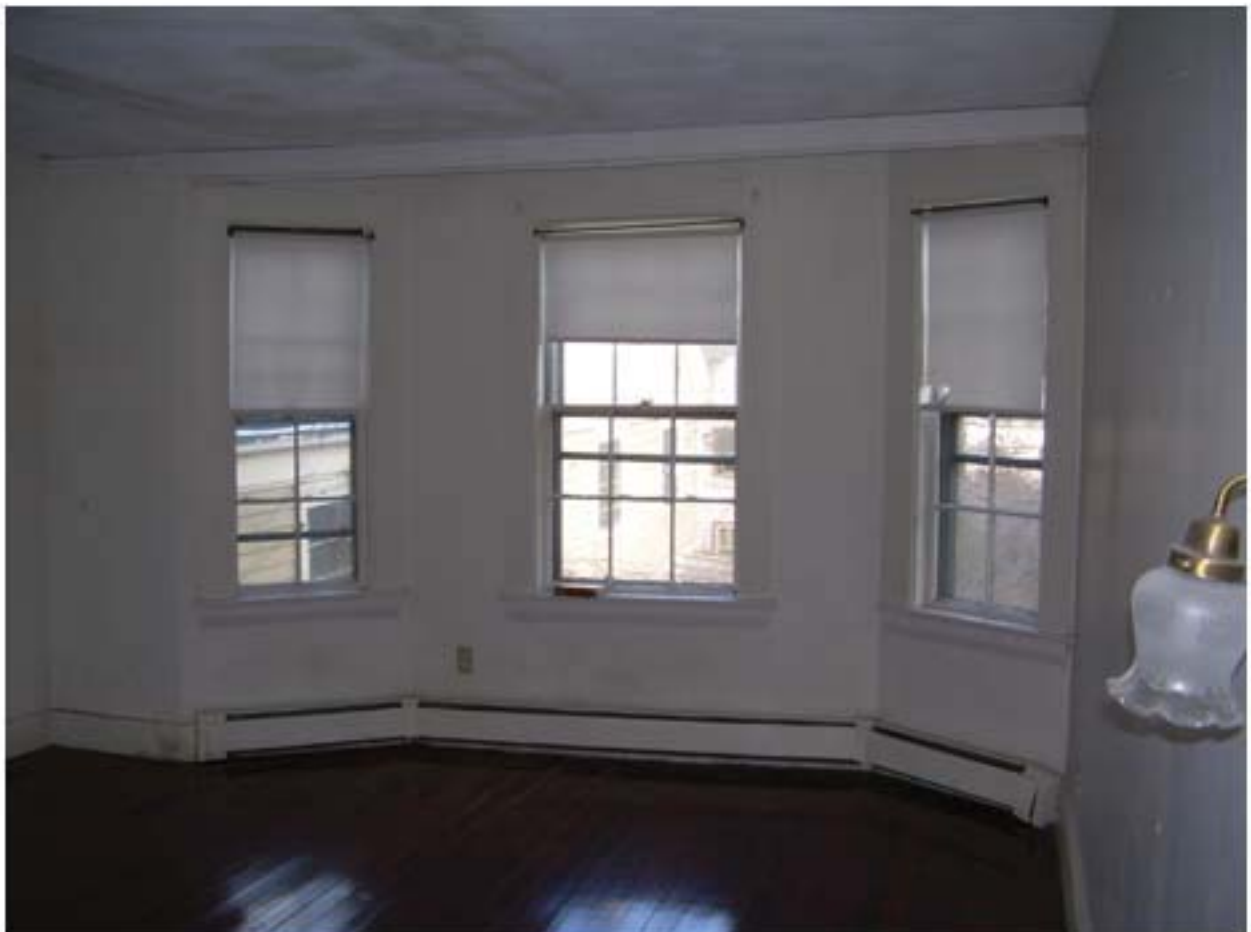
14A (Interior)- Existing double hung windows on second floor of east side of house

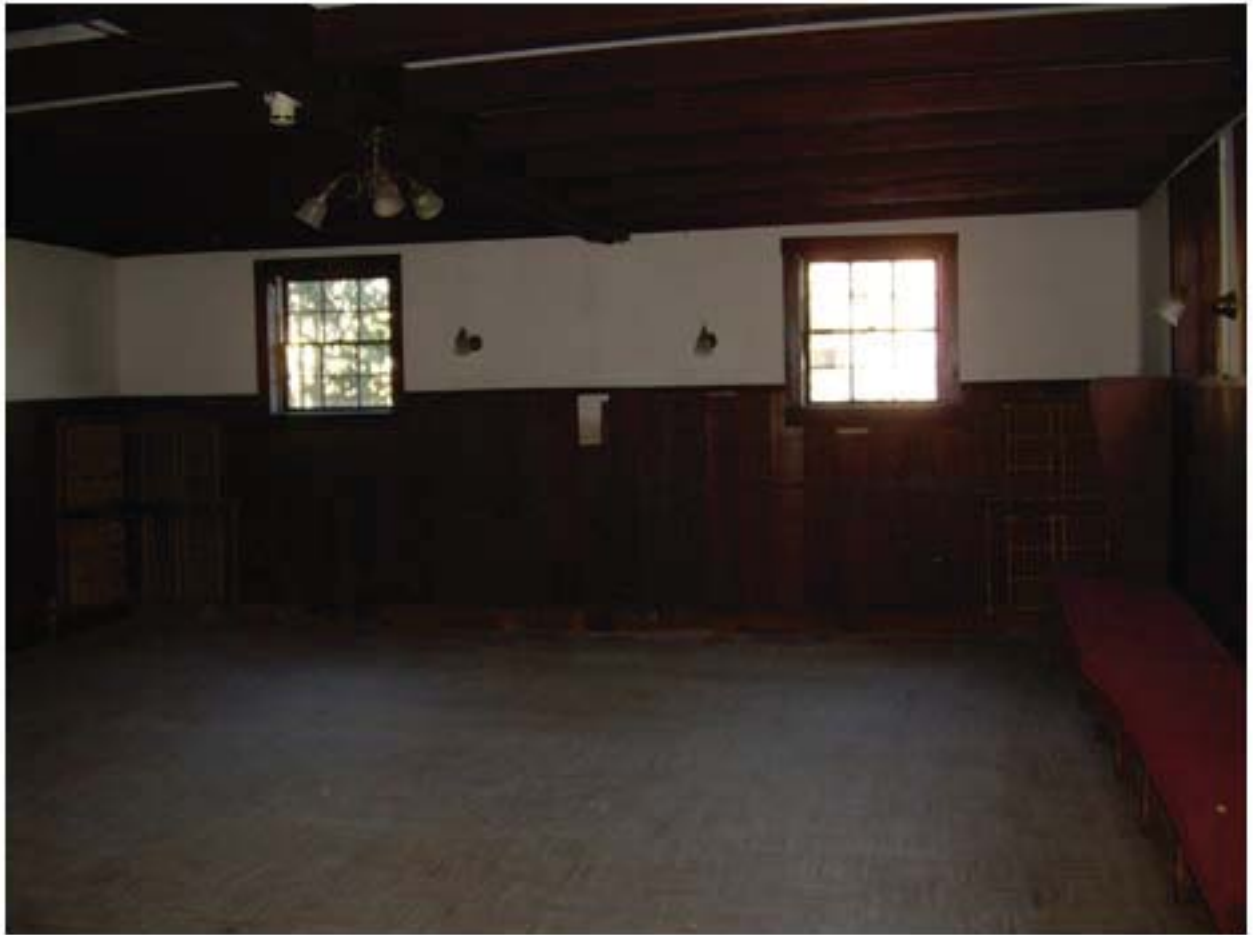
14B (Interior)- Existing double hung wood windows on first floor of east side of barn

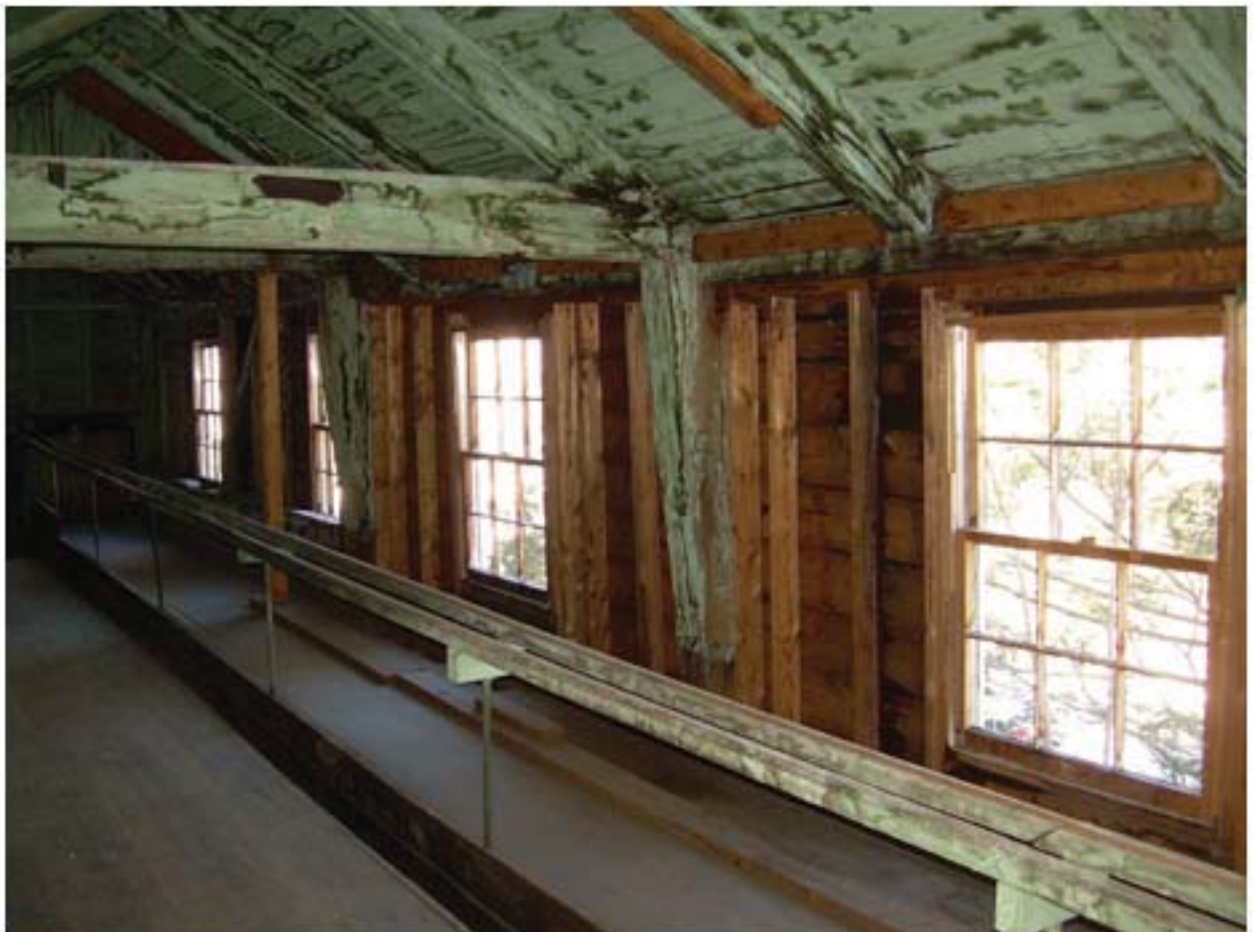
14B (Interior)- Existing double hung windows on second floor of east side of barn

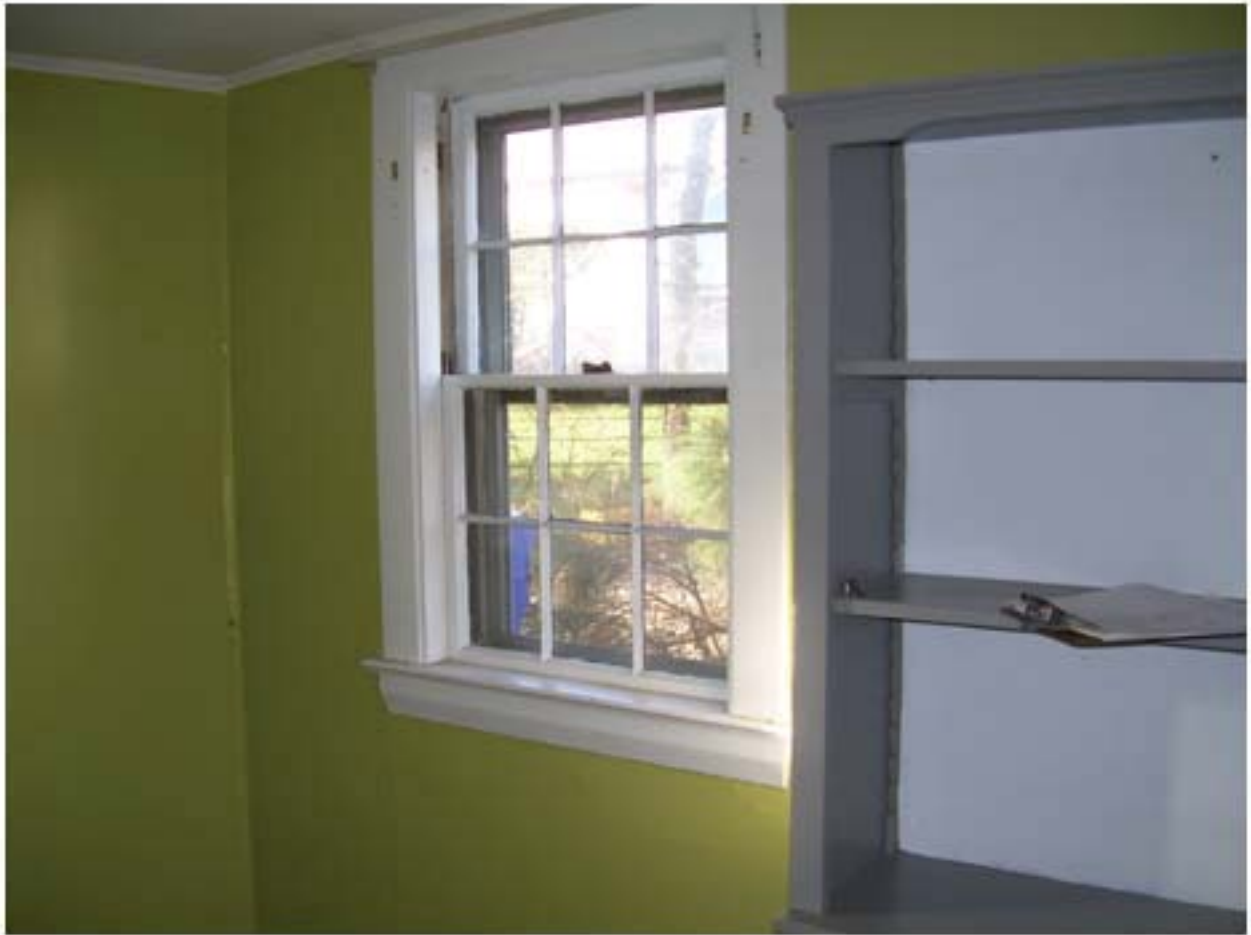
14C (Interior)- Existing double hung wood windows on first floor of north side of house

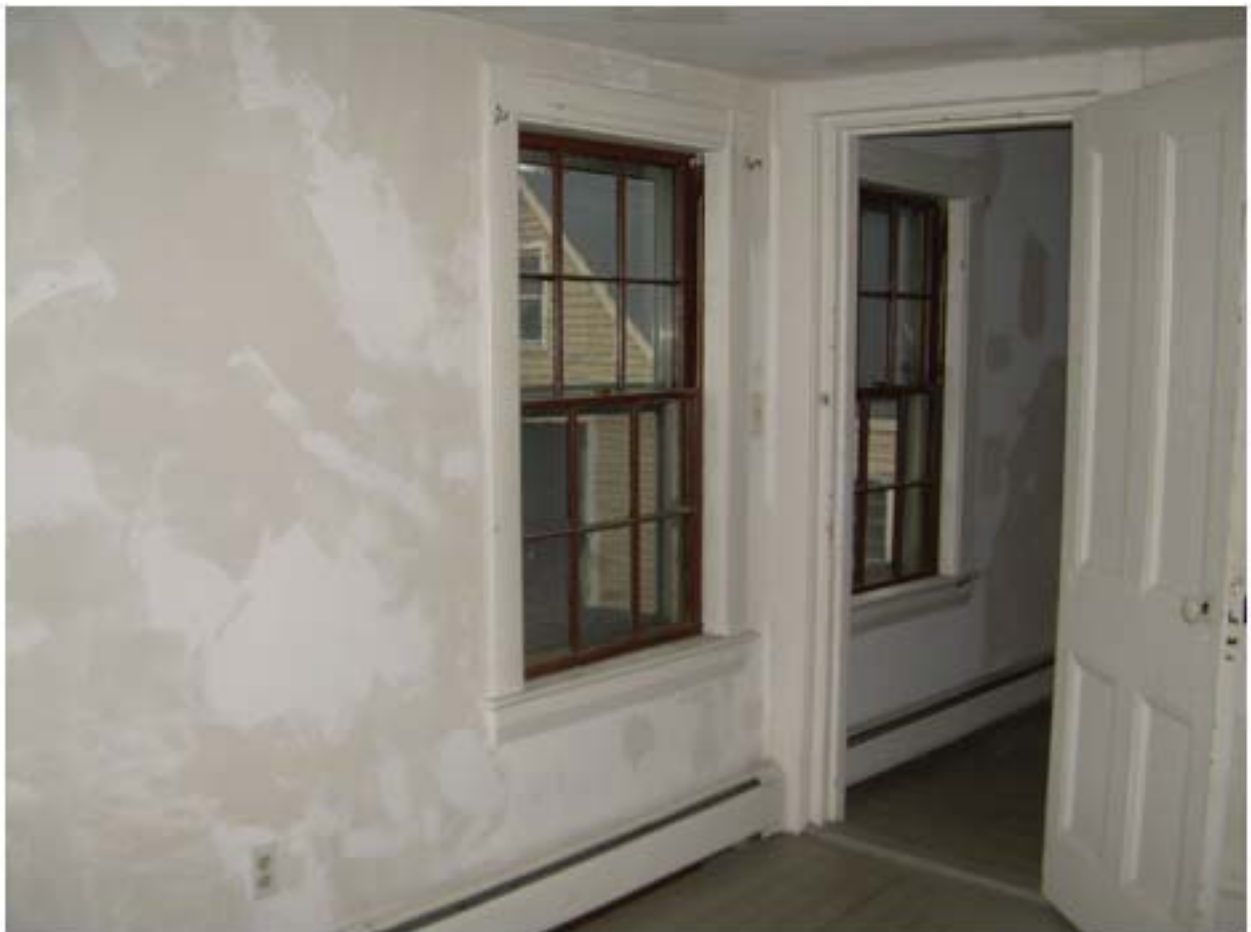
14C (Interior)- Existing double hung windows on second floor of north side of house

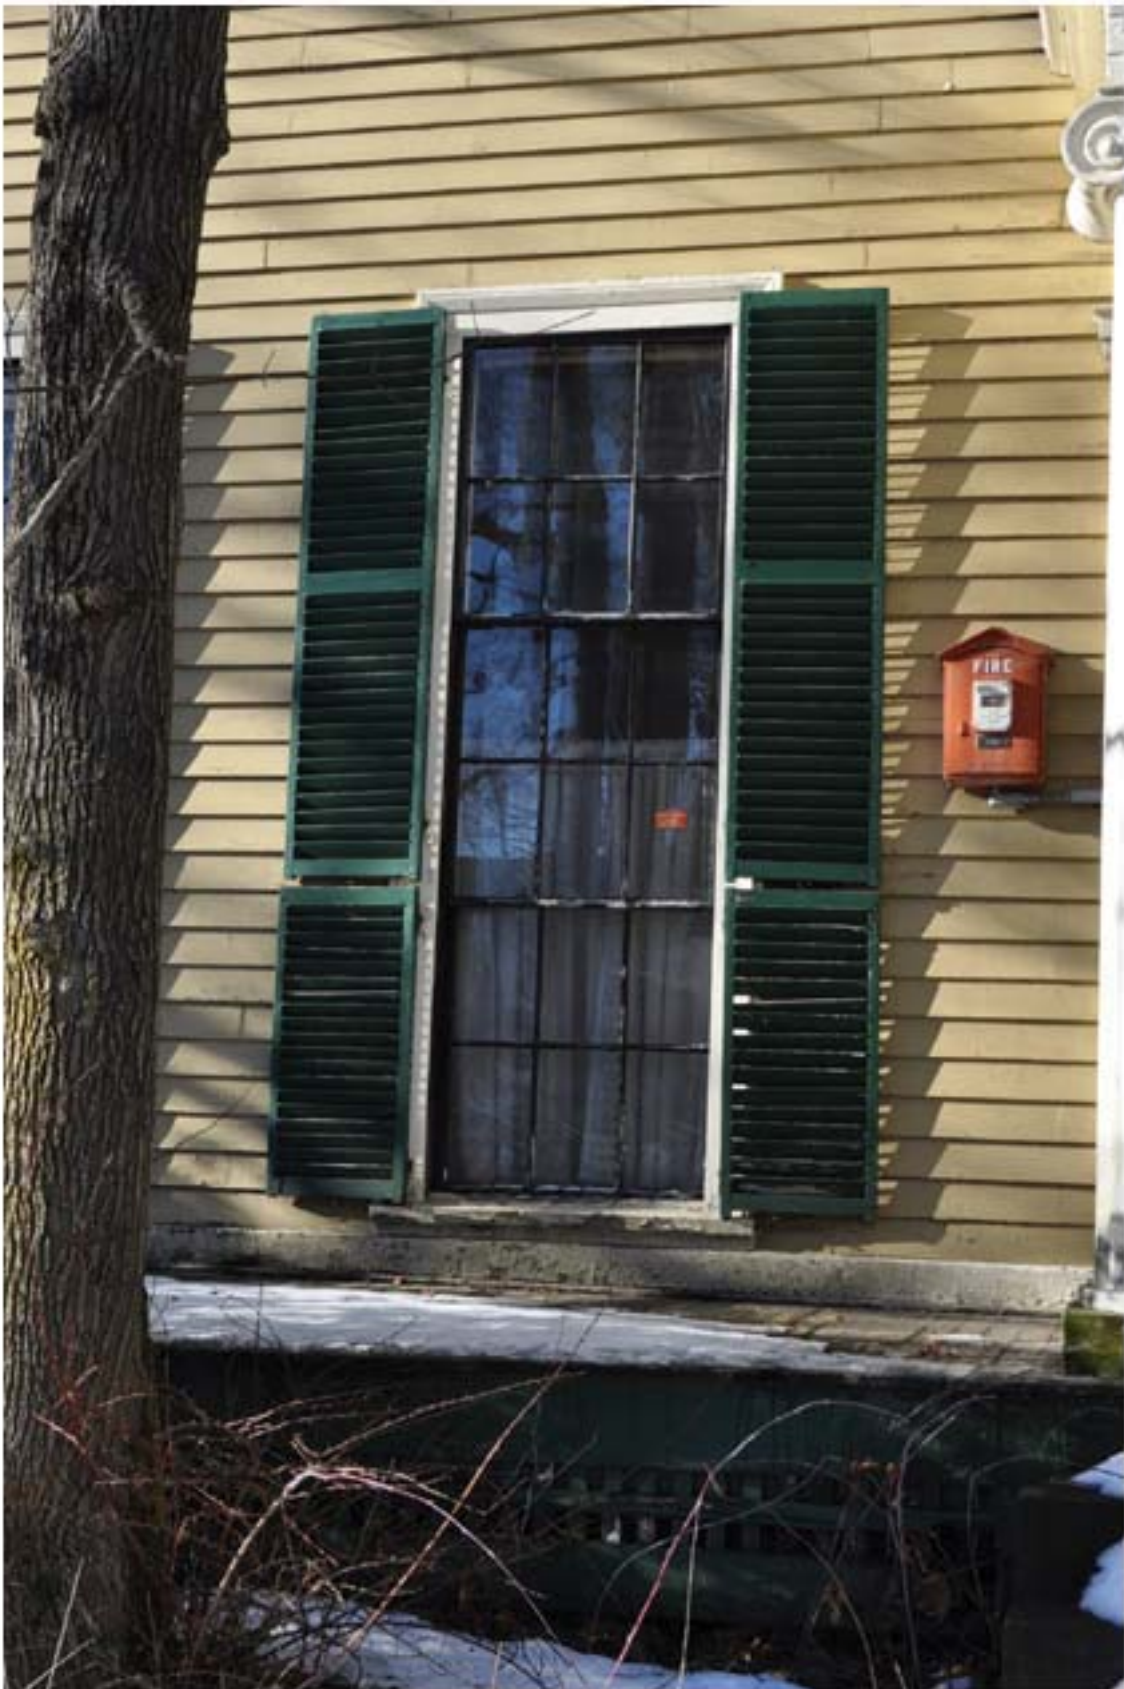
14E- Existing ground floor triple hung window on the south side of house

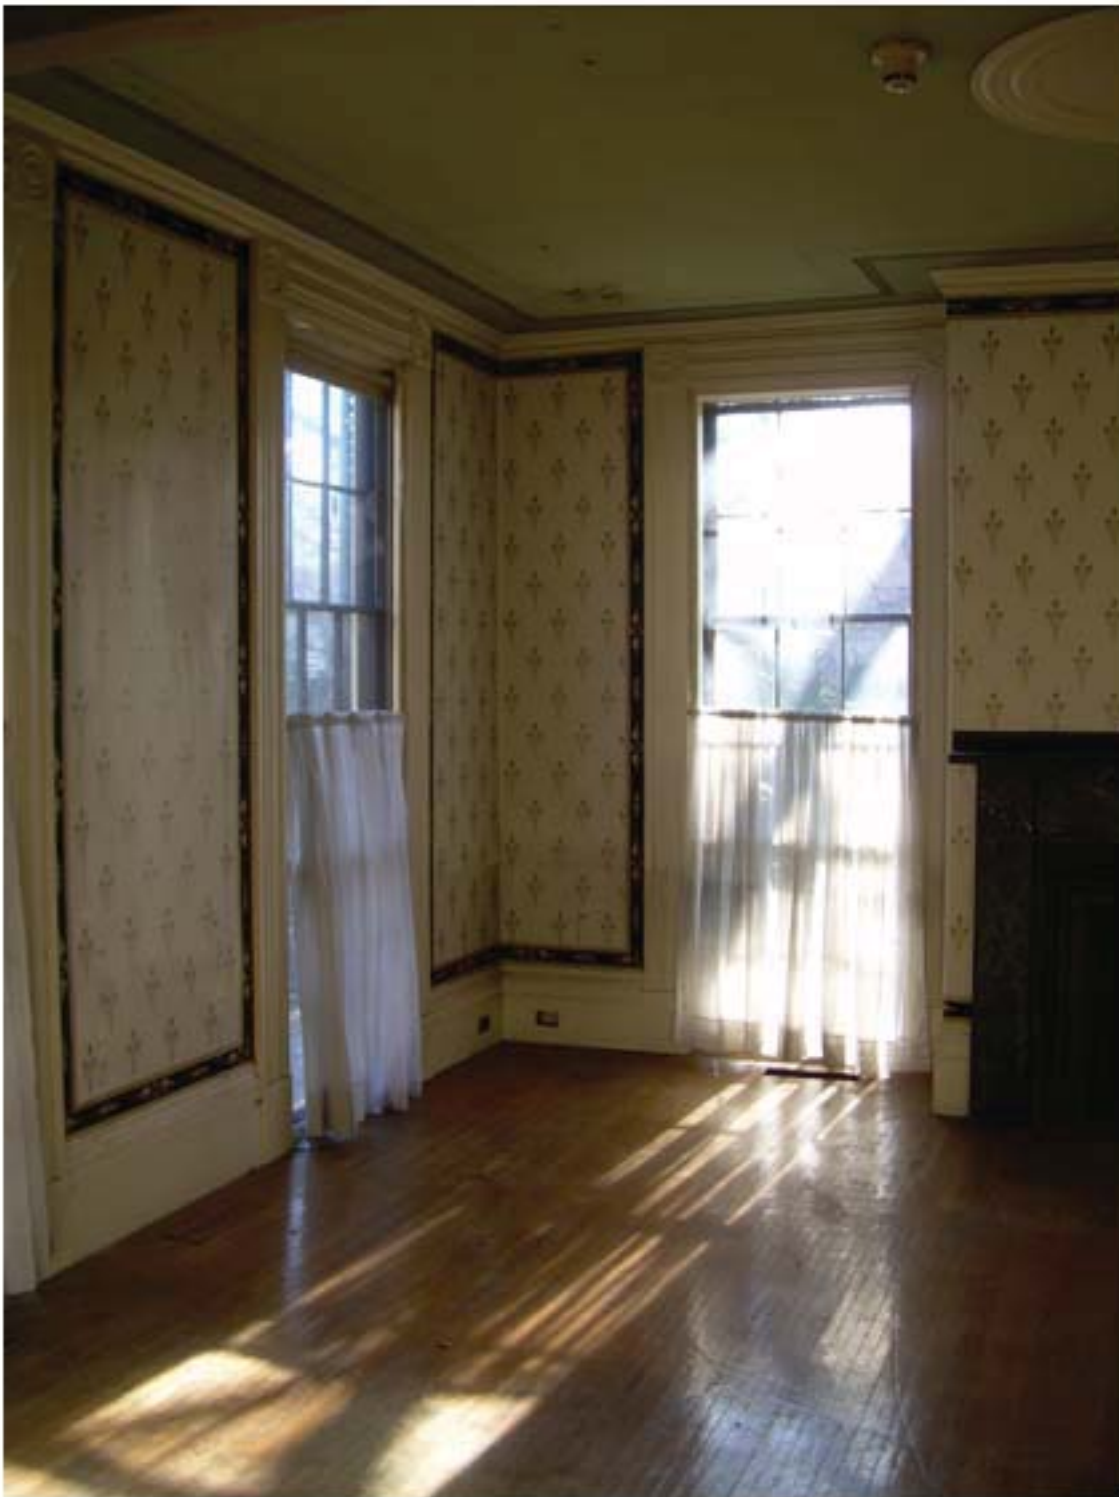
14E (Interior)- Existing ground floor triple hung window on the south side of house

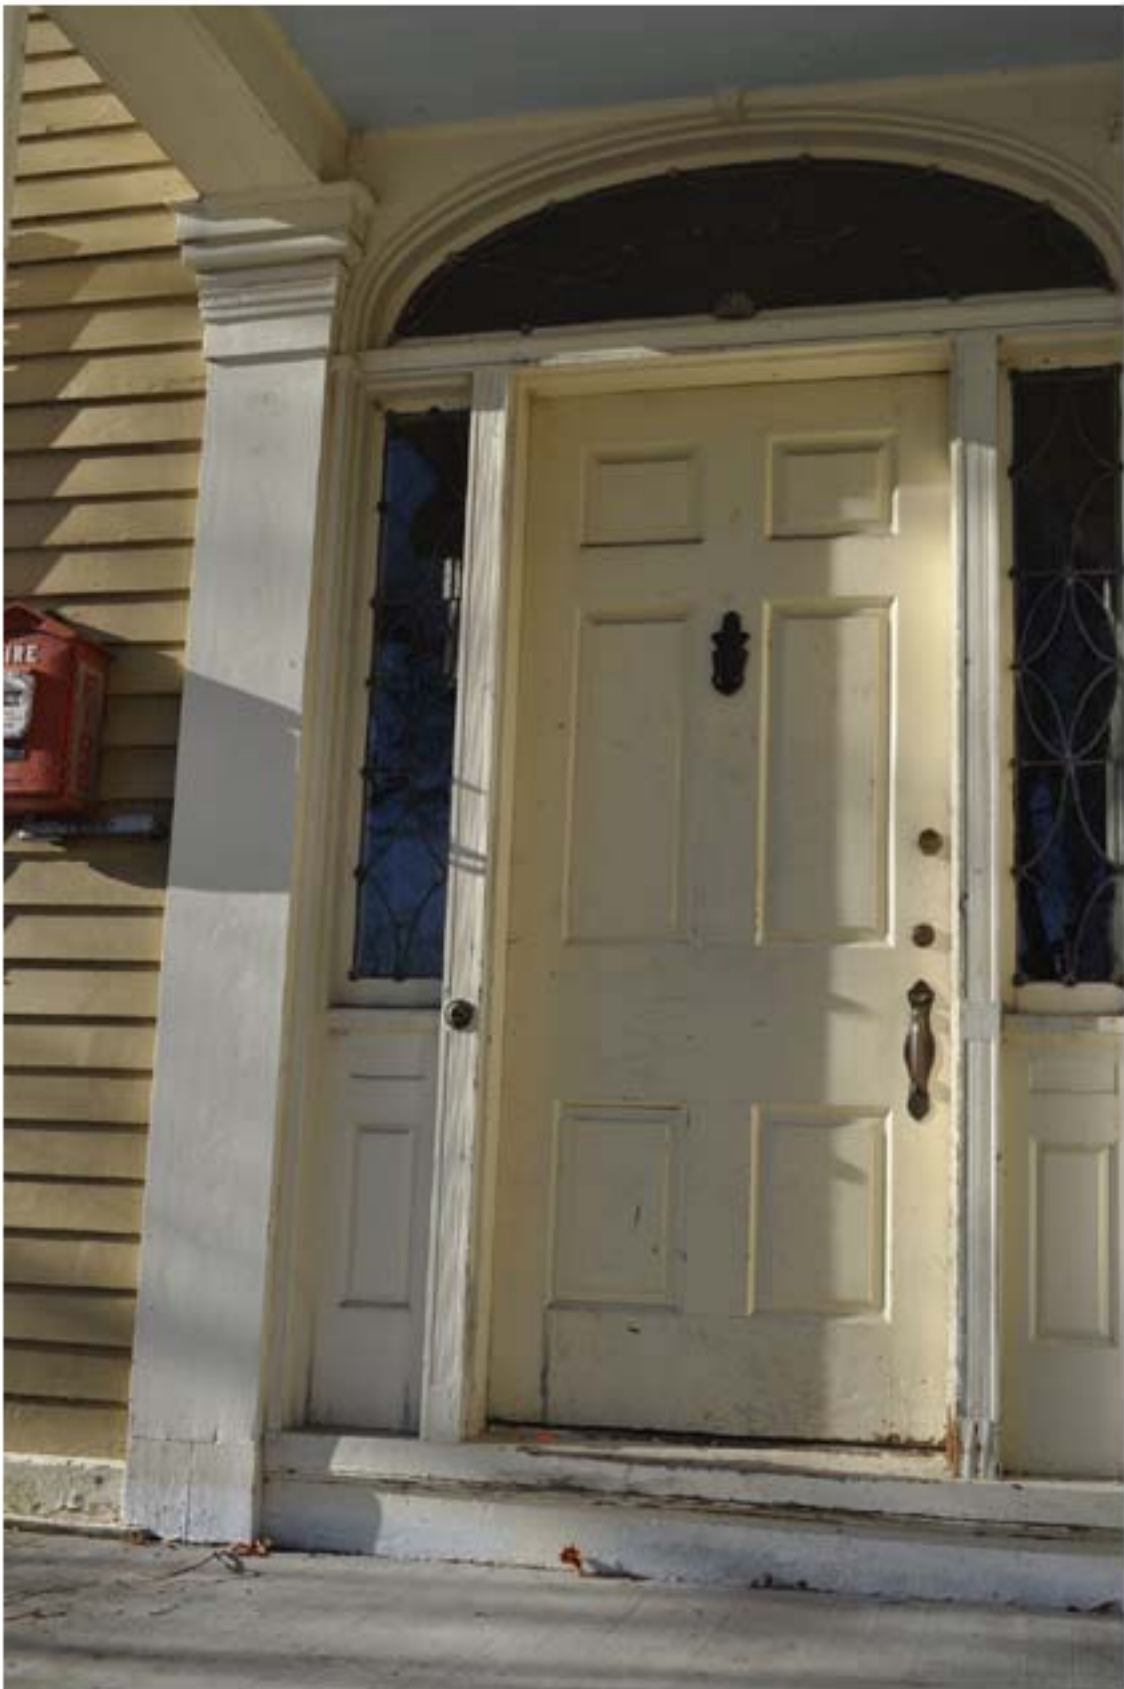
15A- Existing east house egress door and sidelights

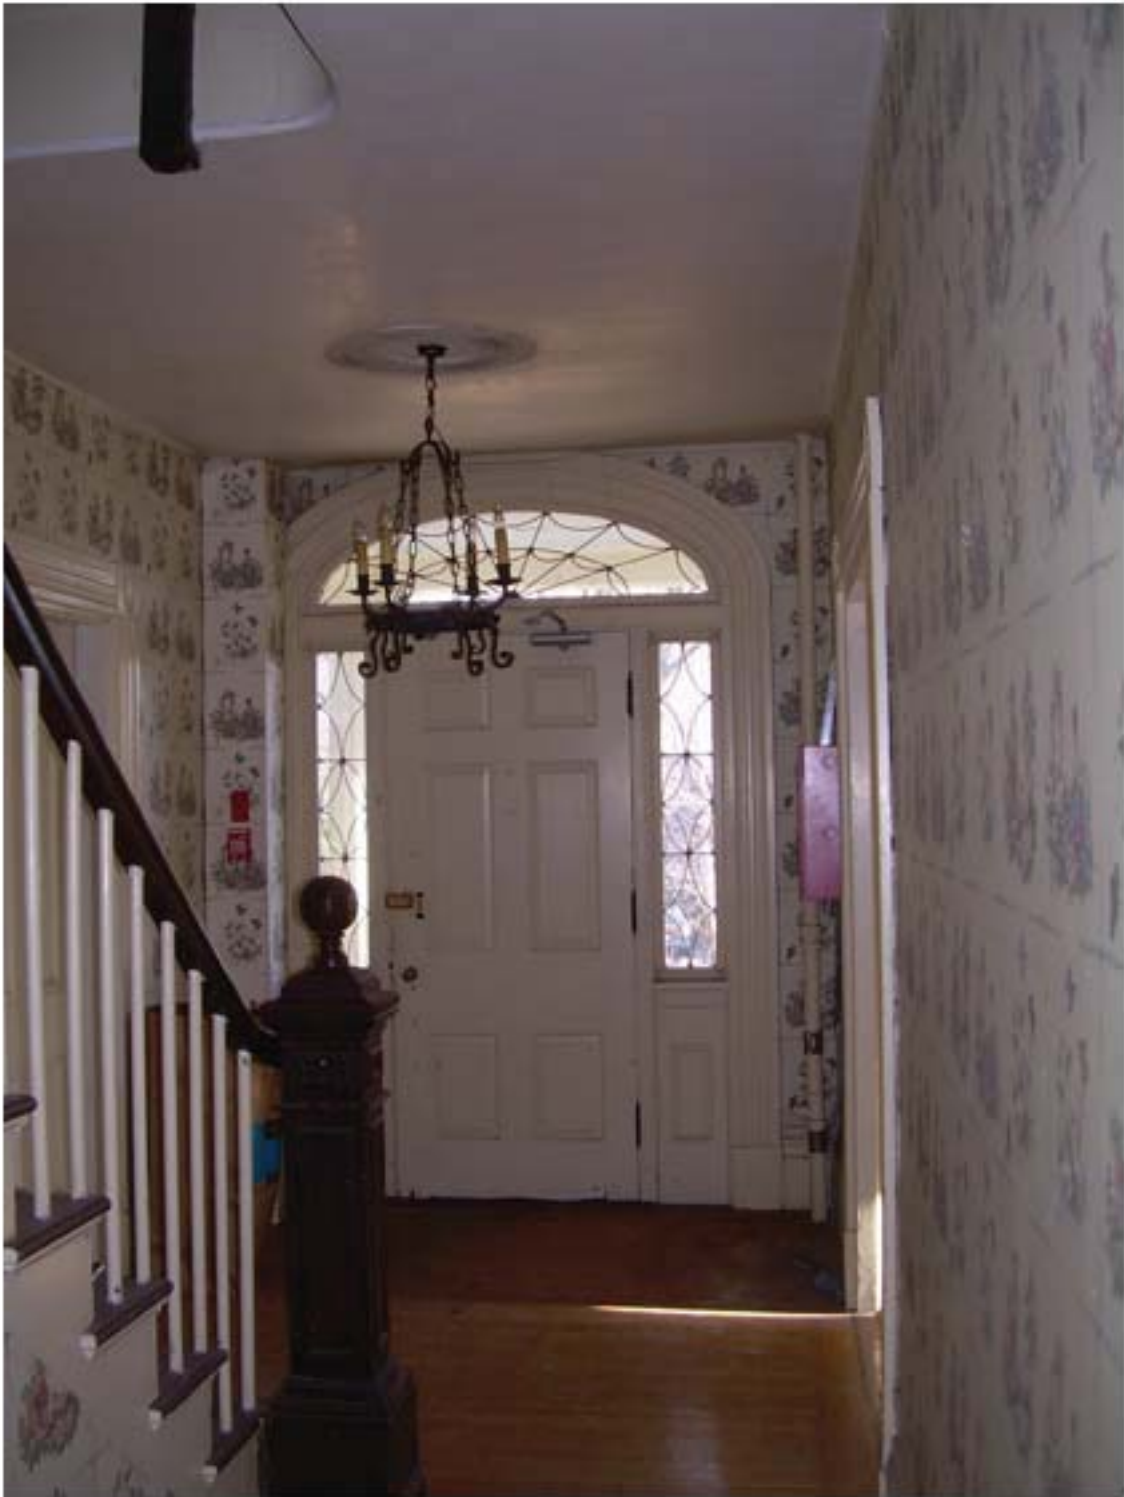
15A (Interior)- Existing east house egress door and sidelights

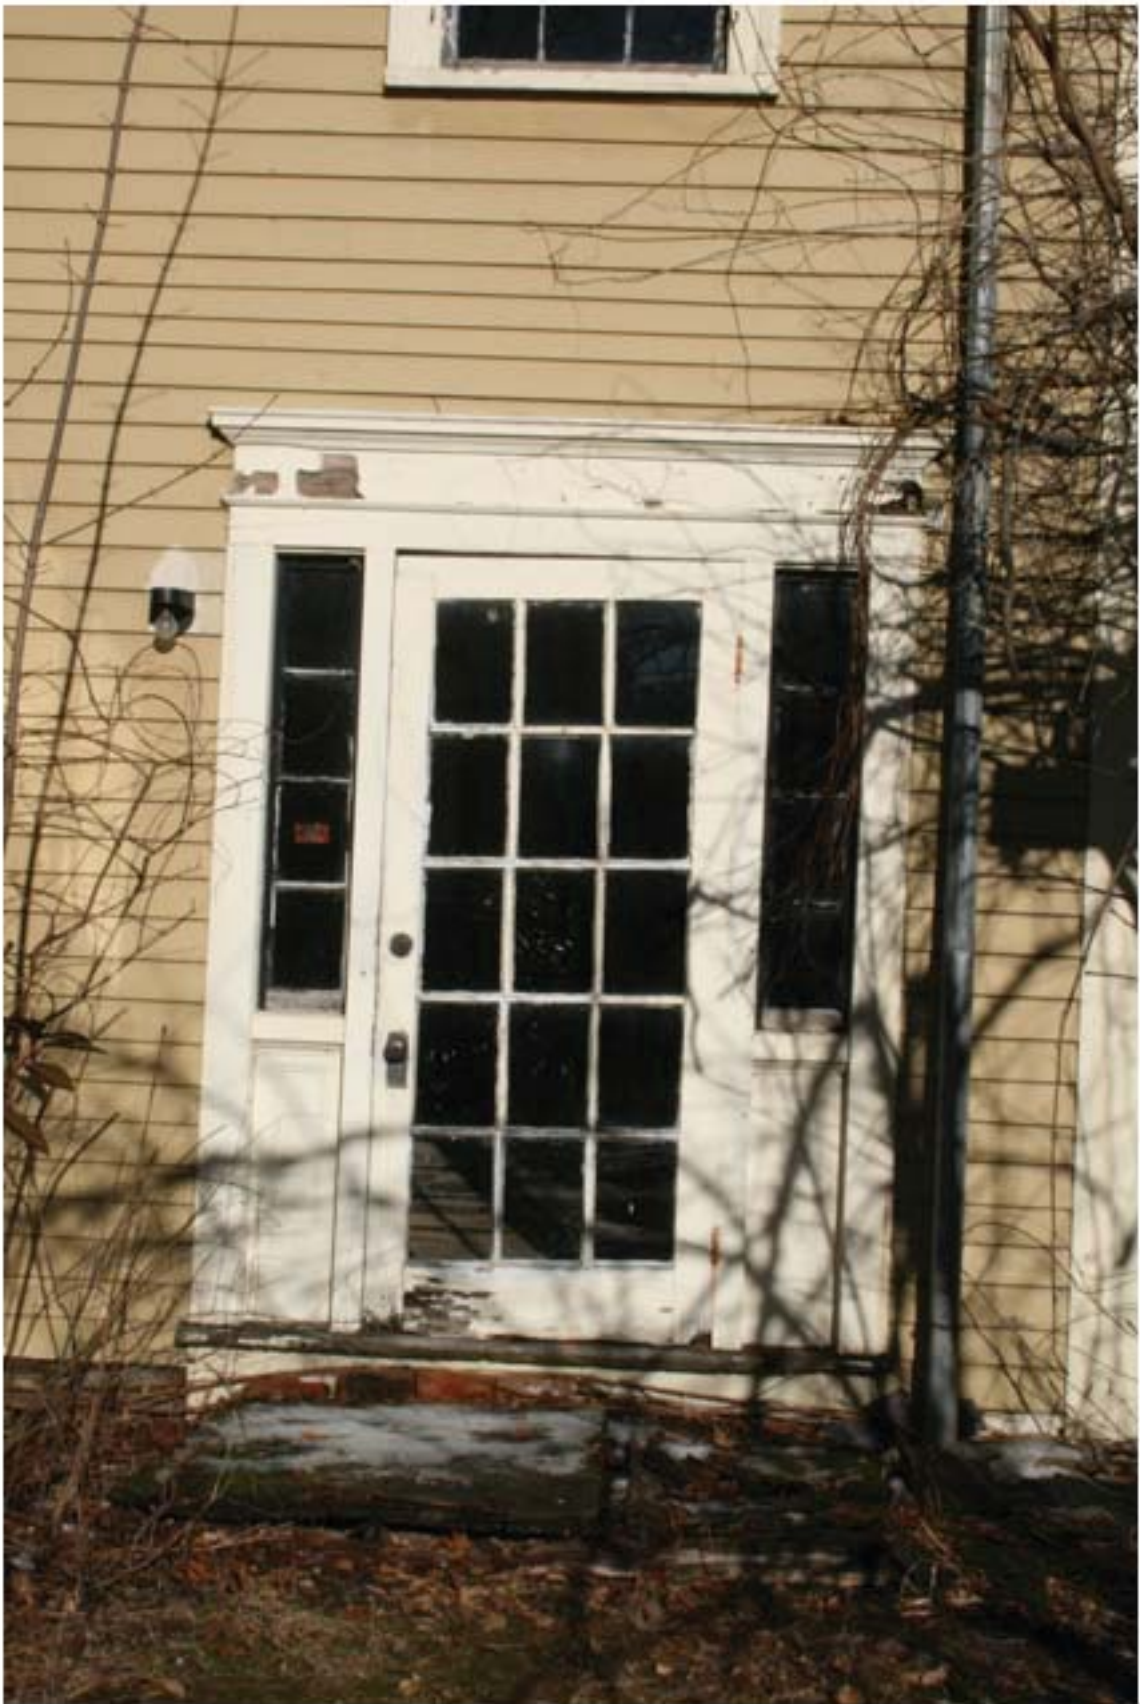
15B- Existing south barn egress door and sidelights

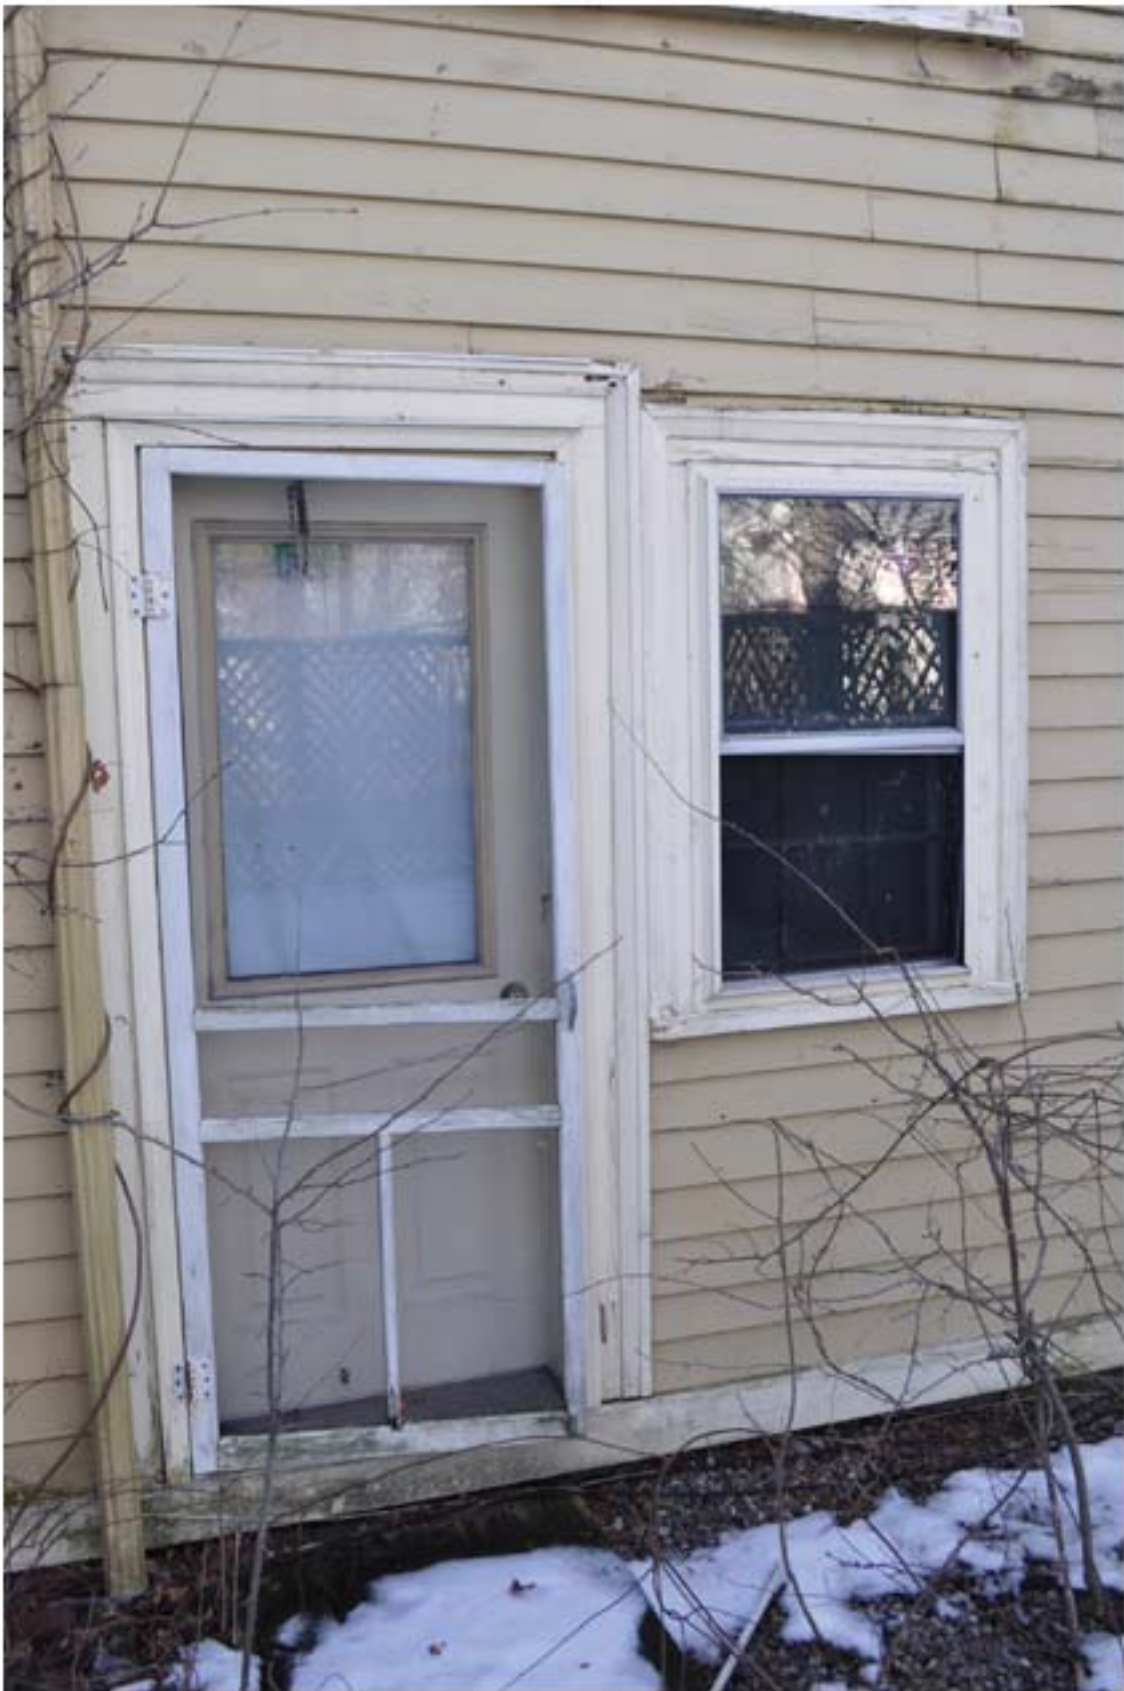
15C- Existing north house entrance door

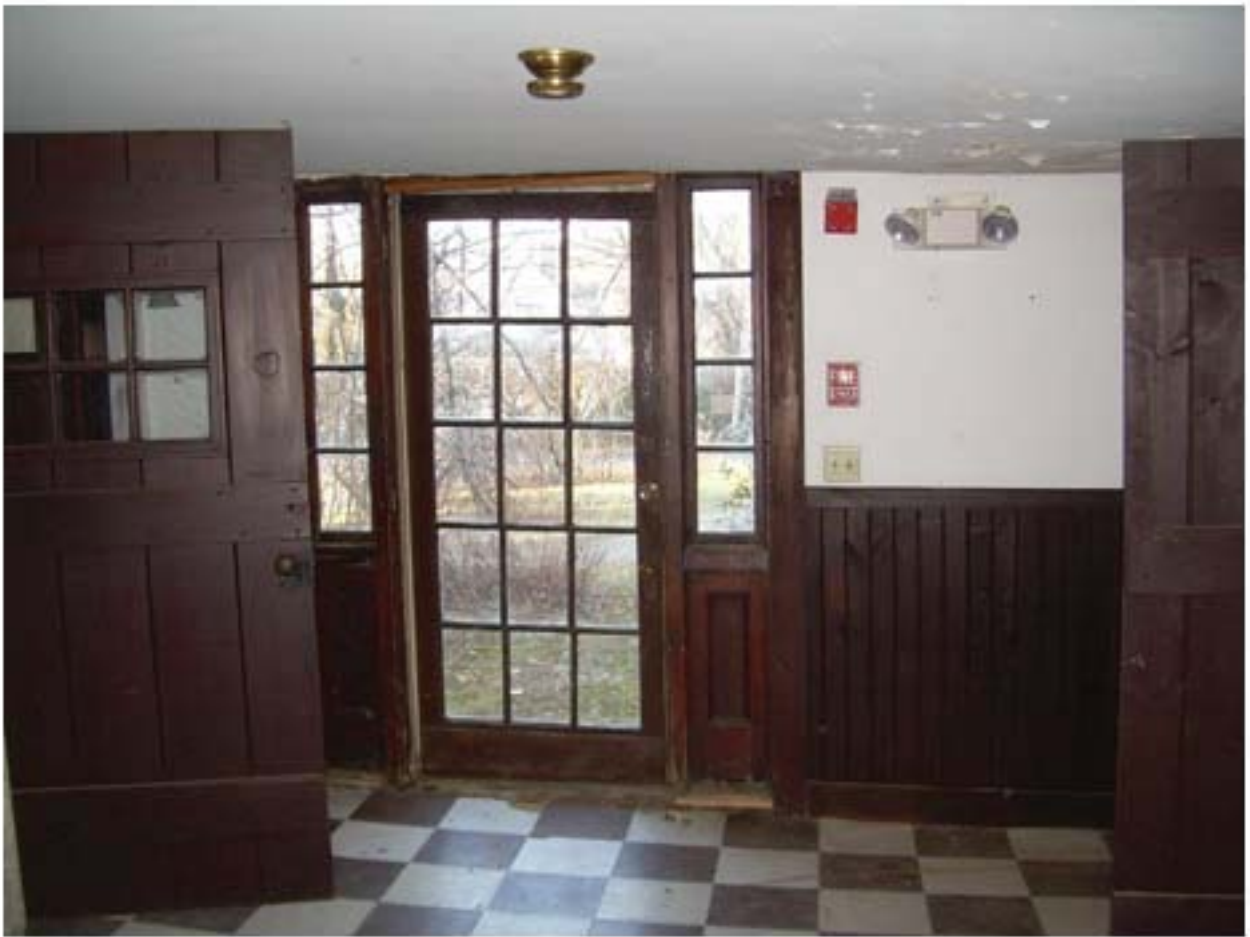
15B (Interior)- Existing south barn egress door and sidelights

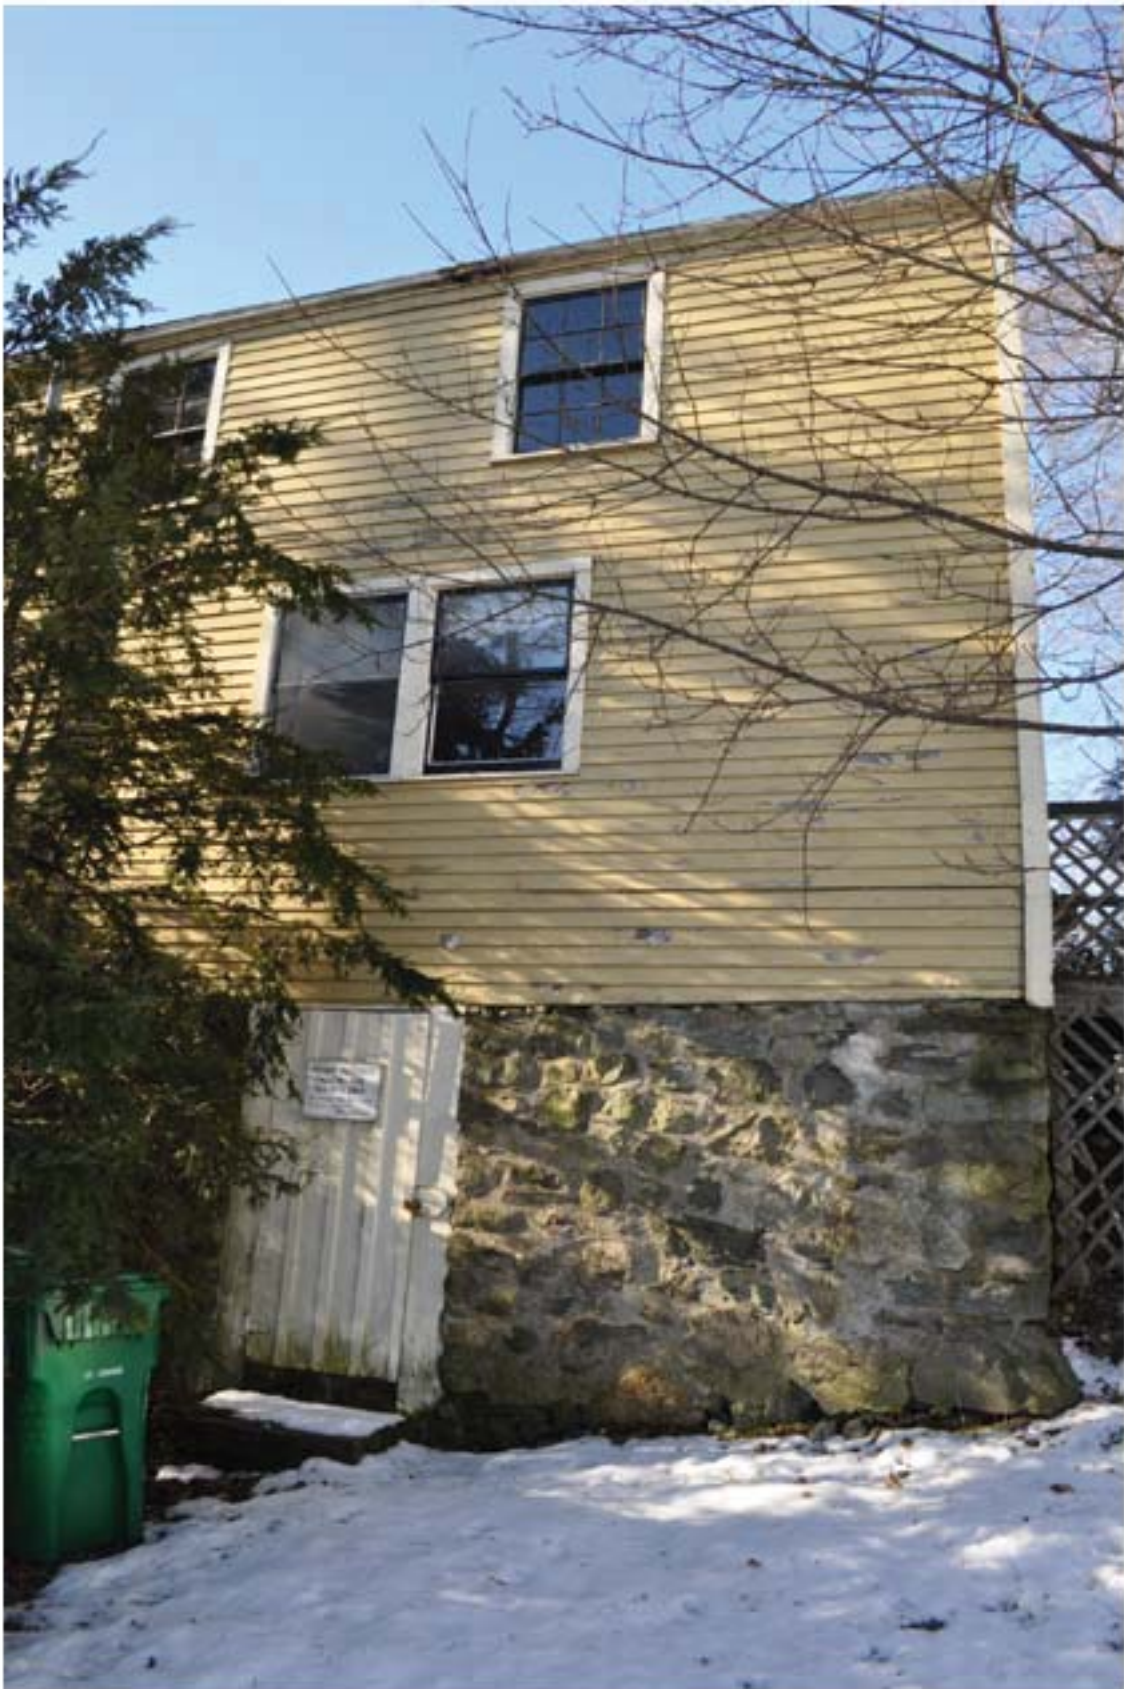
15D- Existing solid wood panel door in fieldstone of lower level east barn facade

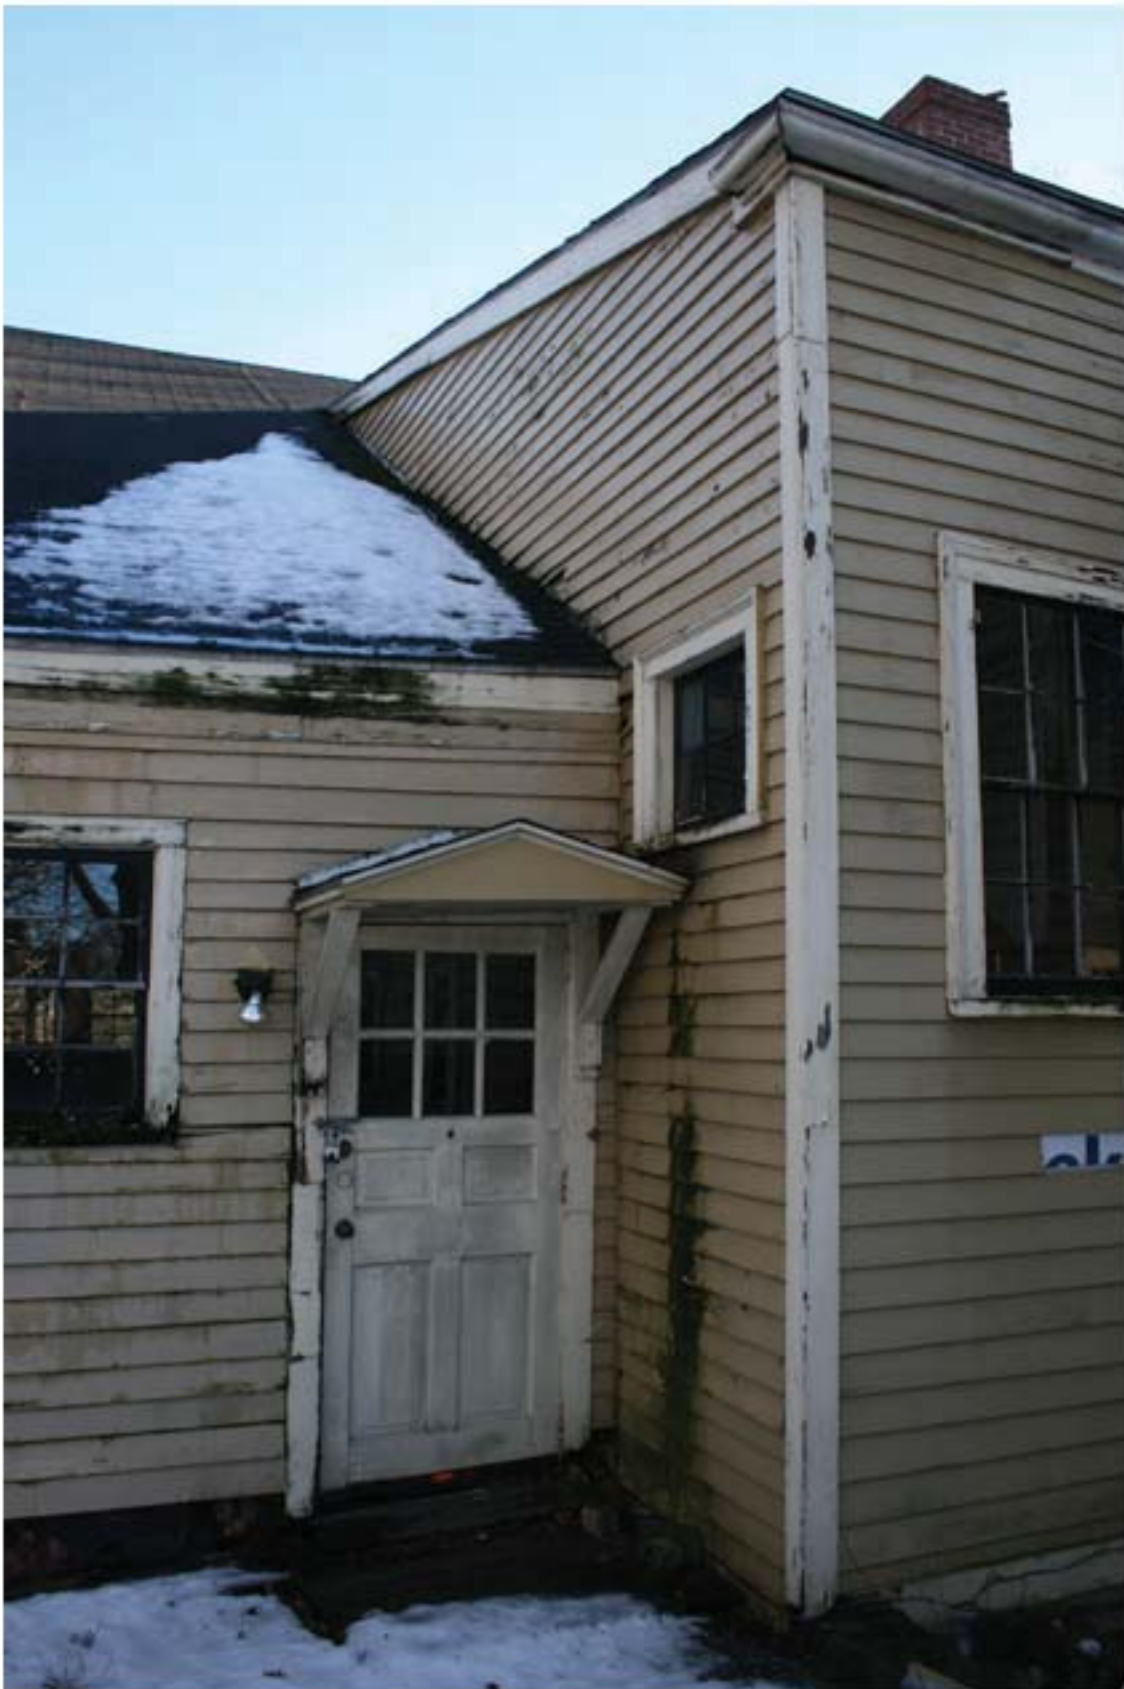
15E- Existing west barn entrance door

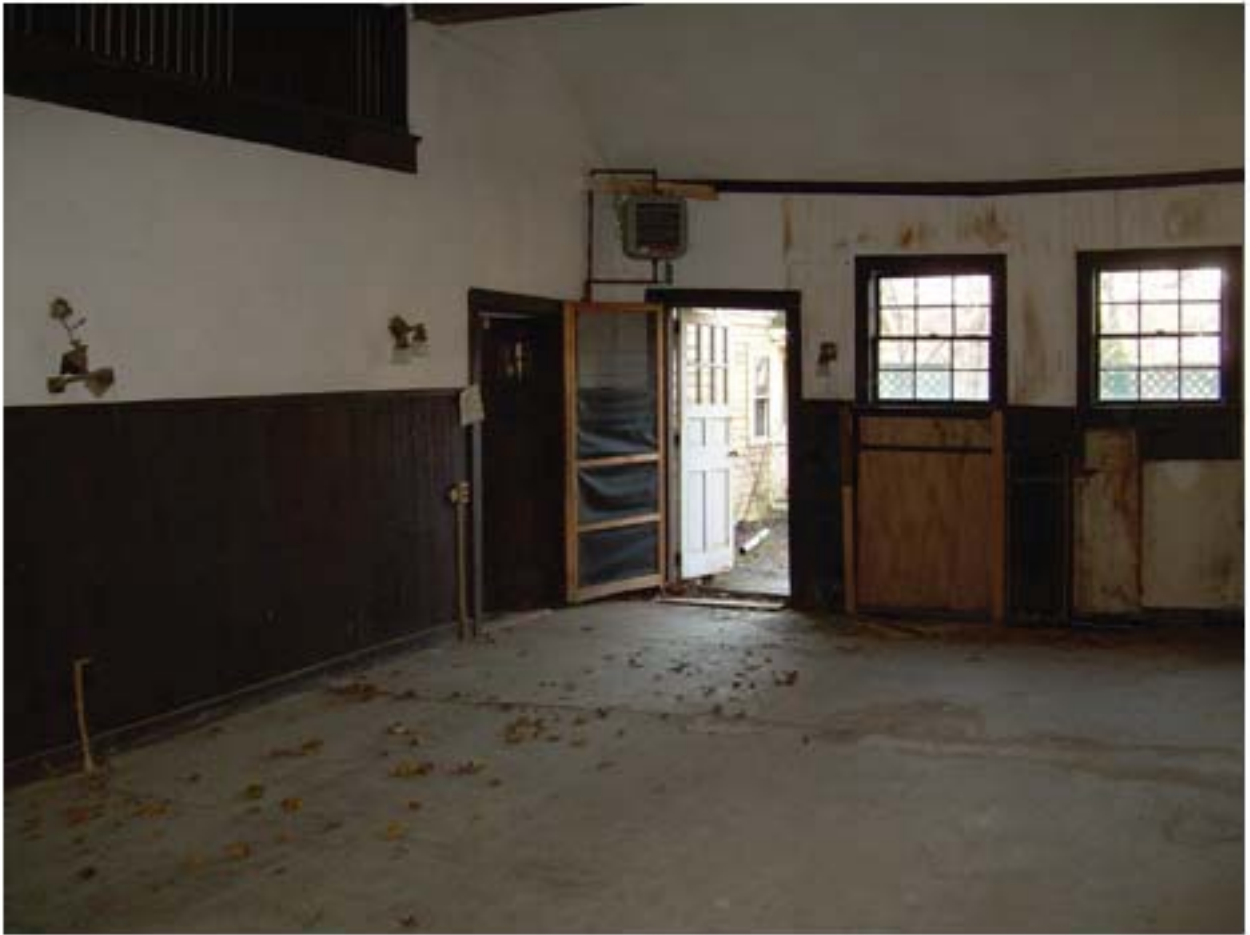
15E (Interior)- Existing west barn entrance door
