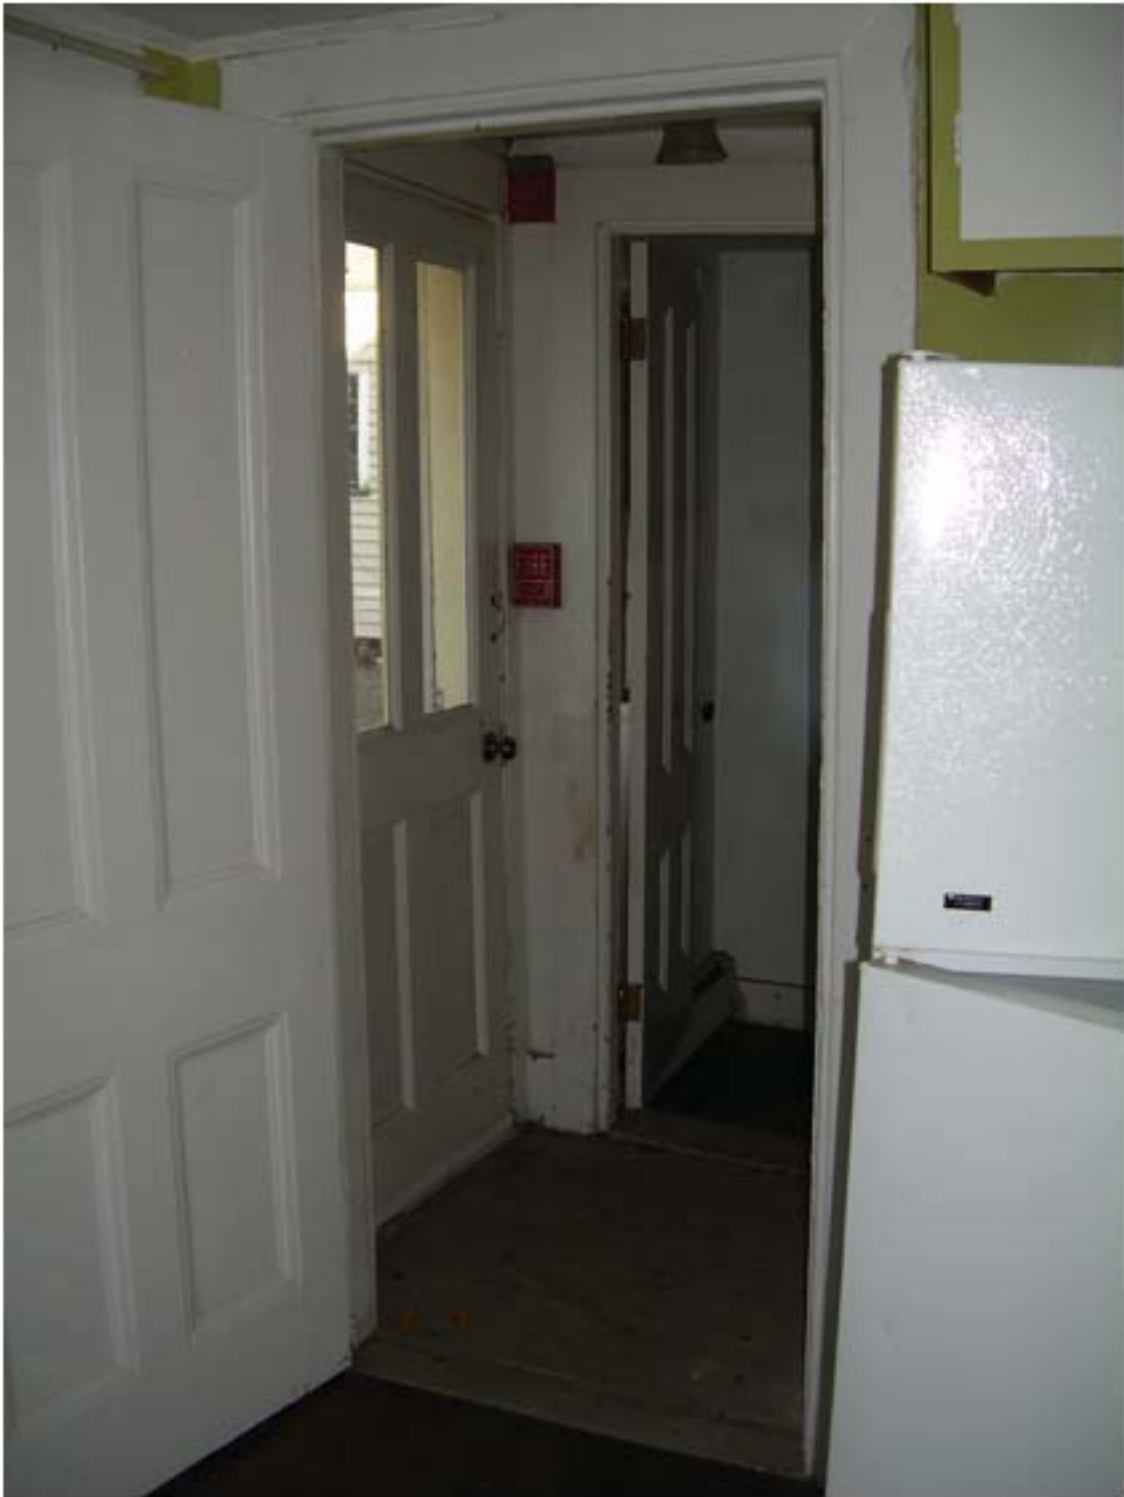
15F (Interior)- Existing north house entrance door

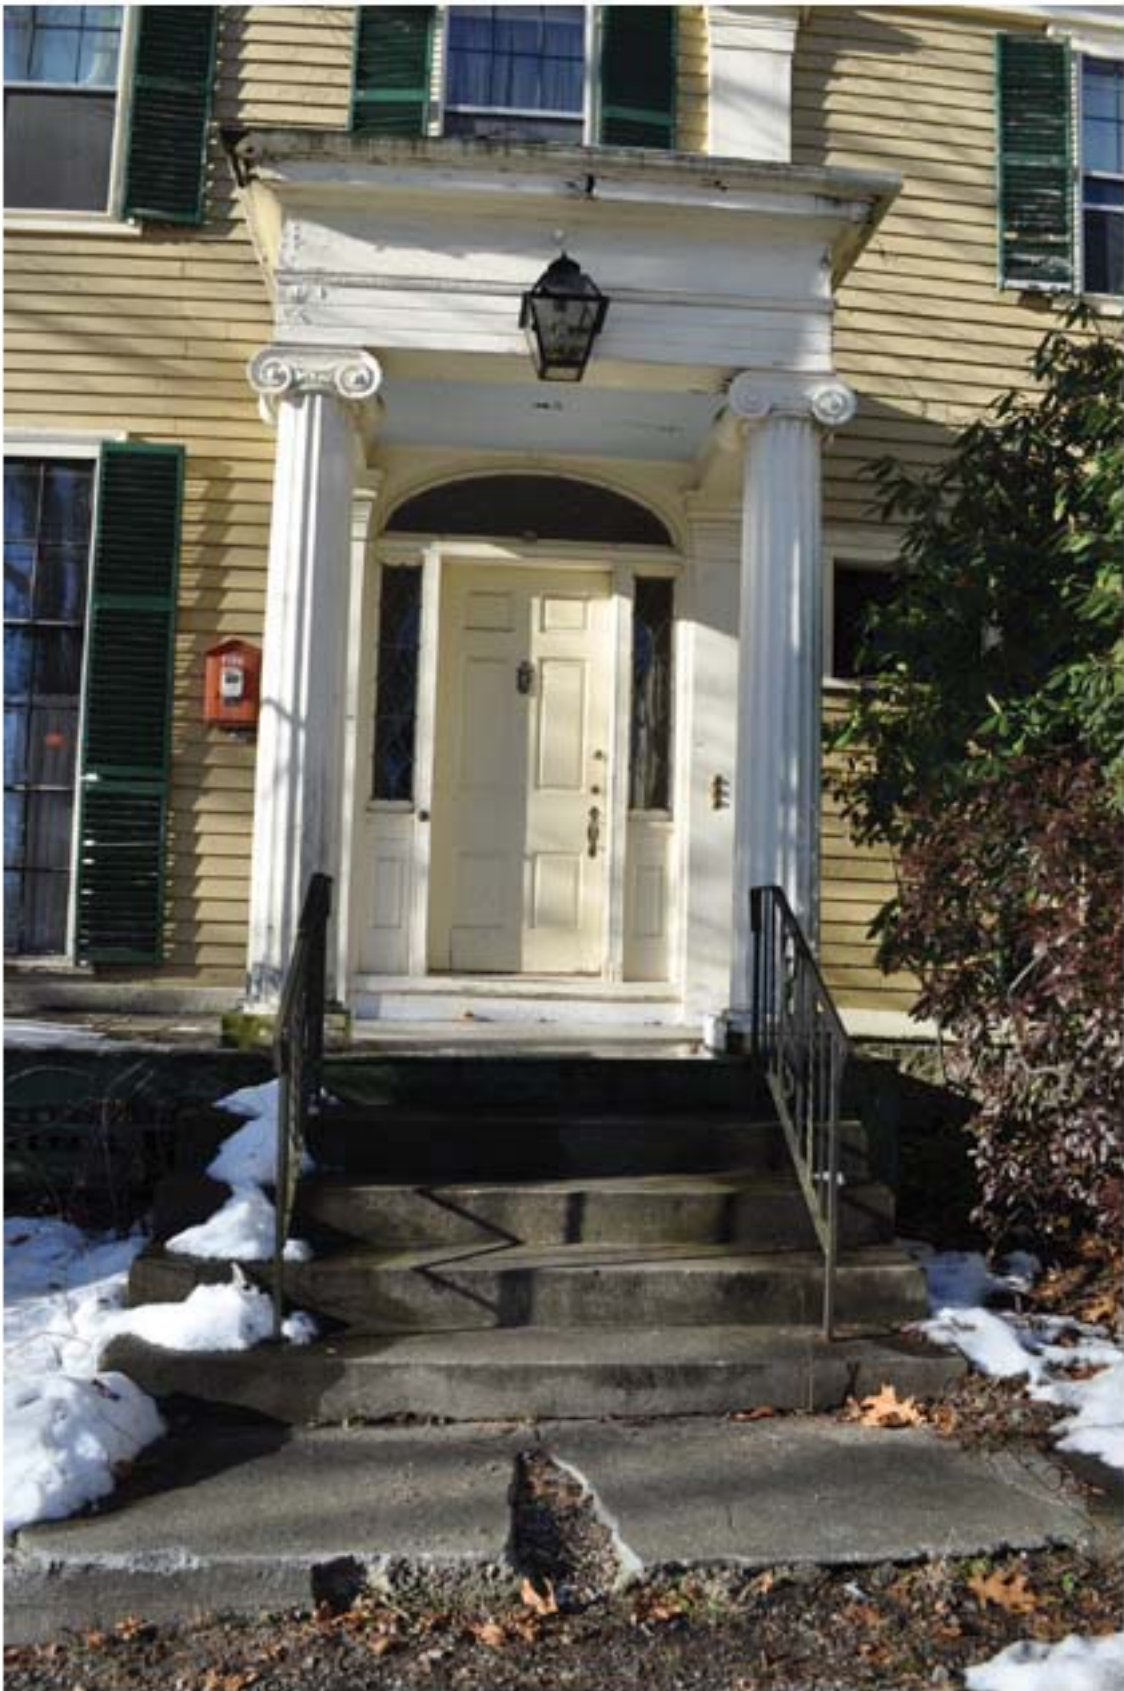
16A- Existing east side house entrance porch

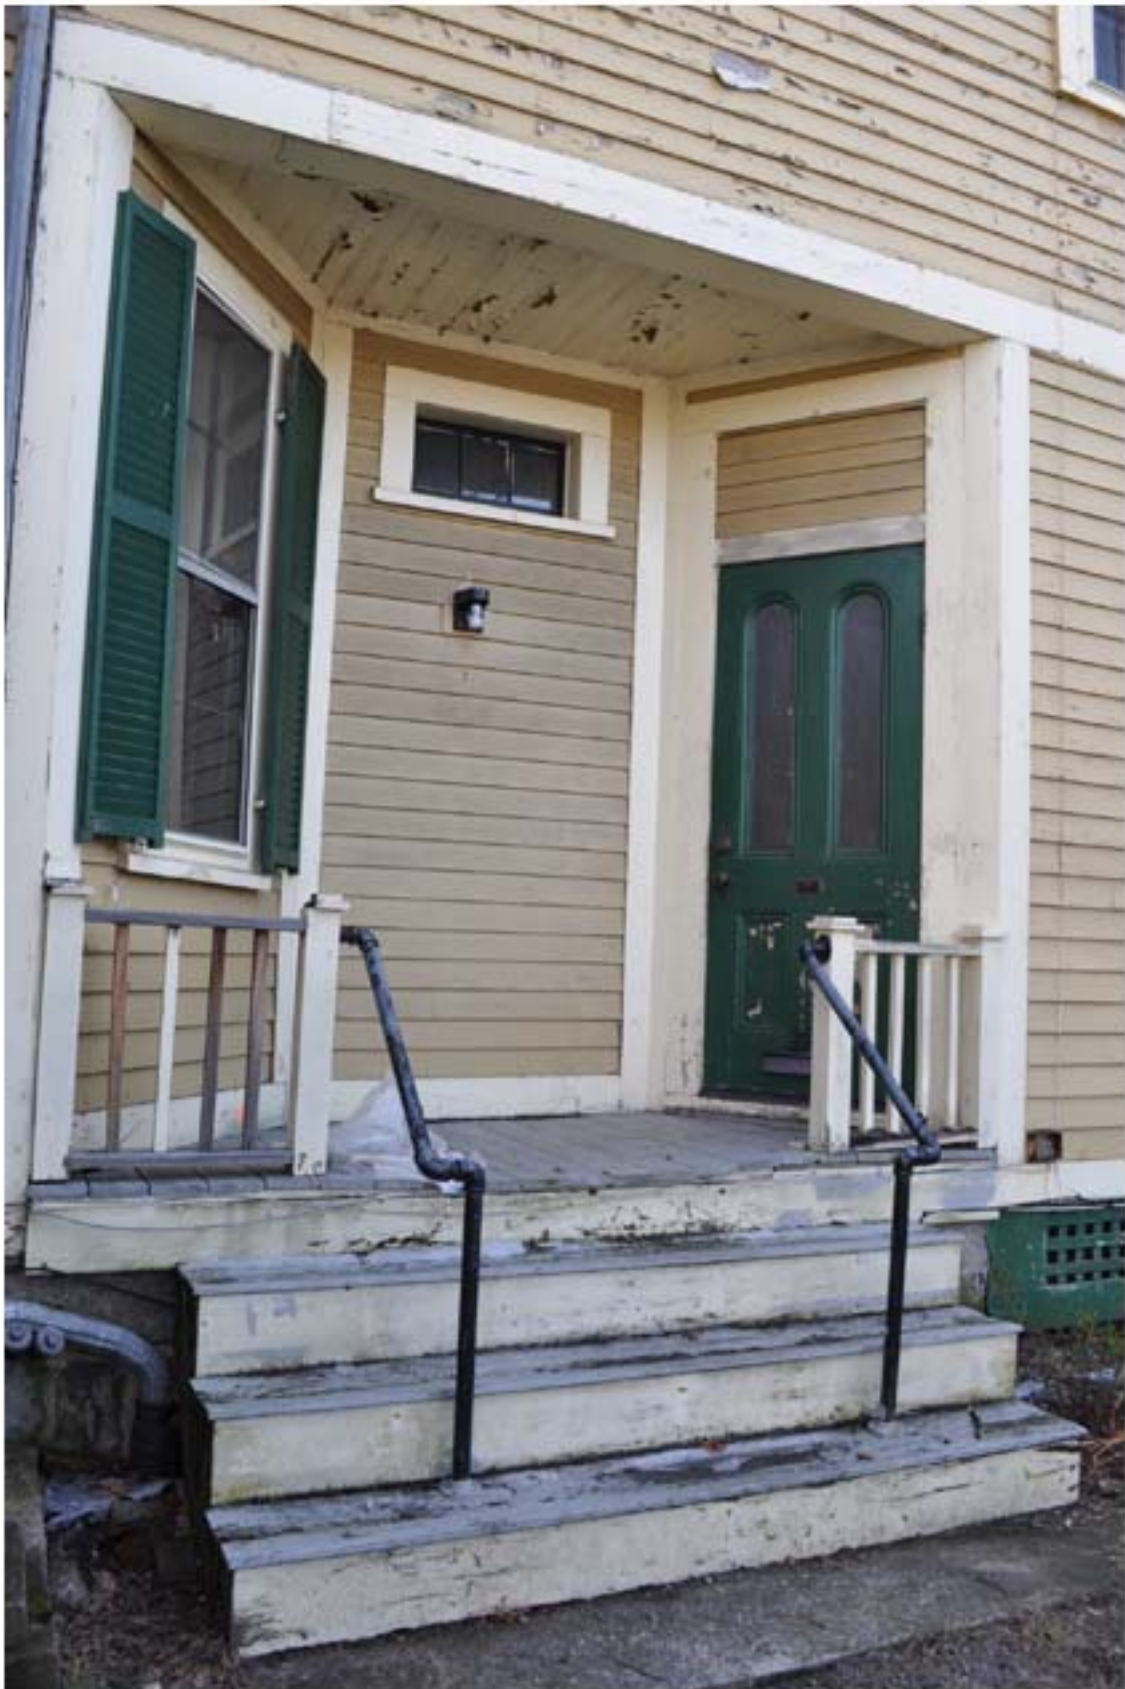
16B- Existing wood porch and steps on west side of house

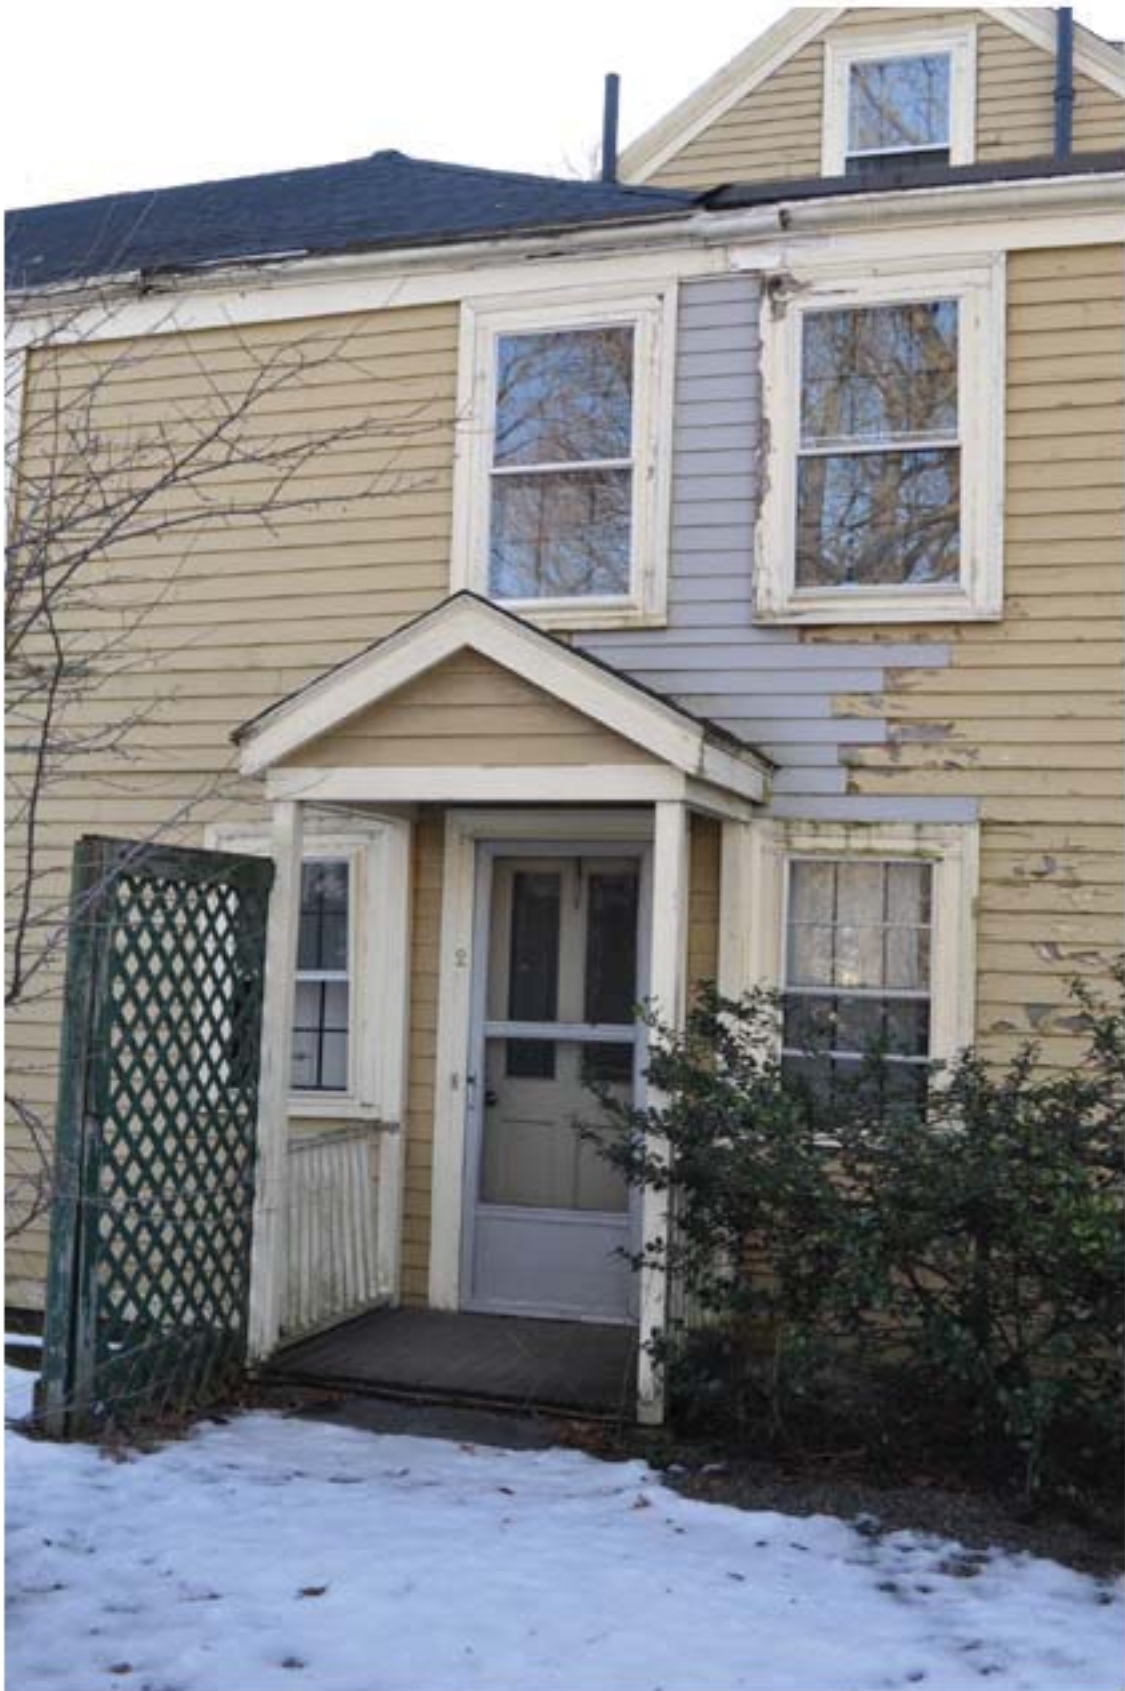
16C- Existing roofed stoop at north side of house

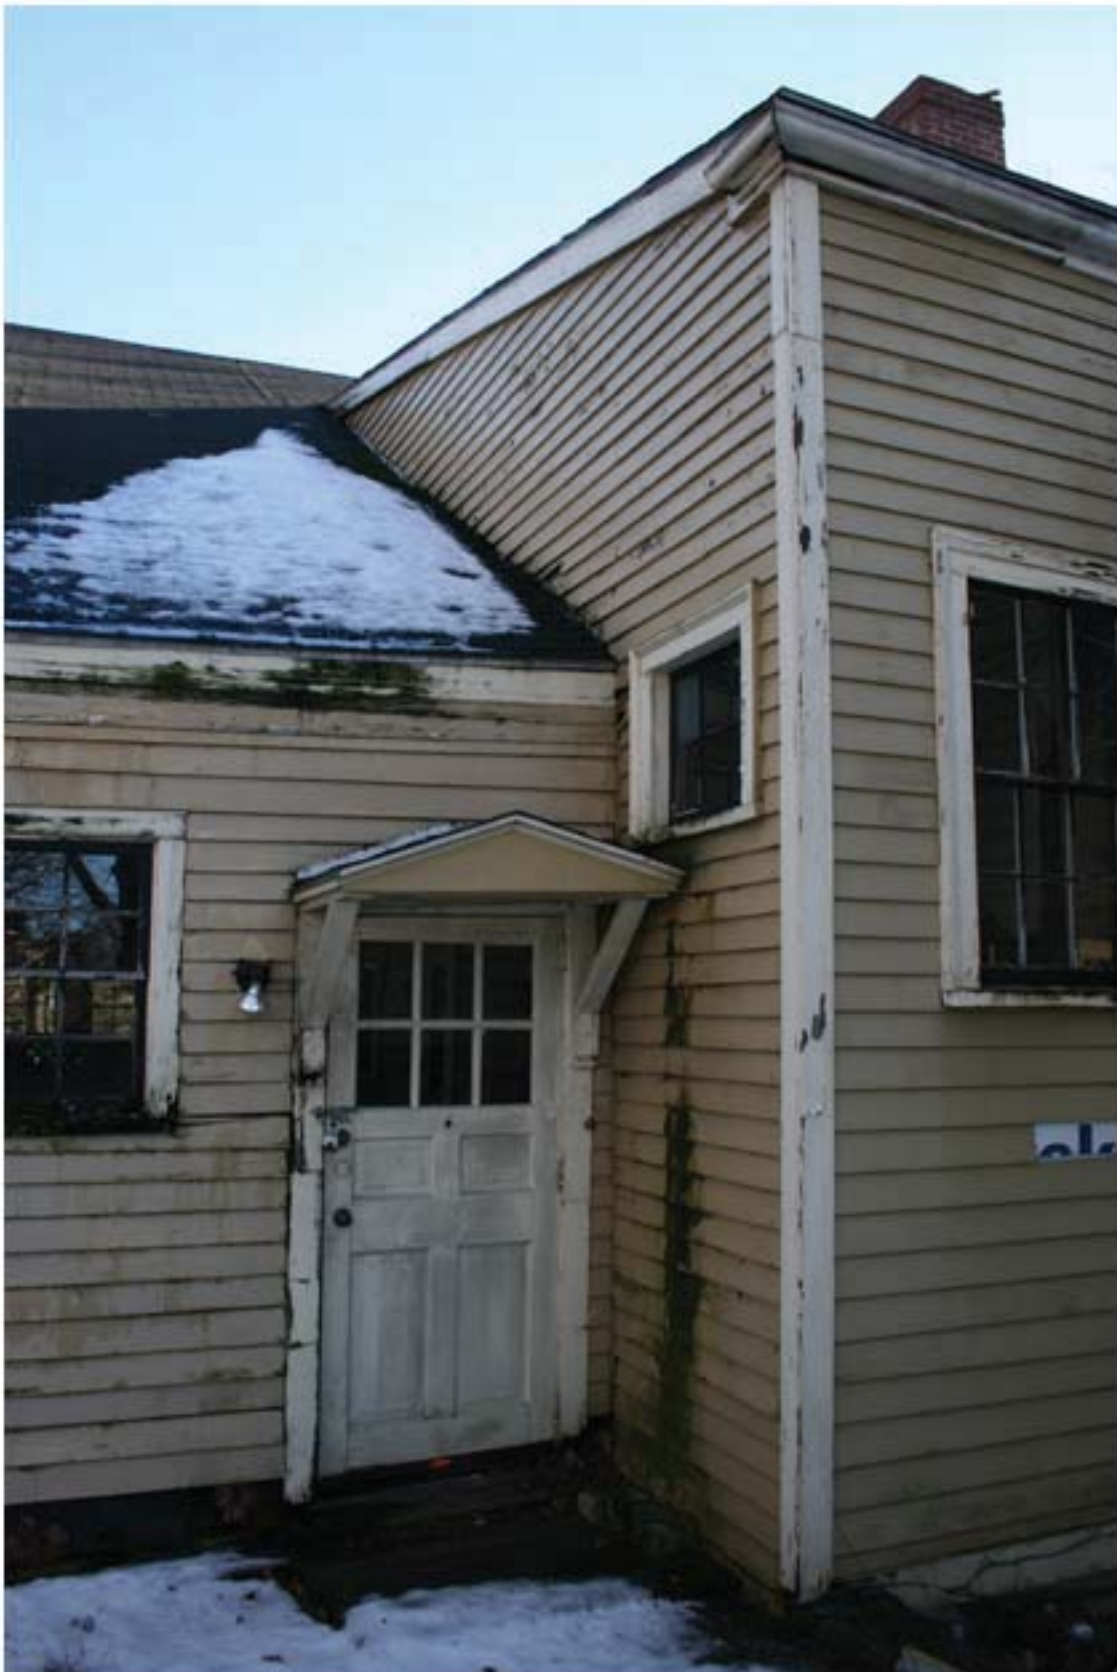
16D- Existing roofed stoop at west side of barn

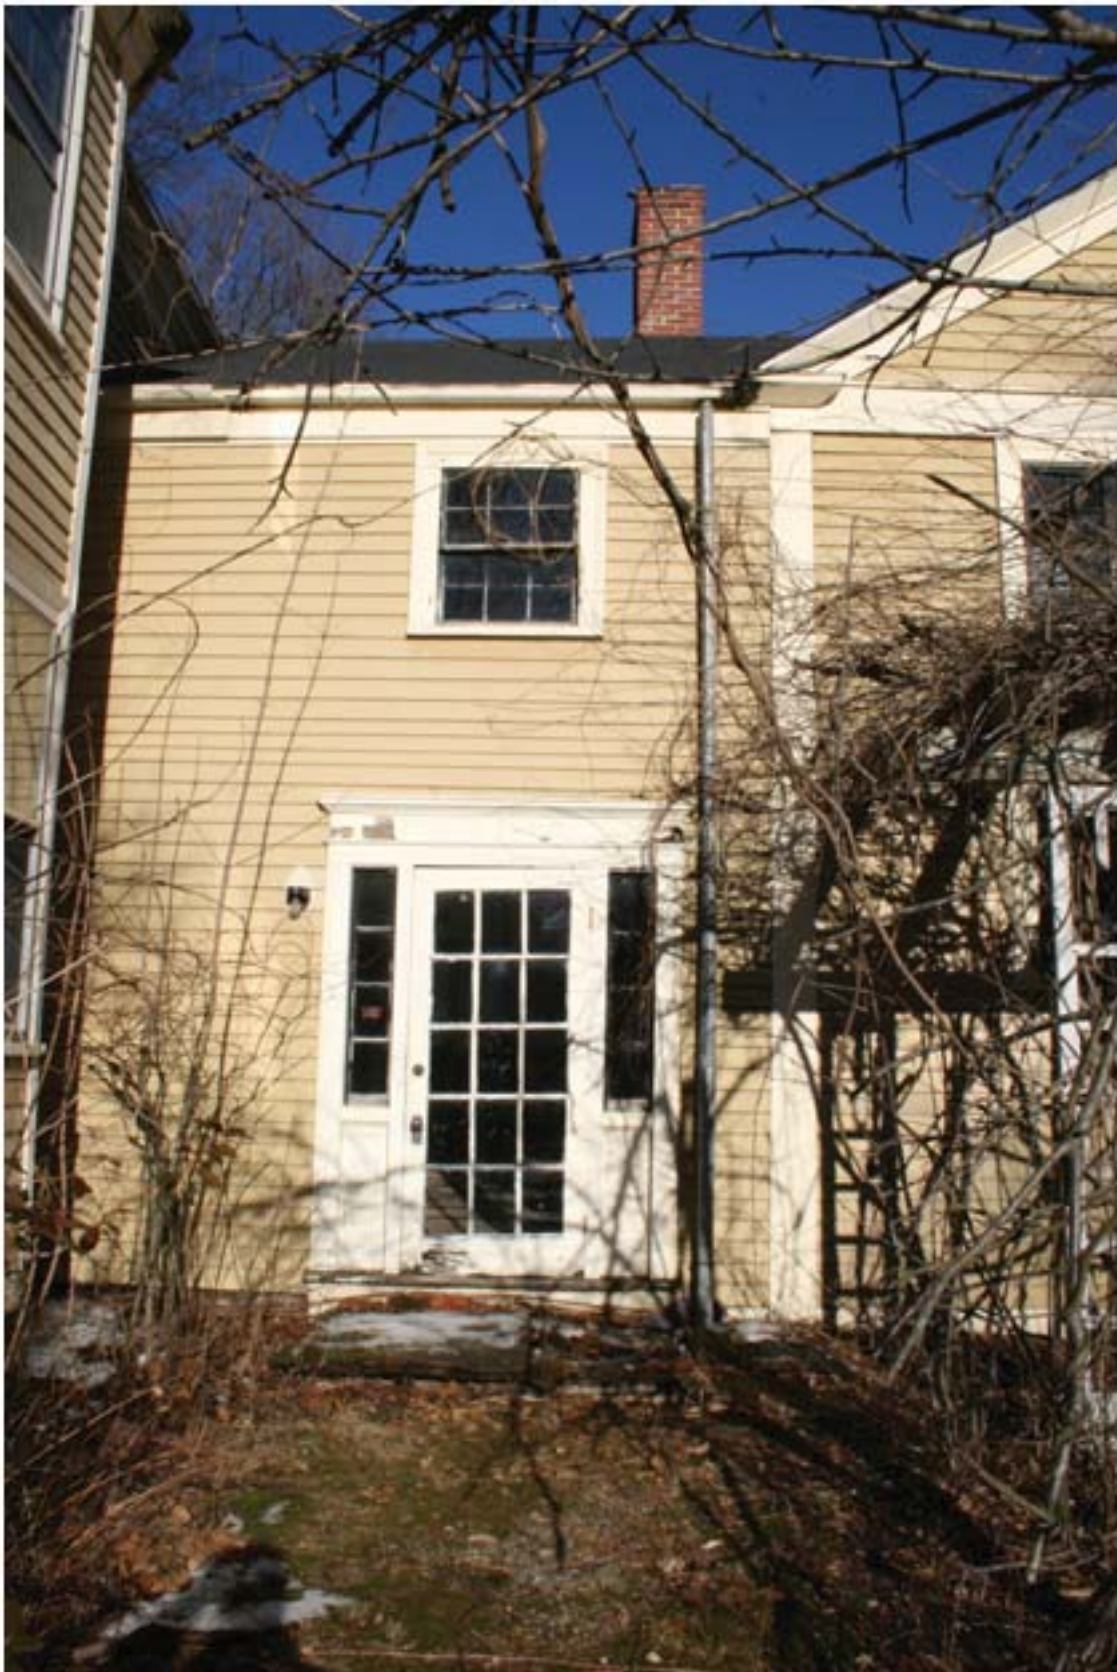
17A- Existing entrance at south side of barn

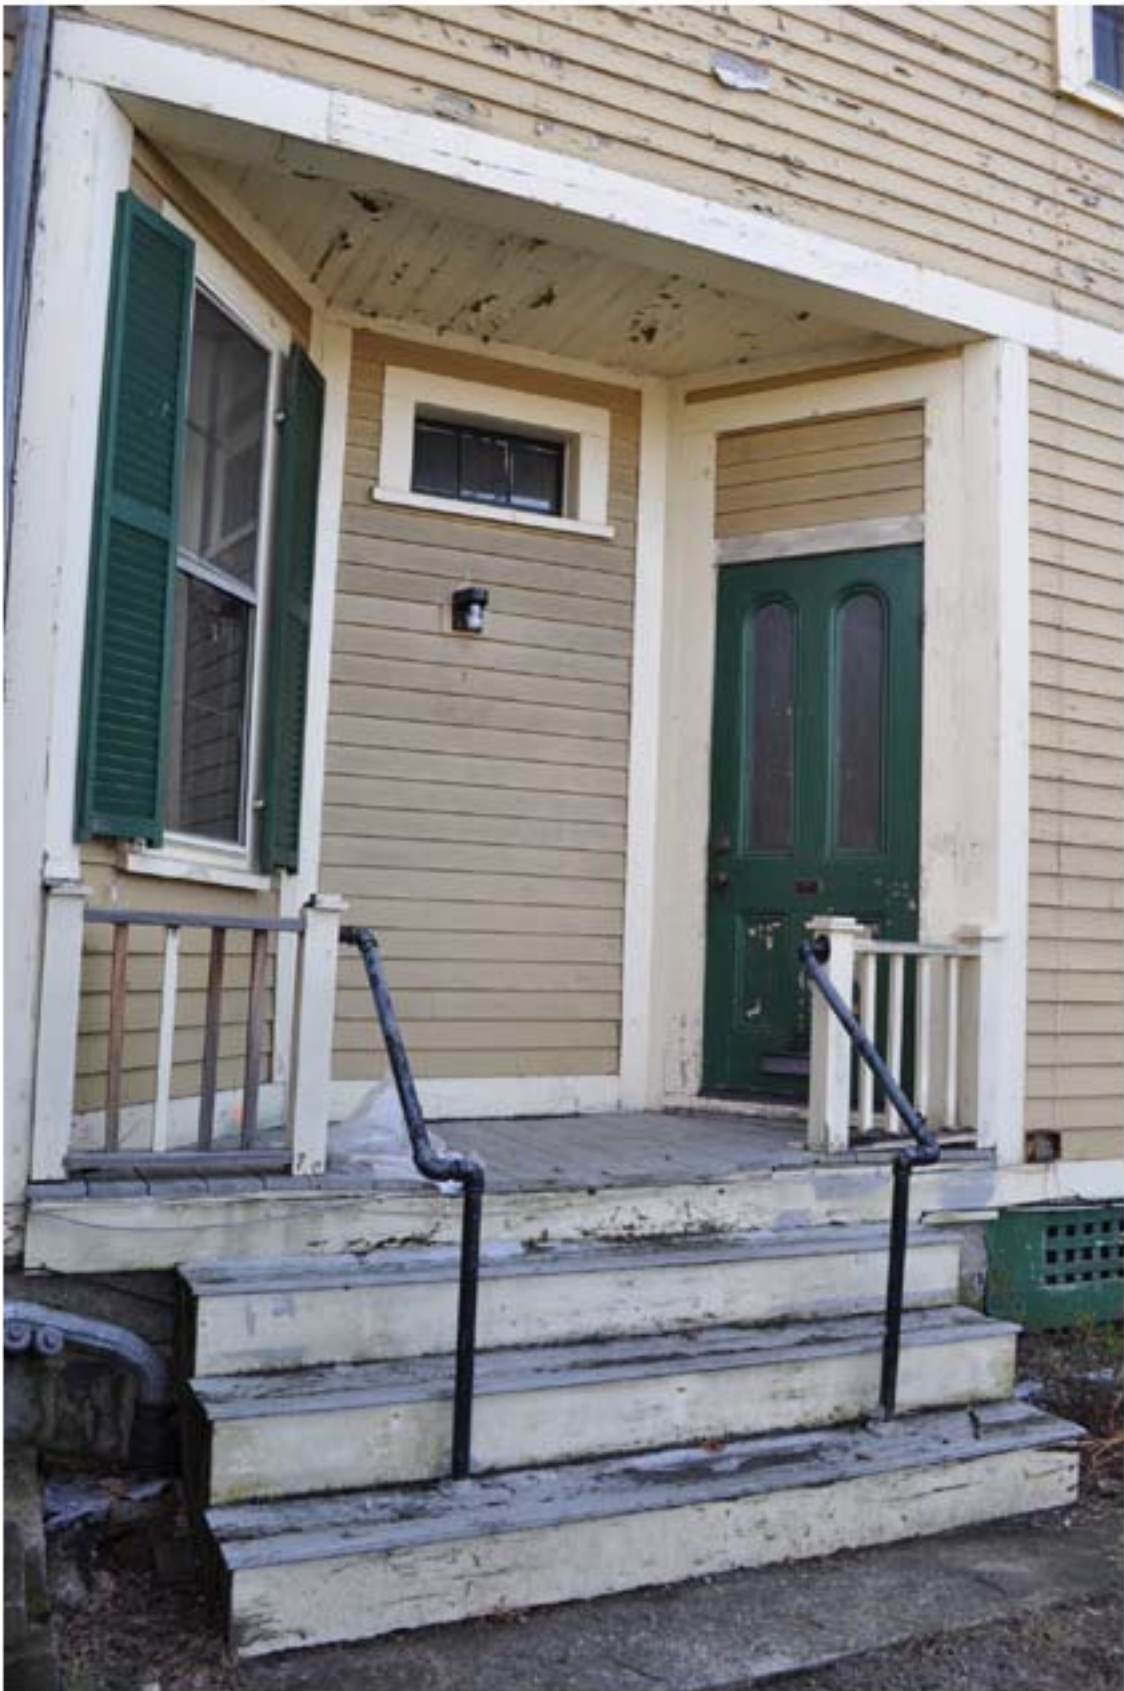
18A- Existing entrance porch and stairway on west side of house

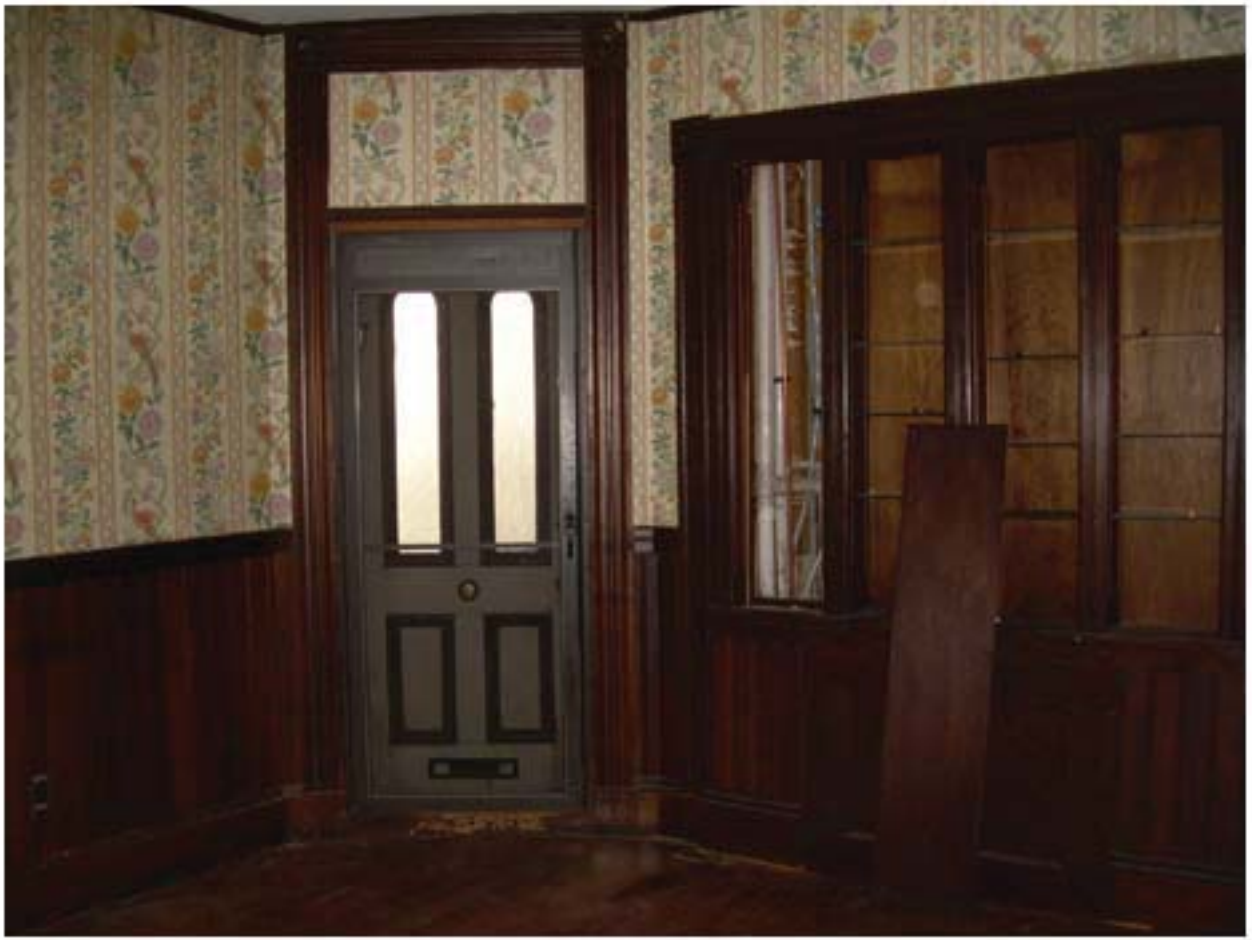
18A (Interior)- Existing entrance to porch on west side of house

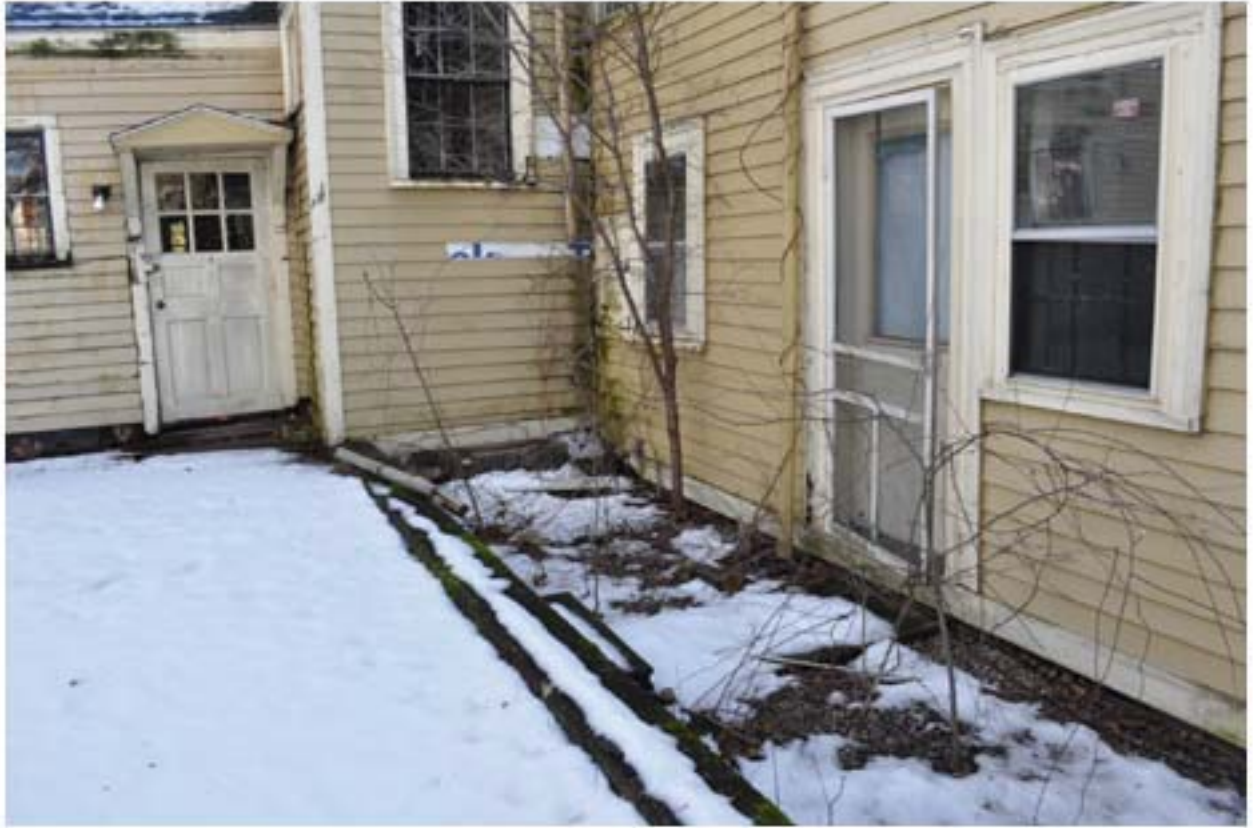
19A- Existing depressed patio grade water damage at the north house and west barn intersection

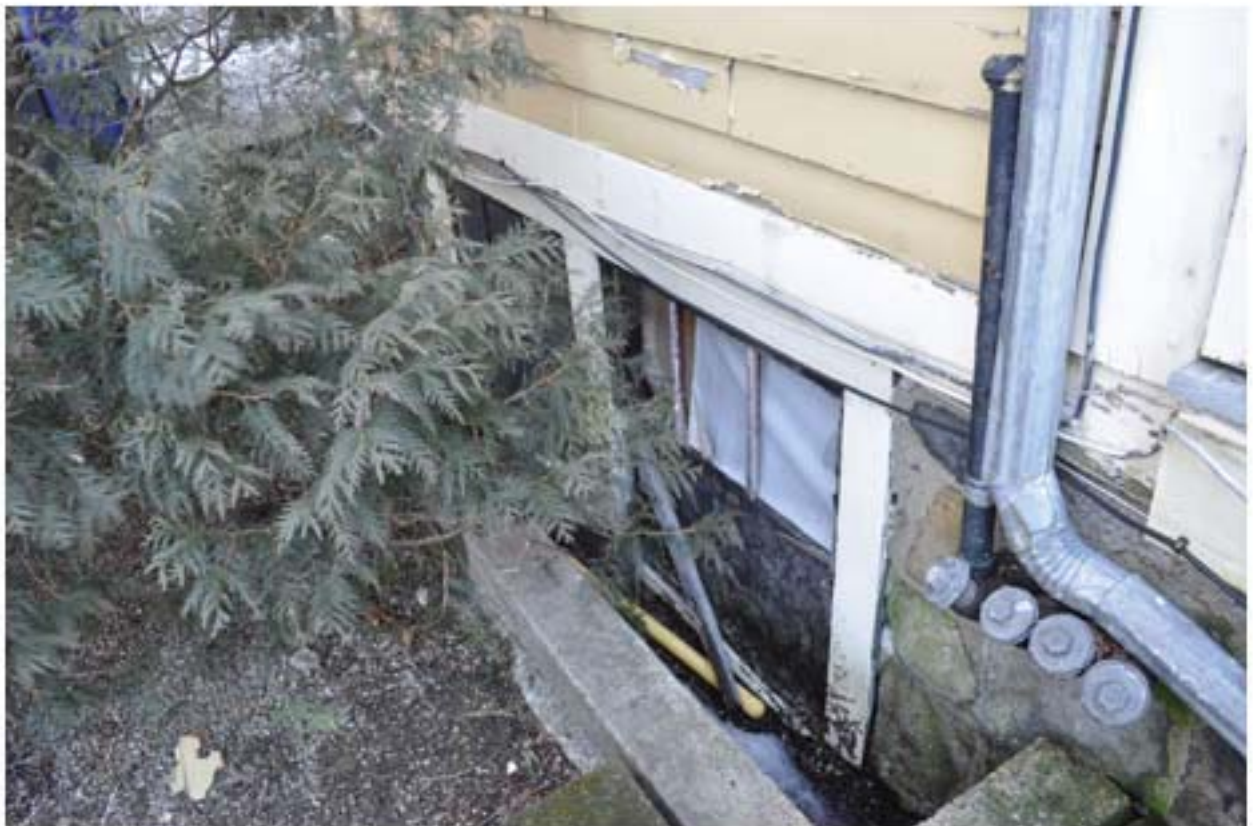
19B- Existing window well at west side of house

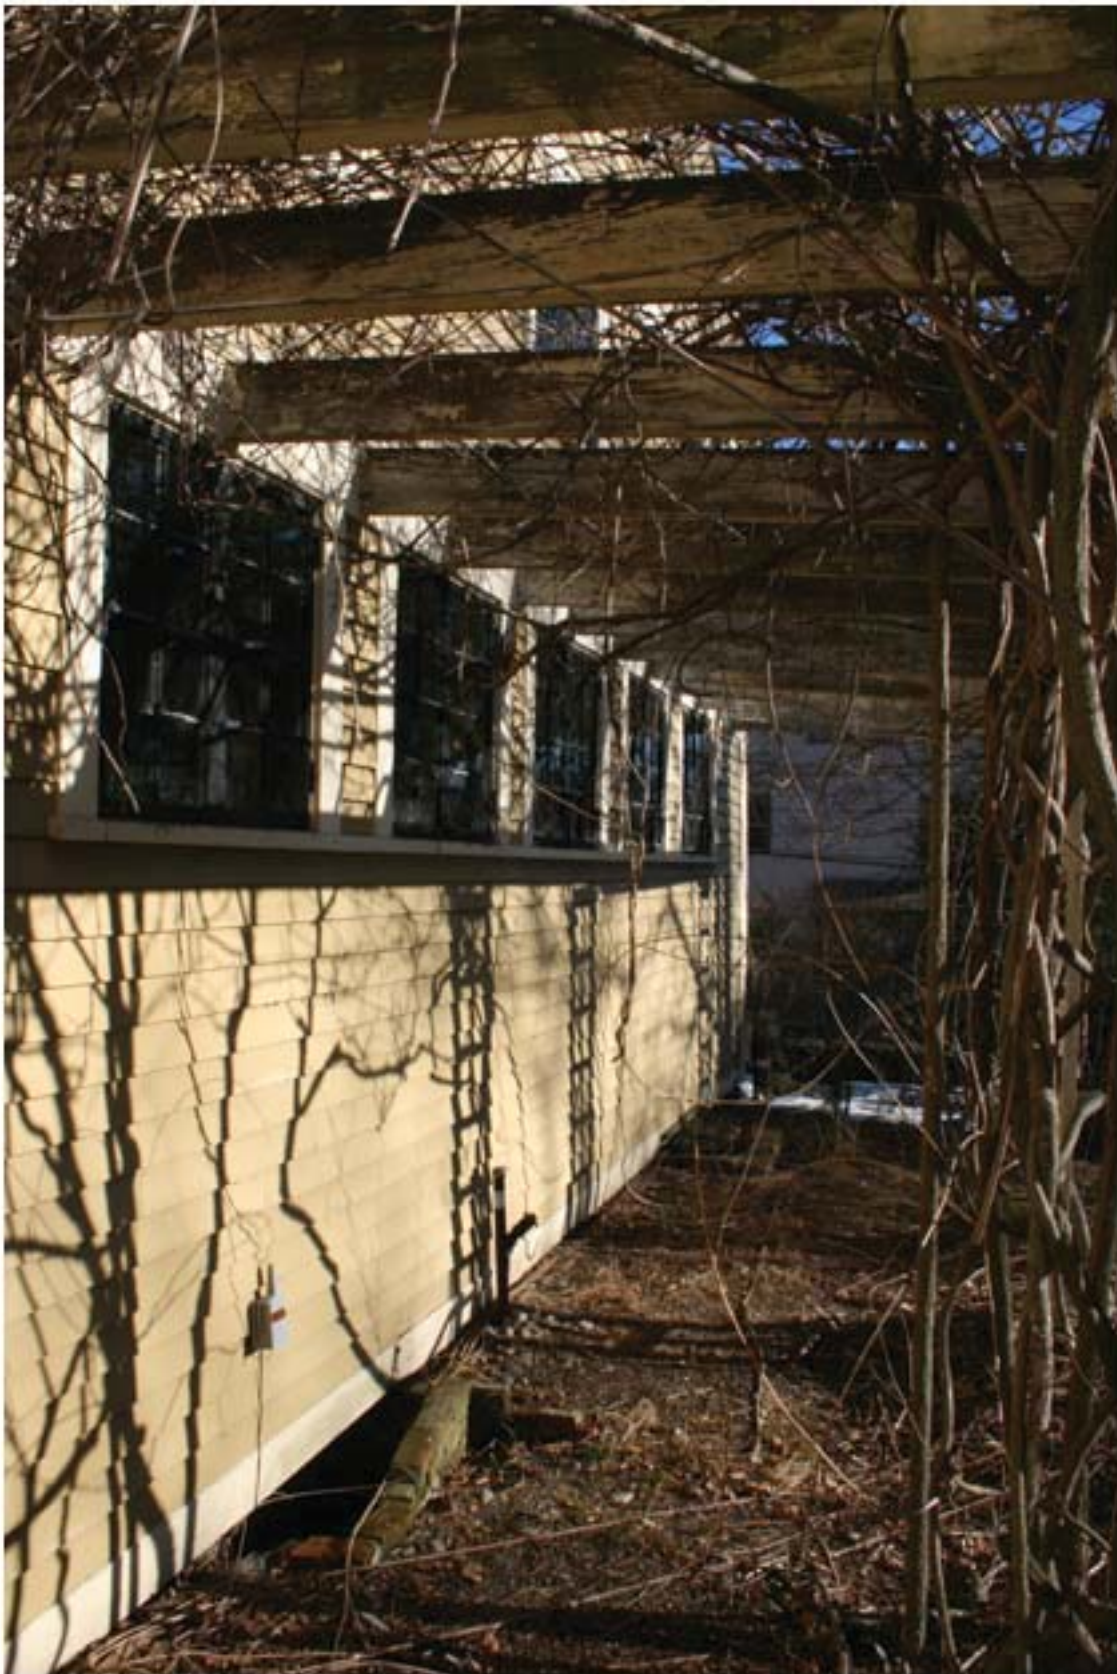
19C- Existing window well at south side of barn

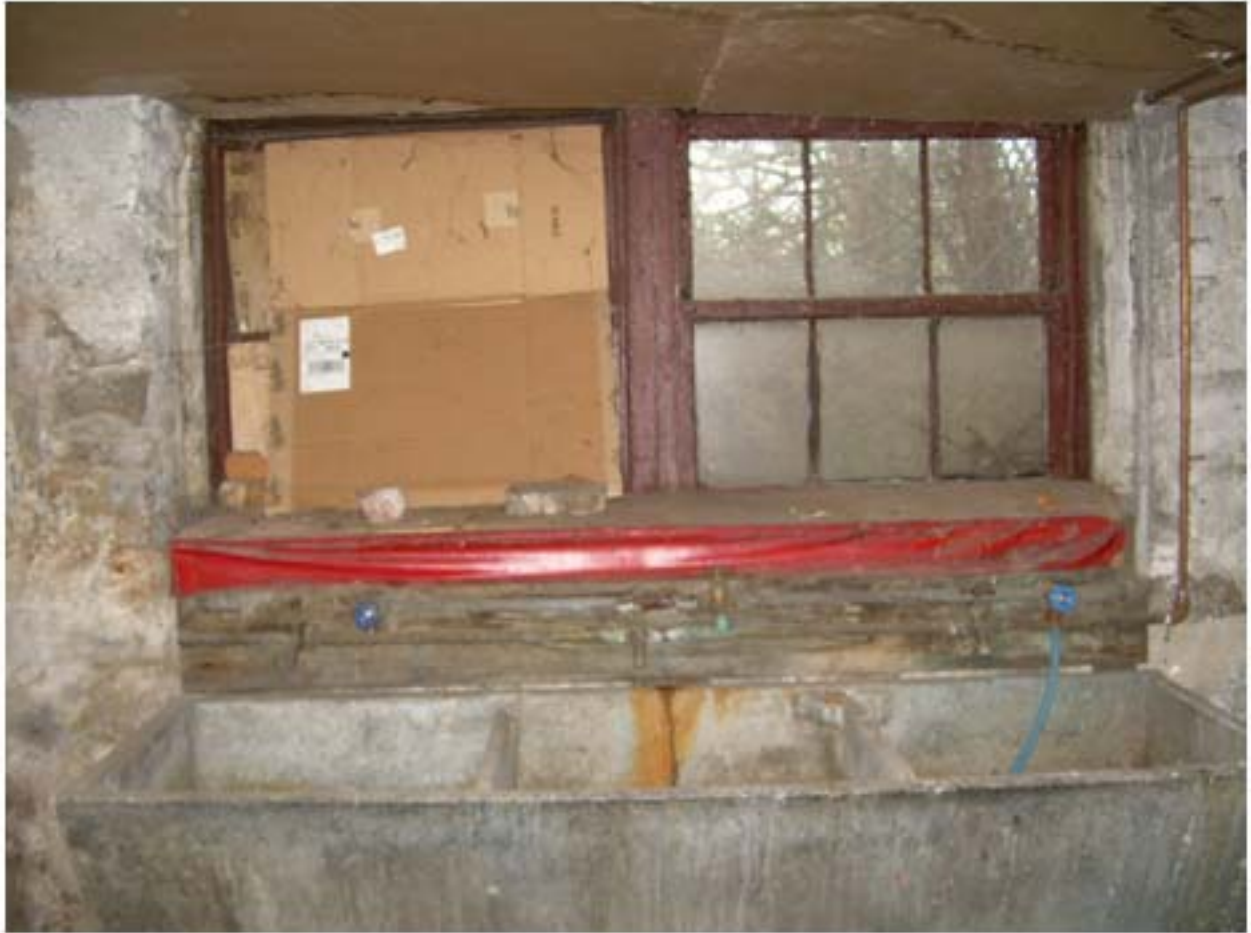
19B (Interior)- Existing basement window at west side of house

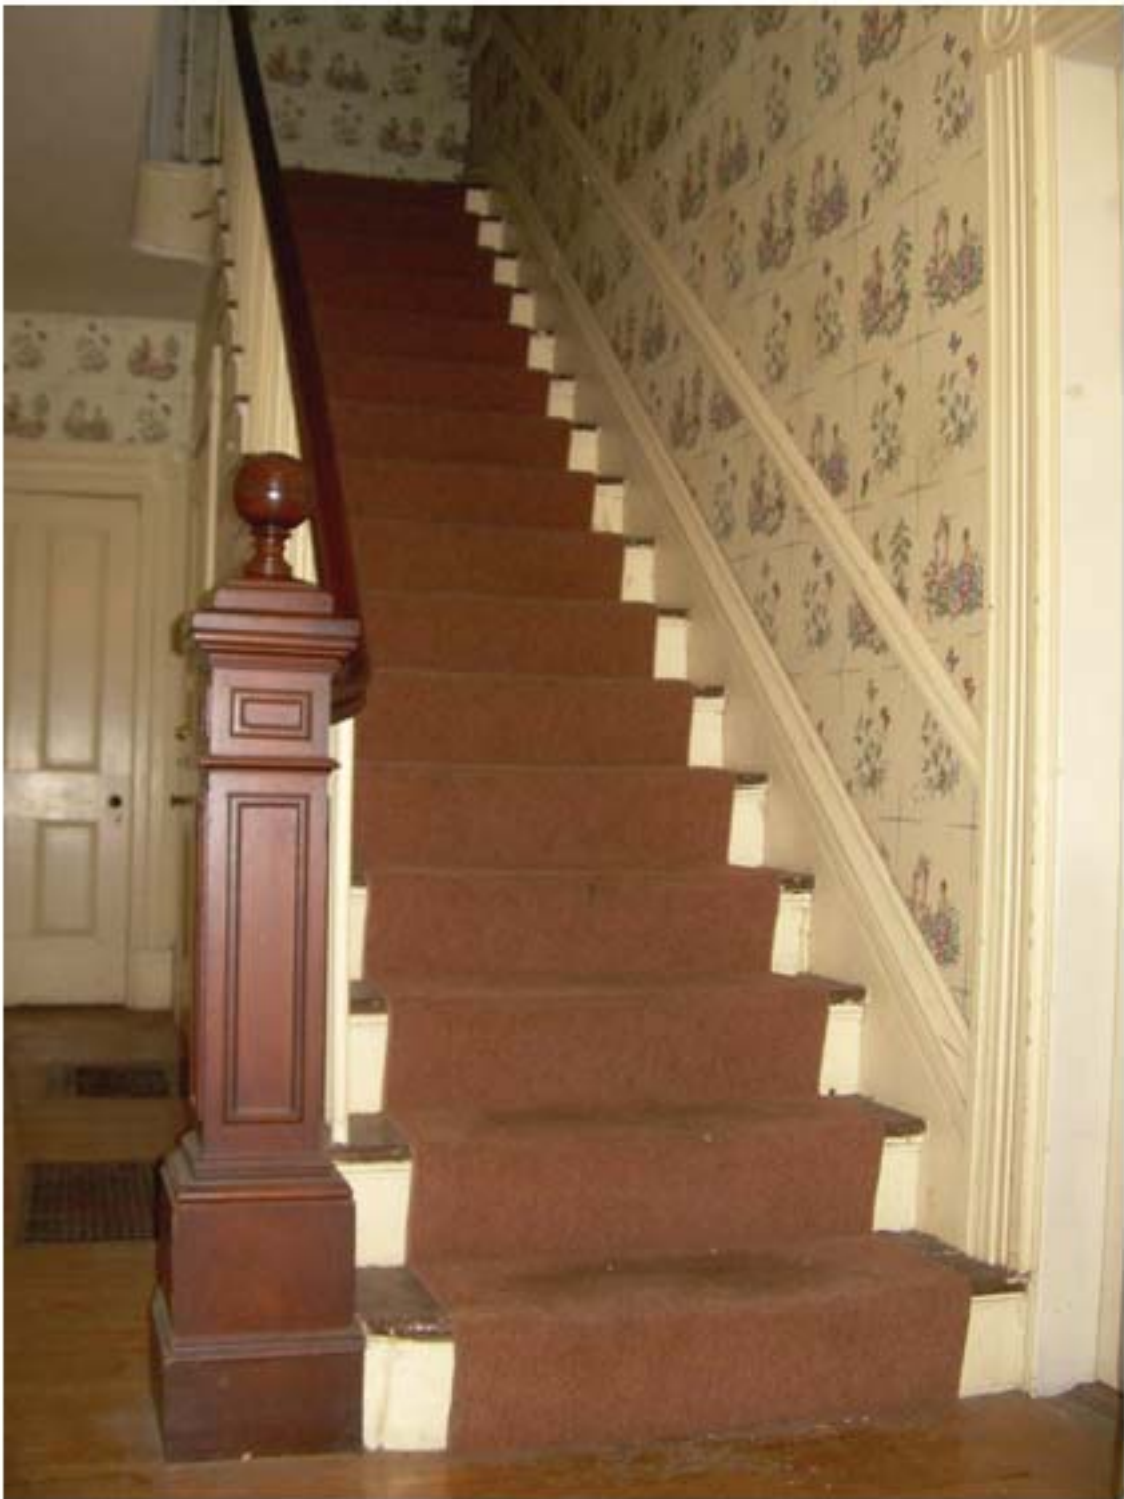
20A- Existing original stairway

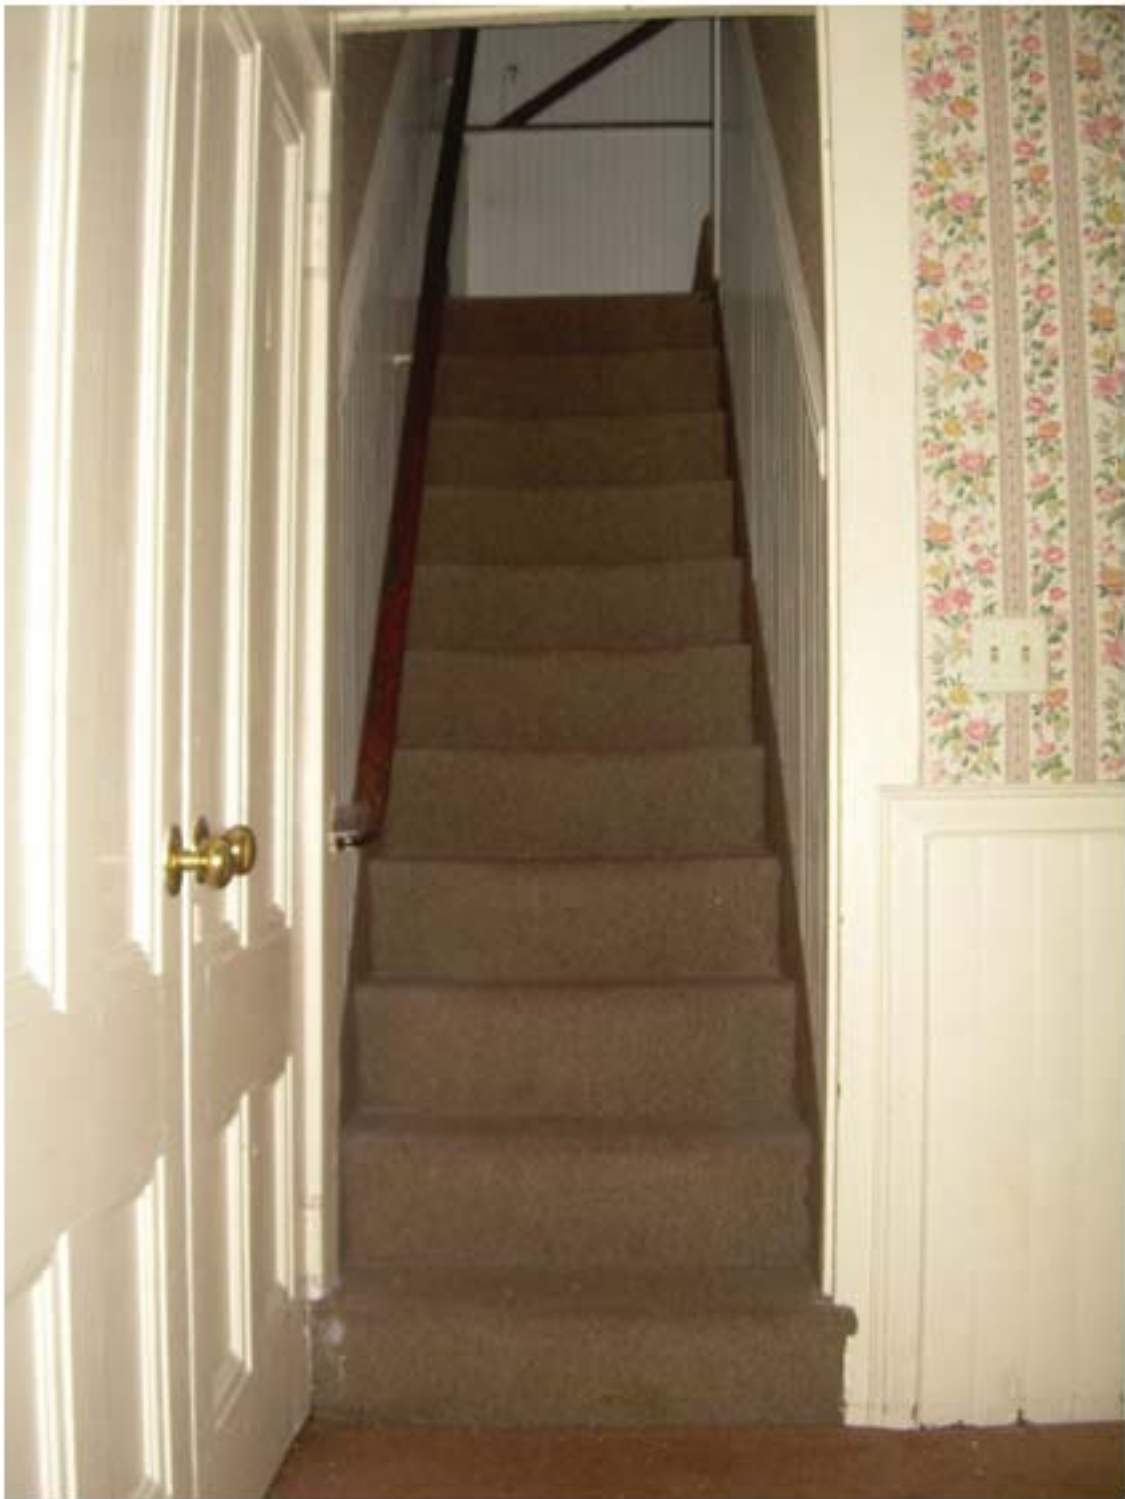
20A- Existing original stairway
