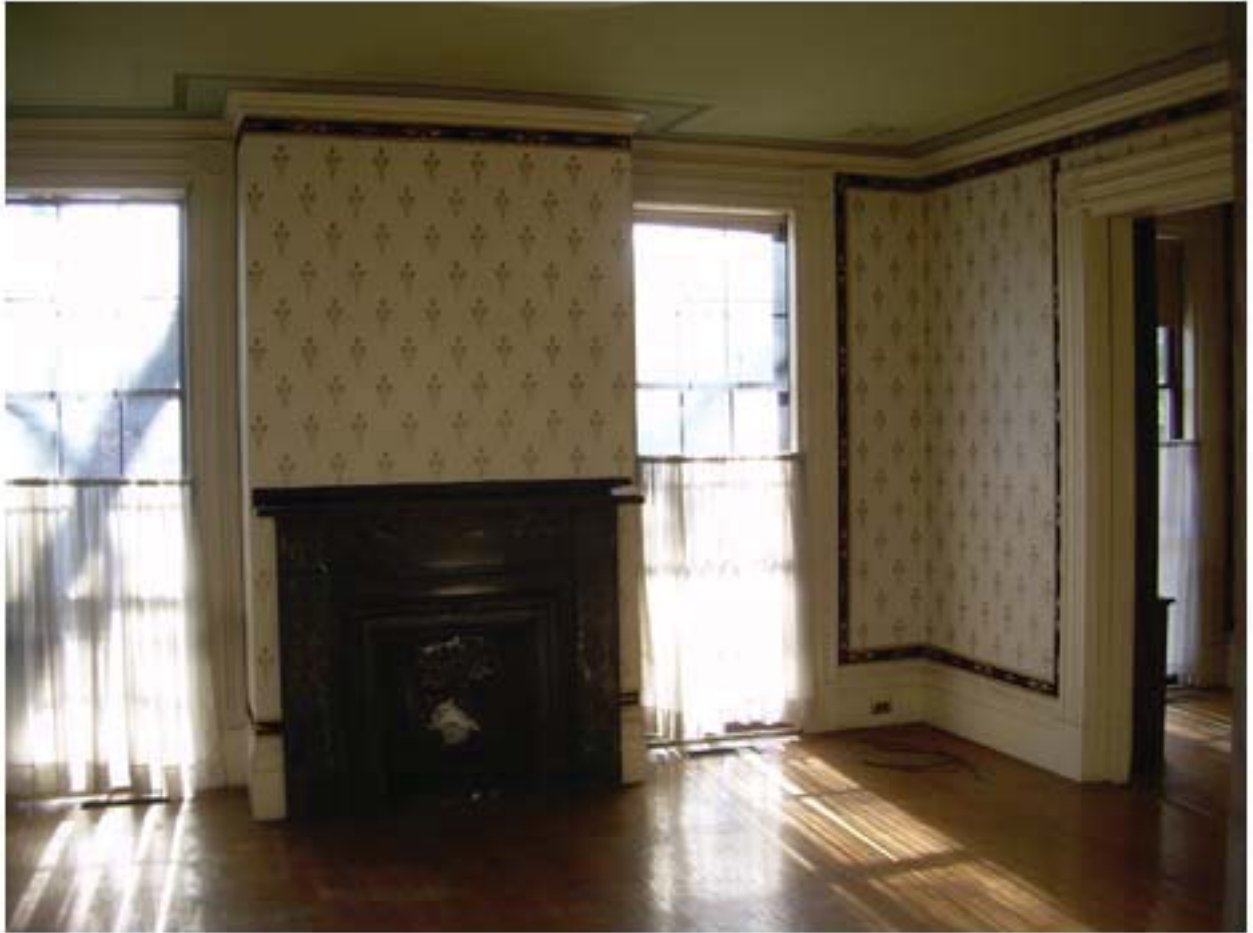
20C- Existing marble mantel, door casing, window trim, mop boards and wood parquet floors

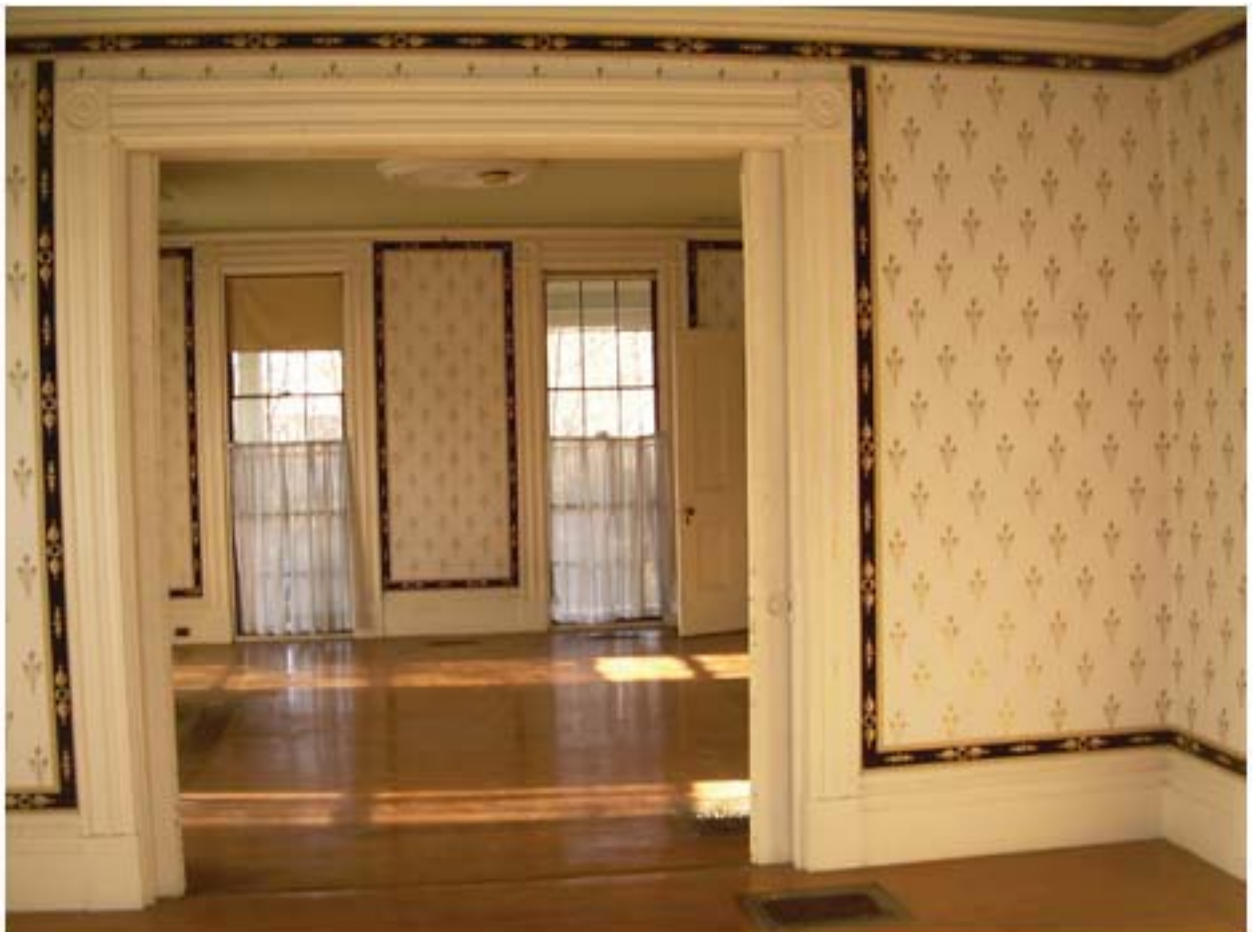
20D- Existing original door and casing, window trim, mop board and wood parquet floors

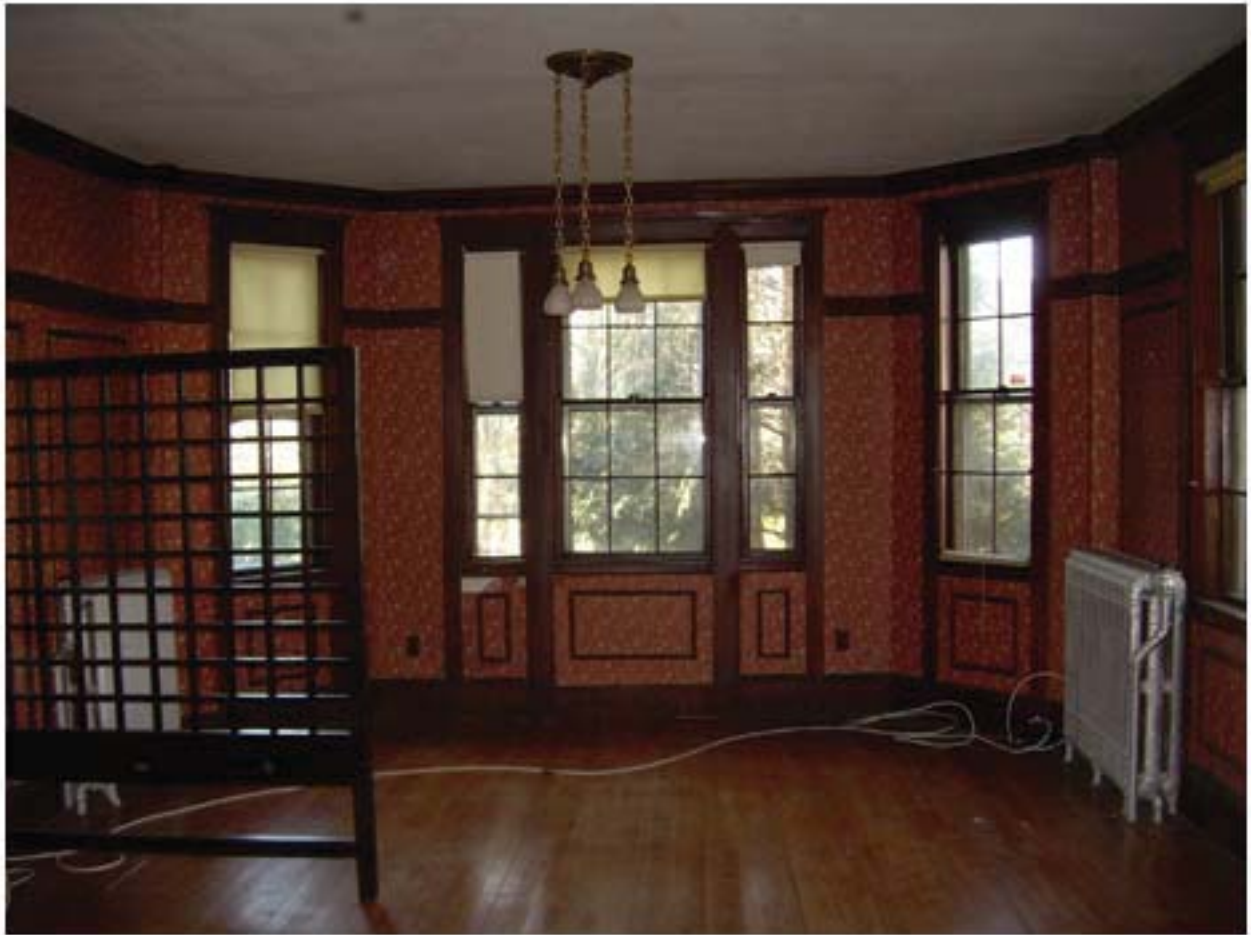
20E- Existing window trim, mop boards, wall paneling and wood parquet floors

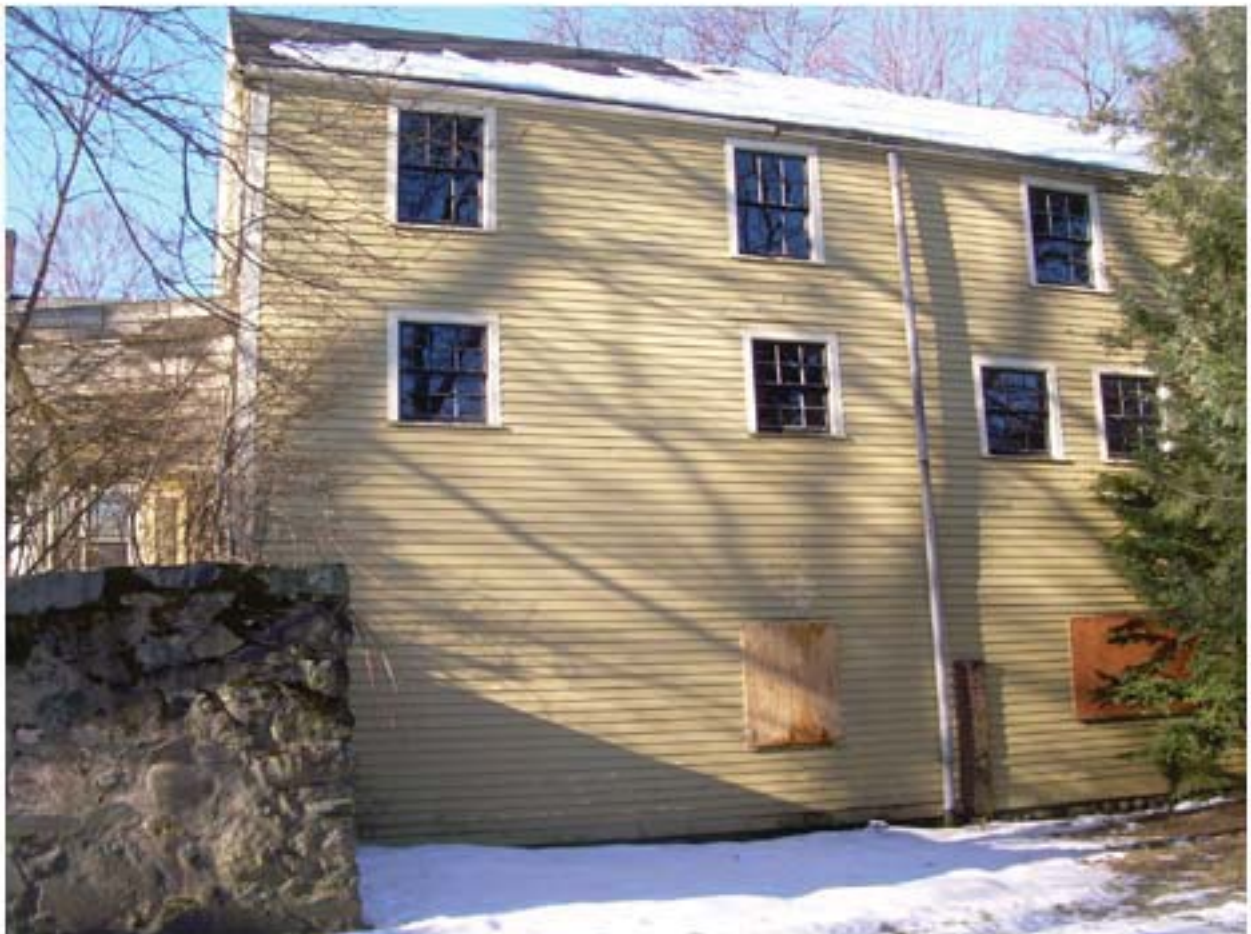
21B- Existing east side of barn
