Paul Cornell and Associates

**Inspection Report
prepared for:**

**Property Address:
236 Auburn Street
Newton, MA 02466**

Date of Inspection : 8/25/2016	Time Started 08:30 AM	Time Finished 02:00 PM
Property Address : 236 Auburn Street Newton, MA 02466	Report Prepared For : CAN-DO Inc	Report ID : AUG16_236 Auburn

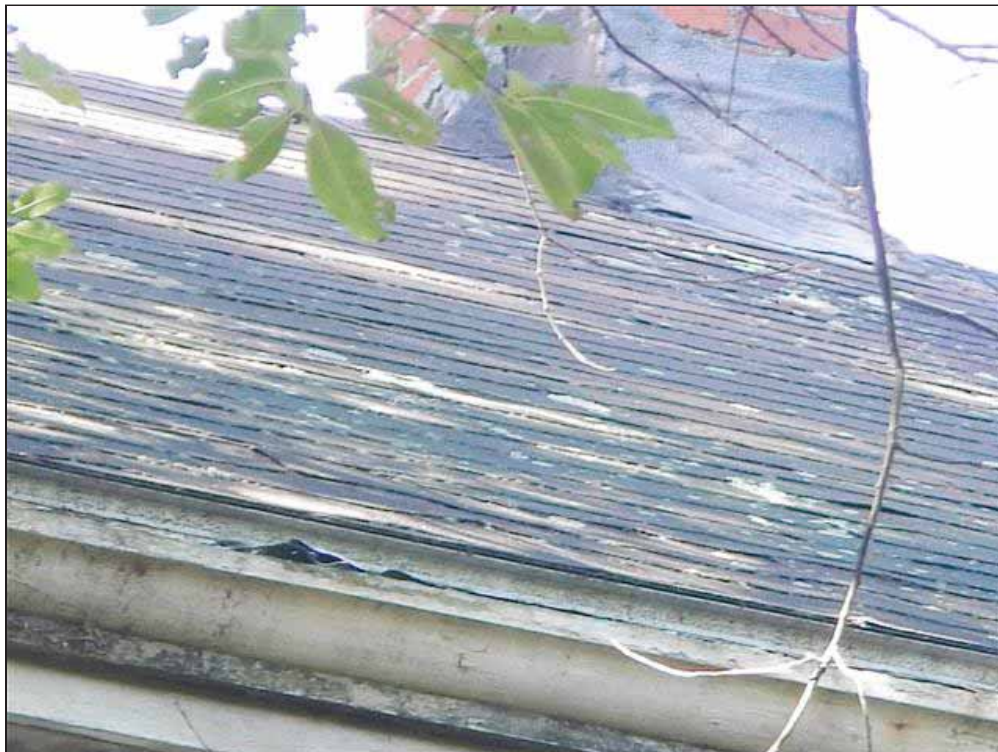
1.1 (Picture 1)

1.1 (1) ROOF COVERING : The roof covering has outlived the useful service life. Immediate replacement is needed. Shingles are dried out, cracked, pitted and are no longer water tight.

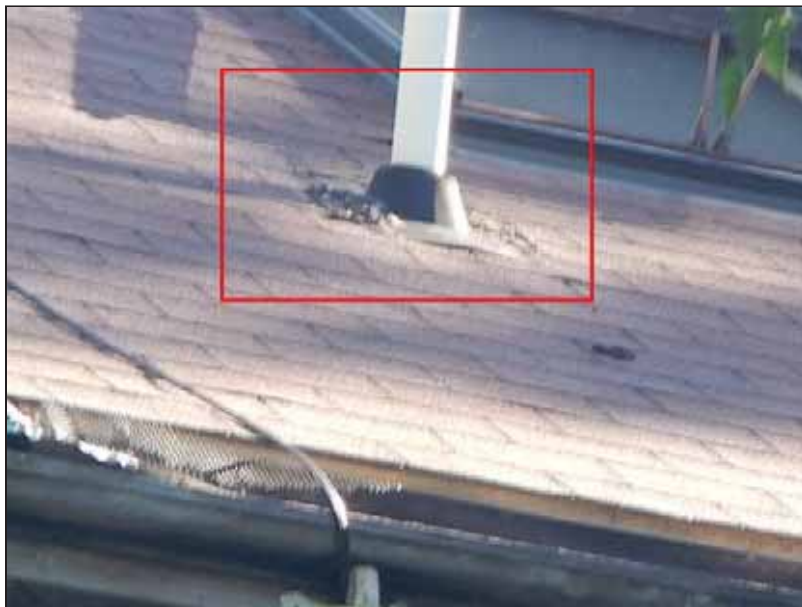
1.2 (Picture 5)

1.2 FLASHINGS : Chimney and plumbing vent flashings have been coated and sealed with roof cement(tar). This would indicate that flashing is damaged or worn and may indicate past leakage issues. This type of repair is temporary at best and must be periodically repeated to perform.

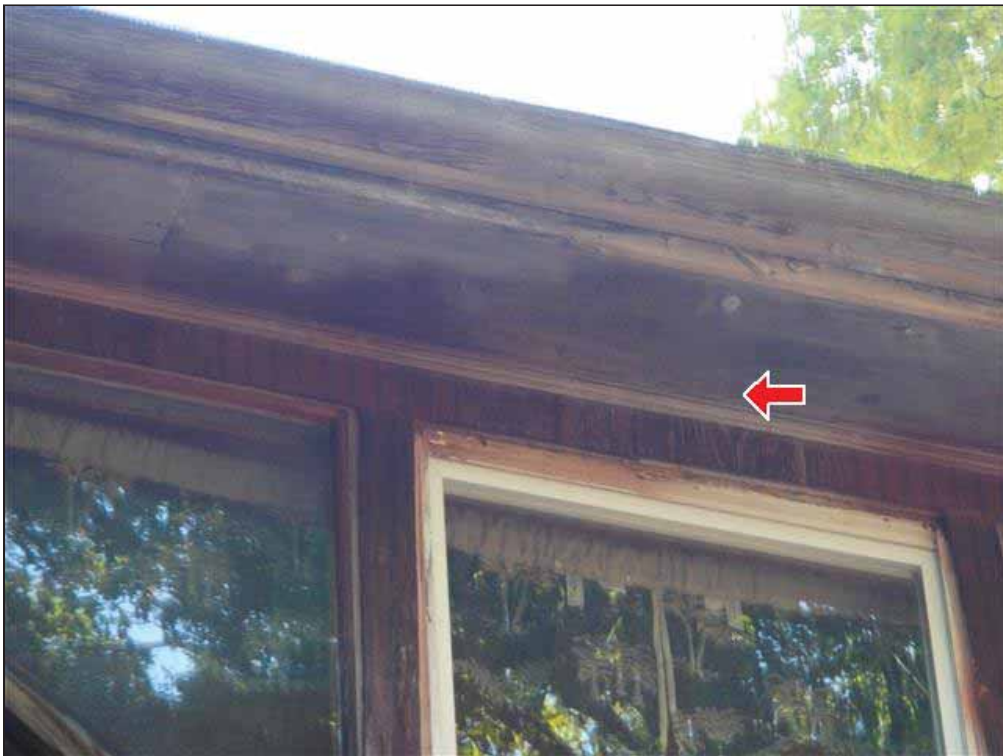
1.3 (Picture 5)

1.3 VALLEYS : Shingles in the right rear valley are cracked. This can contribute to leakage issues. Signs of water penetration in the soffits below the valleys were noted.

Valley systems are difficult to vent and tend to be prone to ice damming issues. Metal flashed valleys are recommended.

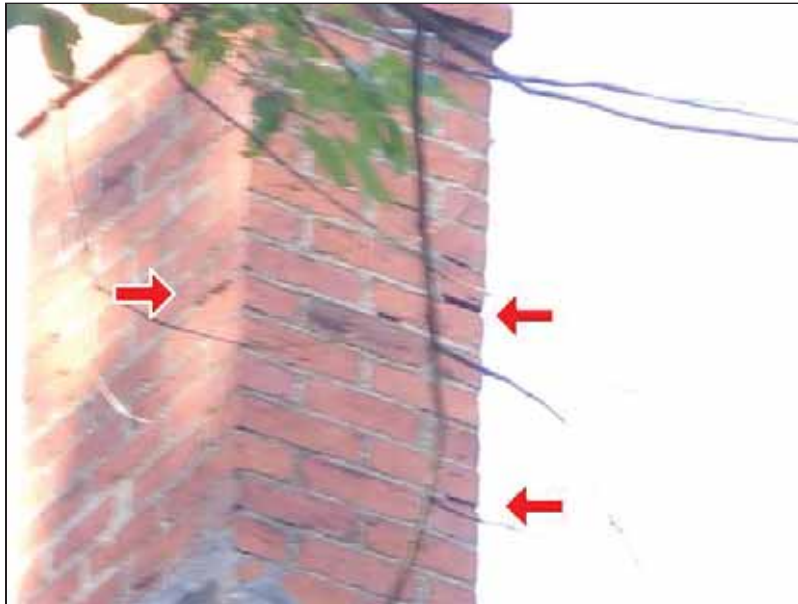
2.0 (Picture 1)

2.0 EXTERIOR SIDEWALLS : Masonry sidewalls of all three chimneys have deteriorated mortar joints and show signs of deep rooted water damage. Extensive repair and partial rebuilding is needed. A qualified masonry contractor should be consulted for needed repairs. Once needed repairs are completed sidewalls should be coated with water repellent to resist related damages.

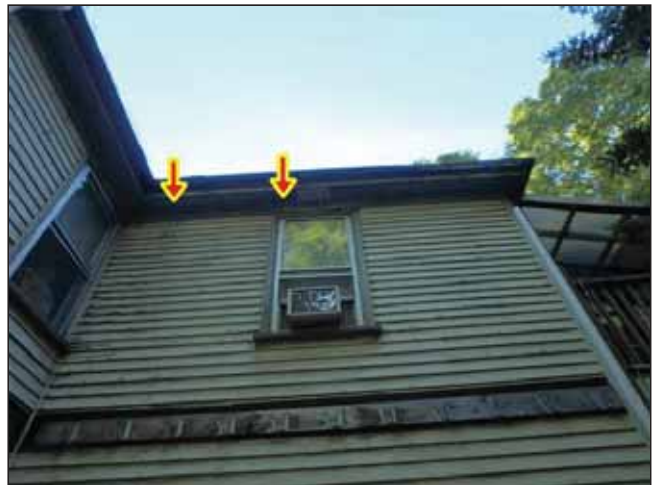
3.0 (Picture 7)

3.0 (2) Siding at many points around the exterior of the house shows signs of water penetration due to rotted and damaged soffits and rotted gutters.

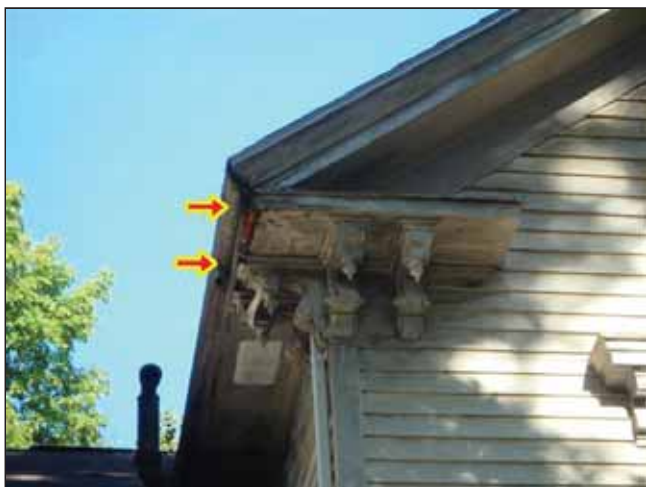
3.4 (Picture 1)

3.4 (1) FASCIAS AND SOFFITS : Soffits and fascias around most of the house show signs of water penetration due to rotted and decayed gutters, are water damaged, need significant restoration.

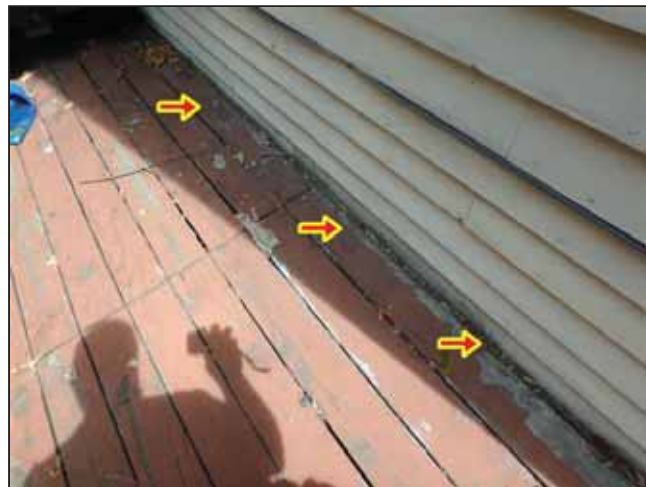
3.5 (Picture 1)

3.5 (1) FLASHINGS : The rear deck is not flashed against the house. The lack of proper flashing between the ledger and the house will allow for water penetration. This will contribute to decay, wood destroying insects and potential mold issues. Correction is needed. A qualified contractor should be consulted for needed repairs.

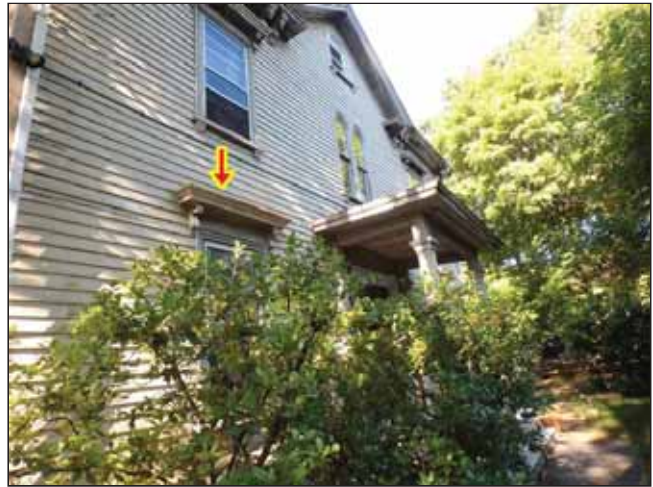
3.5 (Picture 3)

3.5 (2) Flashing on trim on the tops of the windows is rusted, damaged and needs restoration.

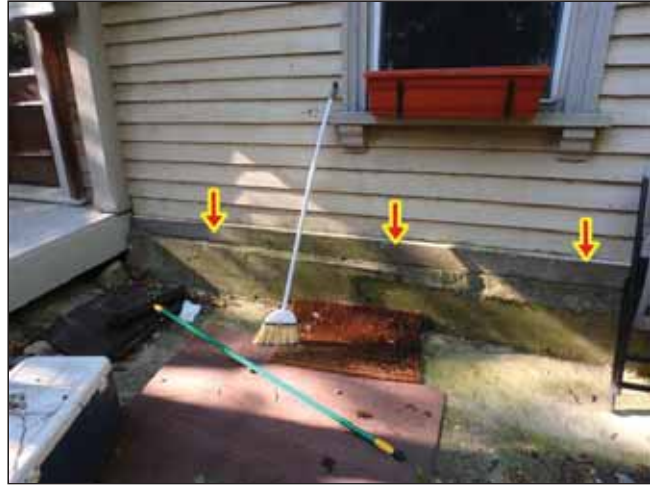
3.6 (Picture 4)

3.6 FOUNDATION WALLS : The front and right side foundation walls show noticeable and unusual signs of distortion. The foundation wall projects past siding. This appears to be a result of structural movement. The rear foundation wall also shows unusual signs of distortion, as well. The interior of the basement area was completely cluttered with storage. Foundation walls were not accessible or visible on the interior of the house as a result. Further investigation is needed. A structural engineer should be consulted for further evaluation, **prior to commitment**.

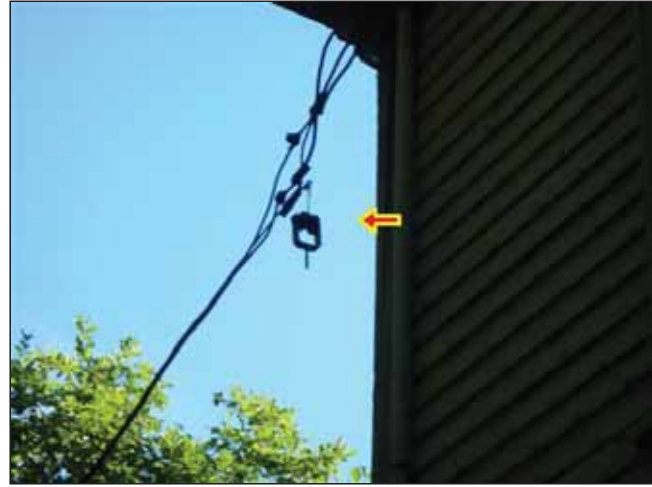
3.10 (Picture 2)

3.10 SERVICE DROP AND ELECTRIC ENTRY CABLES : The cleat attaching the electric service drop to house is not secured and poses a safety hazard as cables are not supported. Immediate repair is needed. The local electric service provider should be consulted for repair.

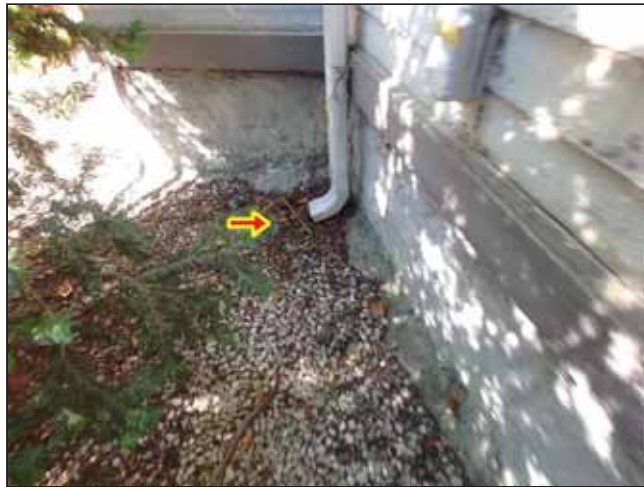
4.2 (Picture 1)

4.2 EXTENSIONS : Downspouts are currently discharging against or close to the foundation. This can contribute to cellar water entry and other moisture related issues. Extensions need to be installed and maintained at all points where downspouts discharge to direct water away from the house. Extensions should be at least 3 to 5 feet in length and should discharge where grading is favorable for drainage away from the house.

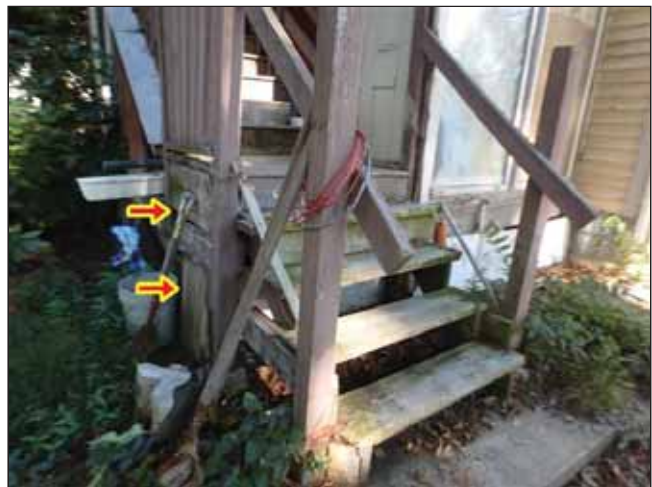
4.6 (Picture 7)

4.6 (2) The rear entry stairway and roof were poorly constructed, were not maintained, have rotted supports, damaged treads, loose and damaged railings are completely unsafe for use. This stairway and entire structure need to be torn off the house and completely rebuilt at once.

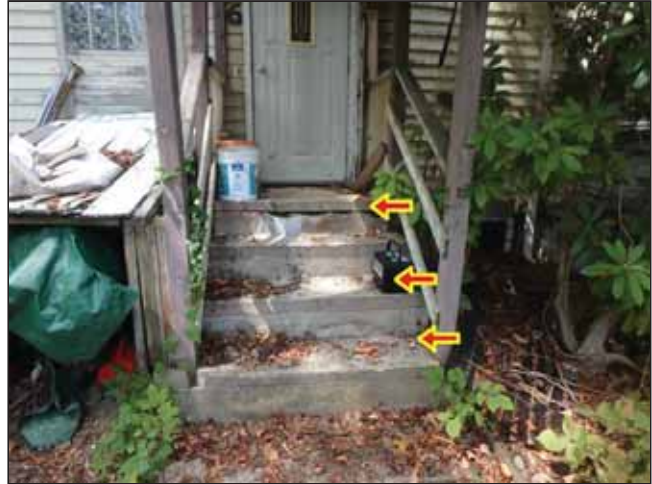
4.6 (Picture 9)

4.6 (3) The left side entry steps have inconsistent rise, are cracked, damaged and are unsafe Steps vary in height throughout the stairway. This is a trip hazard. Rebuilding is needed.

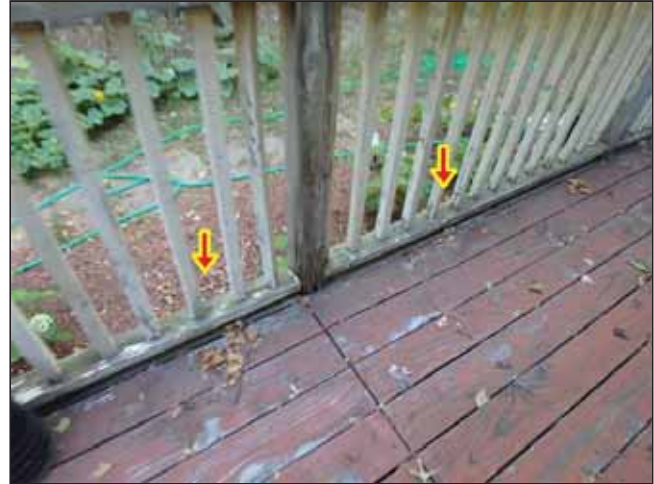
4.7 (Picture 2)

4.7 RAILINGS : Railings along the right side deck are rotted, damaged, are weak, are loose and are unsafe. They need to be completely rebuilt, at once.

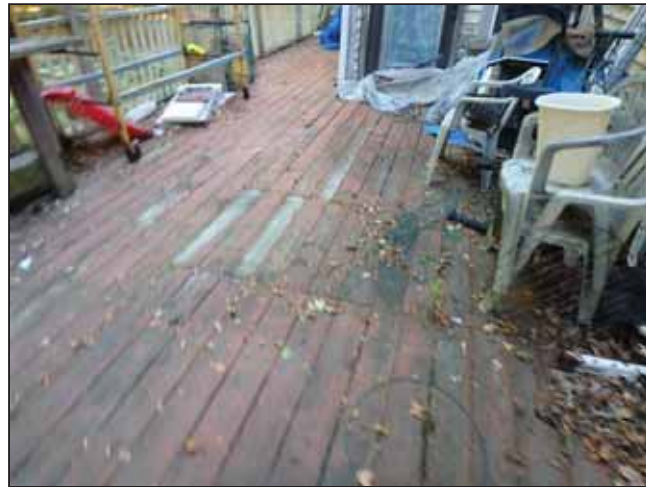
4.8 (Picture 1)

4.8 DECK : The deck is poorly constructed, has not been maintained, has damaged deck boards, rotted deck boards, is sinking, decaying framing, is not flashed into the house and is unsafe. Safety hazard and the risk for person injury exist. Immediate and complete rebuilding of the deck is needed. A qualified & licensed contractor should be consulted for cost estimates.

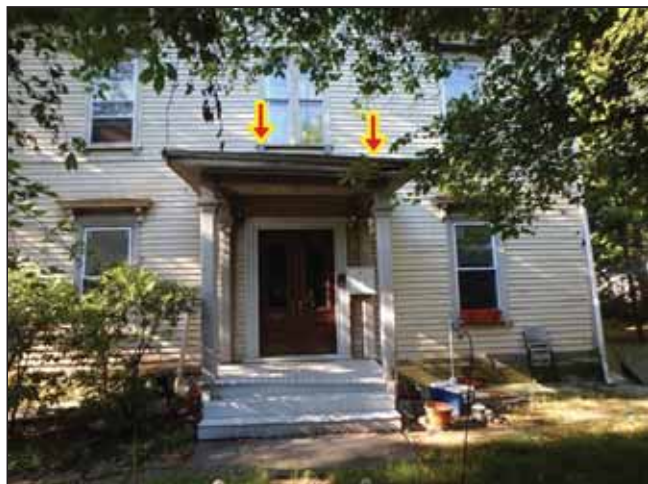
4.9 (Picture 1)

4.9 PORCH : The front entry porch is rotted, is collapsing, is unsafe, poses significant risk for personal injury and needs to be torn down and rebuilt.

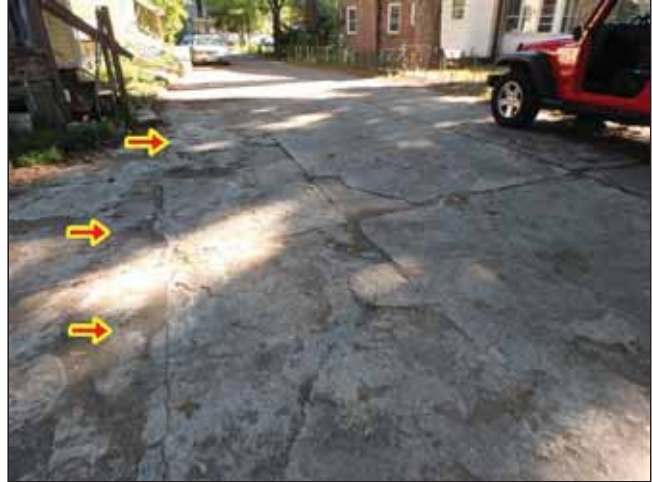
4.10 (Picture 2)

4.10 DRIVEWAY(S) : The driveway has settled, is cracked, heaved and is breaking apart. This will make snow removal difficult and poses tripping hazards. Replacement is needed.

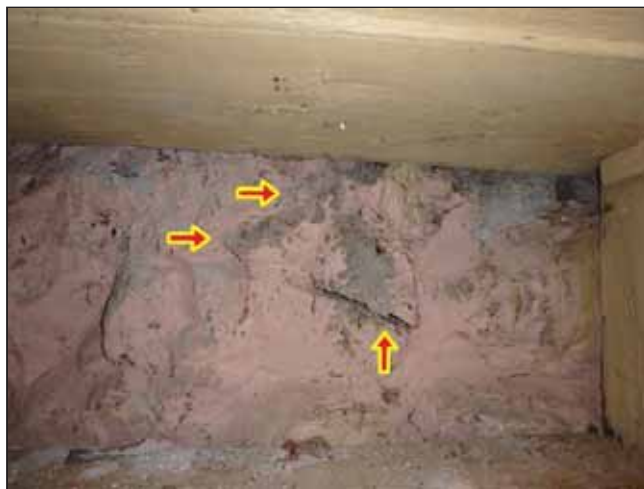
6.1 (Picture 1)

6.1 (2) RE-INSPECTION 09-06-16 : The accessible portion of the right side stone foundation wall has loose and missing mortar. Attempts have been made to re[par or re-point this wall. Mortar was not used. Gaps between stones were filled with debris and a plaster like material. This is not an effective repair. This wall does not appear to be structurally sound in my opinion. I would recommend a licensed and qualified structural engineer be consulted for evaluation of the entire foundation. .

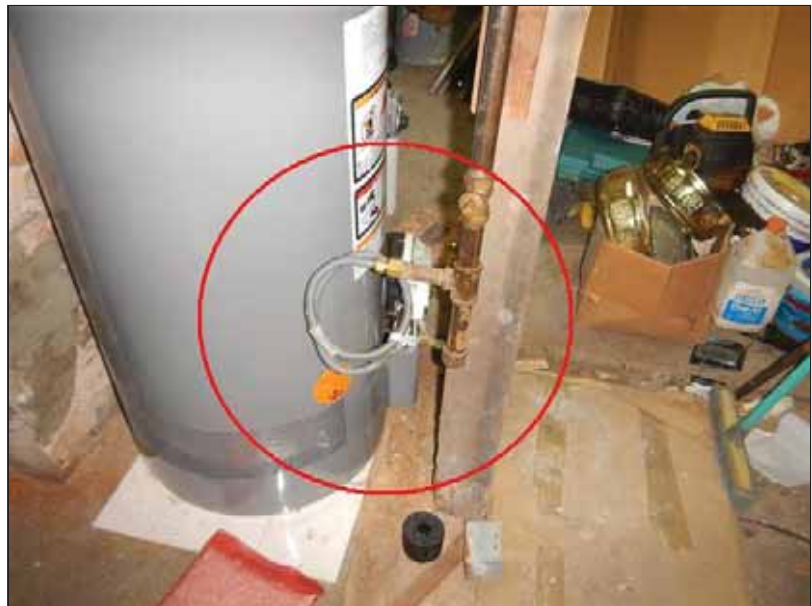
9.4 (Picture 1)

: The gas piping to the water heater appears unprofessional. The flexible gas pipe connection should be evaluated by a licensed plumber.

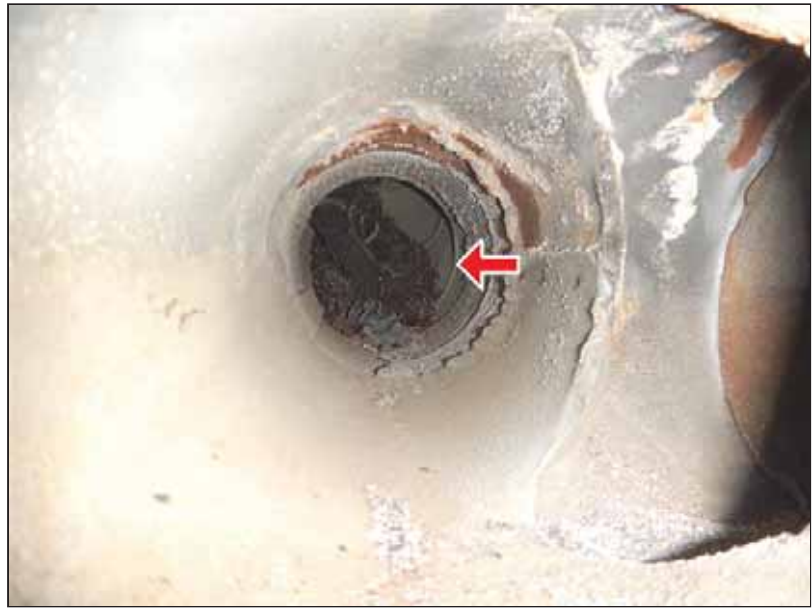
9.6 (Picture 1)

9.6 (1) FLUE PIPE CONNECTOR :A dead bird was noted in the flue passage of the left front chimney. This poses an obstruction. Immediate correction is needed.

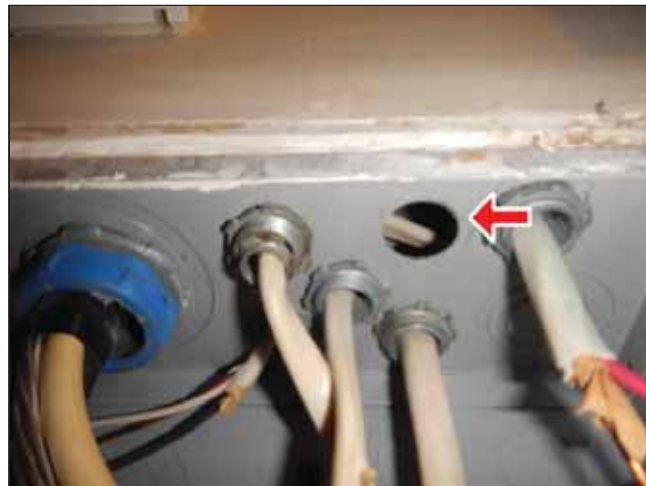
10.2.A (Picture 1)

10.2.A BUSHINGS/KNOCKOUT PLUGS : There is a missing knock out from the top of the main panel. It needs to be pugged.

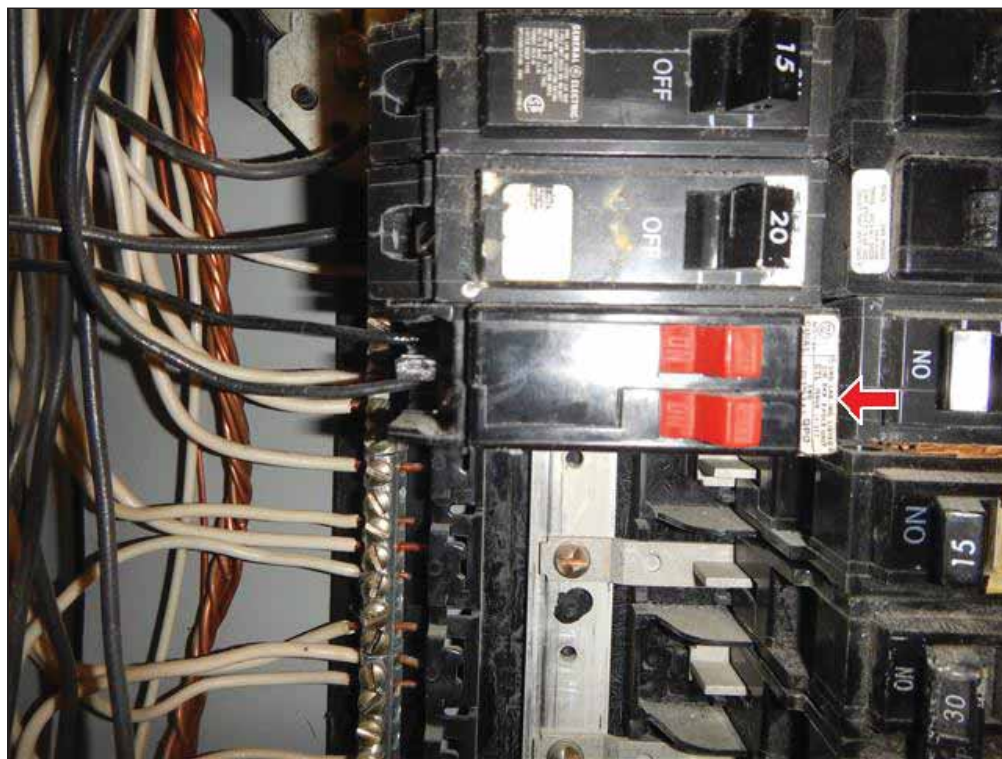
10.3.A (Picture 1)

10.3.A (1) CIRCUIT BREAKERS : This cabinet does not list duplex style circuit breakers as compatible. These breakers are typically field altered to be installed. This can void manufacturer's warranty and work the panel beyond the designed capacity. Correction is recommended.

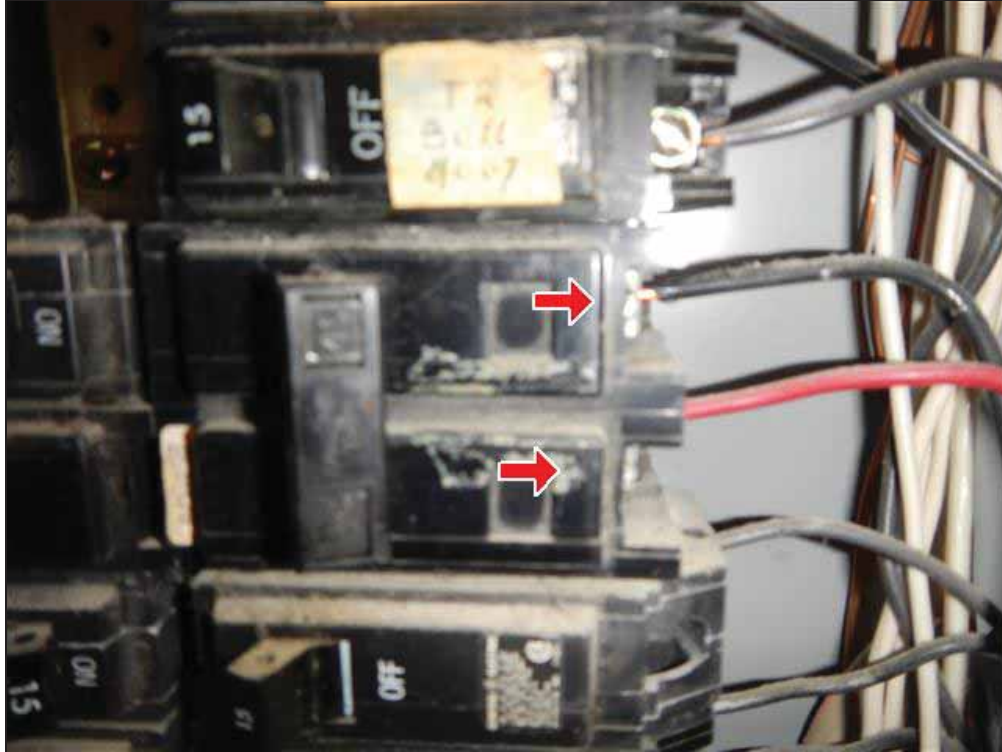
10.3.A (Picture 2)

10.3.A (2) At least Two circuit breakers in the main panel are of a different manufacturer and are not listed for use in this cabinet according to the manufacturer's label. Replacement with approved breaker(s) is needed as this can pose a safety issue. This also voids manufacturer's warranty and could result in property damage or injury.

10.3.A (3) One 40 Amp circuit breaker and two 20 Amp breakers in the main panel are over fused. Wires connected to the breaker can overheat if the circuit is overloaded before the breaker will disconnect power. This is a potential fire hazard and needs immediate correction. A licensed electrician should be consulted for further evaluation and needed repairs.

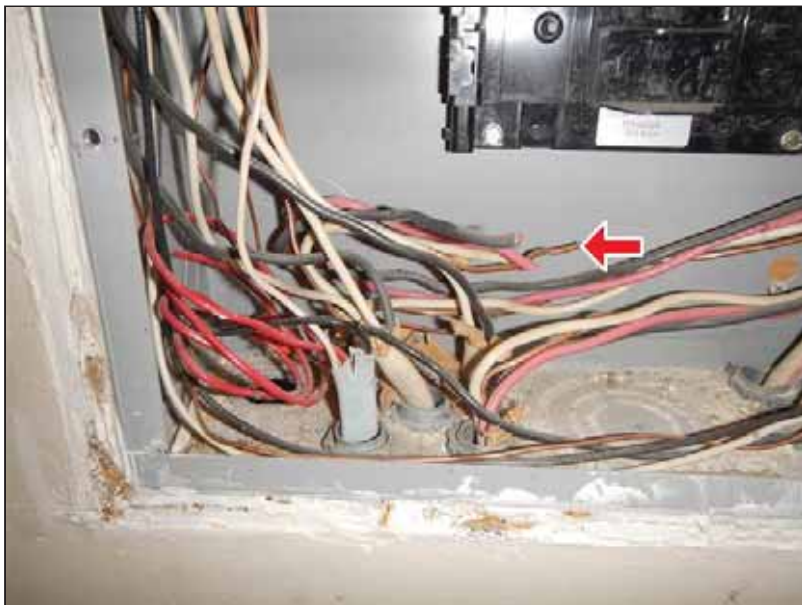
10.4.A (Picture 1)

10.4.A (2) Workmanship in the panel and throughout the house is sloppy and appears non professional. Wire terminations in the panel are not properly capped. Evaluation of conditions within the panel was somewhat limited as a result.

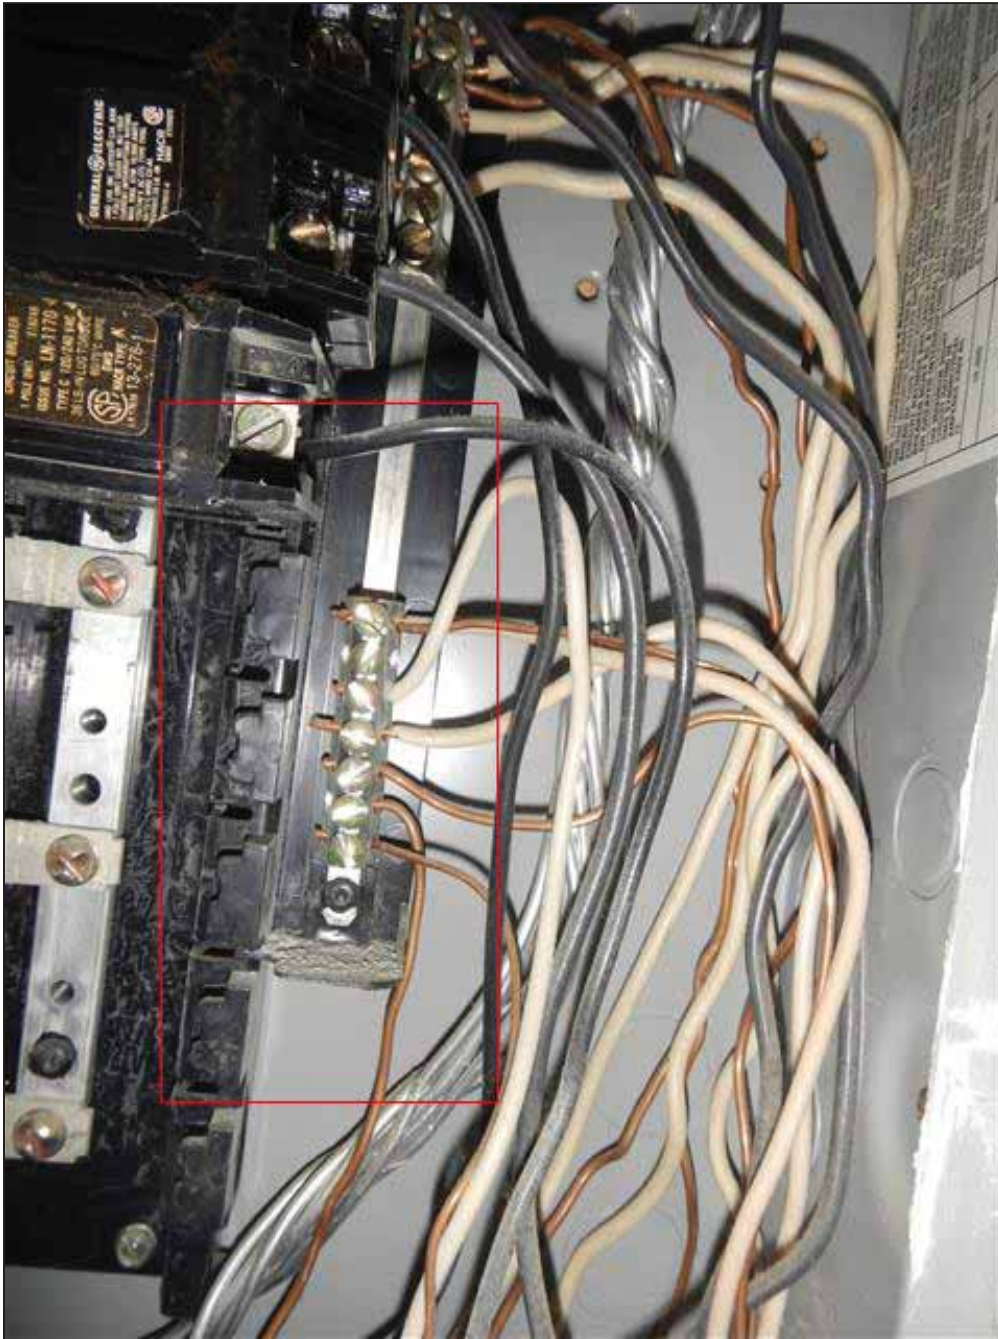
10.1.B (Picture 1)

10.1.B GROUNDING : Grounds and neutrals need to be isolated as is required. This is a potential hazard and needs immediate correction. A licensed electrician should be consulted.

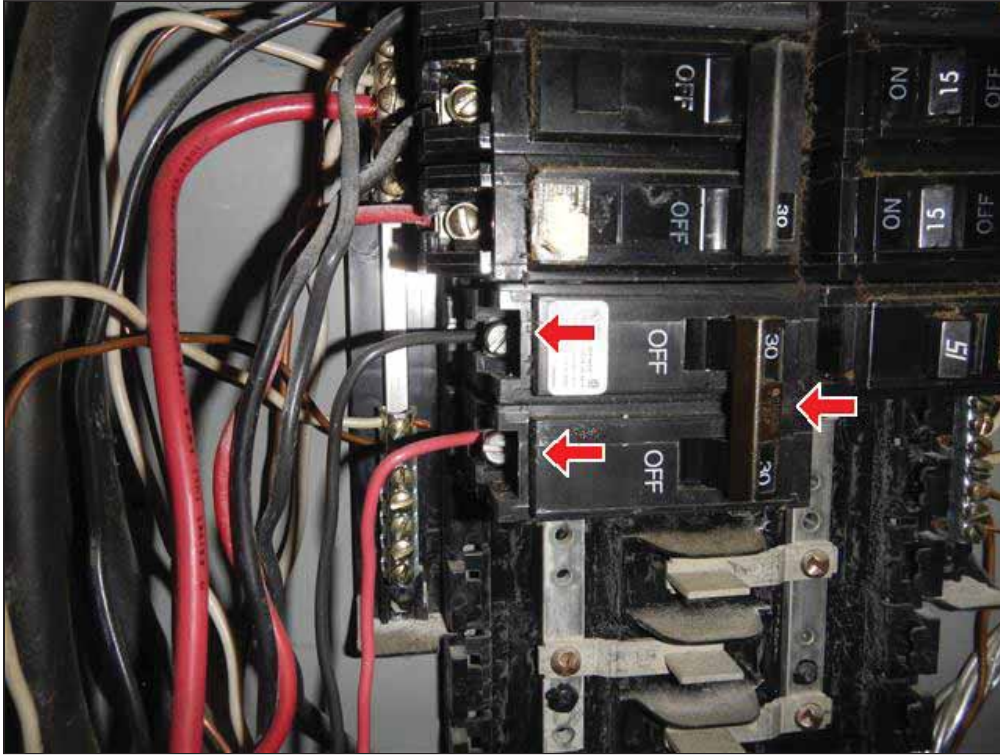
10.2.B (Picture 1)

hazard and needs immediate correction. A licensed electrician should be consulted for further evaluation and needed repairs.

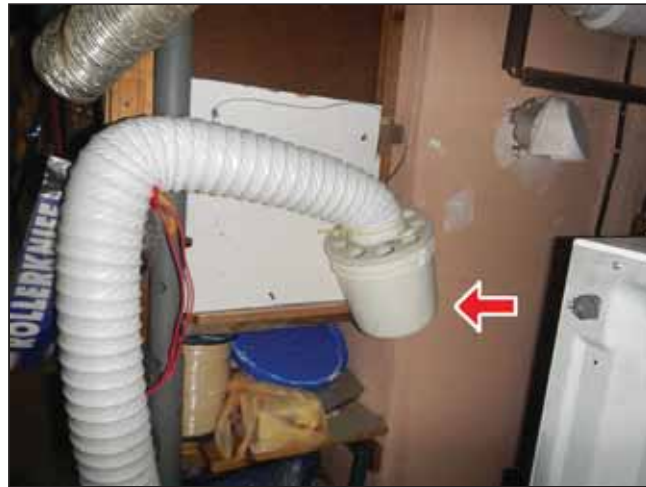
11.2 (Picture 2)

11.2 (2) The dryers in the cellar are venting into the cellar. Moisture can promote mold issues if not addressed.

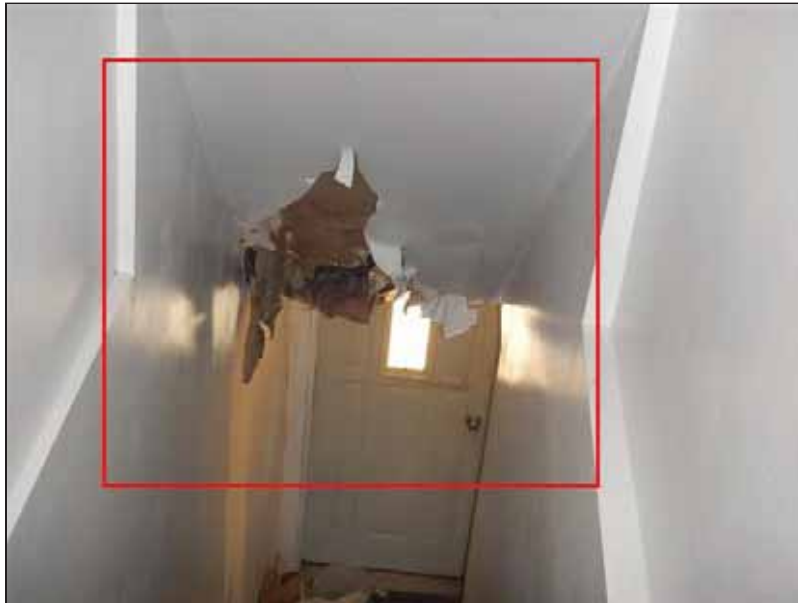
12.0 (Picture 1)

The ceiling in the rear stairway is water damaged. Repair is needed.

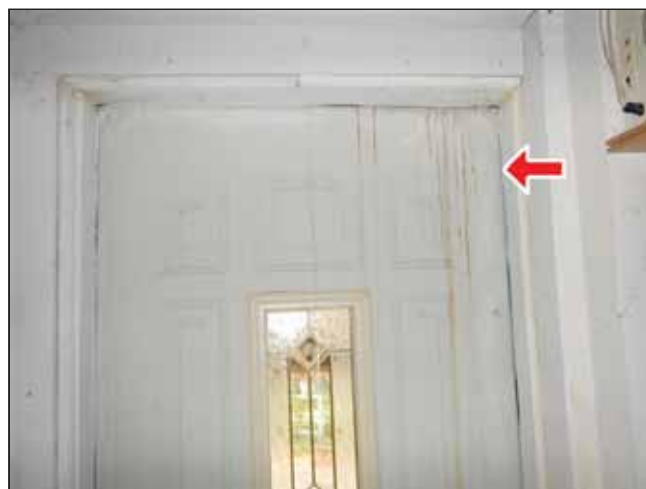
12.0 (Picture 4)

12.0 (2) The ceiling in the rear entry shows signs of water penetration.

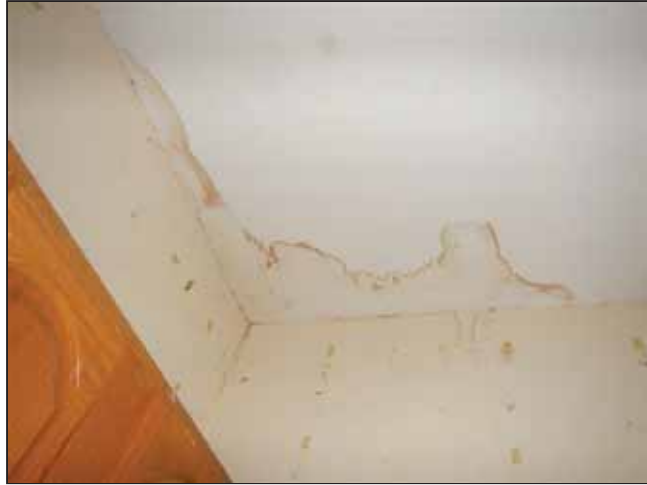
13.0.A (Picture 1)

13.0.A WALLS AND CEILINGS : The ceiling shows signs of past water damage.

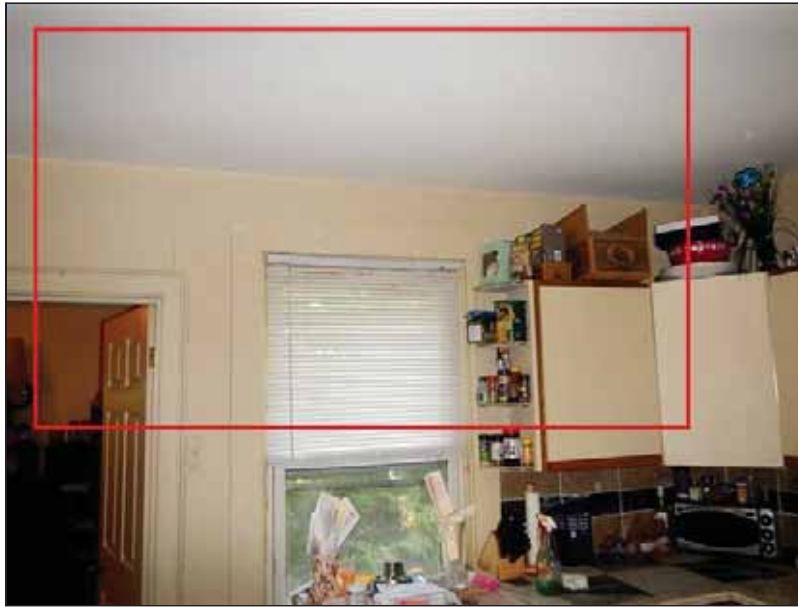
13.0.C (Picture 1)

The ceiling shows signs of past water damage.

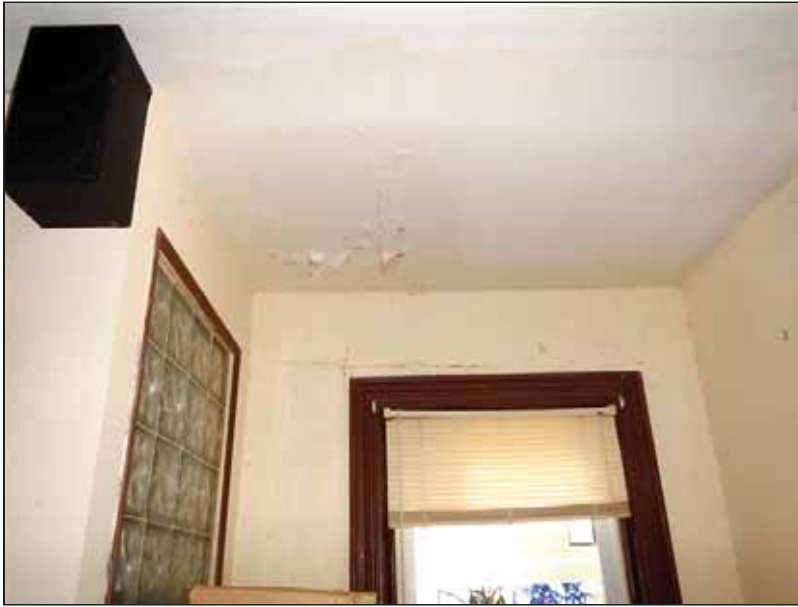
15.0.A (Picture 1)

15.0.A The ceiling shows evidence of water damage. Water damage was also noted below the window.

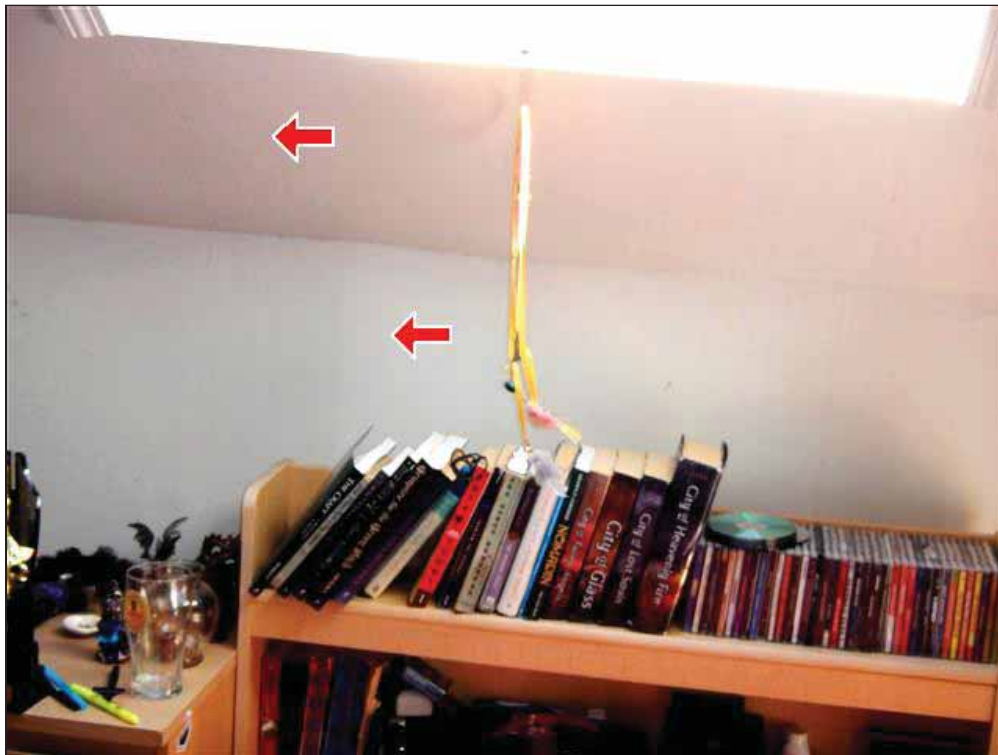
15.0.B (Picture 1)

The ceiling shows evidence of past water damage below the skylight.

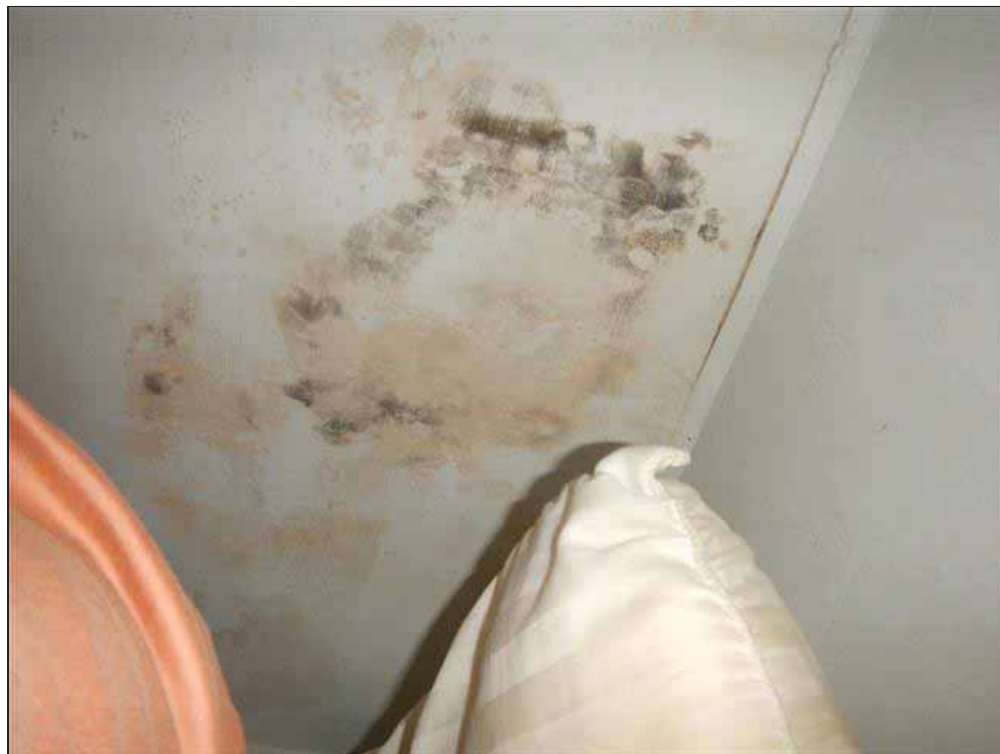
15.0.C (Picture 1)

15.0.C The ceiling shows evidence of water damage. Mold was visible in the ceiling. This can pose certain health hazards. Immediate correction is needed.

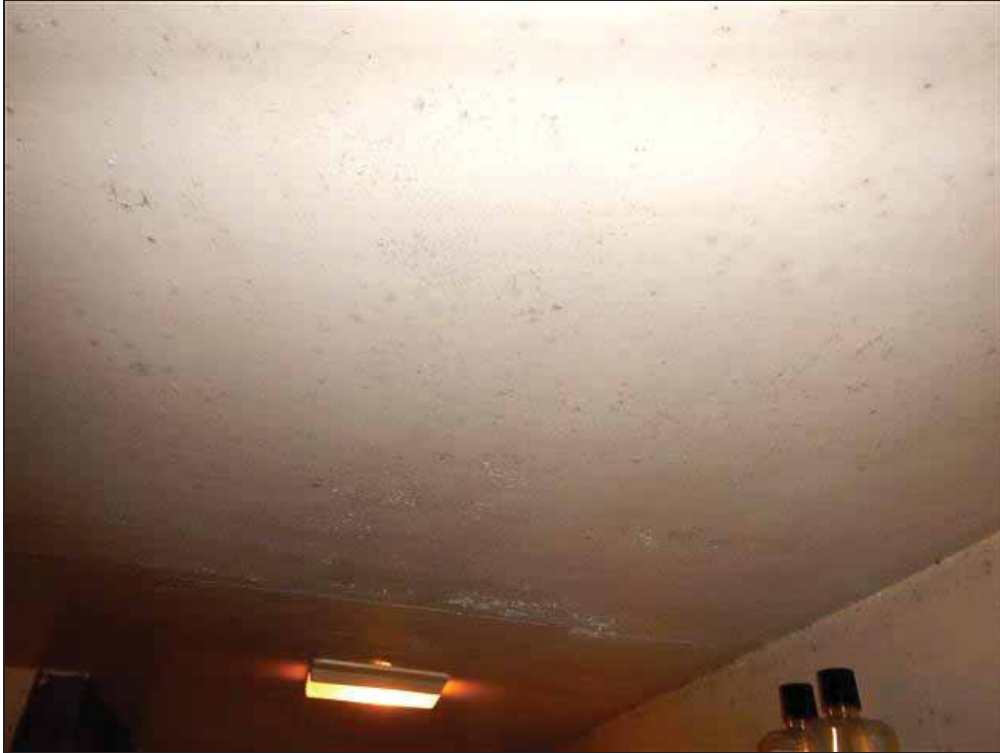
16.0.B (Picture 1)

16.0.B WALLS AND CEILINGS : Mold growth was noted on the ceiling of the bathroom. This can pose certain health hazards.

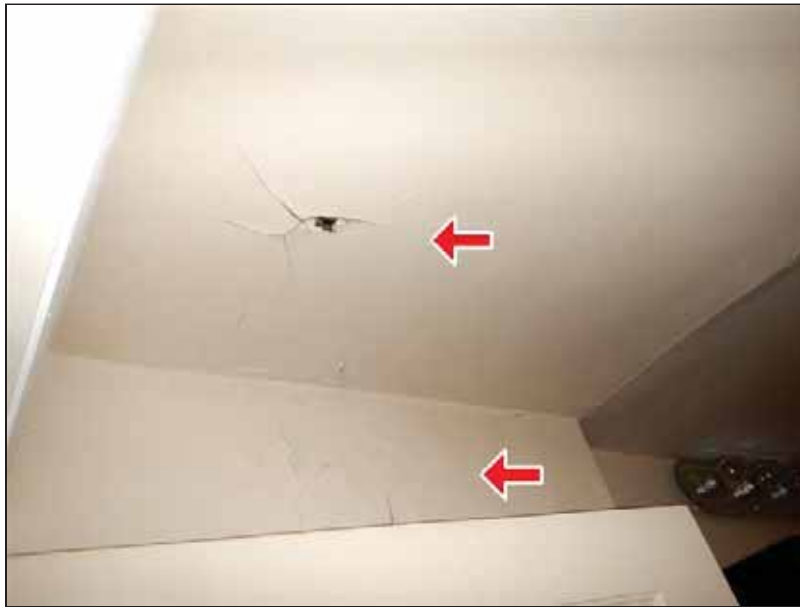
16.0.C (Picture 1)

16.0.C WALLS AND CEILINGS : The ceiling is water damaged. Further investigation as to the cause is needed.
