WEST PARISH BURYING GROUND

1901 MASTER PLAN

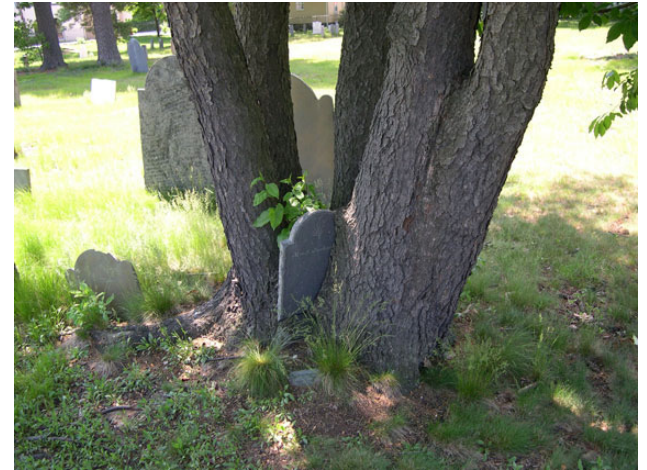
impact of volunteer growth on gravestones - West Parish Burying Ground

Volunteer growth can be hazardous to historic grave markers within a burying ground. Remove all volunteer growth along the fences and structures within the interior of the burying ground. Maintain an annual program of removals. Consult with a stone conservator prior to using any herbicides which may be hazardous to gravestones. Consult with an archaeologist to determine if volunteers can be gently grubbed out without disturbing burial markers or burial sites. Volunteer trees that are displacing gravestones should be cut flush to the ground in a manner that does not impact the stones. Stones should be left in the remaining stump.

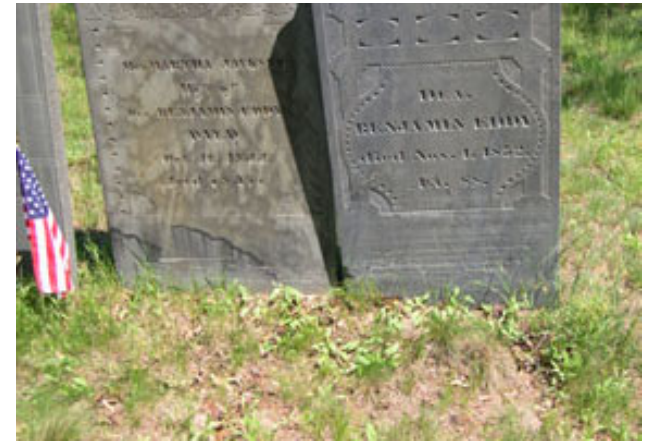
gravestones damaged by mower - West Parish Burying Ground

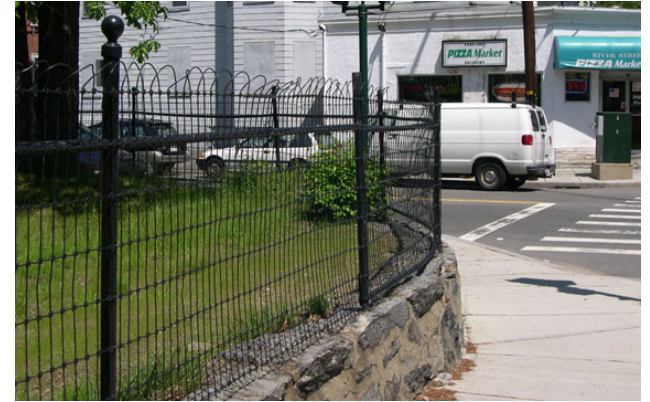
damaged crosslink fence - West Parish Burying Ground

Because the wire can be easily deformed, the fence is extensively damaged. The cross-link fencing is clipped onto four foot high, 1-7/8 inch diameter pipe posts that are embedded into cored holes on top of the stone wall. The spacing between posts varies from 8' to 9'-6". A decorative ball cap covers the top of each pipe but 13 of the 66 ball caps are missing (20 percent). Likewise, approximately 15 percent of the posts and 15 percent of the top rails are missing, loose, bent or corroded through. In addition, many of the posts are tilted. At four locations, the cross-link fencing has been replaced with modern chain link fencing. The interior side of the fence is painted green while the street side has been painted black.

The cross-link fence needs extensive repairs. The fencing itself has historic interest but it is too lightweight to provide a secure barrier in a contemporary context. Options include replicating the existing fence fabric with a more durable matching vinyl coated mesh fabric, replacing the existing fence with a historically appropriate steel bar stock fence and gate or removing the fence altogether.

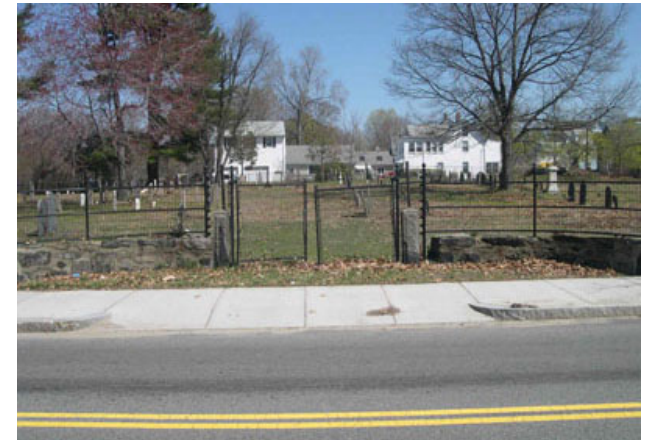
A four foot height chain link fence runs along the west and northern boundaries. The fence is in good condition. One portion of the fence has been painted green. No rust is evident.

existing chainlink fence and gate - West Parish Burying Ground

The current gate is a modern 10' wide, 6' high galvanized chain link gate with two leaves that swing inward. The gate is sagging. It is locked with a chain and lock at all times except during maintenance periods. The lock is rusting and difficult to open and close.

Consider replacing the existing green painted chain link fence along the north and west boundaries of the site with a 4' height black vinyl coated chain link fence. The vinyl coating will reduce maintenance costs over the years.

Replace existing gate with a new gate to match the new fencing. The gate should be opened and closed at prescribed hours for public access into the burying ground. Provide gate stops to hold the gate in place in an open position during visiting hours.

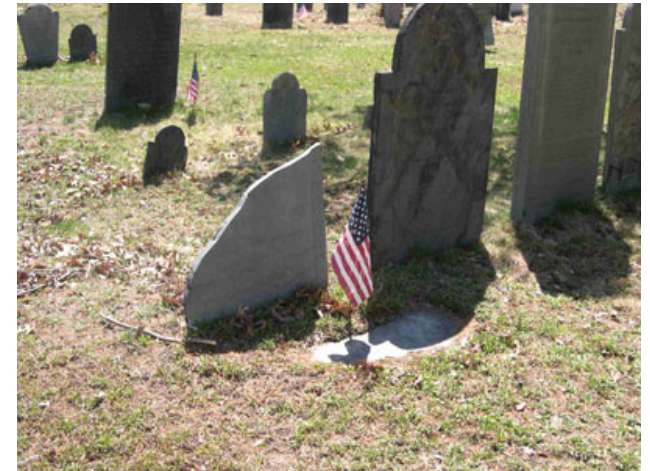
damaged gravestones

dozen headstones and roughly an equal number of footstones, lie loose within the burying ground. Some are propped against other stones while others are partially buried in the ground. Stones are damaged from mowers scratching the stones. Volunteer plants are growing next to headstones and footstones causing them to tilt.

One of the most effective preventive techniques that Newton could undertake would be to reset stones that are leaning more than 15 degrees (typically slates). This is a relatively straightforward task that would greatly benefit stones that are at risk for falling or breaking. A related, but slightly more complex issue is that stones are broken off at the base. The preservation section of the Association for Gravestone Studies website offers specific guidance on this technique. “A Gravestone Preservation Primer” by Lynette Strangstad is also a useful resource.

Treatment by a trained conservator is often needed once a stone is broken or damaged. This can range from reattaching components that have become separated to fitting together multiple fragments like pieces of a puzzle. Previous repairs that have failed are the best reminder to use extreme caution. Newton has many cases where a stone has come loose from its base and is in danger of falling or being stolen. In cases like this where the components are intact, reattachment is a relatively straightforward task that could be undertaken by city staff, using guidelines from the preservation manuals cited above. Reassembly of multiple fragments, especially pieces that have been separated for a long time and have become eroded, should be undertaken by only a stone conservator.

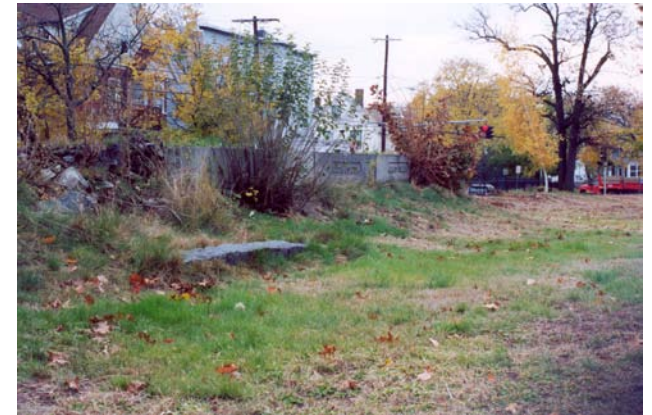
There is a row of mound tombs that is parallel to and along Cherry Street near the northeast corner of the burying ground. The front walls of the tombs are extensively deteriorated; in fact, the mound tombs are little more than mounds with the inscribed lintels propped up on the mound. Although brick vaults were noted in the 1990 Master Plan, they are no longer visible. They appear to be covered with a recent addition of earth but it could not be seen whether the vaults are still intact or have been repaired in any way since 1990. Considering the current poor condition of the front wall, they were likely buried without repair. Without further investigation, it would be difficult to determine whether they have even been backfilled or whether they have collapsed prior to the recent placing of fill on the mound.

mound tombs - West Parish Burying Ground

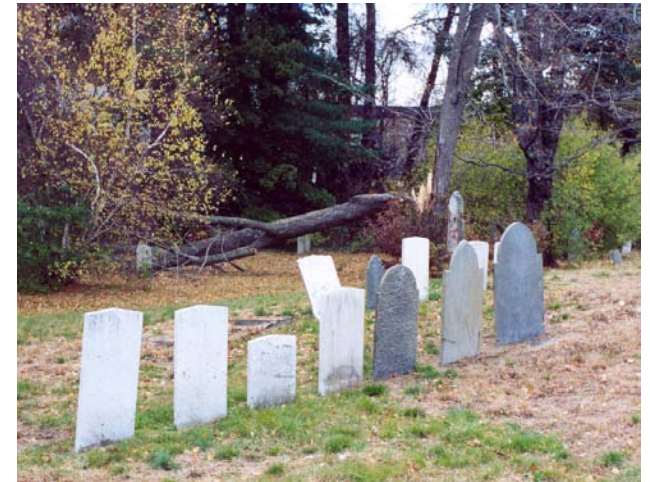
fallen tree, South Burying Ground

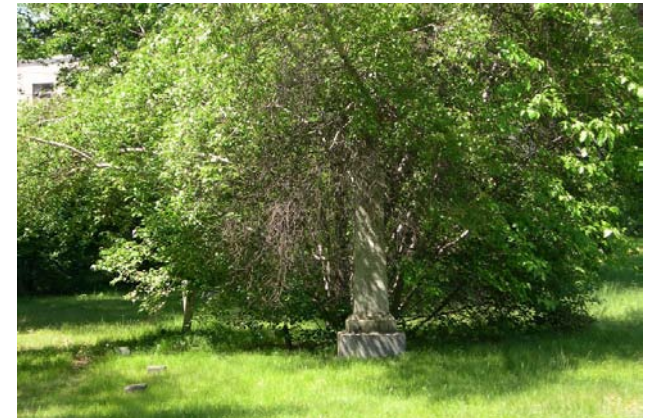
Volunteer shrub growth is evident on mound tombs, markers, walls and along the western, northern and eastern fences. Species include Grey Birch, Black Cherry, Catalpa, Aspen, Buckthorn, Poison Ivy, Bittersweet, Devils Paintbrush, and Loosestrife.

volunteer growth at South Burying Ground monument

Remove all volunteer growth. Consult with Structural Engineer and Stone Conservator to review structural integrity of markers, tombs or walls prior to removal. Continue to remove naturalized plants on an annual basis.

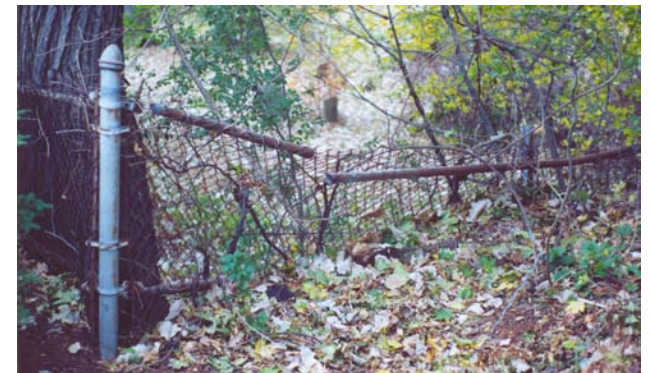
There are three newer 4' height galvanized chain link fence panels located at the corner adjacent to the office building along the northern edge of the property. This older chain link fence is in poor condition with broken and corroded horizontal bars. Chain link fabric is retaining earth on the parking lot side of the fence. It is assumed that the abutters filled against the fence to allow for the new bituminous drive to be built. Top rails are cracked from corrosion and previous fallen trees. New chain link at storage building at lumber yard is not secured to the building. Some top rails are missing. Most fence fabric is corroded. There are several breaches in the fence, making it possible for people to enter the site when the gate is locked.

collapsed chain link fence, South Burying Ground

Temporary improvements to security can be made by repairing existing chain link fabric fence until further fence improvements can be made.

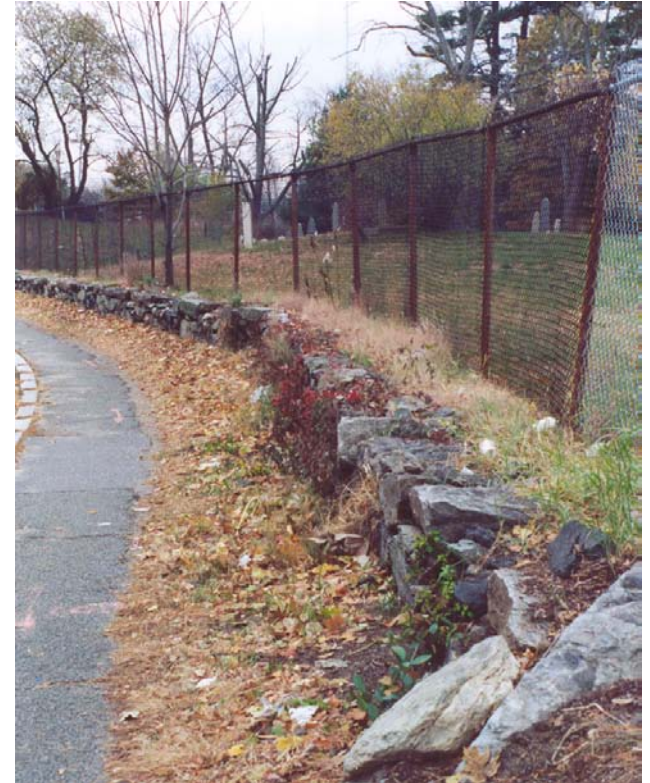
The site is contained within an 18" high dry laid local puddingstone rubble wall. A 12' section near the existing entrance gate has been recently damaged by an automobile accident. There are missing stones in some places. A portion of the stone wall shown on the 1901 plan has been removed along the office building site.

stone wall and fence along Winchester Street, South Burying Ground

Repair the stone wall near the entrance gate.

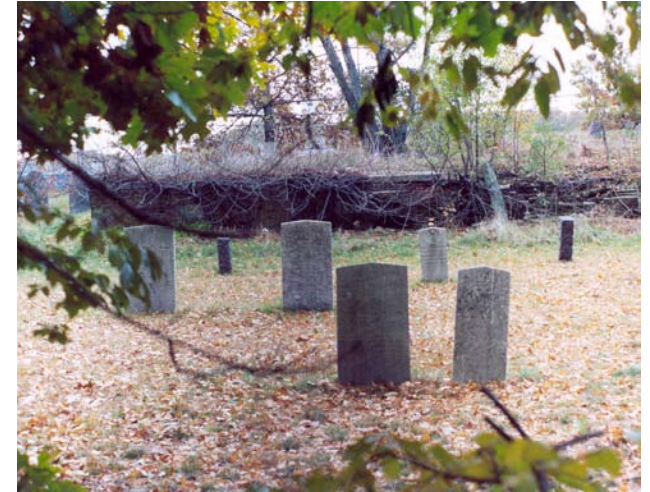
mound tomb - South Burying Ground

The front walls of the first four tombs at the north end of the row are deteriorated beyond repair. There is no evidence of any vaults behind these partially collapsed walls, although they may be hidden behind a load of gravel recently dumped between the back of the wall remnant and the vaults. The front walls of the next three tombs are relatively intact but have horizontal cracks in the bedding joints due to invasive volunteer plants. The front wall of the stone tomb is intact except where the corner has collapsed.

The first option would be to demolish the deteriorated brick walls at the first four tombs (A-D) and repair the masonry walls and corners at the second four tombs (E-H). This option would be better if the vaults still exist insofar as there would only be hollow space behind the walls. Because of its many joints and small units, brickwork is vulnerable to water infiltration and freeze-thaw wedging actions if the back of the wall is directly exposed to earth backfill and water. If the vaults
