Town of Newton, Massachusetts  
Conditions Assessment and Treatment Recommendations for Tomb Plaques,  
Table Top Tombs and Obelisk.

Re: Letter of Report - Newton Burying Grounds - Stone Conservation

Reference: Newton's Historical Burying Grounds Condition Report

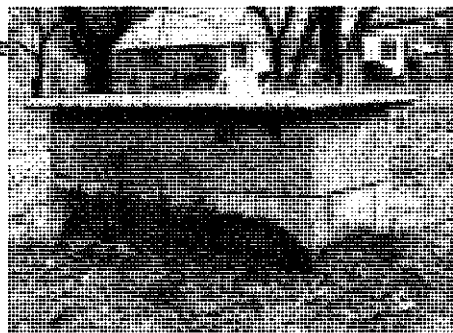
**Tomb E- Kendrick**

**Conditions Assessment of Marble Top and Granite Base:**

- a) No visible foundation- set directly on subterranean vault?
- b) Failing Portland cement mortar at marble to granite and granite to granite mortar joints.
- c) Spall at Northwest corner resulting from the corrosion and expansion of original iron cramp.
- d) Small losses at edges of granite blocks.

**Treatment recommendations:**

1. Remove marble slab from base (no additional treatment to marble slab required)
2. Remove failing mortar at top of granite.
3. Remove corroded iron cramp(s) (See attached sketch E- Kendrick)
4. Remove and reset upper course of granite- leave lower granite course in place.
5. Pin upper granite course to lower, or *install new stainless cramps (?)*
6. Reset marble slab on new mortar bed (no pin required between marble and granite)

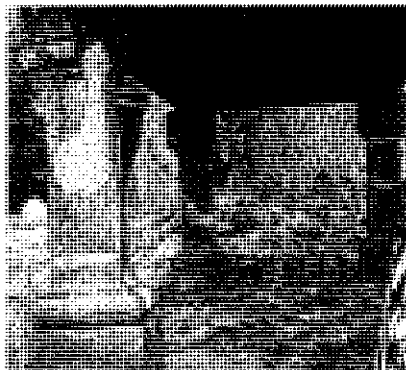
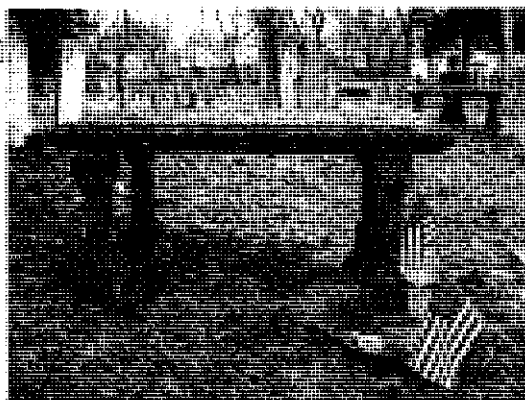
**Tomb E- 1113**

**Conditions Assessment of Brownstone Top and Legs:**

- a) Extensive delamination on top surface of slab.
- b) Four brownstone legs are set in concrete pads.
- c) legs 2 and 4 (See attached sketch Tomb E-1113) are supporting the top.
- d) Three of the four legs have been extensively repaired with adhesive and cement patches.
- e) Prior repairs on all four legs are failing but legs 2 and 4 which are bearing all of the weight of the top are vulnerable to failure.

**Treatment recommendations:**

1. Remove brownstone slab and clean biological growth on slab surface
2. Inject hollow areas and fill recesses on top of slab.
3. Remove scaling from underside of slab and fill loss with tinted patching material.
4. Remove cement pads from all four legs.
5. Remove prior repairs from legs 2-4 and evaluate stone for structural integrity.
6. Reattach fragments with epoxy and stainless steel pins and fill areas of loss.
7. **Alternate:** Replace legs 2,3 and 4 with new Portland Brownstone legs carved to match the existing.

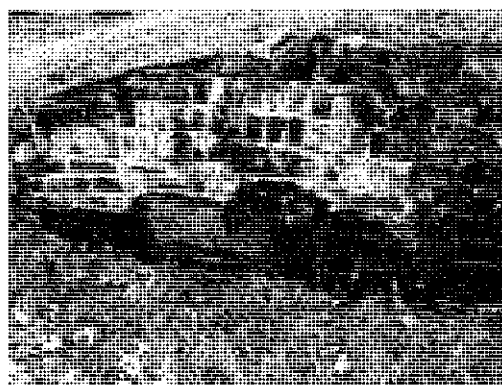
**Tomb E- 1344 and 1346**

**Conditions Assessment of Stone Plaque:**

- a) Biological growth present on both slate plaques embedded in brick wall.
- b) Plaque at north end of tomb is broken into at least 3 fragments.

**Treatment recommendations:**

1. Remove and rebuild brick front as per recommendations in the report by Structures North.
2. Remove cement mortar by hand from slate plaques.
3. Repair cracked plaque at North side with epoxy and tinted repair mortar.

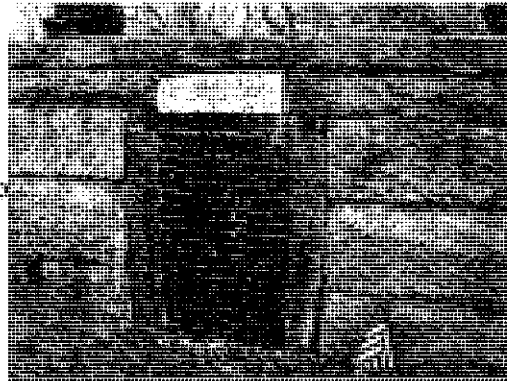
**Conditions Assessment for Marble Plaque and  
Brownstone Lintel:**

- a) Light biological growth on marble plaque.
- b) Fissures at edges of marble plaque and losses to upper North corner.
- c) Brownstone lintel below marble plaque is broken in tow places.

**Treatment recommendations:**

1. Follow recommendations in report by Structures North for taking down and rebuilding front wall.
2. Salvage marble plaque, remove old mortar by hand and clean to remove biological growths.
3. Fill area of loss at upper left corner with composite mortar.
4. Replace cracked brownstone lintel with new Portland Brownstone lintel.

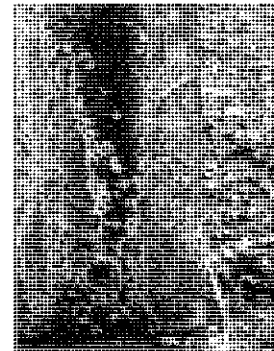
**Conditions Assessment for Multipart Marble and  
Granite Obelisk:**

- a) The two marble units are pinned to each other but not to the granite base.
- b) The marble units have shifted off center probably as a result of the settling of the rubble stone footing.
- c) The upper marble unit has surface cracks on the northeast corner.

**Treatment recommendations:**

1. Clean all 3 units to remove biological growths
2. Fill cracks at the northeast corner of upper unit.
3. Remove all three units.
4. Re-level footing and reset all three units with a stainless steel pin between the lower marble unit and the granite base.

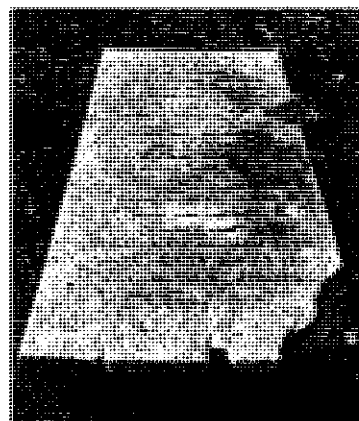
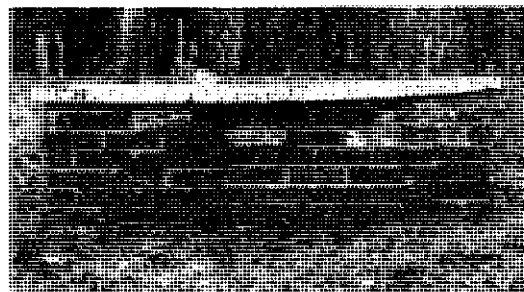
**Tomb E- 211**

**Conditions Assessment of Marble Slab:**

- a) Marble slab bowed, cracked and broken into 3 pieces
- b) The marble slab was reset in the 20<sup>th</sup> century on a rebuilt brick base and thick and a thick mortar bed that conforms to the bowing of the slab
- c) Heavy biological growth on marble slab.
- d) Extensive sugaring and at the edges of cracks and edges of the fragments.

**Treatment recommendations:**

- 1. Carefully remove marble slab for conservation treatments and to facilitate rebuilding of the brick base as per the recommendations in the Structures North report.
- 2. Pre-consolidate and then clean marble slab.
- 4. Consolidate marble with OH100
- 5. Reattach the small fragment to largest with epoxy, but do not reattach lower piece to top.
- 6. Fill small areas of loss in marble, but not the top north corner.
- 7. Reset marble slab in two pieces on reconstructed brick base without pins.
- 8. Grout seam between upper and lower pieces of marble slab. (See sketch E- 211)

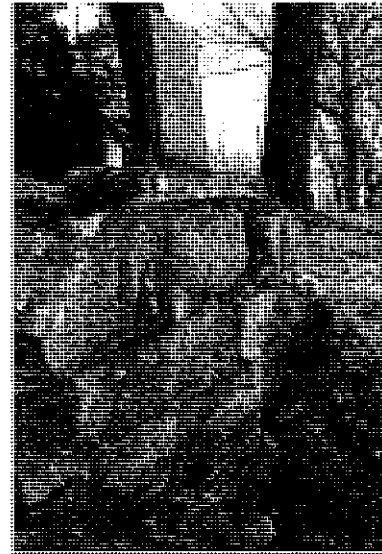
**Conditions Assessment of Bluestone Slot-Base:**

- a) The bluestone slot base, which supports the slate marker at the top of the tomb is broken, lengthwise, into two pieces. The fragments are held in place by the cement mortar between the top of the front tomb wall and the bluestone.

**Treatment recommendations:**

1. Remove upper piece of slate and set aside.
2. Re-attach fragments of slot base with epoxy and grout seams with tinted mortar.
3. Re-set slate and fill slot with sloped mortar.

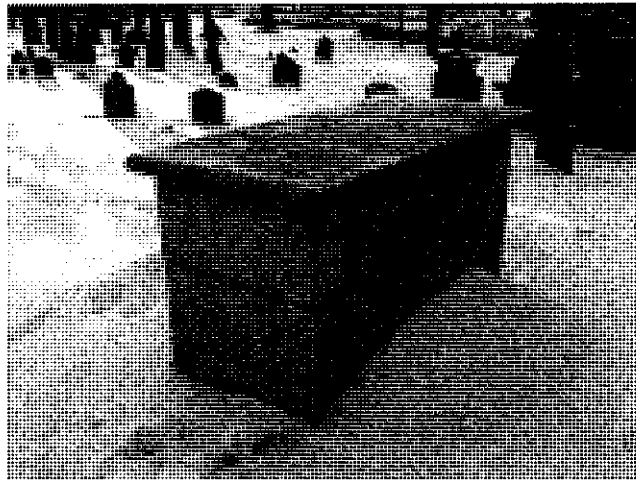
**Tomb E- T. Jackson**

**Conditions Assessment - Granite Base and Marble Top**

- a) Marble top is in good condition with only small fissures at the edges.
- b) Mortar joints at granite base are open and failing.
- c) One granite unit is cracked and one has shifted out of plane.

**Treatment Recommendations**

1. Treatment of this tomb is not as urgent as the other tombs
2. Removal and resetting of top and base stones is optional.
3. Repointing the mortar joints and grouting the fissures in the marble would stabilize the tomb for several decades.

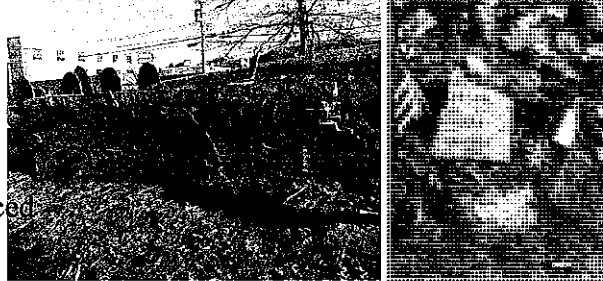
a) As a result of the collapse of the center portion of the front wall of these connected tombs, at least three marble plaques have been displaced and one of those is fragmented. Additional plaques or fragments may be buried in the rubble.

1. Number coping stones prior to disassembly of the tomb walls. In addition, document end to end orientation.
2. Document location and placement of marble plaques. So that they can go back in the same location in the reconstructed wall.
3. Clean marble and brownstone.
4. Scour wreckage for plaque fragments.
5. Remove mortar from around plaques by hand.
6. Reset coping stone and plaques in their original position.

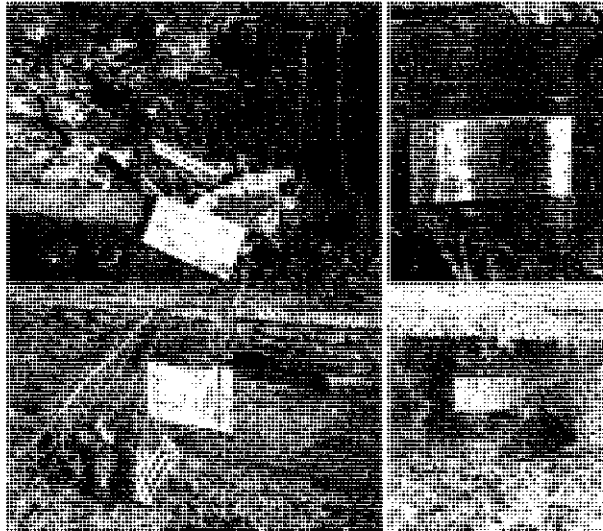
b) The remaining marble plaque has moved forward out of the wall.

d) The inscribed brownstone plaque or lintel at the southern end of the wall is in stable condition with some yellow biological growth on the surface.

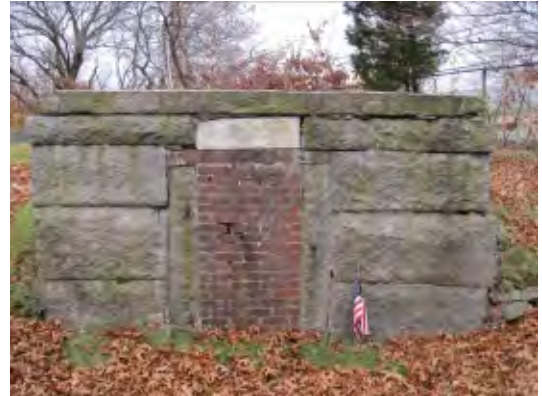
The mound tomb located at the southwest corner of the burying ground. The front elevation is constructed with large granite stones with brick backup, a white marble marker and a brownstone lintel over the door opening (which may have had a metal door but has since been removed and the opening filled with brick). The tomb vault is presumably a brick arch which is the typical construction.

Vegetation has grown between the stone tomb front and the brick backup, and along with water intrusion and freeze-thaw jacking have pushed the two apart. There is moss growing in the mortar joints indicating that water is present within the masonry. Although it is no longer a structural element, the brownstone lintel has cracked.

The front wall of the elevation should be taken apart and rebuilt including the brick backup. The area should be cleaned of all trees and bushes prior to rebuilding the wall. When the interior of the tomb is exposed, it should be examined and any repointing and rebuilding of the vaulted completed. The brick infill should be replaced with a cast iron door or slate slab. The front end of the brick vault may need to be re-knitted against the head wall and the two structures should be pinned together with stainless steel ties. The vault top should be exposed and re-covered to relieve soil pressure from the front wall (please see "Wall Tie Options" and "Vault Capping Options", under "General Recommendations" above).

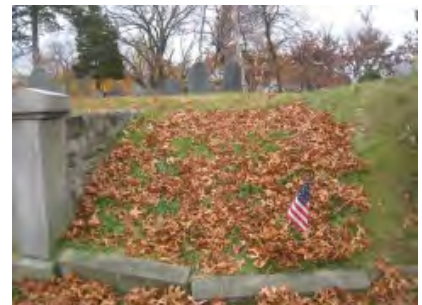
The front of this tomb is missing and because of the slope of the grade, it is likely that at least the front part of the tomb vault has collapsed. Some "curb" stones have been

placed at the base of the slope as an indication of the tomb location. Two of the three stones have shifted.

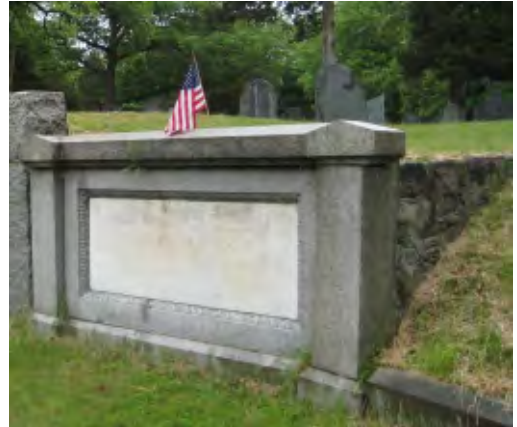
The granite on the front elevation has shifted over time leaving enlarged open mortar joints for grass and other vegetation to grow through. The south side wall has shifted outward from soil pressure on its back side.

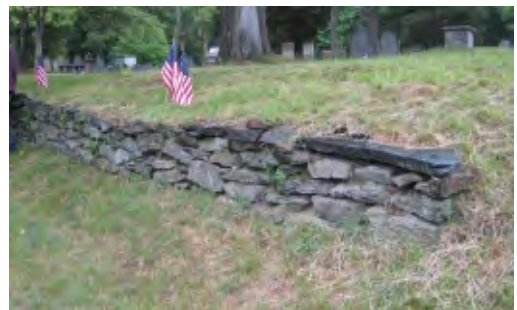
These tombs share a front rubble stone wall with no markers. There is little mortar between the stones with moss and vegetation taking its place. Some of the stones have shifted.

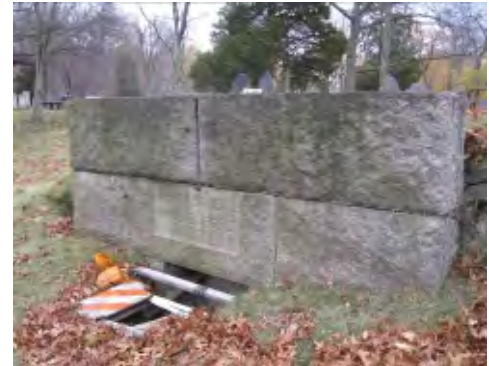
The front of this mound tomb is constructed of rock faced coursed granite with the center stone honed and engraved as a marker. The stones covering the entrance steps in front of the tomb have broken or fallen, opening the tomb interior for view. The vault is comprised of a brick arch and rear wall at the top half which sit on stone foundation walls.

From the visibility allowed without entering the tomb, the interior masonry appears to be in good condition. The exterior mortar joints contain some moss and there has been some minor shifting of the upper stones.

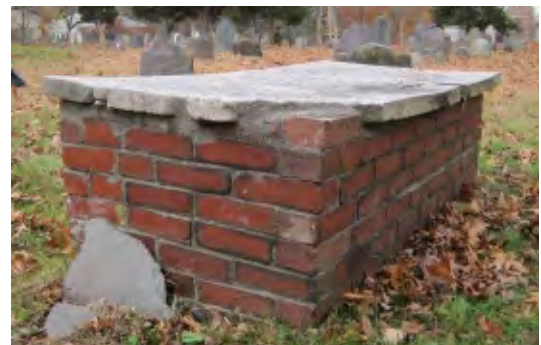
An engraved white marble slab covers the top of this brick table top monument. The top stone has been broken at a couple locations thought it appears some repair attempts have been made. During the repairs to the marble the upper course of brick was adjusted to make up for the slope of the top slab so the existing brick walls are not level. Within the brick masonry there are some open mortar joints and a crack through the bricks

at one end.

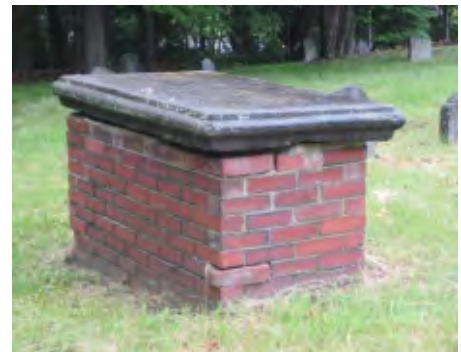
The brick table top monument is topped with an engraved piece of brownstone which has moved and is no longer centered on the brick walls below. Within the brick walls there are some cracked and open mortar joints and a brick is missing at one end.

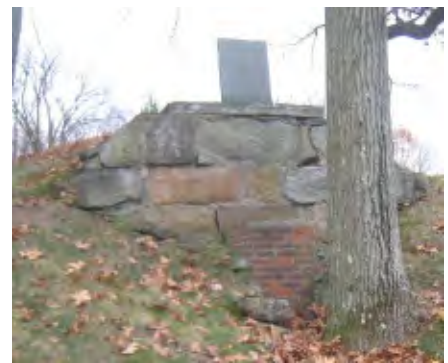
The front wall of this mound tomb is built of stone with the door having been bricked in, most likely to replace a broken slate door. There are open mortar joints within the stone front and rodent holes all around the tomb. There is a short entranceway in front of the tomb door with small sidewalls; presently blocked by a large tree. On top of the wall is a slate marker that sits on a cracked stone base (please see "Wall Tie Options" and "Vault Capping Options" under "General Recommendations", above).

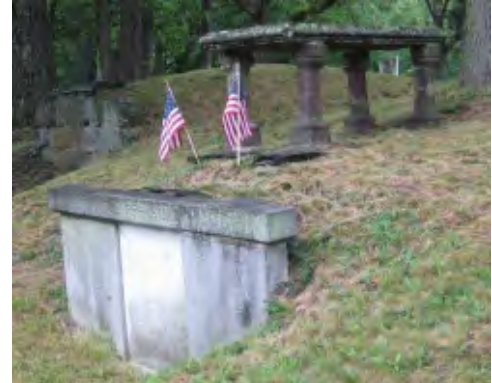
The granite tomb headwall has shifted forward exposing the end of the brick vault, being under an unusually high amount of lateral earth pressure with the upward sloping grade above it. On top, three of the brownstone table legs are cracked and all have moved. The top surface of the table slab is covered with moss and lichen and the bottom side is spalling.

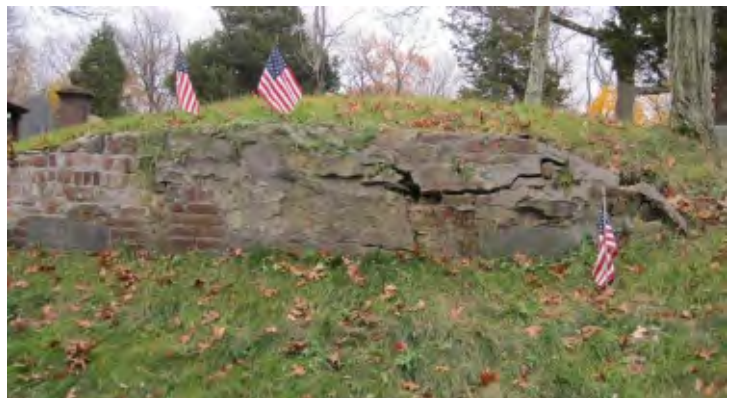
The masonry is cracked and shifted, particularly at E-1344. The slate marker of E-1346 has cracked.

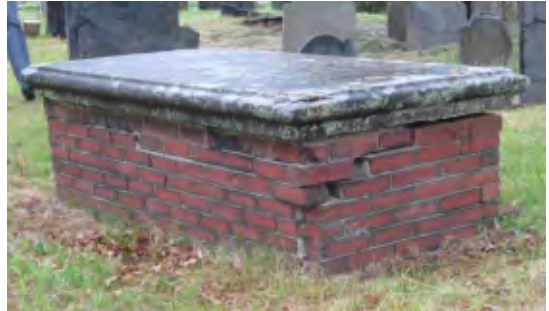
The brick table top monument is topped with an engraved brownstone slab. At the lower brick portion, the mortar is missing and large sections of masonry have shifted out of place causing some bricks to fall. The missing bricks allow for the interior of the monument to be viewed, showing that the bottom side of the brownstone slab is spalling, the exterior surfaces of with are partially covered with vegetation.

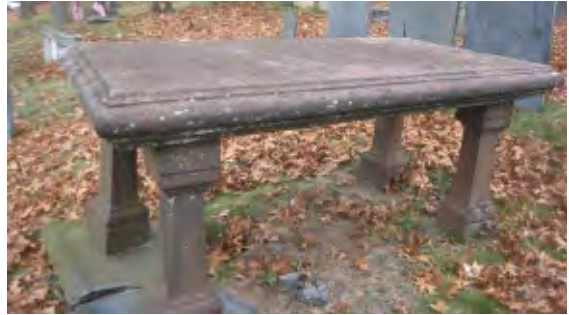
The brownstone table top monument located at this tomb is construction of four legs and a top slab. The legs have rotated and moved out of their original locations. Although the engraving on the top surface of the top slab is in good condition, the bottom side is spalling.

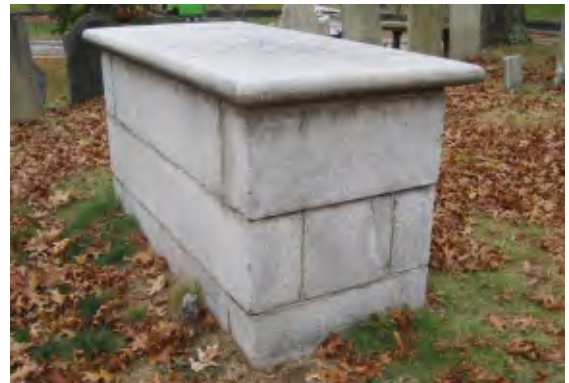
The table top monument is made of granite stone blocks with a marble engraved top. At the sides there are some open mortar joints and a couple stones have slightly shifted out of place.

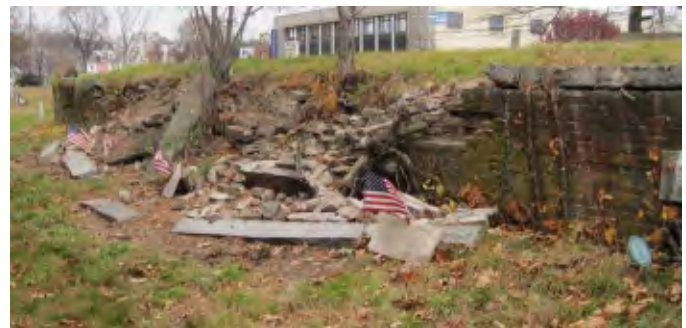
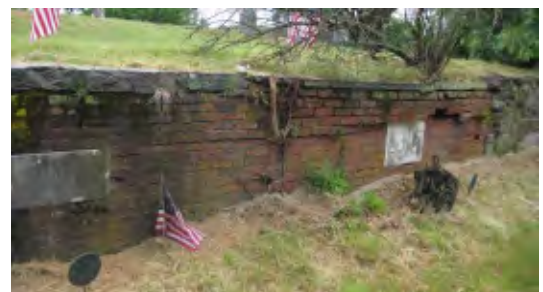
Trees have grown in the soil directly behind the front wall with the root systems stretching along the wall pushing it outward and causing it to collapse or become close to falling apart. There are two tombs which have not been as greatly affected by the vegetation growth but there is moss growing in the mortar joints, some cracking and the capstones have shifted.

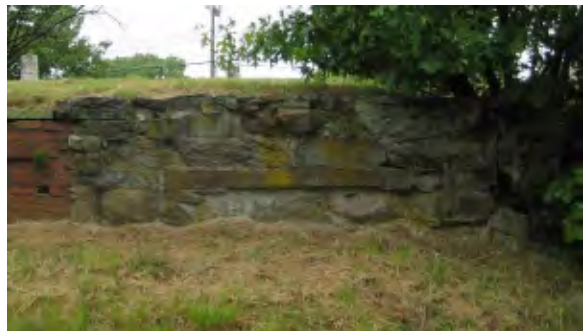
The end tomb appears to have been constructed at a later date than the rest of the tombs in this line, using a stone head wall. Along the top and end of the wall there are open mortar joints and some shifted stones which may be partially caused by the tree growing next to the tomb. There is a stone slab over the stairs leading into the front of the tomb, with a hole along the edge that allows viewing access into the tom. By probing through the hole, we found the accessible portion of the tomb’s interior to be in good condition.

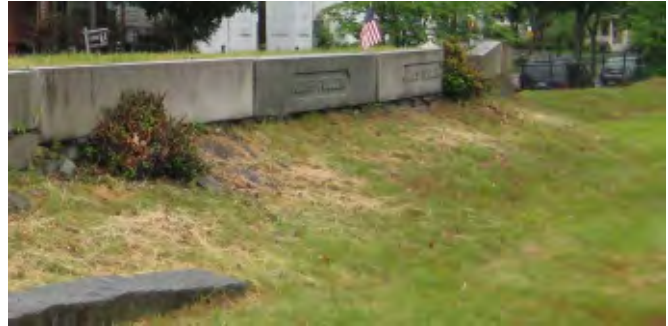
The fronts of these four mound tombs consist of large dressed granite curbstones at the top of a grass berm over slanted tomb stair covers, one of which is presently exposed at tomb W-D. All of the granite have shifted in some way. At tomb W-A the front wall has moved forward and the rest have rotated out of line by approximately 3 inches.

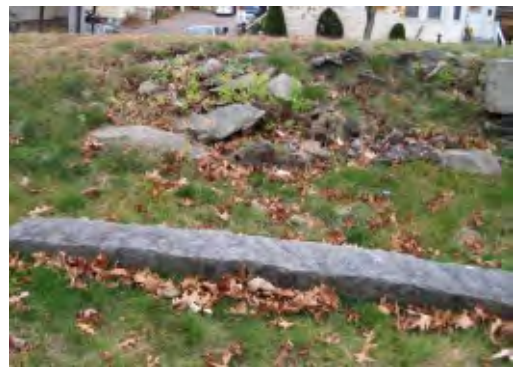
The stone front, most likely similar to tomb W-A, has collapsed leaving a rubble pile of bricks and stones and the stone tomb marker lying on the ground.

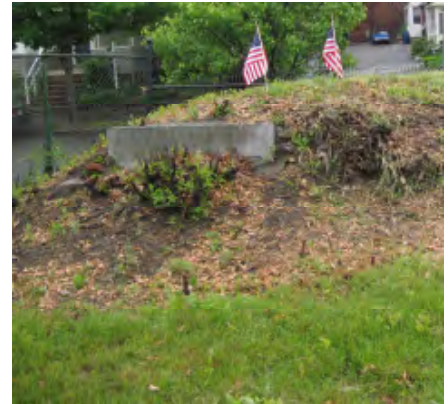
Tomb W-J

In similar fashion of the other mound tombs in this row, there is a granite curbstone marking the tomb, which has shifted, at the top of a slope which contains the covered tomb entrance. Some bushes have grown next to the granite curbstone and are the most likely cause of the movement noted. The rear of the brick arch vault is exposed showing some eroded mortar joints.

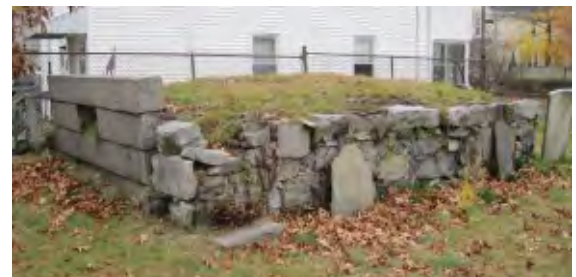
The tomb has three stone walls and one soil and grass wall with a grass top. The front entrance is a dressed granite stone wall with an opening at the top which may have been the location of a tomb marker stone; a raised area of soil at the base of the wall may indicate the buried missing stone or a covered entrance stairway. All of the stone walls have moved outward slightly, particularly the front wall this is most likely cause by soil pressure from the top of the tomb. The random rubble side and rear stone walls are missing mortar from the joints and there is a large variety of vegetation growing from these open joints
