Paul Cornell and Associates

**Inspection Report
prepared for:**

**Josephine McNeil
Can-Do**

**Property Address:
10 Cambria Road
Newton MA**

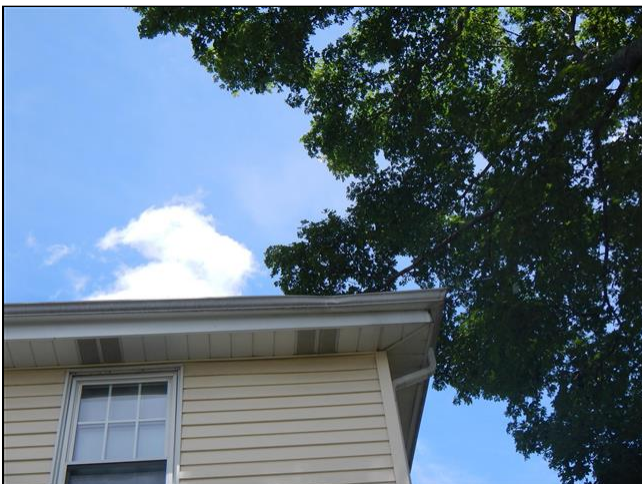
1.1 Item 1(Picture)

1.1 (1) Tree limbs that hang over the house should be cut back as they can damage the roof cover and allow squirrels easy access.

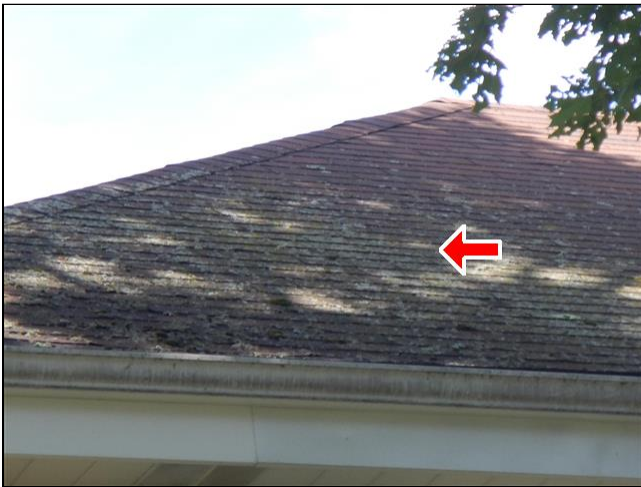
1.1 Item 2(Picture)

1.1 (2) The roof cover is nearing the end of its useful service life and will soon need to be replaced.

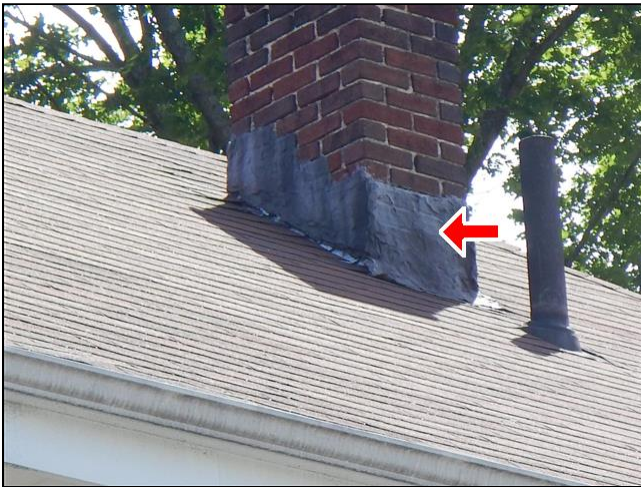
1.2 Item 1(Picture)

1.2 Tar laden chimney flashings should be replaced.

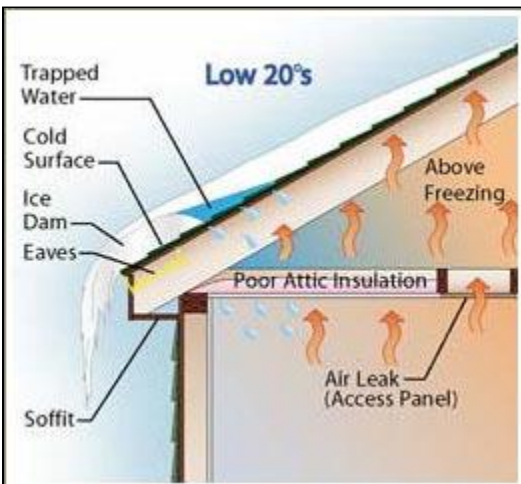
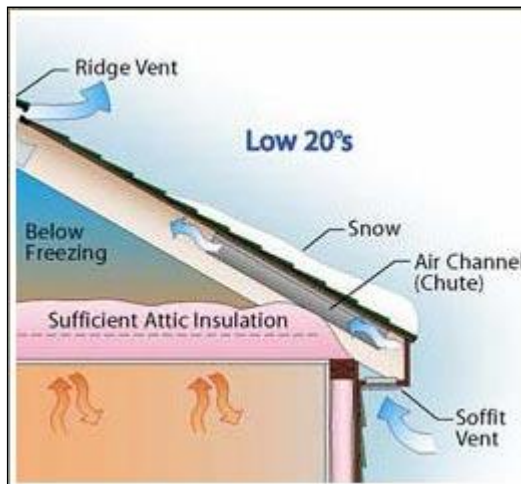
1.5 Limited roof ventilation will contribute to ice damming and condensation problems during winter months, and excessive heat build up during warmer months. These conditions can considerably shorten the serviceable life of the roof cover as well as contribute to mold and decay issues. See attic section of report for recommended improvements.

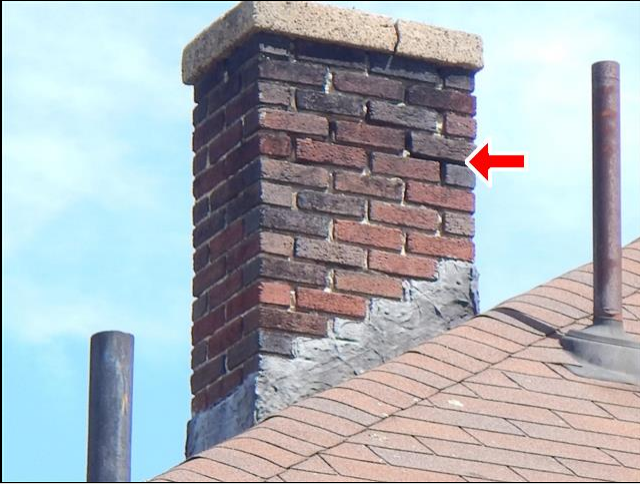
2.0 Item 1(Picture)

2.0 Chimney sidewalls should be cleaned, pointed as needed and coated with a water repellent to resist water related damages.

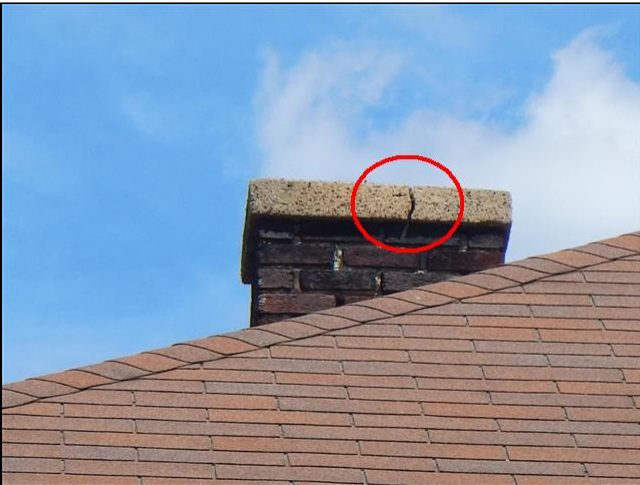
2.2 Item 1(Picture)

2.2 The chimney top is cracked and needs repair.

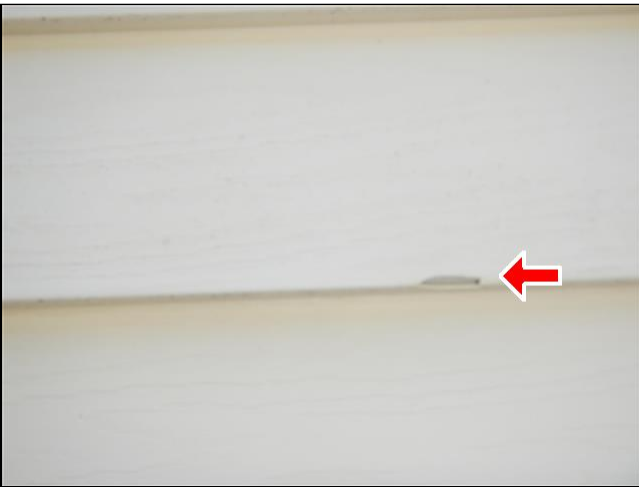
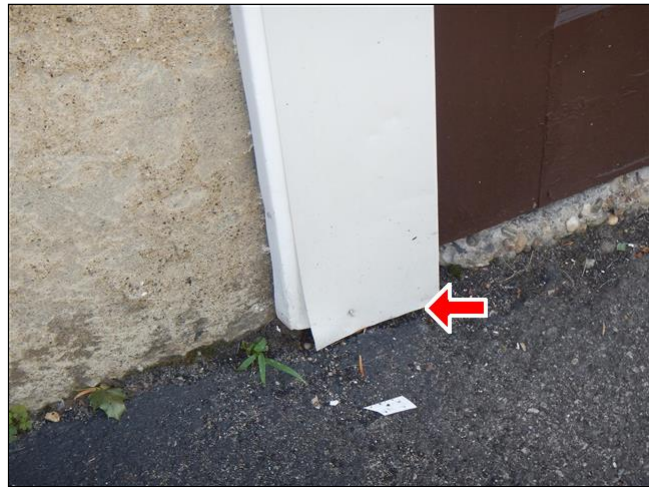
3.0 (1) Damaged siding panels need to be replaced as they are less than water tight.

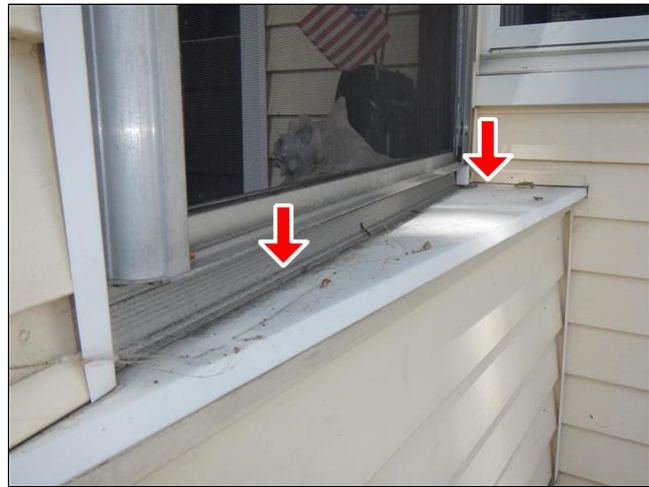
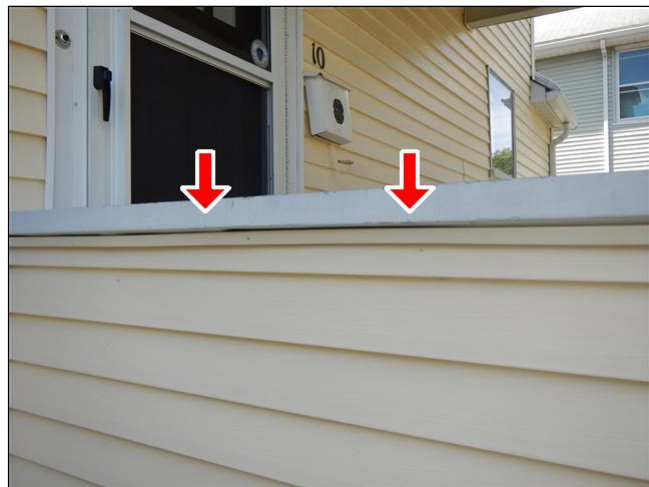
3.0 (2) Much of the metal trim and siding is poorly installed and is less than water tight. A qualified siding contractor should be consulted.

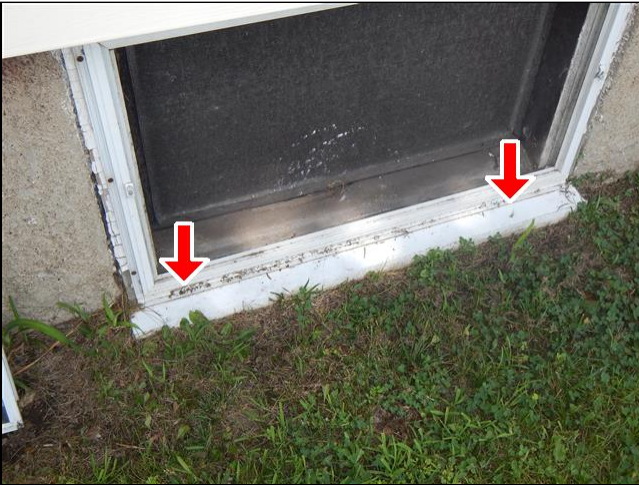
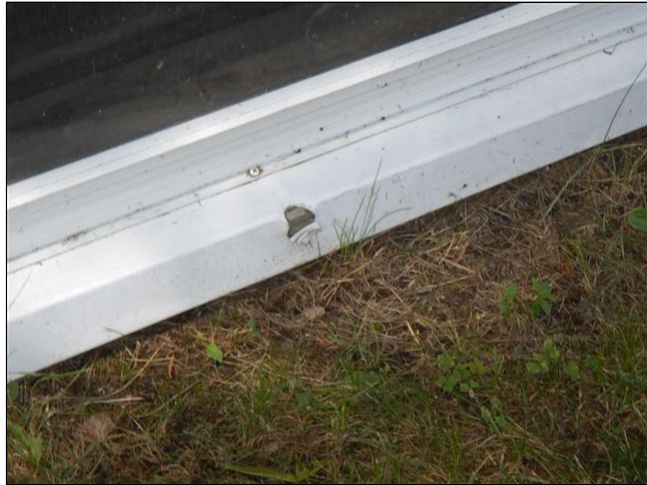
3.5 (1) Cellar windows are in direct ground contact which is conducive to decay and wood destroying insect problems. Correction is needed.

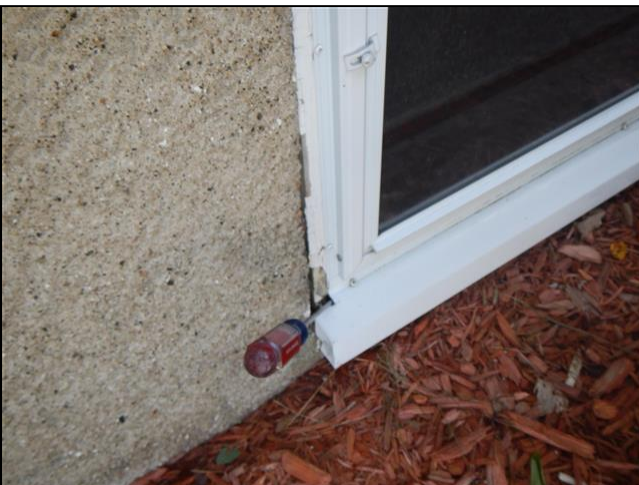
3.5 Item 3(Picture)

3.5 (2) Damaged cellar window units should be replaced as needed.

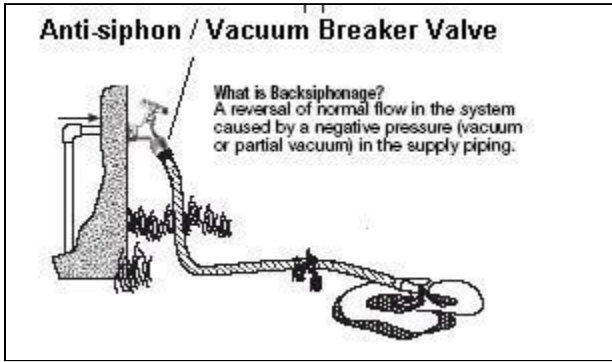
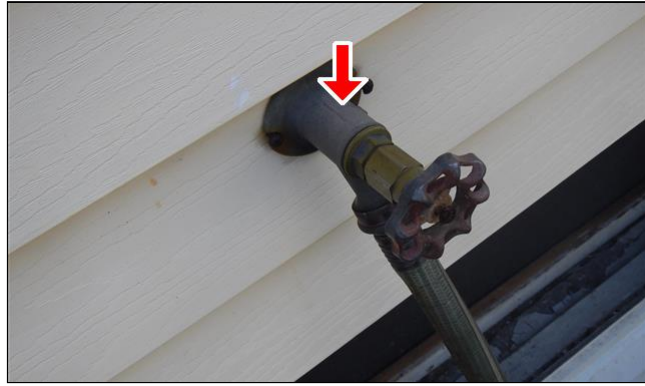
3.8 All exterior sill cocks should be updated with modern frost free anti siphon units to prevent freeze up and potential contamination of the potable water supply system.

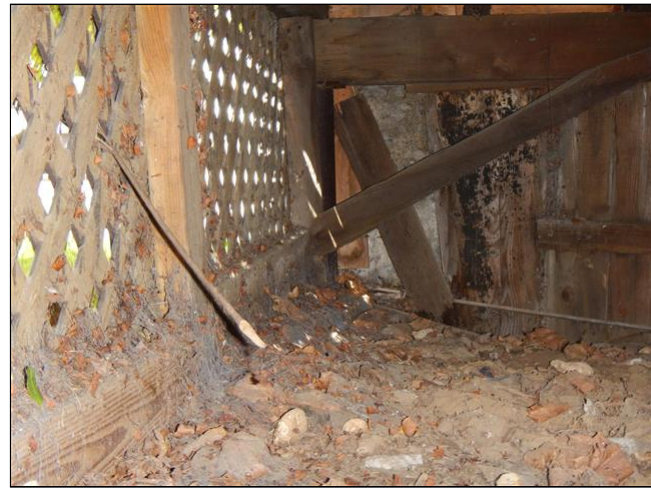
3.9 The rear entry structure needs to be re-supported. A qualified contractor should be consulted for estimates.

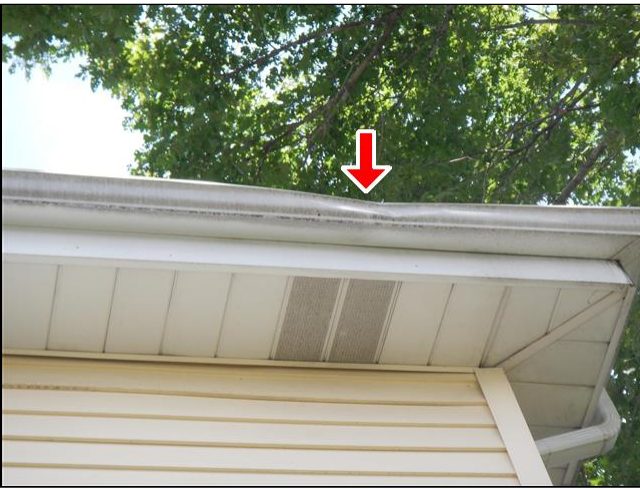
4.0 Item 1(Picture)

4.0 The rear gutter is damaged. Replacement is needed.

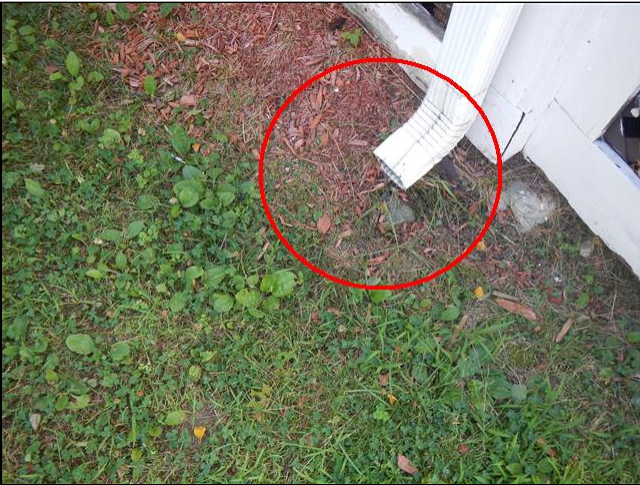
4.2 Item 1(Picture)

4.2 Downspouts that discharge against the foundation can contribute to cellar water issues. Extensions of at least 3-5 feet in length should be added at all points of downspout discharge.

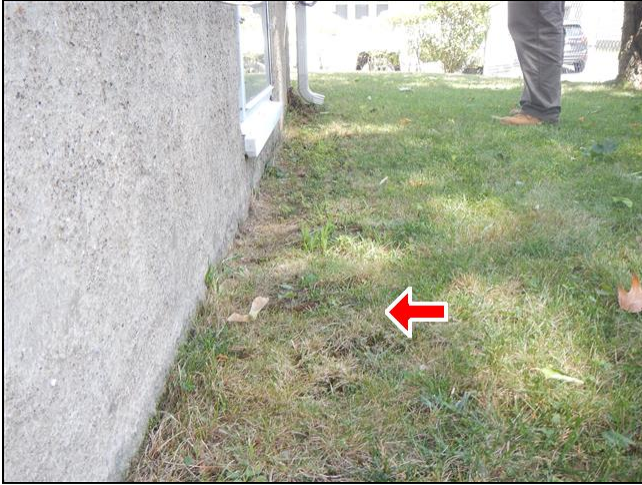
4.3 Item 1(Picture)

4.3 Negative grading that directs water to the foundation will contribute to basement water issues. For proper drainage, it is recommended that the grade slope away from the foundation a minimum of 1" per foot for 5 feet wherever possible. Periodically, fill will be needed to maintain this grade. If available, clay should be used. Foundation grading should be kept free of wood mulch as it is conducive to wood destroying insect problems such as termites.

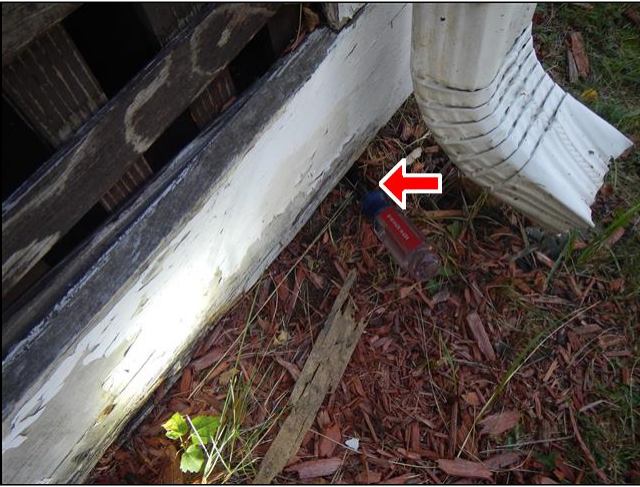
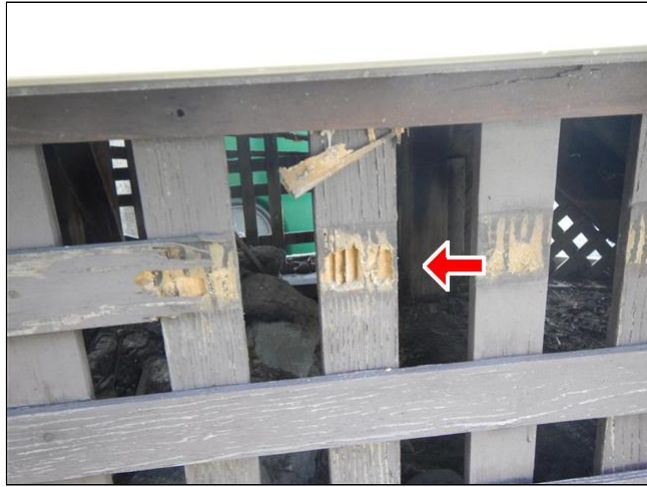
4.6 (2) Much of the lattice and support system of the right side forward entry landing has been heavily damaged by termites. **Any excessive rise, inconsistency, poor workmanship, poor maintenance or deterioration in a stair system poses hazards and risks of personal injury. Immediate correction is recommended.**

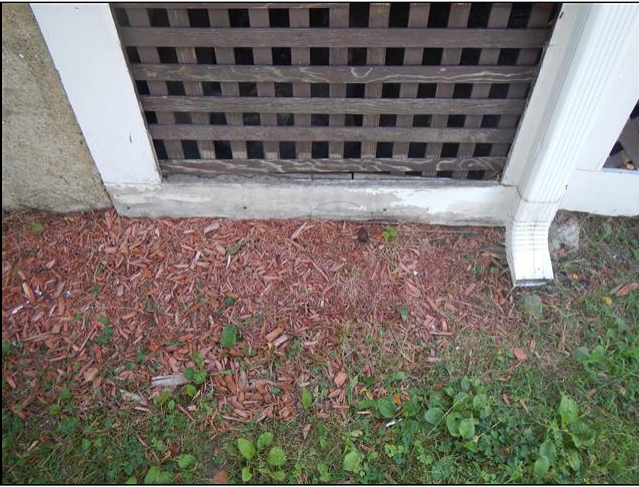
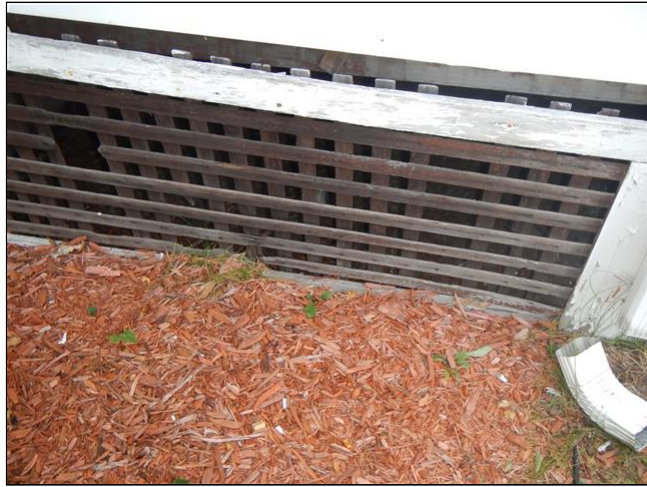
4.8 (1) There is no physical access under the front porch deck. Condition of framing, supports and quality of workmanship is unknown. Lattice work in ground contact is conducive to decay and wood boring insects. Correction is needed.

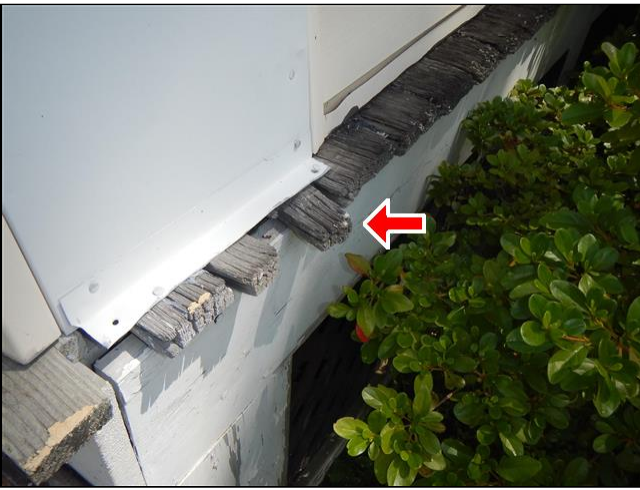
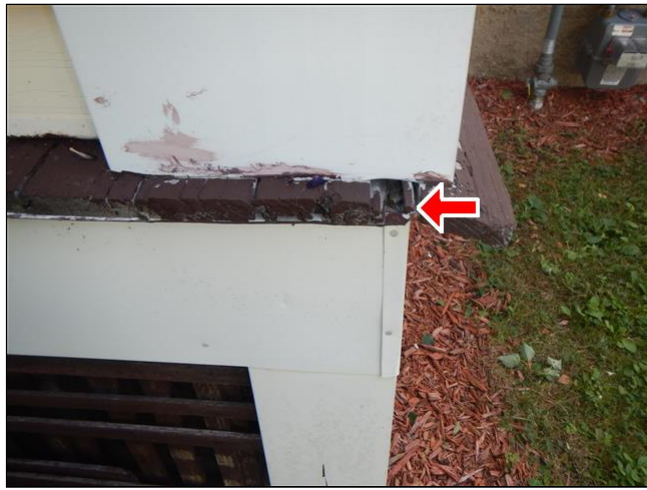
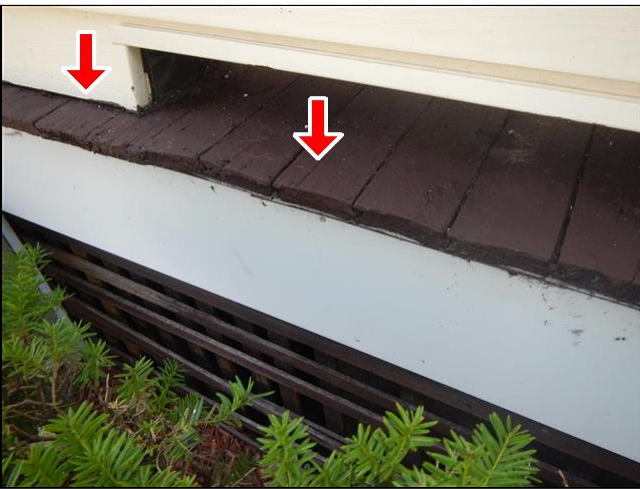
4.8 (2) Decaying decking poses a hazard and should be replaced now.

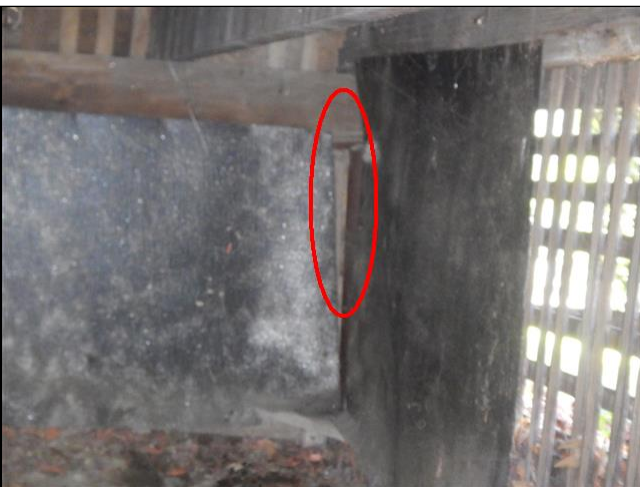
4.8 Item 6(Picture)

4.8 (3) The support post at the right front corner of the porch is no longer plumb and appears to be rotted where it penetrates the ground. Replacement is needed.

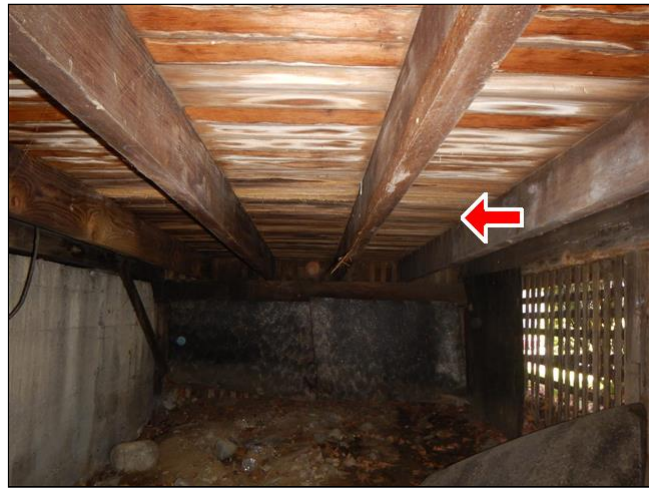
4.8 Item 8(Picture)

4.8 (4) The front porch deck is under framed and should have intermediate support added.

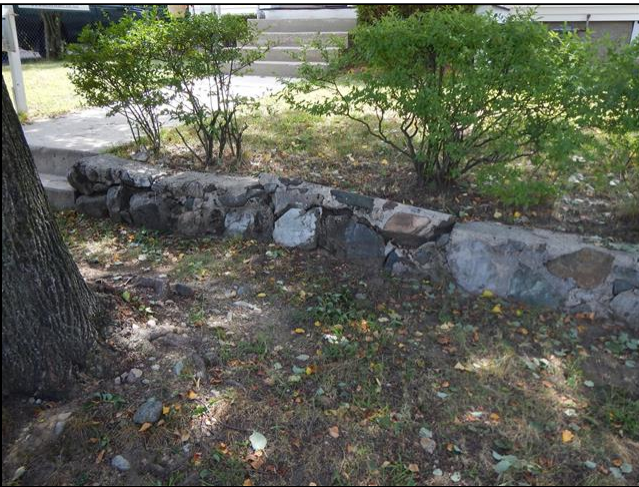
4.10 Item 1(Picture)

4.10 The front retaining wall needs to be rebuilt.

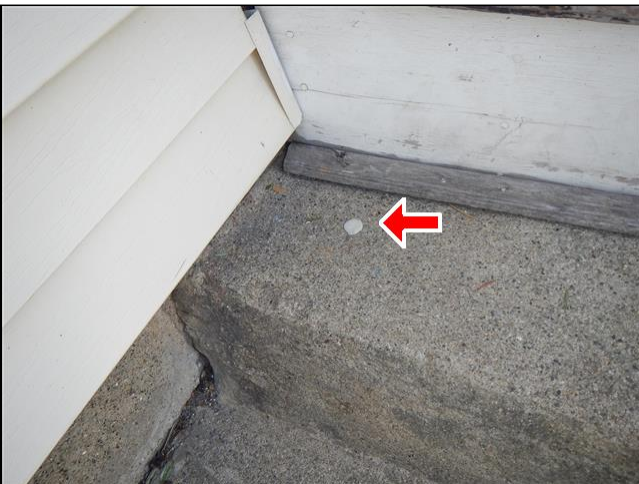
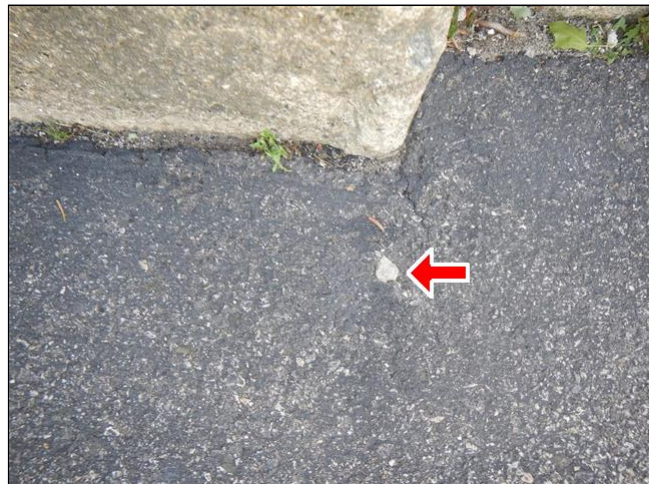
4.11 Patched drill holes were noted at along the exterior of the house . This would indicate a termite treatment has been performed. The owner should be questioned as to any history of damage and if there is a current service contract. Documentation of treatment should be obtained.

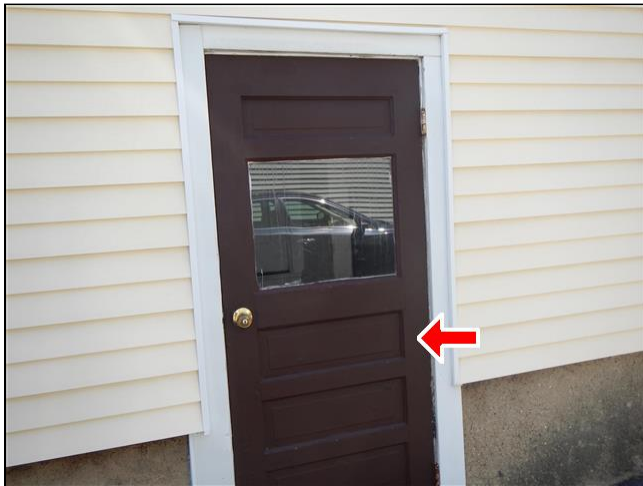
5.0 Item 1(Picture)

5.0 The basement door should be replaced with an insulated door for security and greater energy efficiency.

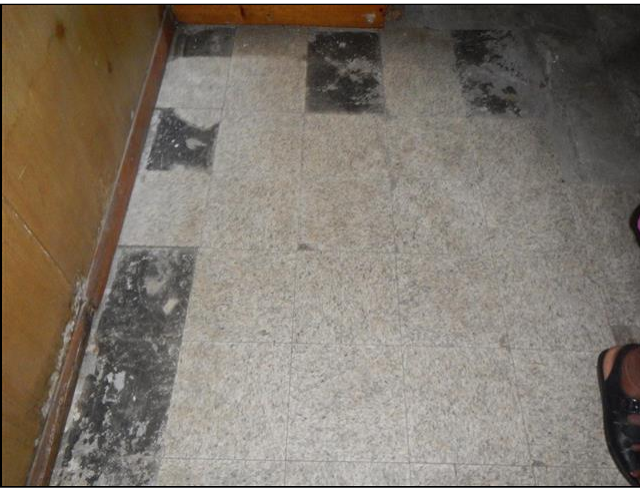
6.2 Item 1(Picture)

6.2 Vinyl floor tiles may contain asbestos. Further evaluation by an expert in this field is recommended.

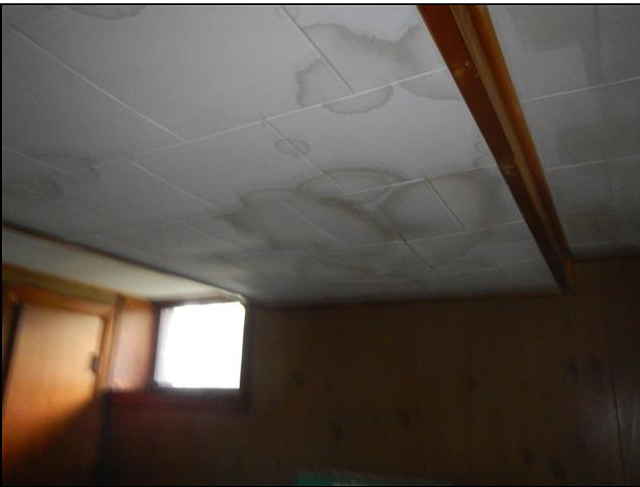
6.3 Item 1(Picture)

6.3 Walls and ceilings need general cosmetic care. Some of the ceilings are water damaged.

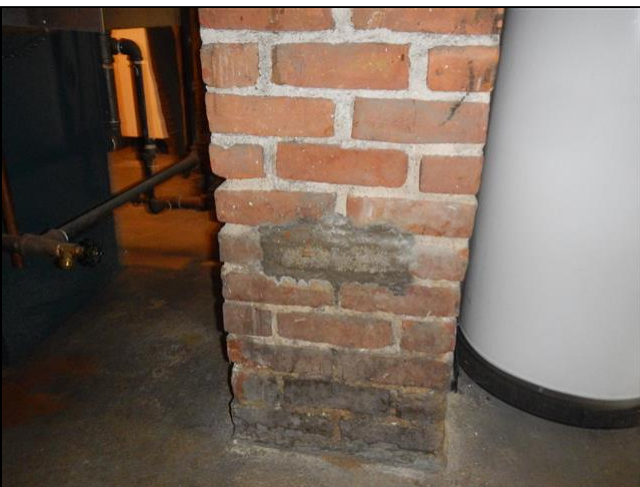
6.5 Item 1(Picture)

6.5 The chimney has no clean out door. One one should be installed.

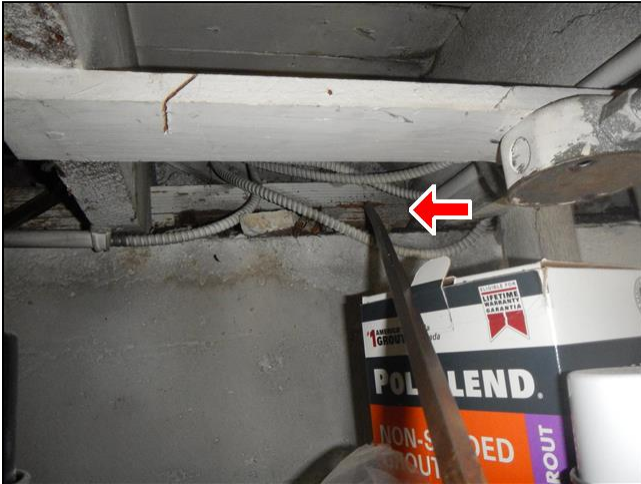
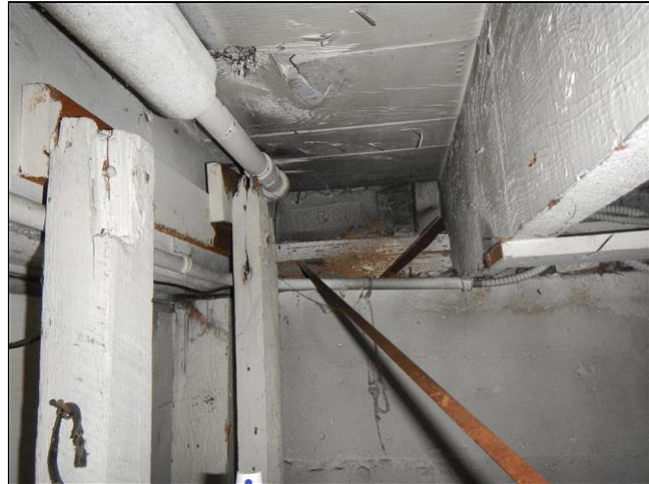
6.6 Approximately half of the right side sill has been significantly damaged by termites and need to be replaced. A qualified contractor should be consulted.

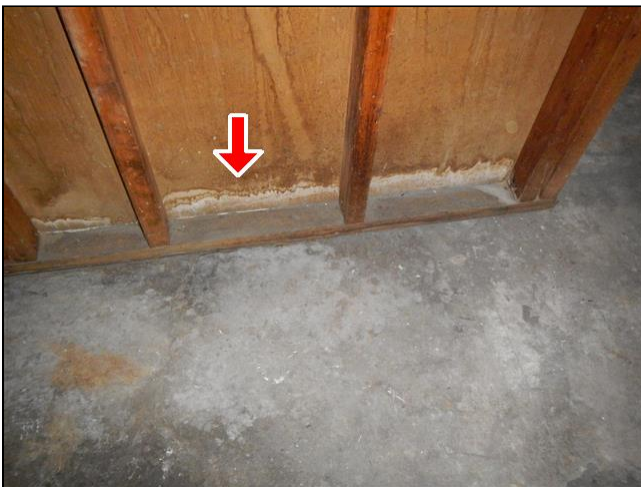
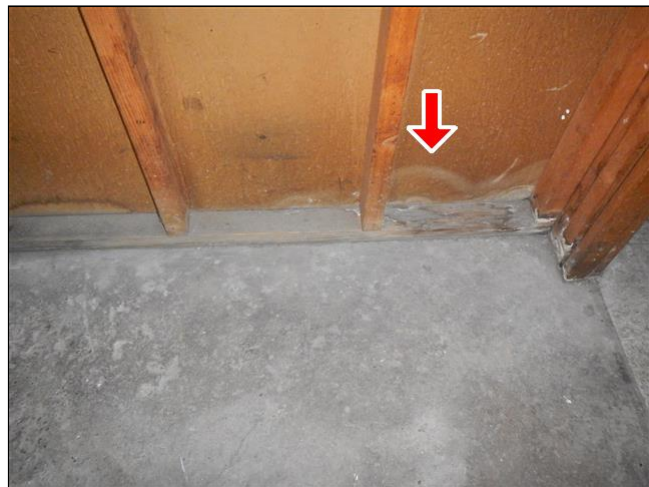
6.10 No basement is impervious to water entry. Under certain conditions seepage or flooding may occur. The owner needs to be consulted as to any history of past water entry. The basement shows evidence of historic and ongoing water issues. A basement water control specialist should be consulted, prior to commitment.

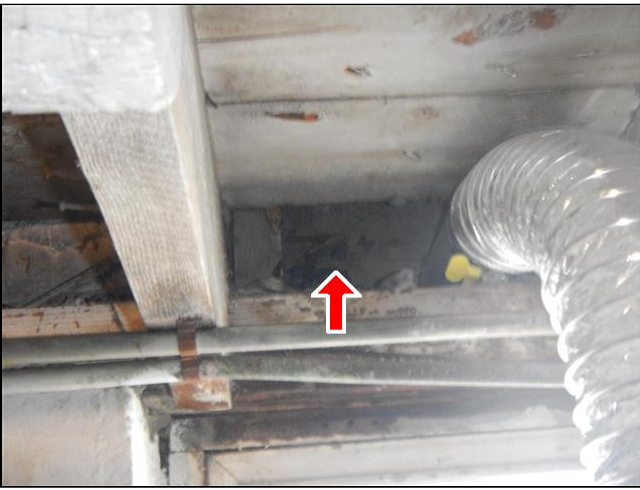
6.14 Item 1(Picture)

6.14 Balloon framing should be fire stopped as needed.

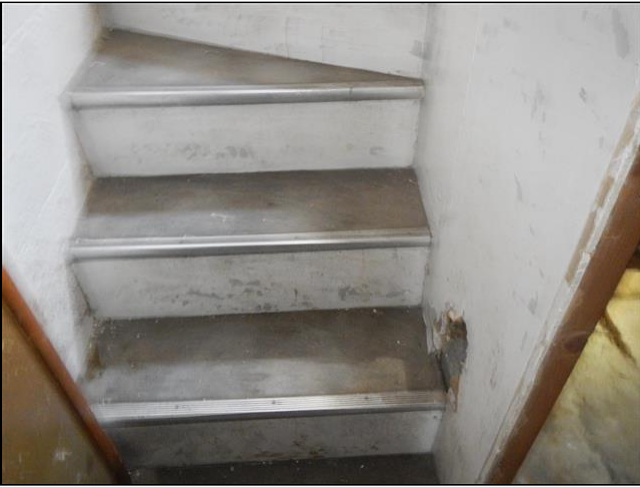
6.15 Item 1(Picture)

6.15 The cellar steps have inconsistent rise. This poses a trip hazard and should be corrected. The risk of personal injury exists.

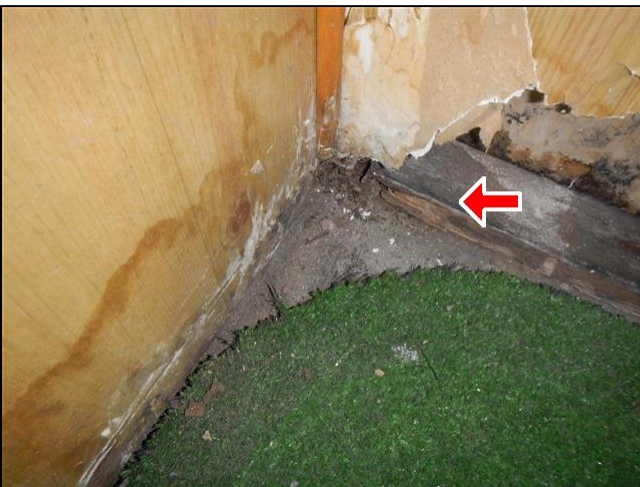
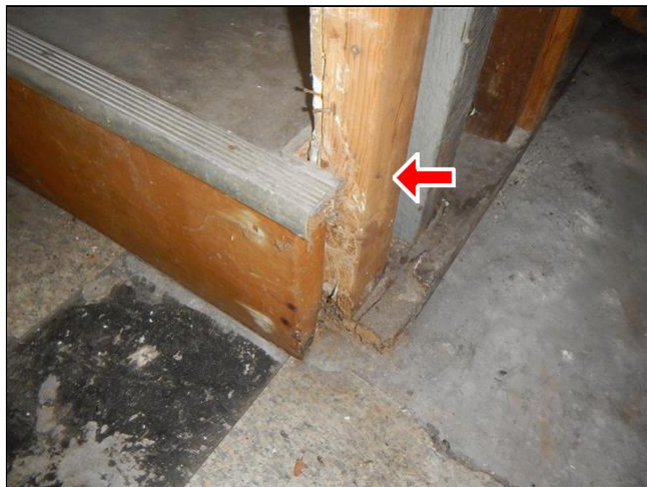
6.16 (1) Several of the partition walls have been damaged by termites. Repairs are needed.

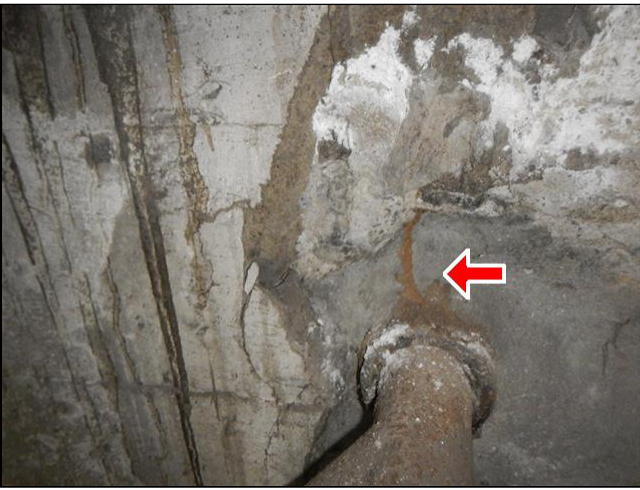
6.16 Item 3(Picture)

6.16 (2) Termite shelter tubes were also noted on foundation walls.

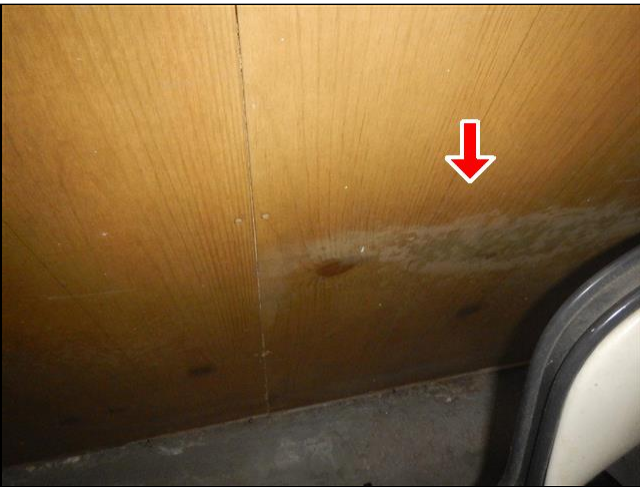
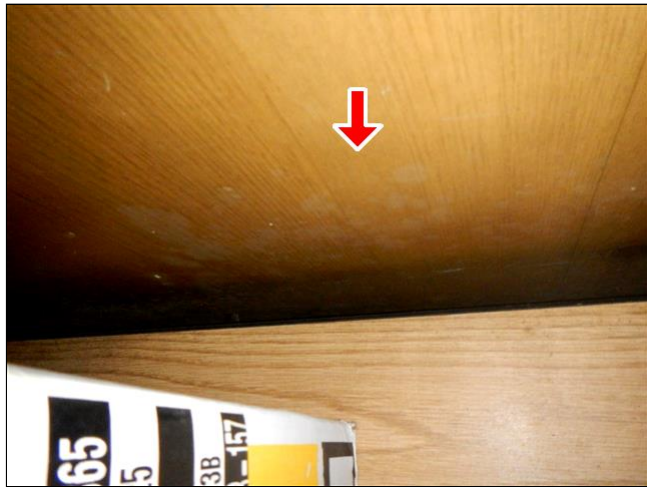
6.16 (3) There appears to be a mold like substance on finished walls at many points throughout the cellar. Further evaluation by an expert in this field is recommended.

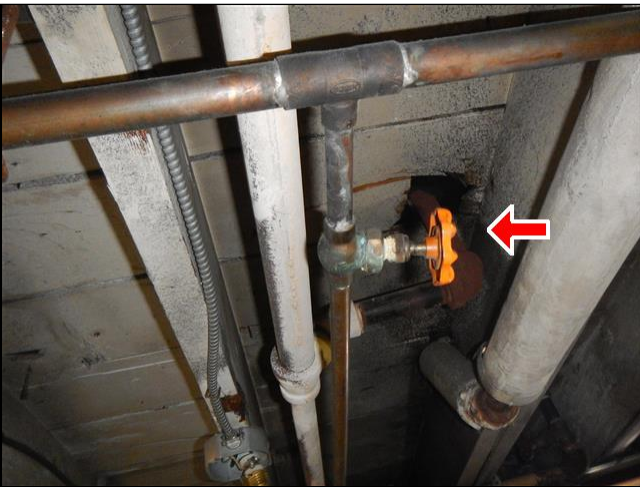
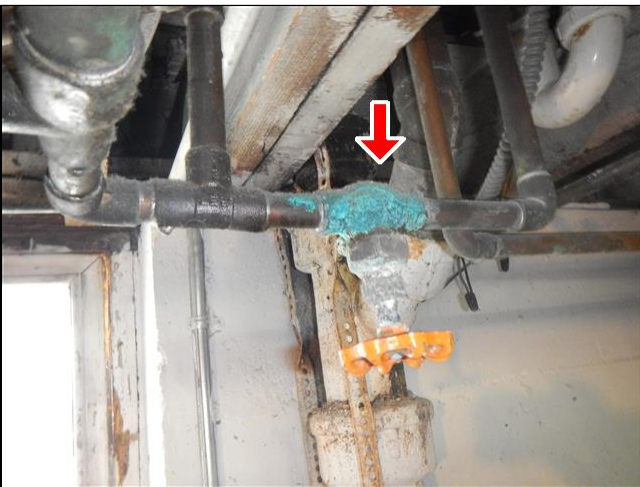
8.0 (1) Copper tubing should be supported with proper hangers. Copper or plastic is recommended as steel will and has caused galvanic action to occur.

8.0 (2) Corroded shut off valves should be replaced.

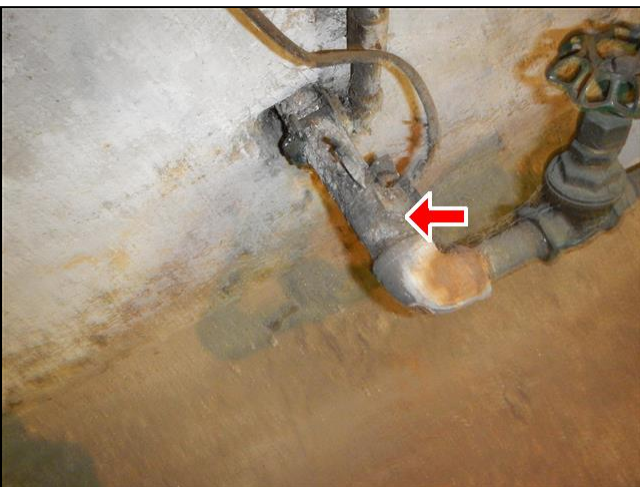
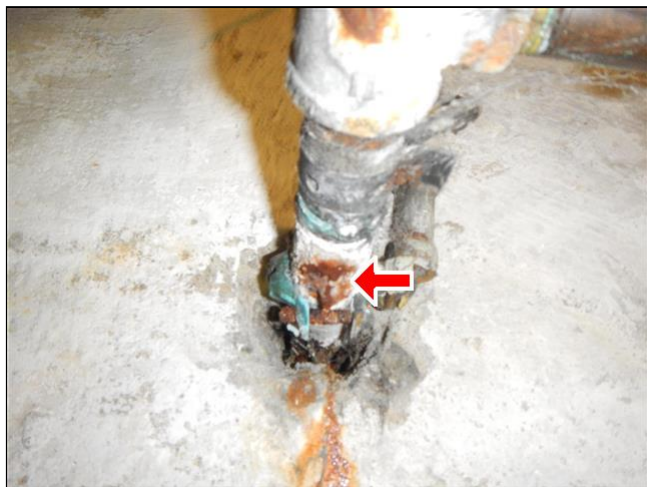
8.0 (3) The main water line in from the street is iron. This type of pipe tends to corrode and fail internally. Failure typically occurs with out warning. The water main appears to be leaking and may need to be replaced. A plumber should be consulted now.

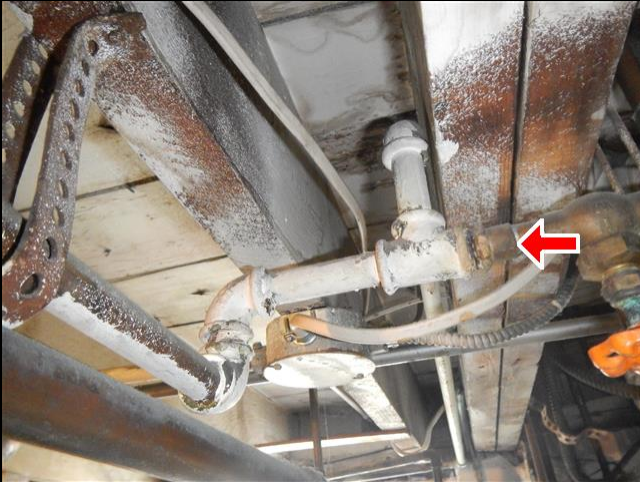
8.0 Item 6(Picture)

8.0 (4) Some original supply plumbing is still in service. Although still functional it, may become problematic. The need for repairs and updating should be expected.

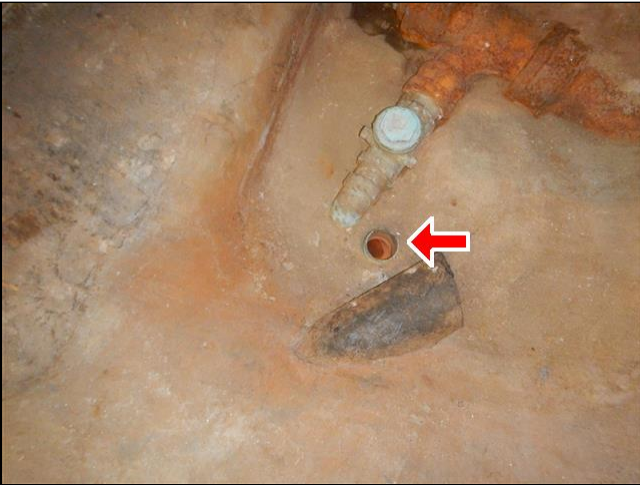
8.1 Item 1(Picture)

8.1 (1) Pipes below the floor should be scoped. The open sewer pipe at the front of the cellar needs to be capped.

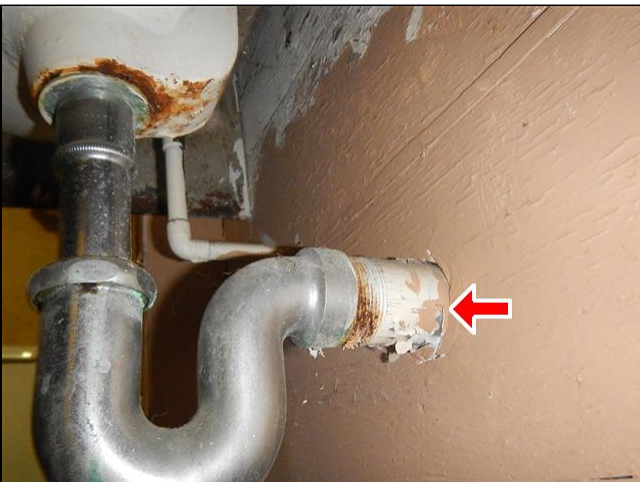
8.1 Item 2(Picture)

8.1 (2) Some of the older waste plumbing is corroded, fatigued and shows signs of leakage. Replacement of affected pipes is needed.

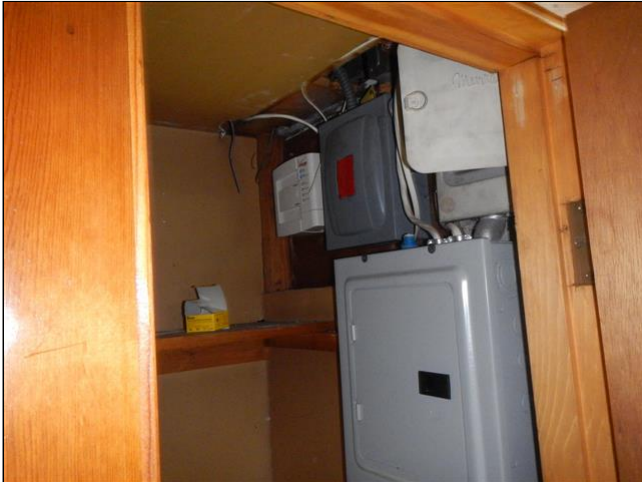
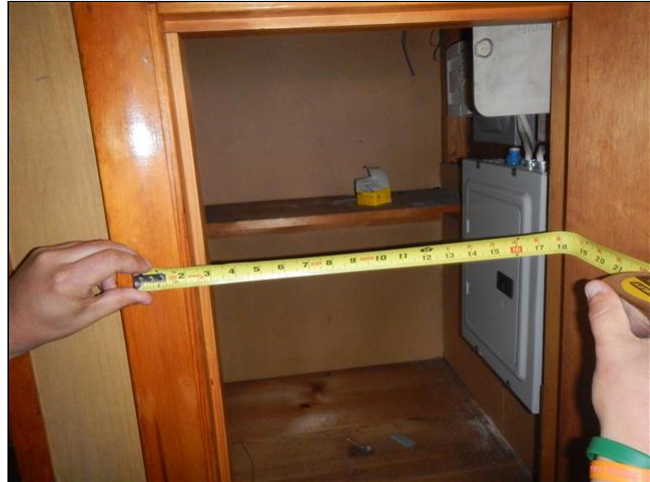
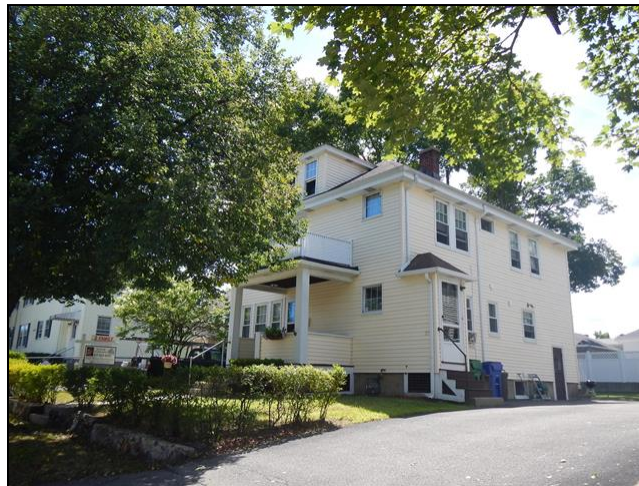
THE INSIDE OF THE ELECTRICAL CABINETS COULD NOT BE INSPECTED AS THE COVERS ARE ENCASED IN FINISHED SURFACES. CONDITIONS WITHIN ARE UNKNOWN. THIS PRACTICE IS NOT PERMITTED IMMEDIATE CORRECTION IS NEEDED.

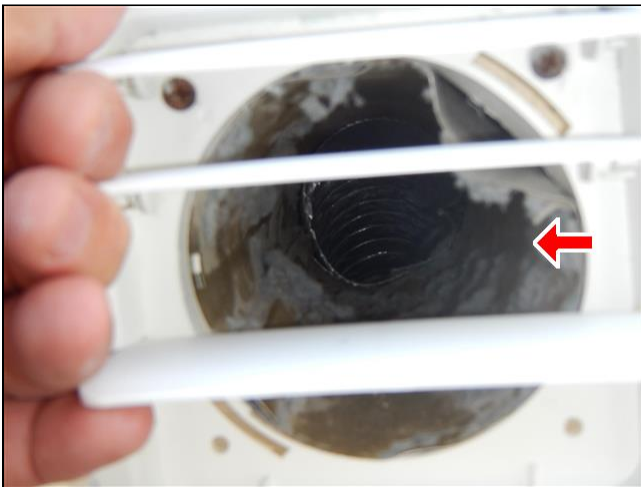
11.2 Item 1(Picture)

11.2 The dryer vents need to be cleaned. The dryer vent needs to be cleaned semi-annually. Lint laden dryer vents are a leading cause of residential fires.

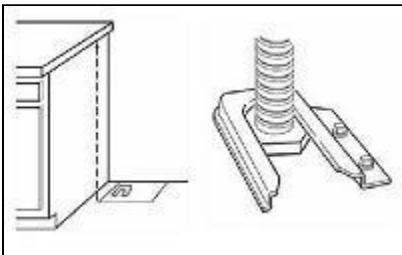
12.12 Item 1(Picture)

12.12 The stove lacks its required anti tip device. This poses a safety hazard. Immediate correction is needed.

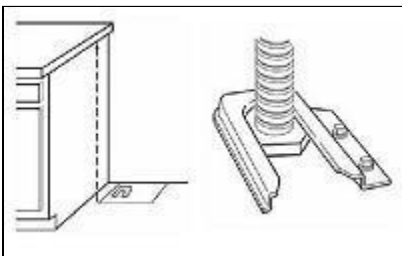
16.13 Item 1(Picture)

16.13 The stove lacks its required anti tip device. This poses a safety hazard. Immediate correction is needed.
