## Inspection Report

Prepared For:  
CAN-DO Inc.  
Josephine McNeil

Property Address:  
11-13 Cambria St  
Newton, MA

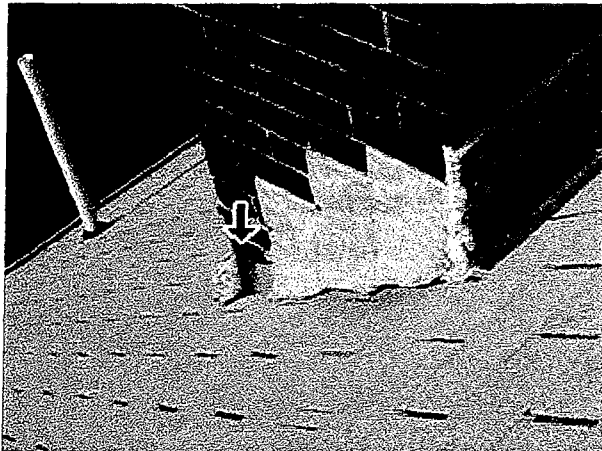
1.2 Picture 1

1.2 A piece of missing flashing on the front left corner of the chimney needs replacing as this will allow for water penetration problems. A flashing saddle should be created to more effectively direct water around the chimney. This should be addressed upon rebuilding of the chimney.

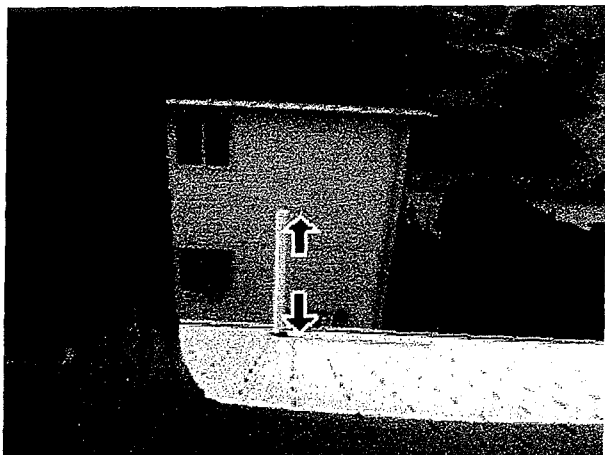
1.3 Picture 1

1.3 The PVC plumbing vent is over exposed, which could lead to failure due to hore frost. The vent should be exposed no more than 24". Correction is recommended. A licensed plumber should be consulted.

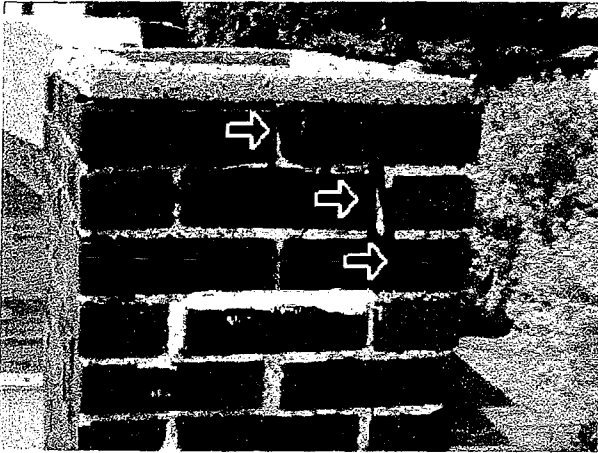
2.0 Picture 1

**2.0** Sidewalls have deteriorated mortar joints , loose bricks and needs rebuilding from at least the roof line up. A qualified mason should be consulted for further evaluation.

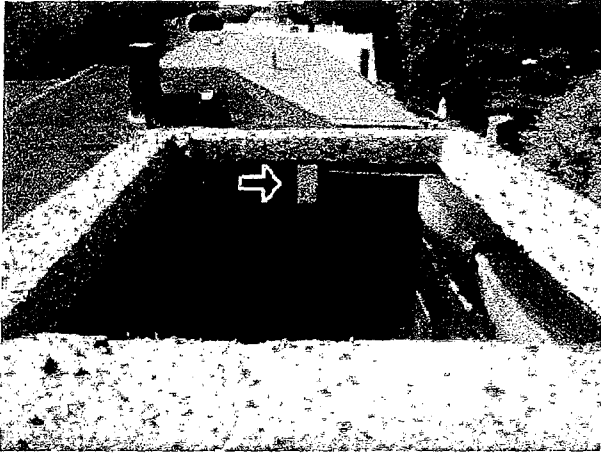
2.2 Picture 1

**2.2** The chimney top has deteriorated mortar joints and needs rebuilding.

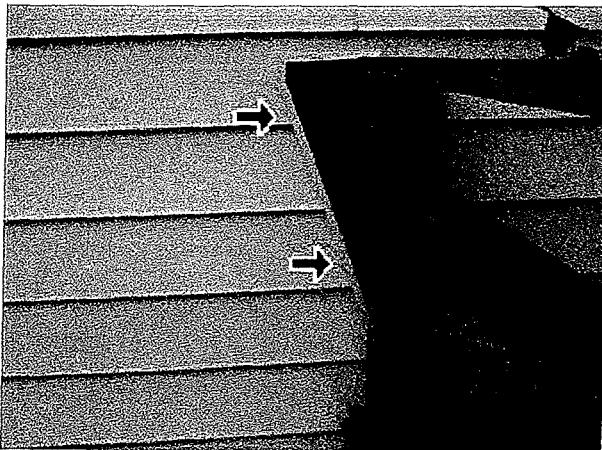
3.0 Picture 1

**3.0** Vinyl siding shows expected signs of fading is chalky and needs cleaning. Missing siding of the rear wall by deck railings needs replacing.

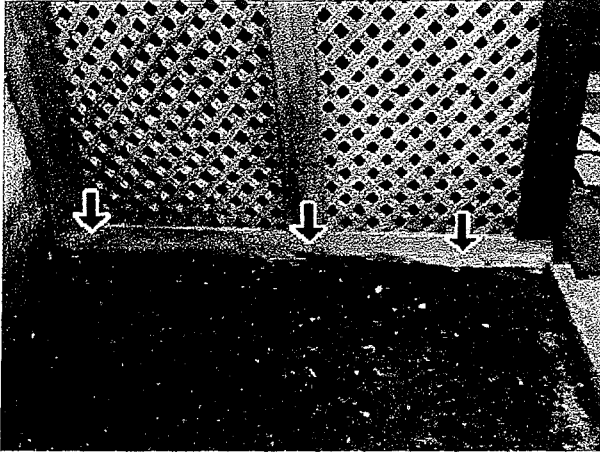
3.2 Picture 1

**3.2** Lattice trim of the rear porch is decaying where in ground contact. Replacement with pressure treated lumber is needed.

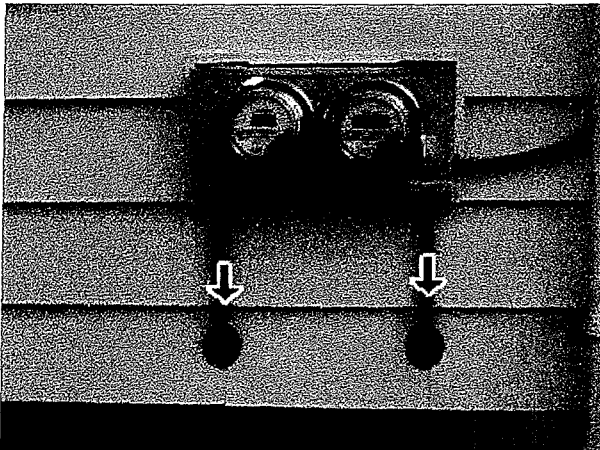
3.8 Picture 1

3.8 The entry cables need to be resealed into siding, to resist water penetration.

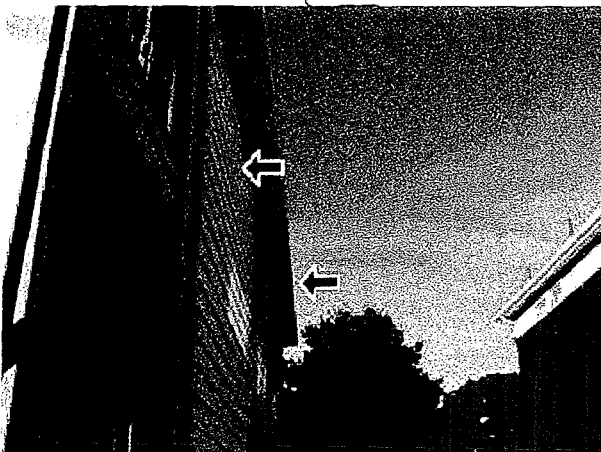
3.10 Picture 1

3.10 The right upper side wall is noticeably out of plumb and bows outward. This is below the sagging of the roof structure. Further evaluation by a structural engineer is recommended. ✓

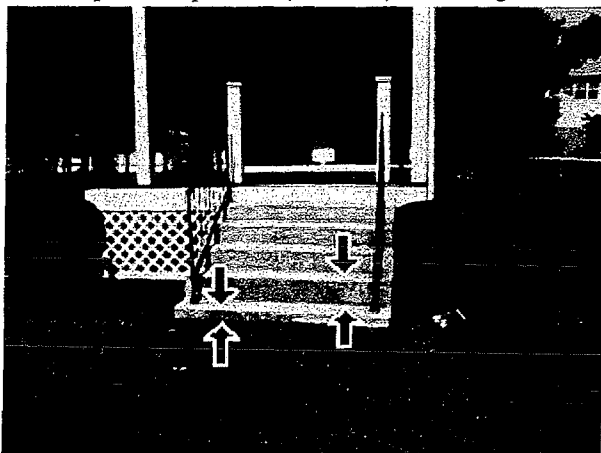
4.6 Picture 1

4.6 Front steps have inconsistent rise(Picture 1) . This poses a trip hazard and should be corrected. Open risers on deck steps can also pose a trip hazard(Picture 2). Covering with trim is recommended.

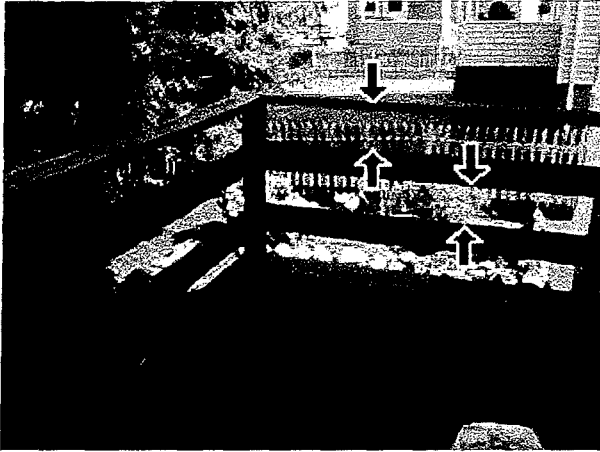
4.7 Picture 1

4.7 Railings on the rear deck have excessive openings. Horizontal railings create a climbing hazard for small children. Rebuilding with vertical balusters, to current safety standards, is recommended.

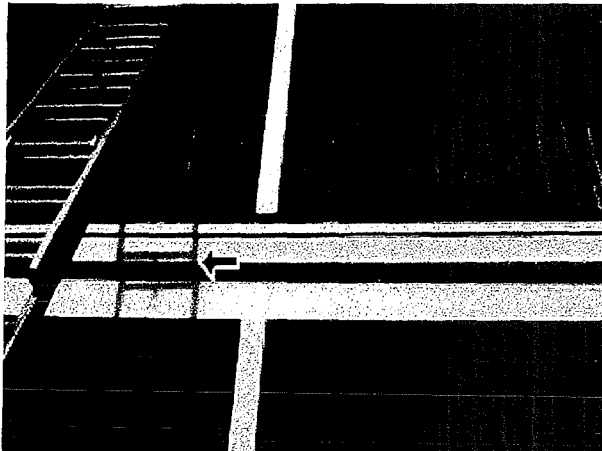
4.9 Picture 1

4.9 Decking of the front porch at the top of the steps is lifted, poses a trip hazard and needs repair. Deflection at this point appears to be a result of lumber shrinkage as the porch has been more recently rebuilt. Water was found dripping from the outside of the 2nd floor porch deck, just to the left of the front steps. Further investigation is needed as water penetration in this area can contribute to decay issues. Trim below the 2nd floor porch deck should be removed to allow for evaluation.

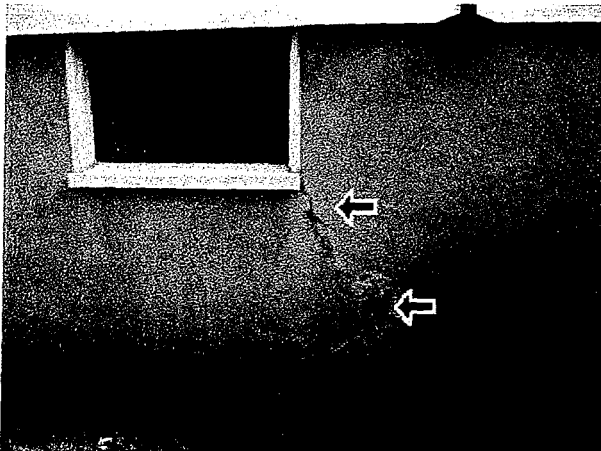
6.1 Picture 1

6.1 Foundation walls need to be cleaned of loose and spalling material, pargetted and sealed as needed. Foundation walls show typical shrinkage cracks as viewed from the exterior.

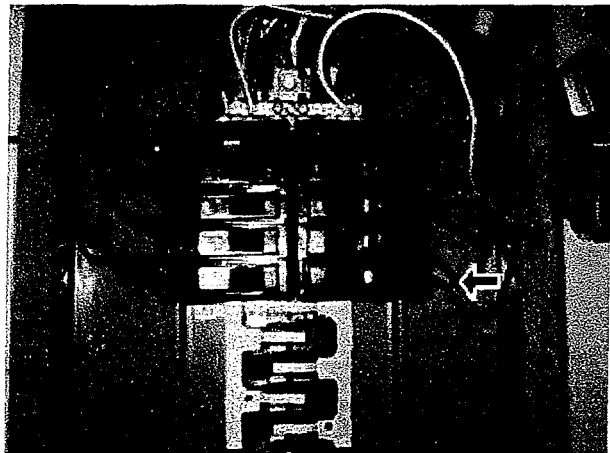
10.3.B Picture 1

**10.3.B** One 20 amp circuit breaker in main panel is over fused which is a fire hazard and needs immediate correction. A licensed electrician should be consulted for correction. The panel is rated for 20 breakers, it has 10.

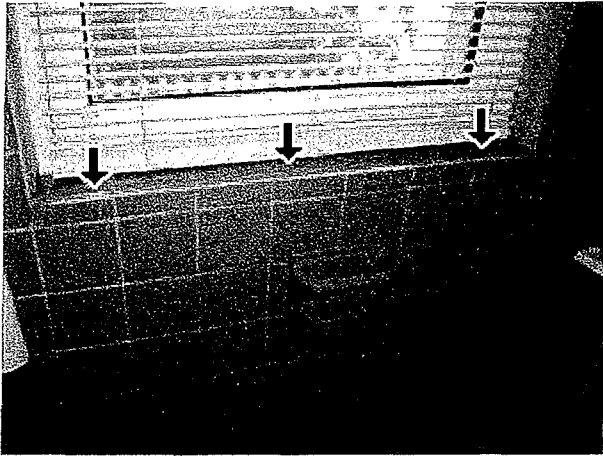
16.17.B Picture 1

**16.17.B** Tiles below the window opening are loose and need repair. A piece of solid material such as plastic or stone is recommended.
