June 7, 2013

***Re: Newton City Hall, 1000 Commonwealth Ave, Newton, MA***  
***Window Conditions assessment and recommendations.***

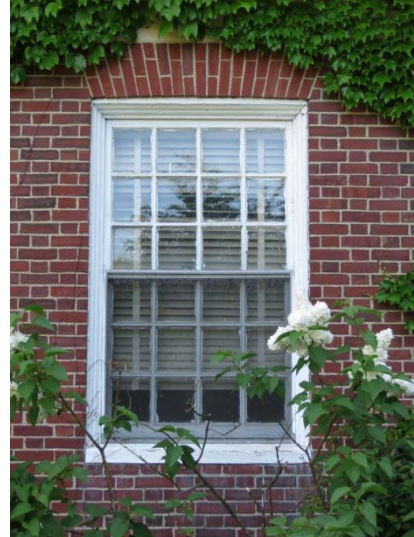
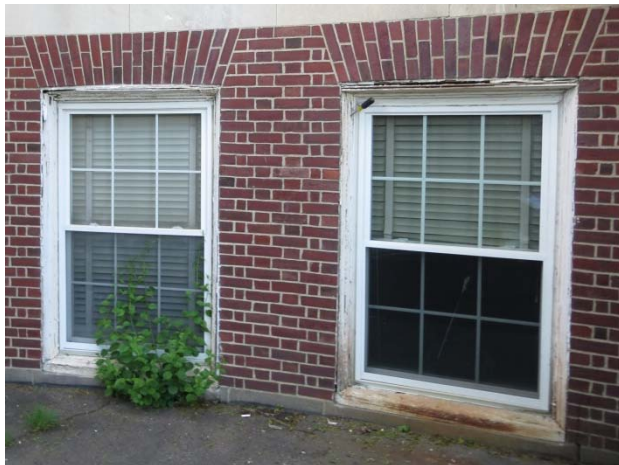
Vinyl replacement windows were observed on the south elevation of the south east wing of the building, facing the parking lot. The windows appear to have been installed recently and exhibit no signs of failure. However, they were installed into the existing wood frames which suffer from failing paint and decay. Inside the service alley where these windows were installed, the wood frames are in the worst shape of any observed on the building. Most of the wood of these frames are deteriorated to an extent that full replacement is needed; indeed, it is a wonder that the sash were installed in frames in such poor condition. At some of the worst frames we observed an omission of flashing over the wood window head which lead to their increased rate of deterioration and to the corrosion of the steel lintel over

**Vinyl windows installed in original wood frames**

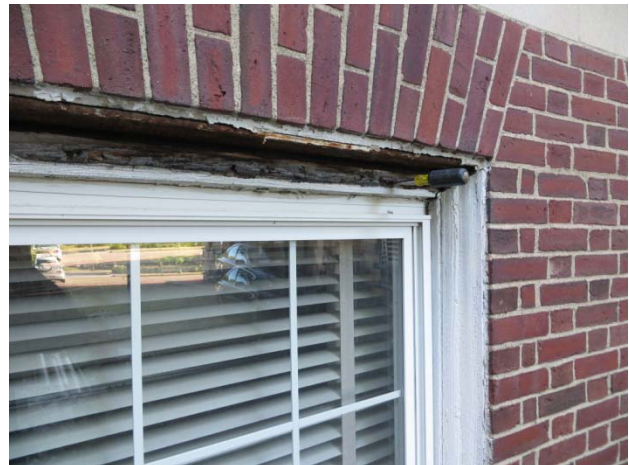
**Missing head of frame and deteriorated steel lintel.  
Note missing flashing at lintel.**

these windows.

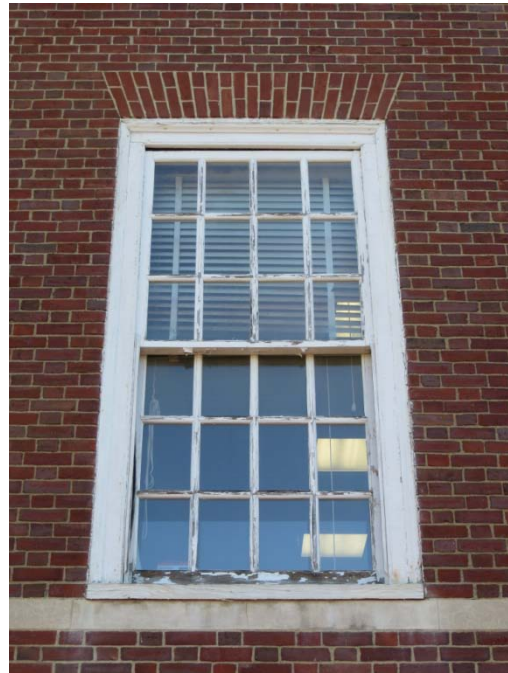
The vast majority of the windows on the building were retrofitted within the last 10 years. It appears that the sash were all removed, stripped of paint, the glazing replaced with new double paned glass held in place with wood stops, and the wood frames prepared and painted. All of the paint is now wearing off of the windows and the wood stops are deteriorating, with failing wood and rusting/loose brads to hold them in place.

**Typical retrofitted window with failed paint and failing wood stops.**

A minor restoration of the windows would involve the following work: re-nailing and replacing selective wood stops; painting of all the windows and frames, installing weather stripping, sealing at the frame to masonry opening and plaster wall. The problem with this approach is that the wood stops are likely to fail again the way that they have over the last 10 years. This means that in 10 years another "minor" restoration will be required. Also at this time it is likely that the seals in some of the double glazed windows will begin to fail. Once the seals fail moisture accumulates and fogs up the windows. This can only be fixed by replacing the pane.

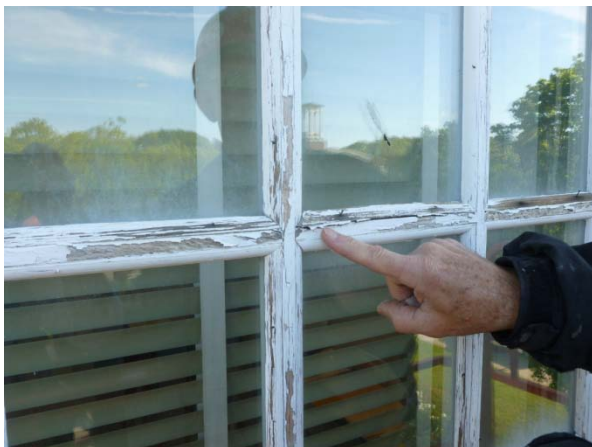
The problem with new growth pine is that it is not nearly as durable as old growth wood and it also expands and contracts at a different rate than the old wood. This consistent, varied movement has caused many of the brads holding the stops in place to wriggle free. The other issue with using wood stops as a glazing seal is that the wood does not adhere to the glass in the way glazing putty does. On the contrary, a joint is created between the glass and stop which allows water to run in behind the wood. This water then sits on the muntin, prevented from getting into the window by the sealant used to hold the glass in place. It then

**Failed paint at muntins and wood stops. Rusted brads sticking up out of wood.**

slowly rots the wood surrounding it as there is no place for the water to escape.

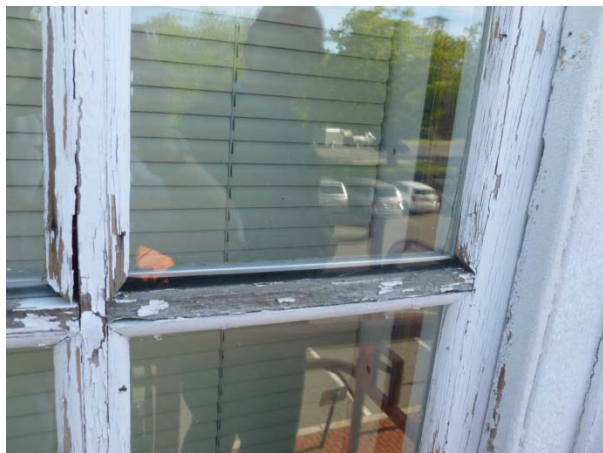
**Missing wood stop.**

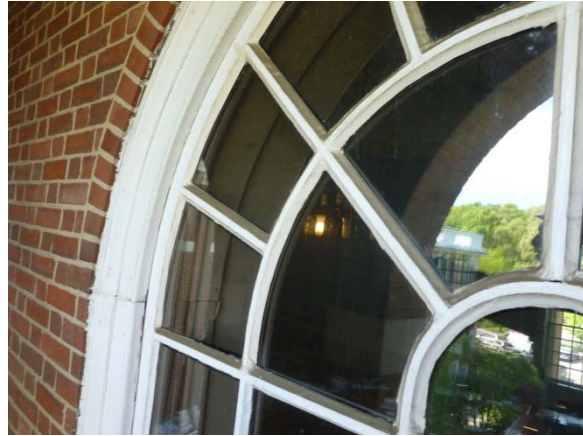
Other windows were retrofitted using sealant as glazing putty instead of the wood stops. The sealant has weathered much better than the wood stops, however it is not paintable and very dirty.

**Window with sealant used as glazing putty.**

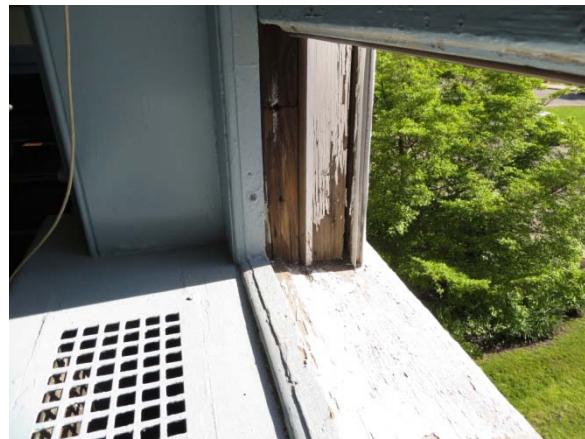
The building occupants give high marks for operability of the windows which is not an easy task with windows of this size. They presently operate using their original weight and pulley system. However, the greatest complaint by building occupants was with regard to how drafty the windows are. Drafty windows are the number one cause of comfort complaints in buildings with historic windows. A cool breeze is more disruptive to the body than a cool thermal mass, so the double pane glass compared with single pane glass does little to address this issue. The drafts in windows generally come from two places: where the sash meets the wood frame and where the wood frame meets the masonry opening. The way to remedy the draftiness is through installing weather stripping at the jambs and sills of the window, as well as at the meeting rail. The goal is to make a tight fit for the window against the frame to seal everything tight. At the masonry opening, ensuring a sound sealant joint between the masonry and wood is imperative as well as on the inside where the frame meets the plaster. This detail can be challenging as there is usually a void for the window weight pockets behind this wood to masonry joint. Having tight joints between each piece of wood is also important. So although the wood of the windows and frames are still in good condition, the thermal qualities of the windows are lacking which leads to consistent user complaints.

**Jamb of typical window. No weather stripping installed at jamb or sill.**
