Paul Cornell and Associates

**Inspection Report
prepared for:**

**Property Address:
54 Eddy Street
Newton, MA 02465**

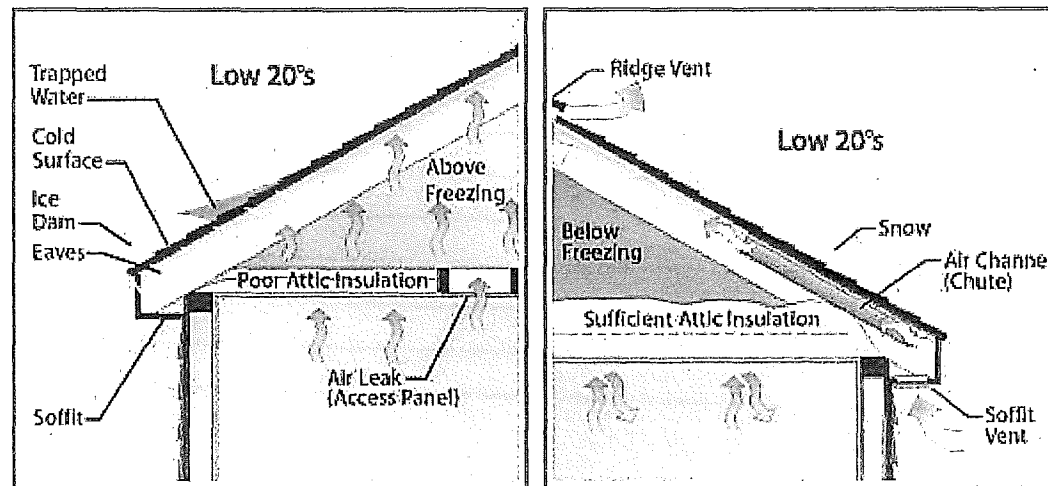
1.5 Picture 1

1.5 VENTILATION : There is limited means of roof ventilation. Limited roof ventilation combined with heat loss into the attic during the winter months can contribute to ice damming and condensation problems when snow is present on the roof. Limited ventilation can also contribute to excessive heat build up in the attic during the summer months and can shorten the serviceable life of the roof cover. The installation of soffit and ridge venting is recommended. Additional appropriations will be needed in the attic area.

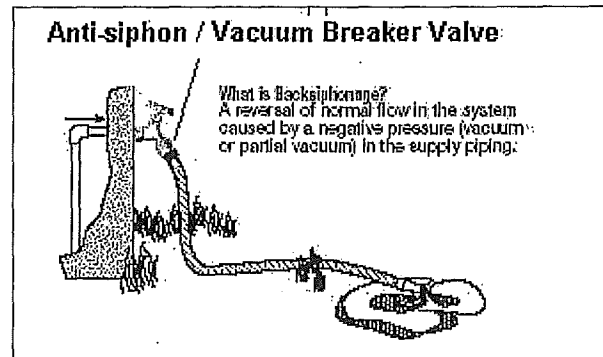
3.9 Picture 1

3.9 EXTERIOR FAUCET(S) : Exterior faucets should be fitted with vacuum breakers / anti-siphon devices to prevent potential cross connections and contamination of the potable water supply system. The installation of modern frost free faucets, with integral back flow preventers, is recommended.

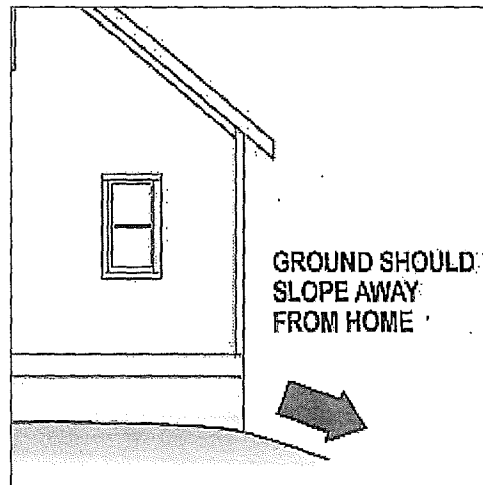
4.4 Picture 1

4.4 (1) FOUNDATION GRADING : Foundation grading should be kept free of bark mulch as it is conducive to wood destroying insect problems such as termites.

(2) For proper drainage, grading against the foundation, needs to be maintained to slope away for a minimum of 1" per foot for at least 5 feet wherever possible.
