**NEWTON PUBLIC BUILDINGS SURVEY
PHASE II – ANALYSIS OF HISTORICAL SIGNIFICANCE**

Angier Elementary School

Address: 1697 Beacon Street
Year of Construction: 1919

Phase II: Analysis of Historically Significant City Buildings, Newton, Massachusetts
Angier Elementary School
DRAFT 4/6/2012

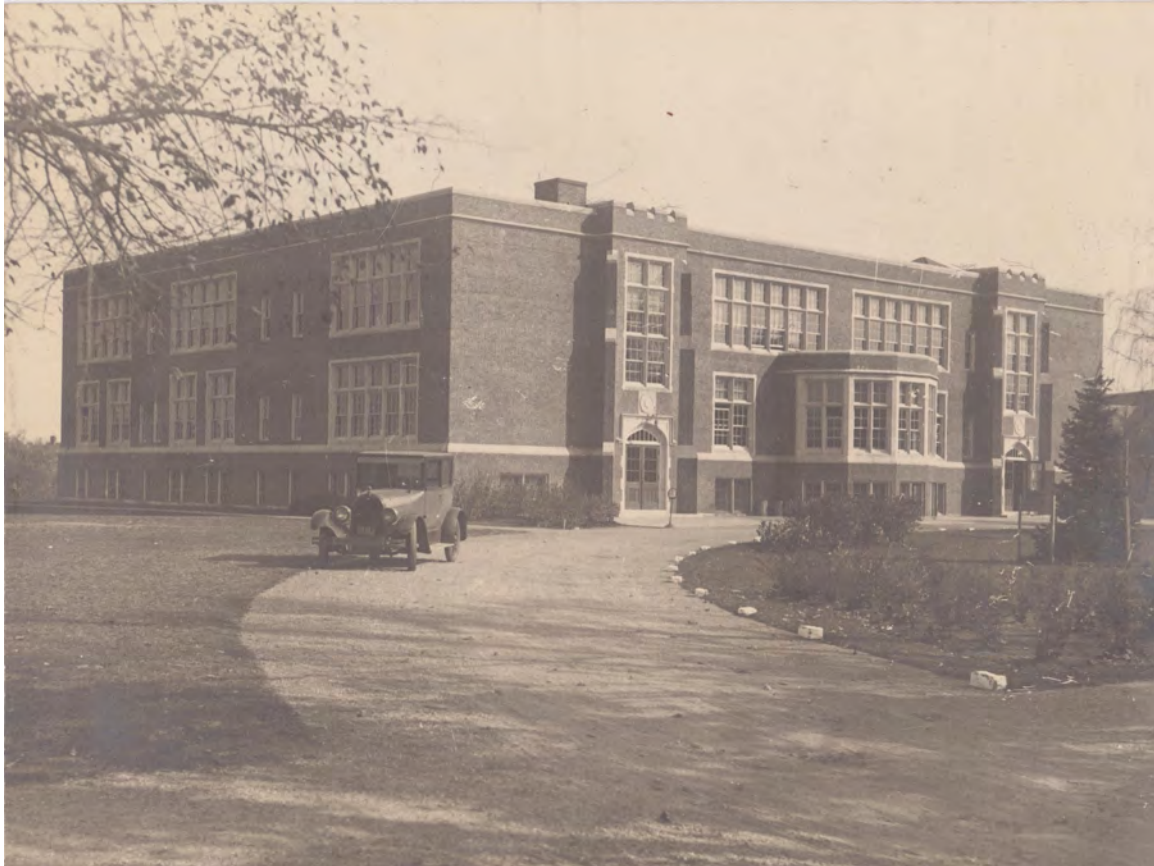
Figure 1: Angier School in 1925. (Credit: Historic Newton)

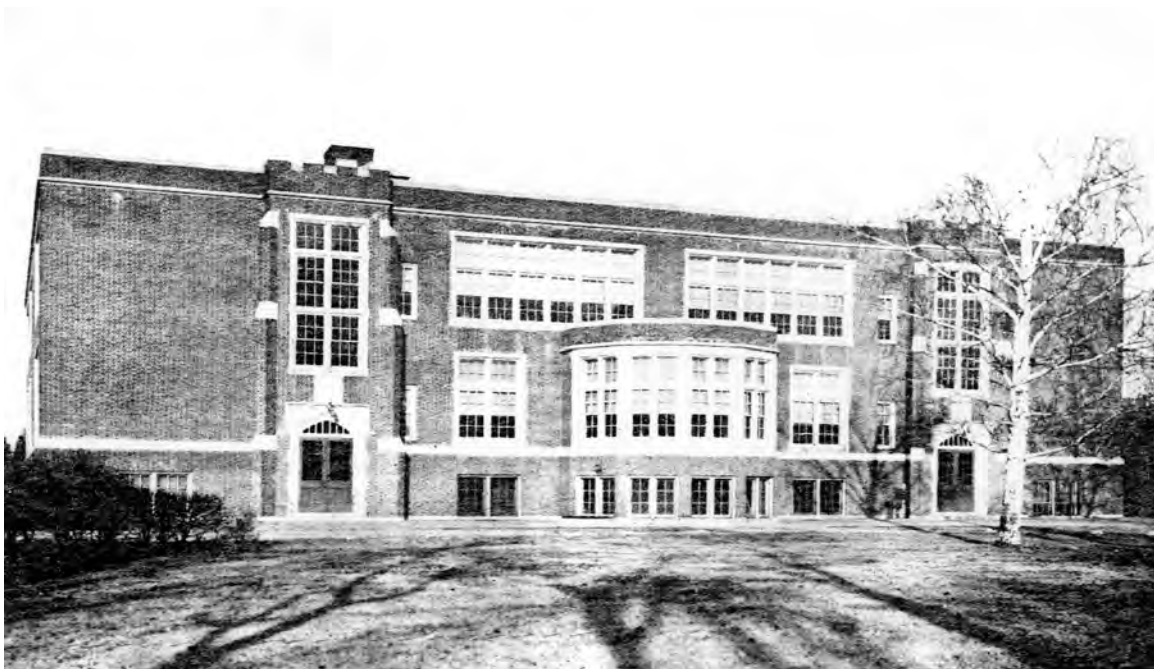
Figure 2: Angier School in 1929. (Credit: MACRIS)

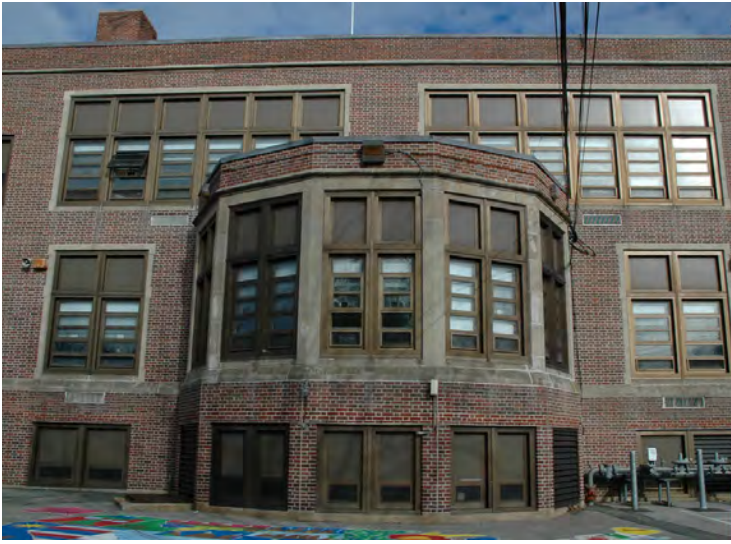
- The delicately detailed original windows have all been replaced with thick aluminum frames and a combination of spandrel transom panels and fixed and awning sashes. Some basement windows have been replaced with louvers. This new configuration bears little resemblance to the original as seen in the historic photos, and is jarring, especially in comparison.

Figure 3: The windows of the front projection and of the general façade, although severely altered and far less elegant, retain vestiges of their original configuration in the wider horizontal mullion dividing the transom sashes from the lower sashes. Compare to the historic photo in figure 1.

- Conduct a thorough survey of window conditions, including the sash, frame, lintel and hardware. Initial exterior inspection indicates there may be some water infiltration into the vertical mullions, but otherwise the windows are generally in good condition. Evaluate the windows in conjunction with daylighting, ventilation and energy efficiency strategies (beyond the scope of this survey), to prioritize replacement. When replacing windows, install operable windows matching the appearance of the original windows.

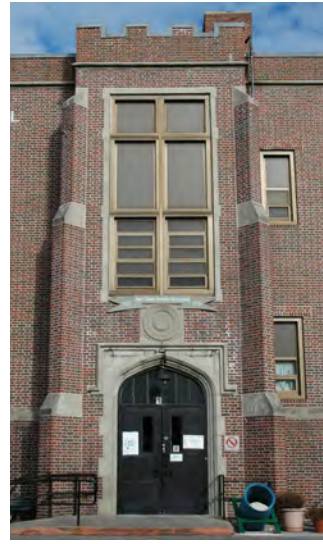
Figure 4: The front entries are given visual importance through the buttressed projection, prominent window and cast stone door surround.

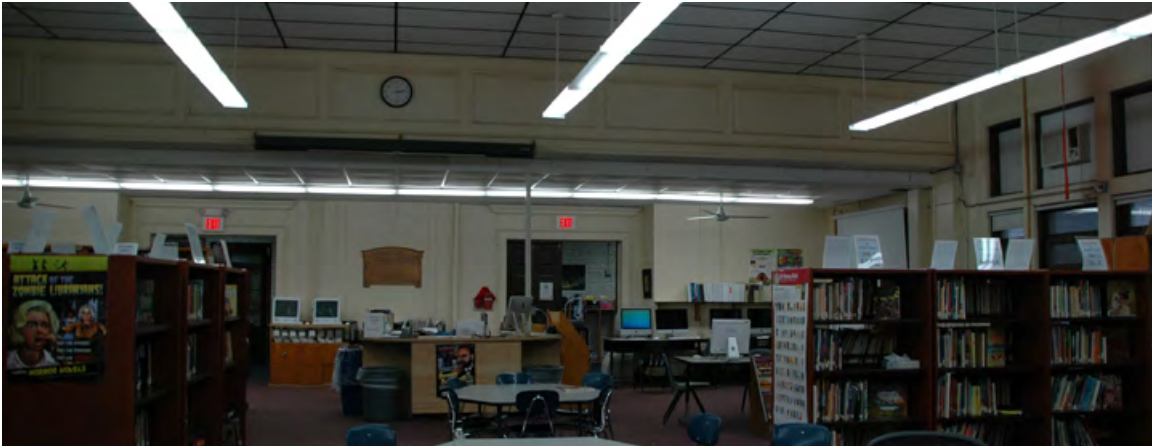
- A low, dropped acoustical tile ceiling obscures the upper half of the space. The original coffered plaster ceiling is still in place above the acoustic tiles.
- The original balcony is currently walled in and divided into offices and storage.
- The stage is still intact, including the wood floor. At the top of the proscenium is the abbreviated quote from the Boston Public Library Board of Trustees: "Education is the Safeguard of Order and Liberty".
- The tall windows at both the north and south sides are in keeping with the original exterior windows, with a transom over each main window. These windows are currently covered up.
- Wall surfaces are articulated with pilasters and running trim, including cornices.
- Decorative hoods are in place over the doorways, with wood panel doors.
- The room contains a bronze plaque in honor of Albert Edgar Angier.

Figure 5: The rear wall and balcony of the original auditorium in the existing library space. The original ceiling is still in place above the dropped acoustic tile.

- Remove the dropped ceiling from the library to reveal the coffered ceiling and full height of the proscenium, wall panels, windows and pilasters.
- Refinish the wood floors in the basement classrooms.
- Repaint painted elements, including walls and radiators with peeling paint.
- Repaint metal stair elements, treads, and landings. Refinish wood handrails.

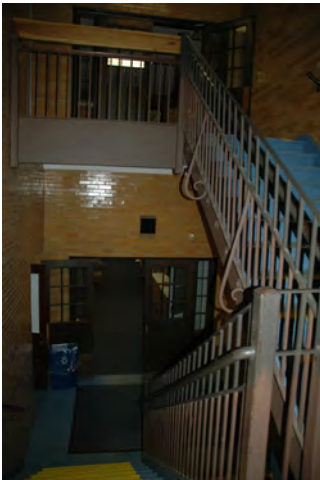
Figure 6: Rear stairwell with original banister and rails.

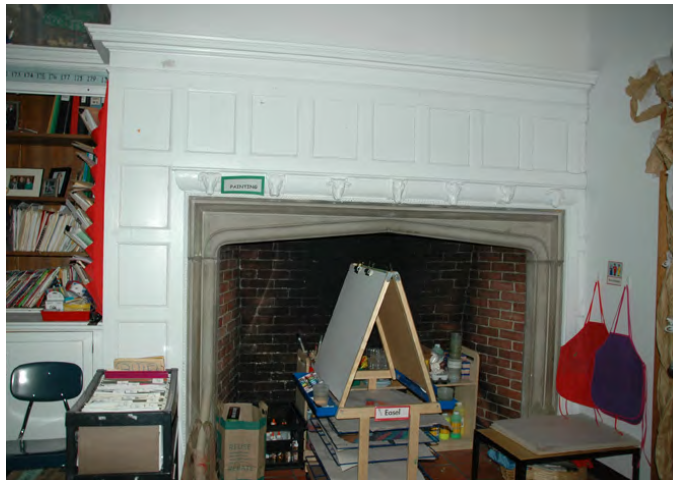
- The front classroom on the main floor contains a fireplace with a carved limestone front, brick firebox, paneled wood surround, and a shallow mantle with seven carved animal heads. It is flanked on either side by built in wood cabinetry.

Figure 7: Fireplace in front classroom with stone surround and carved wood mantel.
