**NEWTON PUBLIC BUILDINGS SURVEY
PHASE II – ANALYSIS OF HISTORICAL SIGNIFICANCE**

Auburndale Library

Phase II: Analysis of Historically Significant City Buildings, Newton, Massachusetts
Auburndale Library
DRAFT 3/9/2012

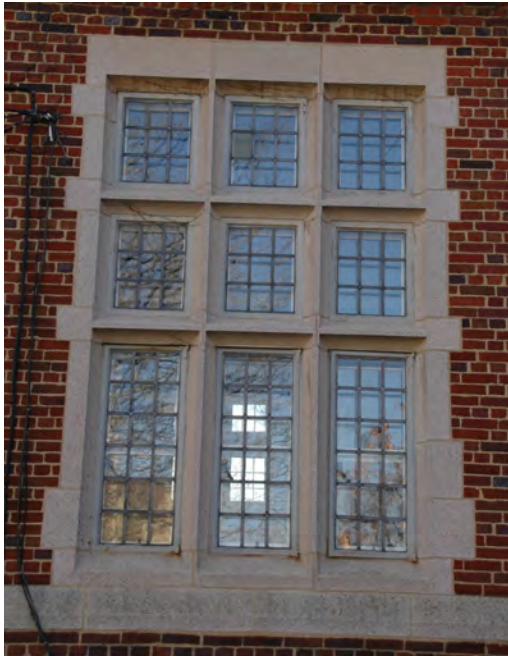
Figure 1 (top left):
typical set of windows

- Conduct thorough survey of window condition, including sash, frame, lintel and hardware. Clean and repaint steel windows. Restore to functioning if not. Replace missing and mismatched panes and missing muntins, including at wood basement windows.

- Some lead windows appear to be bowing; monitor condition. Reset or reinforce as necessary.

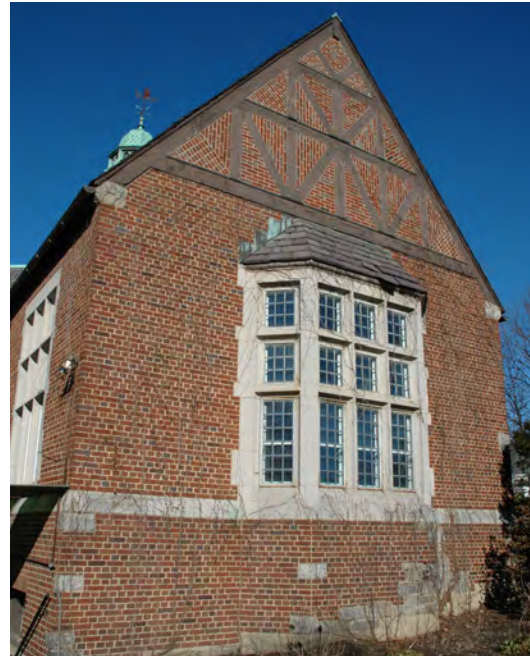
Figure 2 (top right):
south gable end. Note
the bay window and
the decorative
brickwork within a
half-timbered
framework.

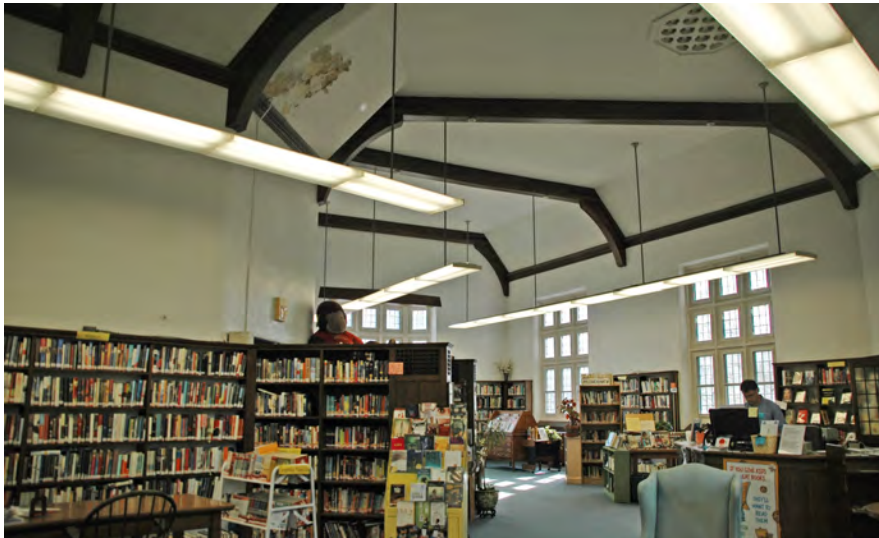
Figure 3 (center): Main
reading room, looking
southeast. The
circulation desk is to
the right.

- Repair roof to remedy cause of water damage at sloped ceiling of main reading room, above the main entry, and in the main entry vestibule.

- Replace the missing wood dentil at the fireplace surround.
- Review lighting strategy for more appropriate, energy efficient solution. While the functionality of the non-original linear fluorescent fixtures is fine, their placement is not visually compatible with the windows or the ceiling trusses.
- Interior door exhibits strange discoloration of wood finish. Refinish.

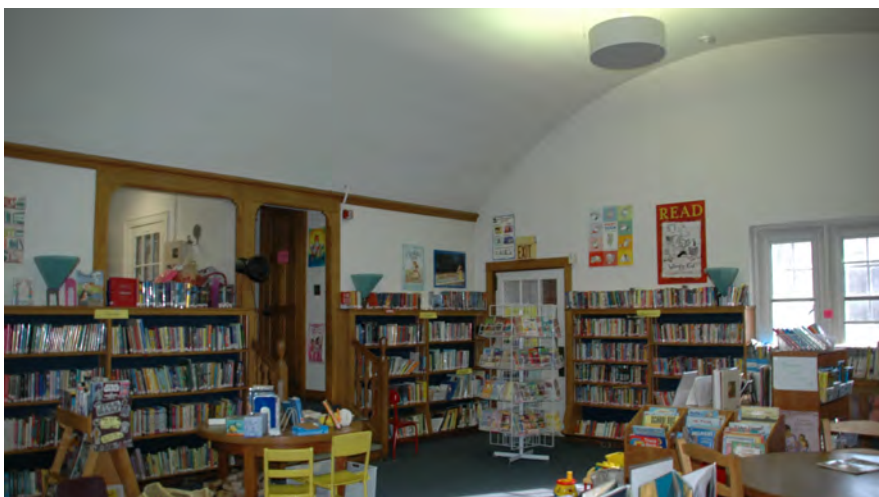
Figure 4 (bottom):
Children's room,
looking southeast.
