**NEWTON PUBLIC BUILDINGS SURVEY  
PHASE II – ANALYSIS OF HISTORICAL SIGNIFICANCE**

**Bowen Elementary School**

Address: 280 Cypress Street  
Year of Construction: 1952

Phase II: Analysis of Historically Significant City Buildings, Newton, Massachusetts  
Bowen Elementary School  
DRAFT 4/6/2012

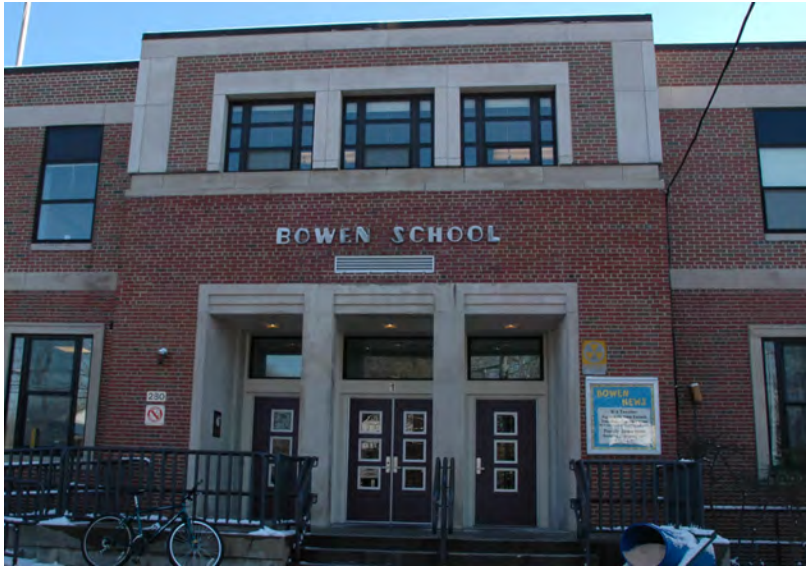
Figure 1 (top): main entrance

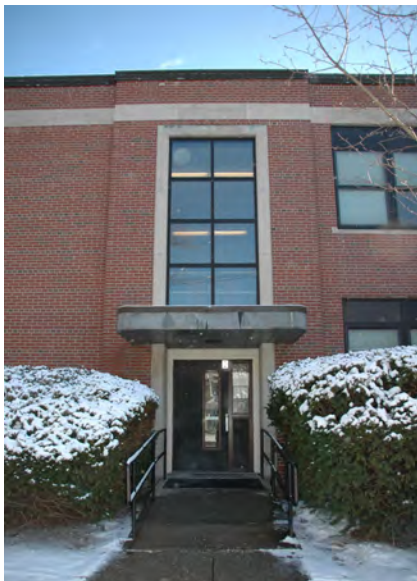
Figure 2 (center left): typical side entrance

- Remove rust and repaint all ferrous elements, including pipe rails and tube section columns at south addition.
- Repair and restore the entry canopies, currently with varying extent of rust and bent cladding. Straighten, or reclad canopies as necessary. Restore or replace in kind the flush light fixtures. If possible, coordinate with restoration of northeast canopy, above.

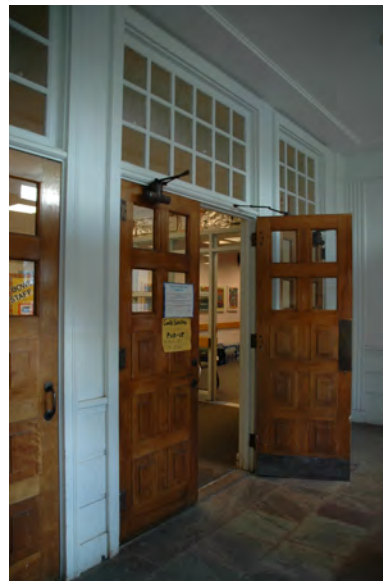
Figure 3 (center right): paneled doors with multi-pane transoms leading from main vestibule to lobby

- Investigate above the acoustic tile ceiling in the main lobby. The pilasters appear as though they may not be fully visible at the top. If possible, restore main lobby ceiling to full height.
- Repaint the stair treads and metal stair elements. Refinish the wood handrails.
- Refinish the wood doors. Prioritize the doors that have the most wear, such as at the front entry vestibule.

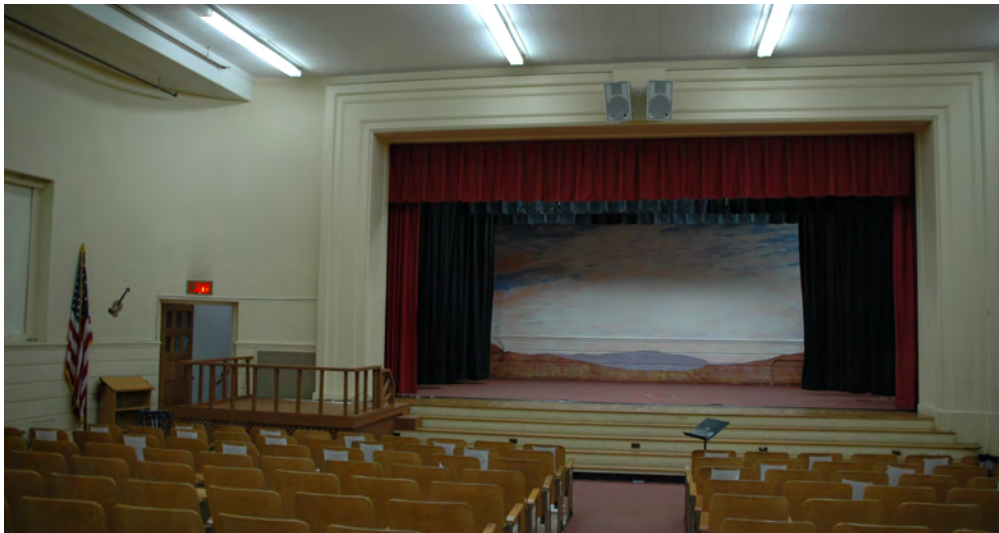
Figure 4 (bottom): auditorium

- Replace in kind the missing acoustic ceiling tiles in the auditorium.
- Sensitively design any code-required stair railing alterations to avoid negative impacts to the original design intent.
- Original floor tiles in many spaces may be vinyl asbestos. Most have been covered and encapsulated or replaced. Some are worn, including in the stair halls. Test floor tiles for asbestos. If positive, abate or encapsulate.
