**NEWTON PUBLIC BUILDINGS SURVEY
PHASE II – ANALYSIS OF HISTORICAL SIGNIFICANCE**

Building Analysis

Brigham House Community Center

Address: 20 Hartford Street
Year of Construction: 1883

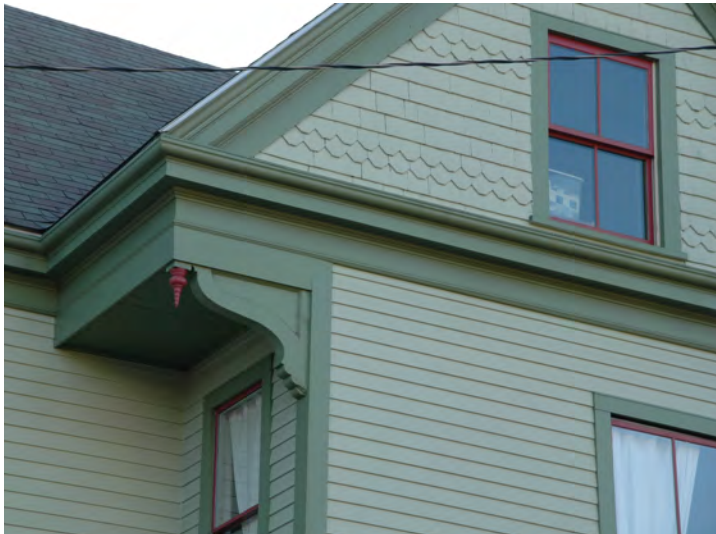
Figure 3: Decorative exterior details include brackets with finials, supporting the roof edges and patterned shingles at the gable ends.

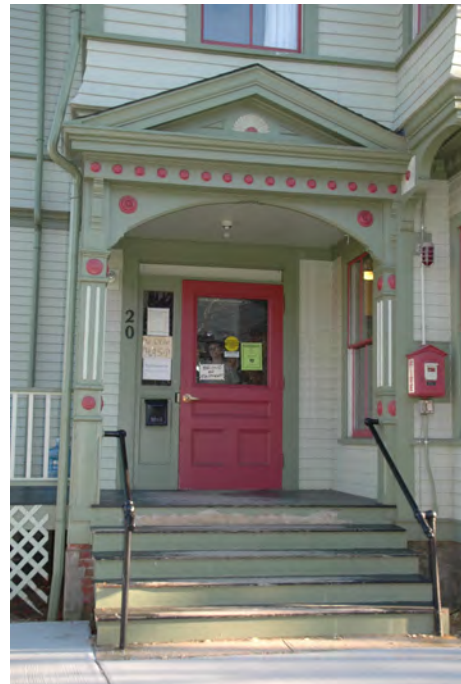
Figure 4: Ornamented front porch with a new accessible ramp added to side.

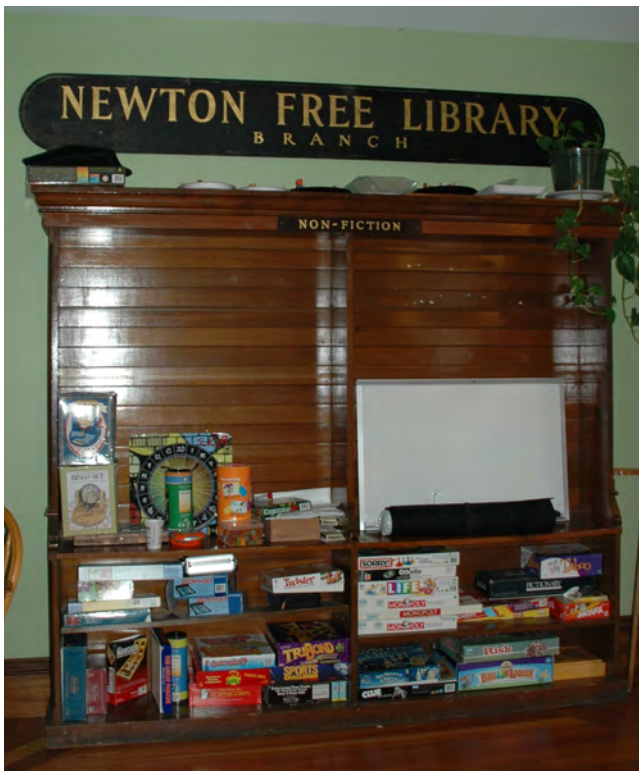
Figure 5: Vestiges of the house's years as a branch library still remain, such as this sign and bookcase.

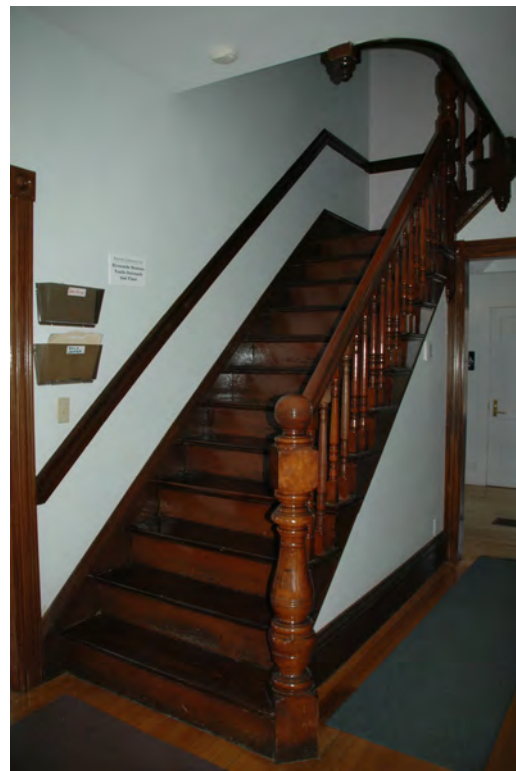
Figure 6: Original interior staircase in good condition.
