**NEWTON PUBLIC BUILDINGS SURVEY
PHASE II – ANALYSIS OF HISTORICAL SIGNIFICANCE**

Building Analysis

Burr Park Field House

Address: 142 Park Street
Year of Construction: 1919

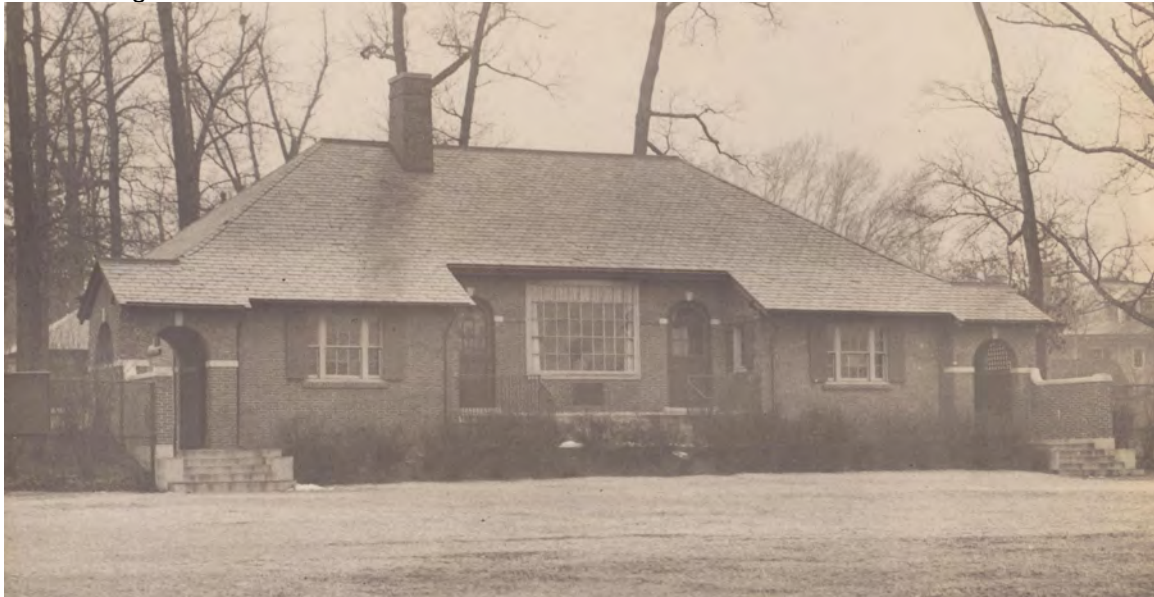
Figure 1: Photo of Field House, c. 1925. (Credit: Historic Newton)

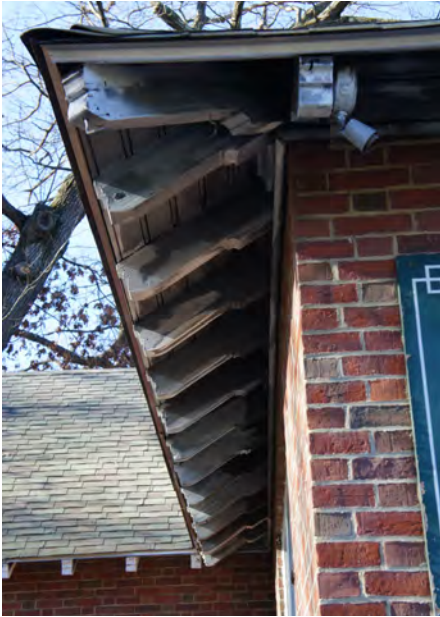
Figure 2: the prominent roof overhang with a wood fascia and beadboard sheathing is supported by rafter tails that wrap the corners of the roof.

- Repair the wood soffit and decorative brackets. Repairs include:
 - Complete removal of existing paint from wood surfaces. It is recommended that paint analysis be performed prior to stripping to identify historic paint colors.

- Installation of new wood dutchmen with profiles matching the existing wood elements at areas of severe deterioration. Replacement of wood elements in-kind at areas of deterioration that are not repairable.

- Consolidation at areas of less severely deteriorated wood.
 - Repainting wood surfaces.
- Repair or replace the concrete terrace walking surfaces and stairs.

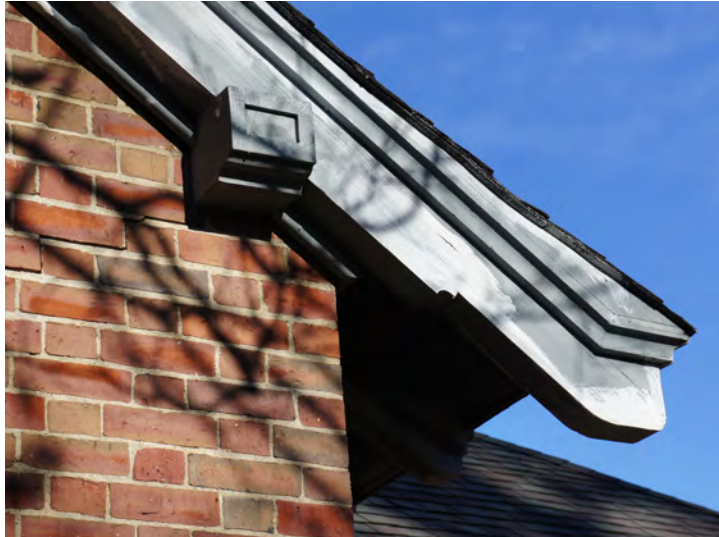
Figure 3: A false exposed purlin visually supports the gable ends.

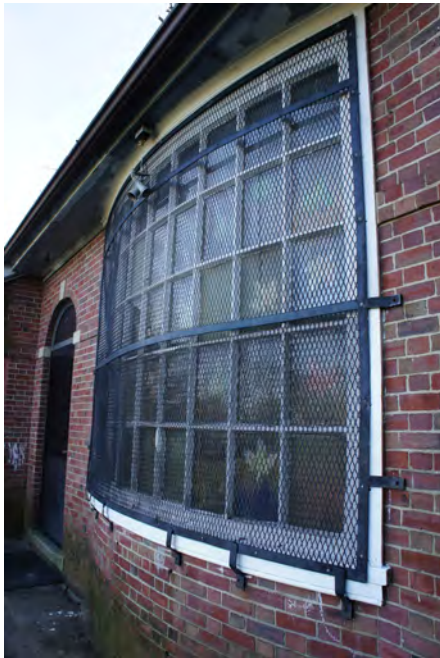
Figure 4: the original 45-pane wood bow Window at the center of the north façade is still intact, although covered with a metal grate.

- Clean and repoint the masonry 100%. Remove paint that has been applied over the brick at areas of graffiti.
- Remove extraneous ferrous elements from building exterior. Patch as required
- Conduct thorough survey of window conditions, including sash, frame, lintel and hardware. The original windows should be retained to the largest extent possible, repaired and made

weathertight. Replace damaged or missing wood elements in kind. Areas of minor deterioration should be repaired with dutchmen or through consolidation. Glazing putty will need to be replaced. The wood should be stripped and repainted in a color matching the original color. Windows that are too deteriorated to repair should be replaced in kind.

- Scrape and repaint the metal handrails at the stairs and upper terrace.
- Remove or scrape and repaint the metal grilles over the windows.
- Re-evaluate the lighting strategy at the building and how the electrical service is entering the structure. The way that the current light fixtures and electrical service box have been mounted to the building has damaged the decorative wood elements at the east elevation. Repair the damaged wood areas.
- Remove the unsightly chain link fence at the lower terrace and replace with a more historically appropriate railing.
- Consider replacing the missing wood window shutters.

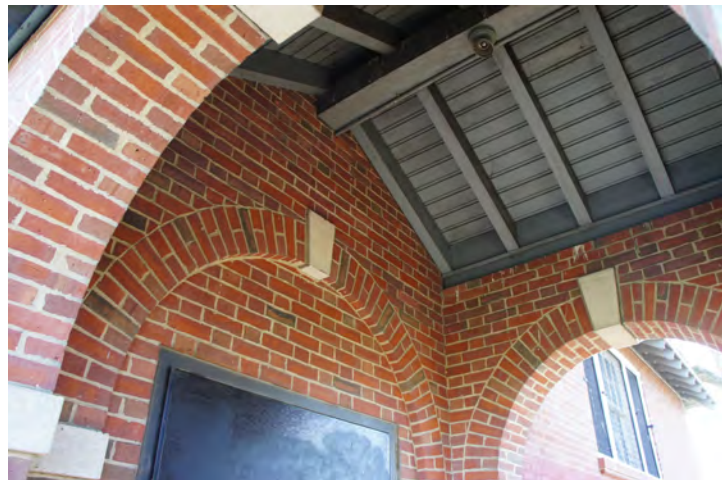
Figure 5: The rounded arch doorways with cast stone keystones and springline are also present within the pavilions. Note also the painted beadboard ceiling and rafters in the lower east corner.
