**NEWTON PUBLIC BUILDINGS SURVEY  
PHASE II – ANALYSIS OF HISTORICAL SIGNIFICANCE**

**Building Analysis**

**Cabot Park Field House**

Address: 101 East Side Parkway  
Year of Construction: 1926

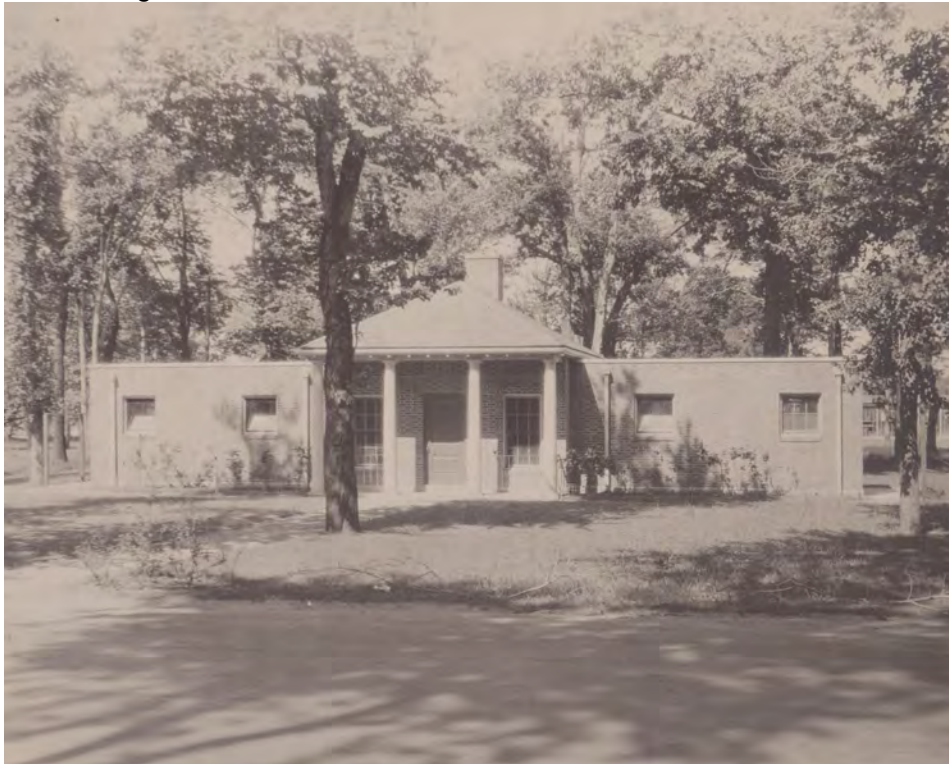
Figure 1: Photograph of the Fieldhouse in 1925 from the City of Newton records (Credit: Historic Newton).

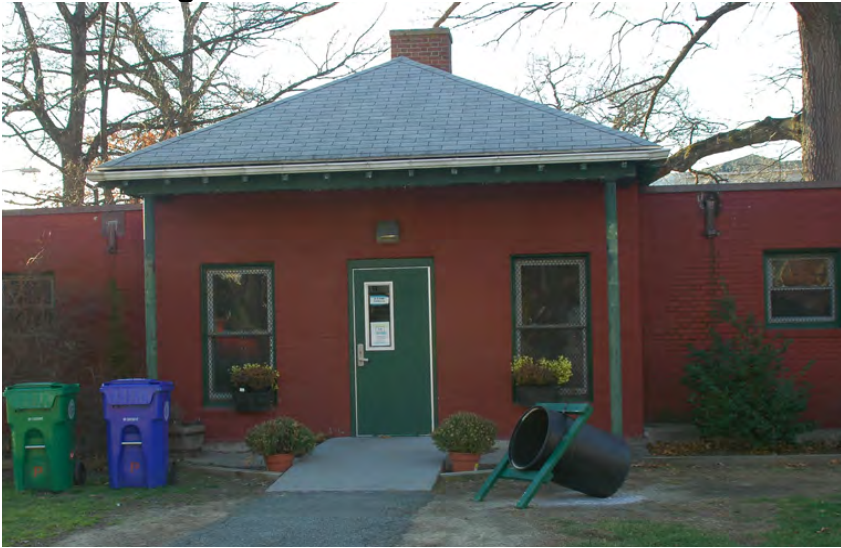
- The hipped roof overhangs the front and rear elevations of the building wall creating covered porches at both sides.
- The edge of the roof at both sides is currently supported by painted steel columns. Historic photos show that the edges of the roof were originally supported by four tapered columns with simple Doric capitals. The original columns were likely made of wood.

Figure 2: Close-up view of front entrance and porch.

- Consolidation at areas of less severely deteriorated wood.
  - Repainting wood surfaces.
- Scrape, prime and paint the steel columns supporting the hipped roof overhang.

- Replace the rubber roofs at the side wings, including replacement of the flashing and scuppers. If possible replace the aluminum coping cap with through-wall flashing below the original cast stone coping stones.
- Conduct a thorough survey of window conditions. Restore original wood casings where existing. As sashes are gradually replaced install more compatible wood or aluminum sashes.
- Consider stripping the paint from the brick surfaces and replacement of the front columns to columns that are more similar in appearance to the original columns.

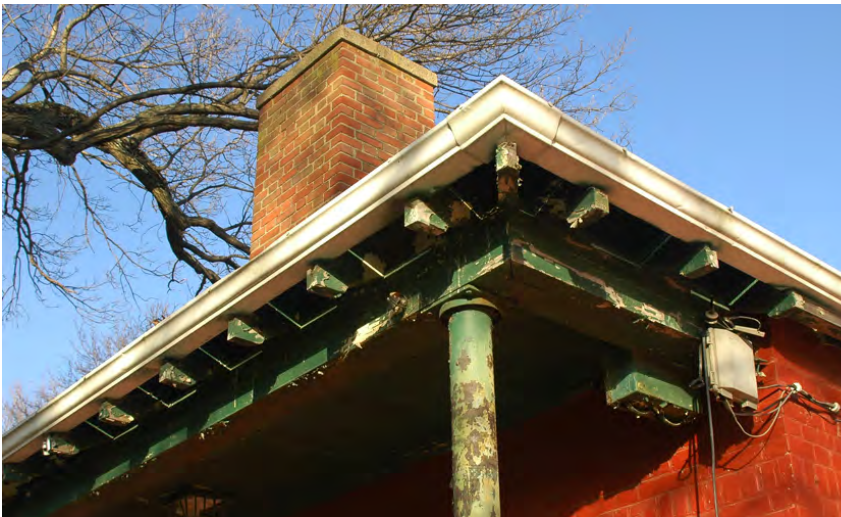
Figure 3: Exposed brackets below hipped roof at rear elevation.

- Repair rotted and deteriorated wood at hipped roof brackets. Repairs include:
  - Complete removal of existing paint from wood surfaces. It is recommended that paint analysis be performed prior to stripping to identify historic paint colors.

- Installation of new wood dutchmen with profiles matching the existing wood elements at areas of severe deterioration. Replacement of wood elements in-kind at areas of deterioration that are not repairable.

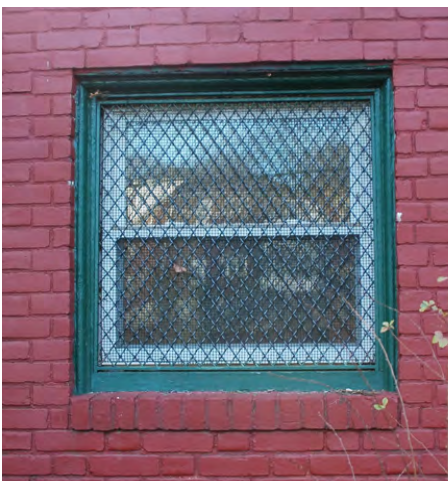
- Window openings at the side wings of the street elevation are shorter than those at the center bay. These window sashes have also been replaced with aluminum, but two of the four windows retain their original wood casings and frames.

Figure 4: Original wood casing at window opening.

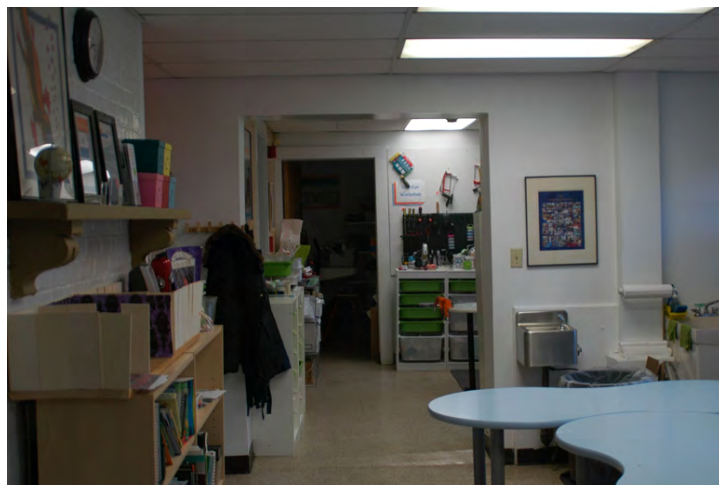
- The building has been extensively modified and few original interior features remain.  
Remaining features include
  - Painted brick at some remaining interior walls
  - A shelf with two heavy wood brackets that may be an original interior feature.

Figure 5: View of the interior space.

- Locate and repair source of water damage at interior.

- Investigate if additional historic features or materials are present below the existing contemporary finishes. As the space is renovated consider how these features can be retained or preserved.
