**NEWTON PUBLIC BUILDINGS SURVEY
PHASE II – ANALYSIS OF HISTORICAL SIGNIFICANCE**

Building Analysis

Cabot Elementary School

Address: 229 Cabot Street
Year of Construction: 1929

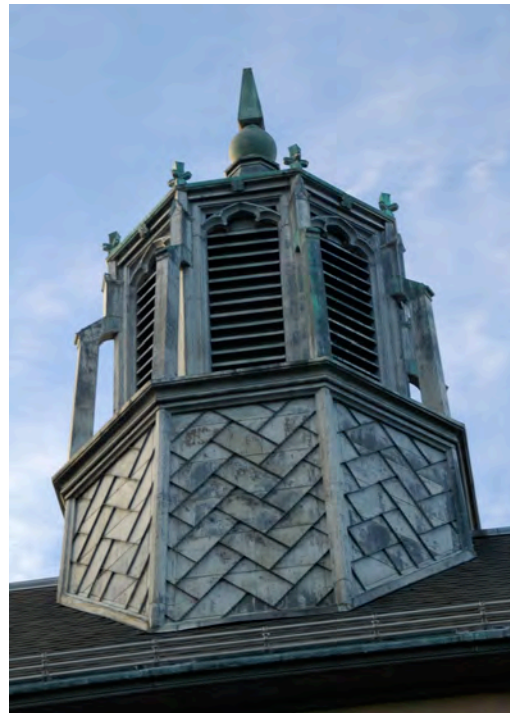
Figure 4: Close-up view of cupola.

- The roof and cupola were not accessible for the survey, and therefore only inspected where visible from ground. Inspect the full roof and repair as necessary.
