**NEWTON PUBLIC BUILDINGS SURVEY
PHASE II – ANALYSIS OF HISTORICAL SIGNIFICANCE**

Building Analysis

Carr School

Address: 255 Nevada Street
Year of Construction: 1934

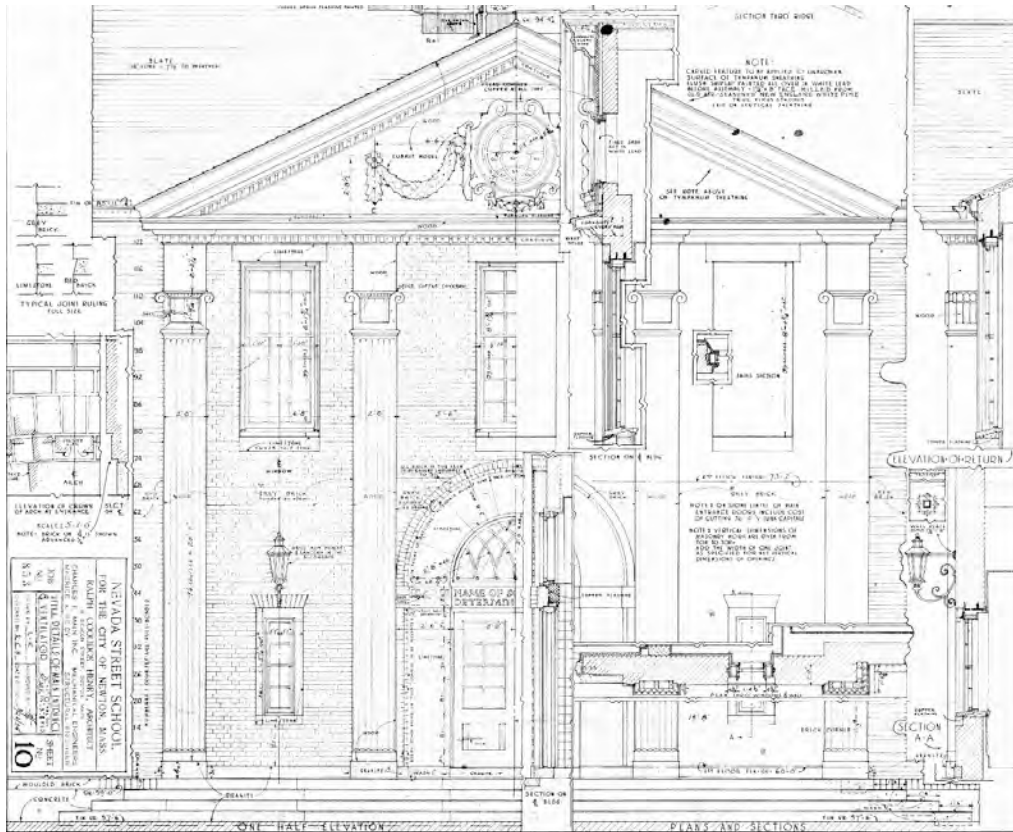
Figure 1: Excerpt from original 1934 construction drawings with a detail of the entrance pavilion. Note the wood carving at the pediment that was never constructed. The drawings specify that the pilasters should be constructed from wood. It is unclear why they were eventually made from cast stone (Credit: Newton Public Buildings Department).

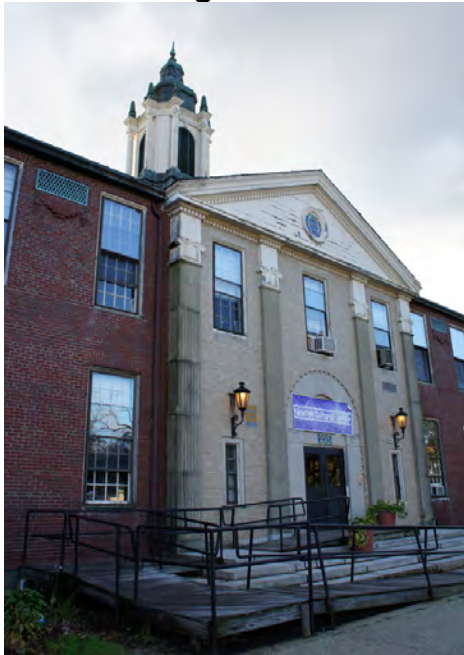
Figure 3: Central entrance bay with its mix of masonry and wood elements.

- In addition to the windows address rotted and damaged wood elements at the cupola, pediment and column capitals at the main entrance, fascia, and rounded bay window at the south wall. Repairs include:

- Complete removal of existing paint from wood surfaces. It is recommended that paint analysis be performed prior to stripping to identify historic paint colors.

- Installation of new wood dutchmen with profiles matching the existing wood elements at areas of severe deterioration. Replacement of wood elements in-kind at areas of deterioration that are not repairable.

- Consolidation at areas of less severely deteriorated wood.
 - Repainting wood surfaces.
- Repair the concrete supports at the steps and landings at all entrances. This will require the removal of the granite units at the steps and landings, which should be reset on the new supports. All abandoned railing ends should be removed from the stone and the holes patched. Original railings should be removed, scraped free of rust, repainted and reinstalled. If modifications need to be made to the stairs and landings for code reasons as much of the original granite and iron elements should be retained as possible. Added elements should be of compatible materials and harmonious with the original design.

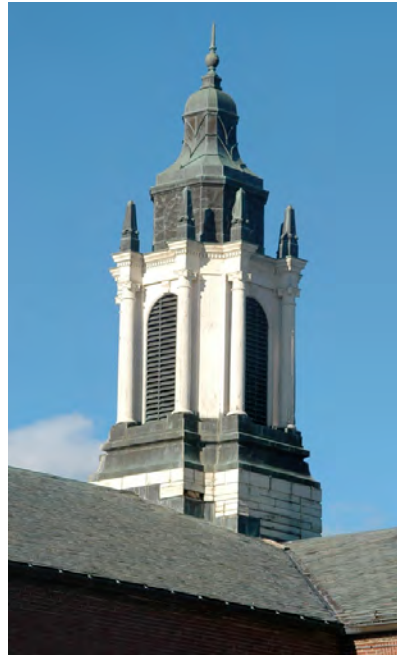
Figure 4: Close up of cupola.

- Repairs to copper elements at cupola.
- Conduct thorough survey of window condition, including sash, frame, lintel and hardware. The existing windows, including the decorative transom over the main entrance and the ocular window in the pediment, should be retained to the largest extent possible, repaired and made weathertight. Deteriorated elements such as the sills should be replaced in kind and areas of minor deterioration should be repaired with dutchmen or through consolidation. Glazing putty will need to be replaced. The wood should be stripped and repainted in a color matching the original color. Windows that are too deteriorated to repair should be replaced in kind.

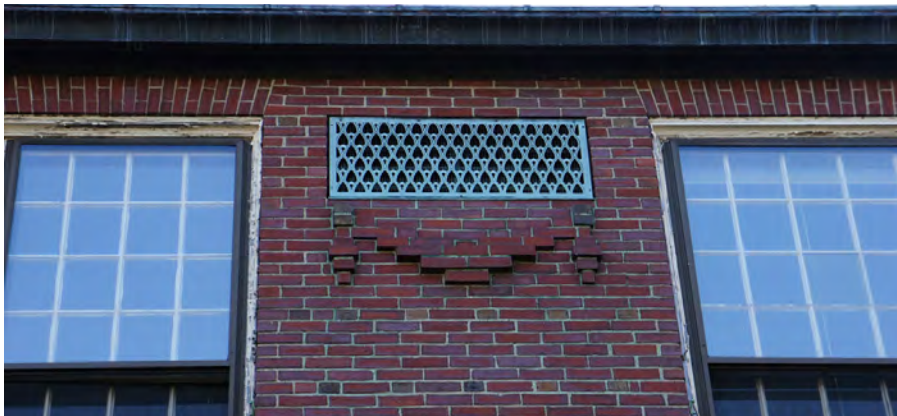
Figure 5: Grille and associated brick swag detail.

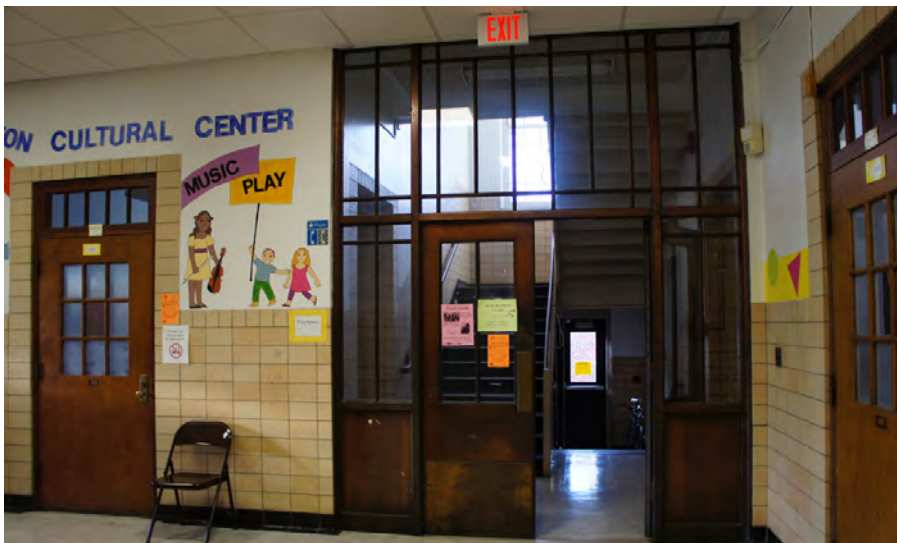
Figure 6: Metal clad partition and doors between first floor corridor and stairwell.

- Replace the glazing putty at the metal clad partitions and doors at each stairwell.
- Replace the glazing putty at the wood classroom and office doors.
- As part of the restoration of the auditorium space the wood elements should be stripped and repainted. It is recommended that paint analysis be performed prior to paint removal to determine the historic colors used in the space. The acoustic tile at the field of the ceiling should be removed and the plaster repaired. The existing floor should be refinished.
