**NEWTON PUBLIC BUILDINGS SURVEY
PHASE II – ANALYSIS OF HISTORICAL SIGNIFICANCE**

Crystal Lake Bath House

Address: 44 Rogers Street
Year of Construction: 1930

Phase II: Analysis of Historically Significant City Buildings, Newton, Massachusetts
Crystal Lake Bath House
DRAFT 3/30/2012

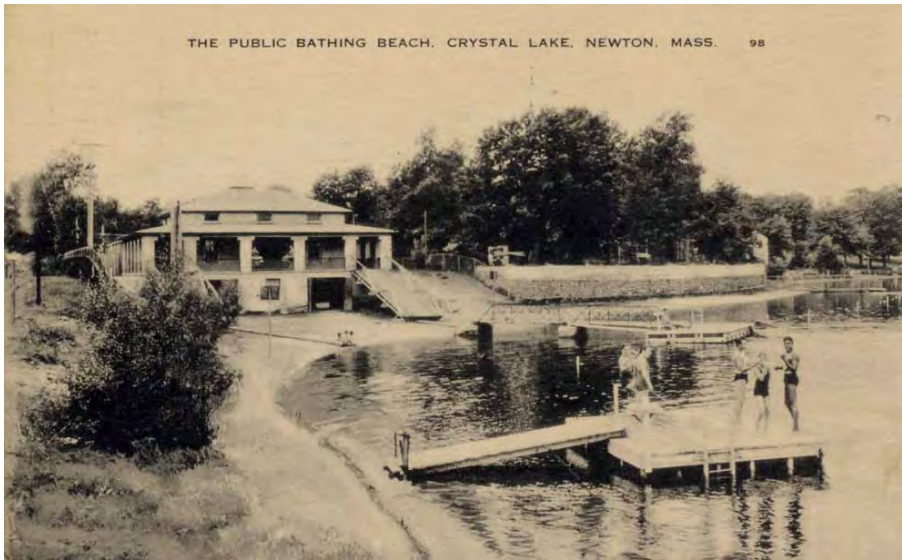
Figure 1: postcard from the 1940s. (Credit: Misspreservation.com)

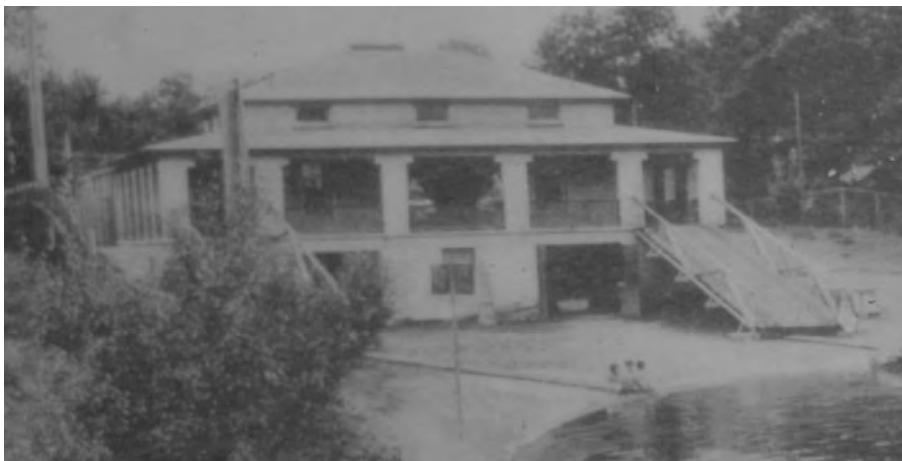
Figure 2: postcard detail. Note the ramps at the north and south porch bays.

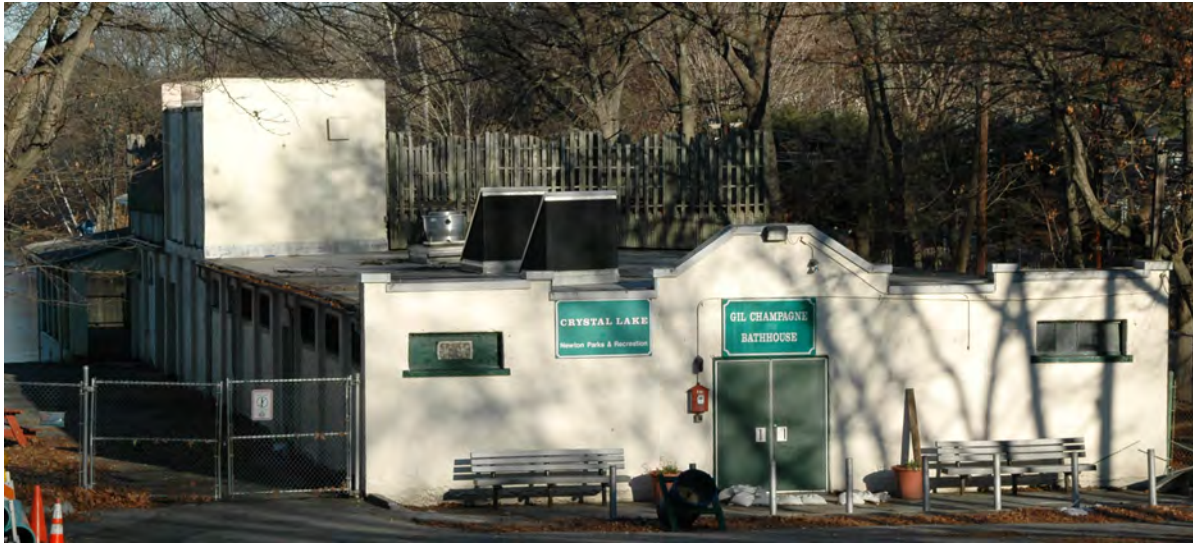
Figure 3 (top): view of the Bath House from the west.

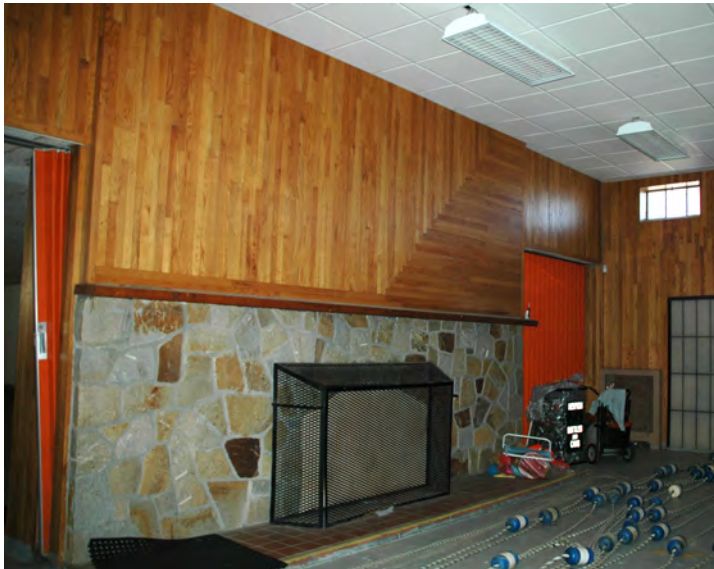
Figure 4 (left center): the interior of the main building has been finished with a stone fireplace and wood wall surfaces

- Clean the soot staining on the stone fireplace surround directly above fireplace
- Clean the smudged wall paint off the wood panel walls.
- Repaint the interior walls.
- Refinish the wood counter in rear extension, east end.
