**NEWTON PUBLIC BUILDINGS SURVEY
PHASE II – ANALYSIS OF HISTORICAL SIGNIFICANCE**

Building Analysis

Education Center

Address: 100 Walnut Street
Year of Construction: 1921

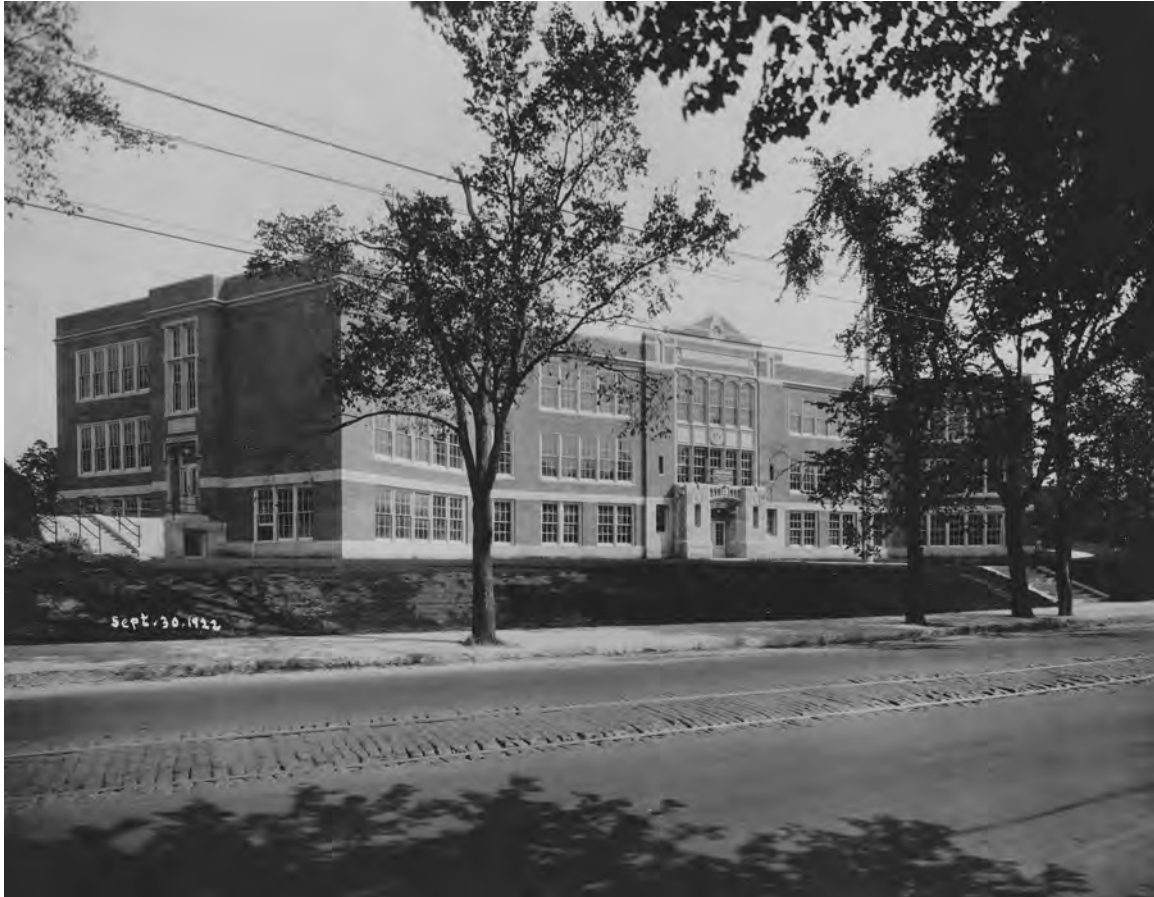
Figure 1: Image from 1925. Note pediment above entry bay. (Credit: Historic Newton)

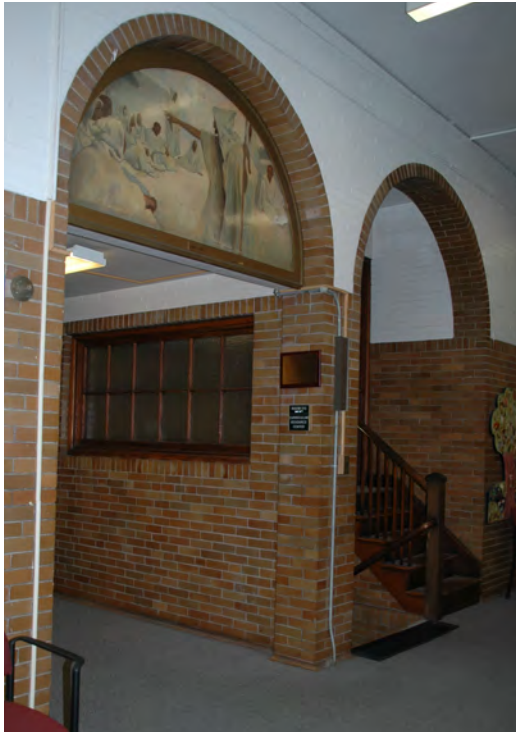
Figure 2: one of two murals within the arches above doorways. This one was given by the Class of 1923.

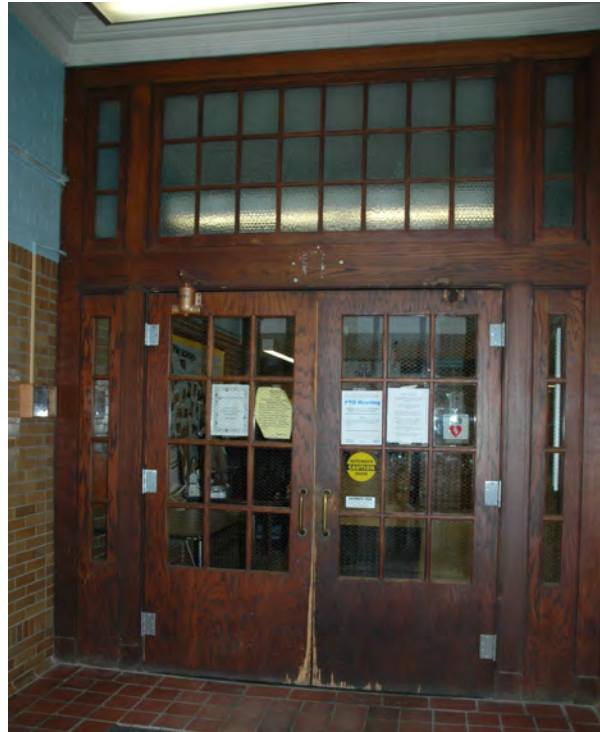
Figure 3: like many of Newton's school buildings of this era, the stairs are separated from the corridors with double doors, sidelights and transom panels.

- Stair treads and landings appear to have had an applied coating; coating is very scratched and worn. Clean, apply finish coating.
- Railings are generally in good condition. Repaint metal stair elements. Clean and refinish wood handrails.
- Some of the doors, including those between the stairs and corridors, are worn. Repair and refinish.

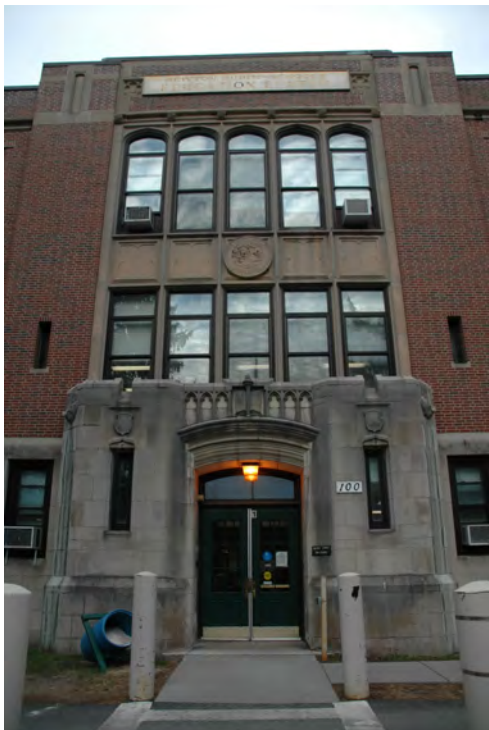
Figure 4: the articulated main entrance bay. Note that the pediment has been removed. Compare with historic photo in Figure 1.

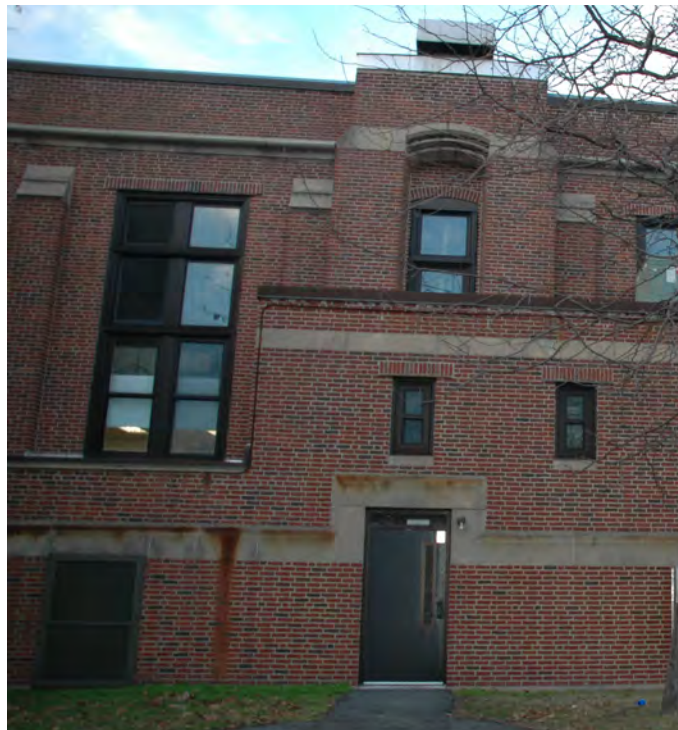
Figure 5: the north (shown) and south sides of the 1934 rear wing are articulated with tall windows between buttresses and a doorway above a lower volume.
