**NEWTON PUBLIC BUILDINGS SURVEY
PHASE II – ANALYSIS OF HISTORICAL SIGNIFICANCE**

Building Analysis

Fire Department Headquarters

Address: 1164 Centre Street
Year of Construction: 1928

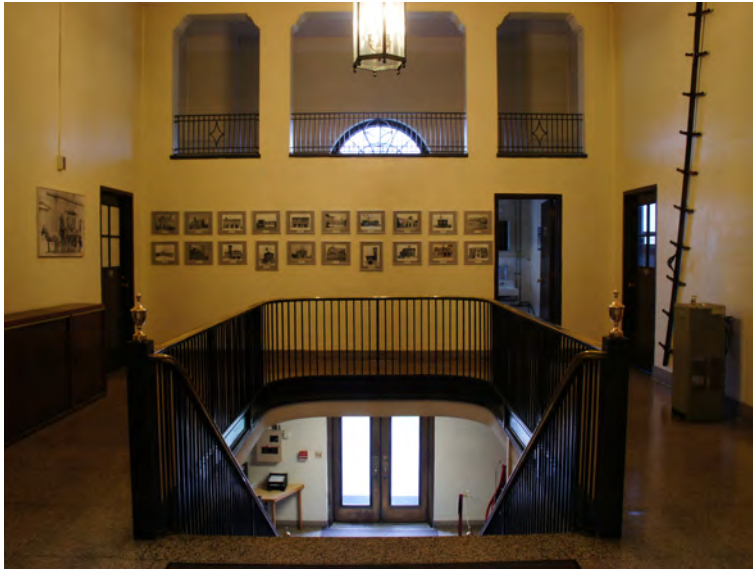
- With the exception of the paint on the walls and the finish on the railings, most original features appear to be intact.
- The floor is terrazzo with an integral base.
- The walls are textured to mimic travertine blocks. They are currently painted but the texture shows through.
- Three openings high up on the west wall have thin sills and decoratively shaped top corners. Metal railings with vertical balusters and spare ornamentation span all three openings.
- A guard rail of painted metal vertical balusters and polished brass handrail protects the opening to the monumental stair.
- The other doors have 4 glass lights. All appear to be original.
- The six-sided glass ceiling-mounted light fixture centered over the monumental stairs appears to be original.

Figure 3: second floor stair hall. Compare with the historic photo in figure 1.

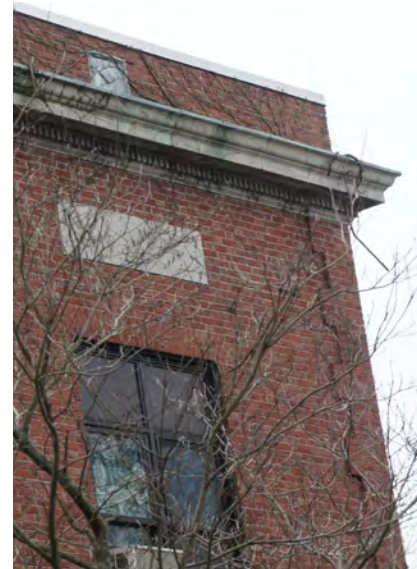
Figure 4: typical window with cast stone panel above. Note the brick quoins at the corner and the small cast stone panel within the parapet.

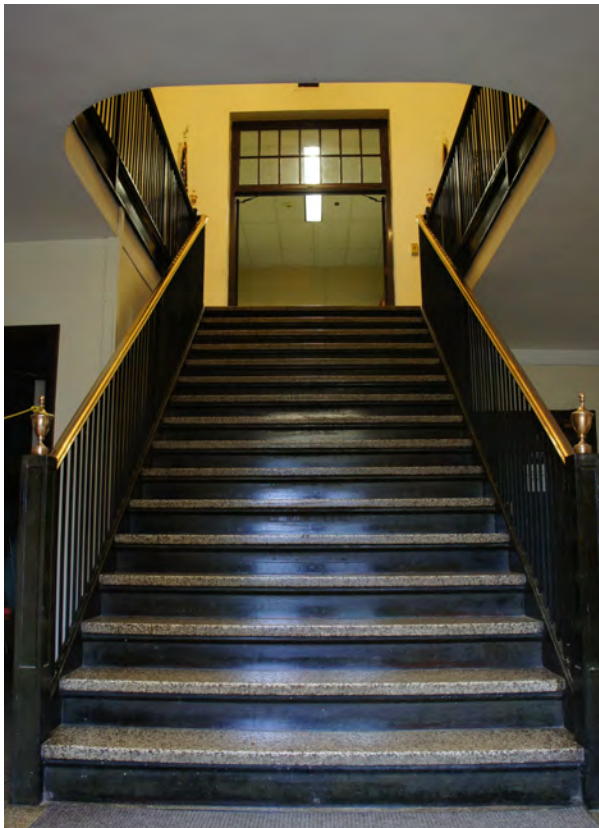
- The floor is terrazzo with an integral base.
- The ceiling is painted plaster.
- The walls are textured to mimic travertine blocks. They are currently painted but the texture shows through.
- A monumental stair to second floor is prominently centered in the space. It is a metal pan stair with terrazzo treads. The handrail and finials at the newels are polished brass; the remainder of the metal is painted black. Historic photos indicate it may not have always been painted.
- A historic fire sleigh is on display next to the stair.

Figure 5: first floor stair hall.

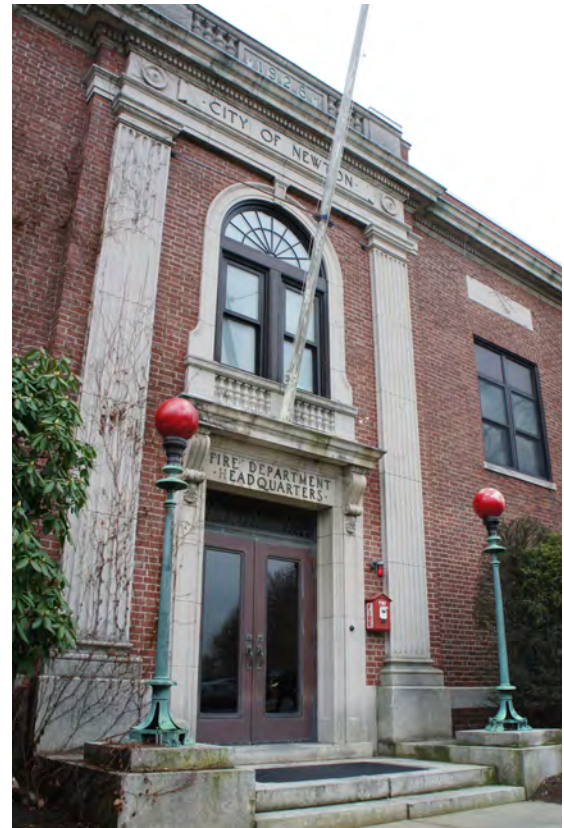
Figure 6: main entrance at west elevation.
