**NEWTON PUBLIC BUILDINGS SURVEY  
PHASE II – ANALYSIS OF HISTORICAL SIGNIFICANCE**

**Franklin Elementary School**

Address: 125 Derby Street  
Year of Construction: 1938

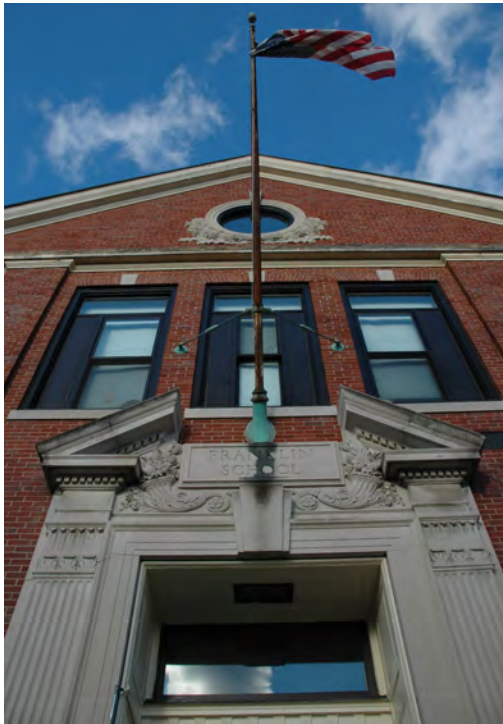
Figure 1: front entry characterized by the door surround, flagpole, and decorative circular window centered within the pediment.

- Monitor spalled limestone at base of front door surround. Use non-salt deicer to prevent further damage.
- Maintain all gutters, leaders and drains to keep clog-free.
- West elevation basement stair is protected by non-contributing but non-obtrusive corrugated metal roof. Maintain good condition.
- Continue regular maintenance of character-defining features.

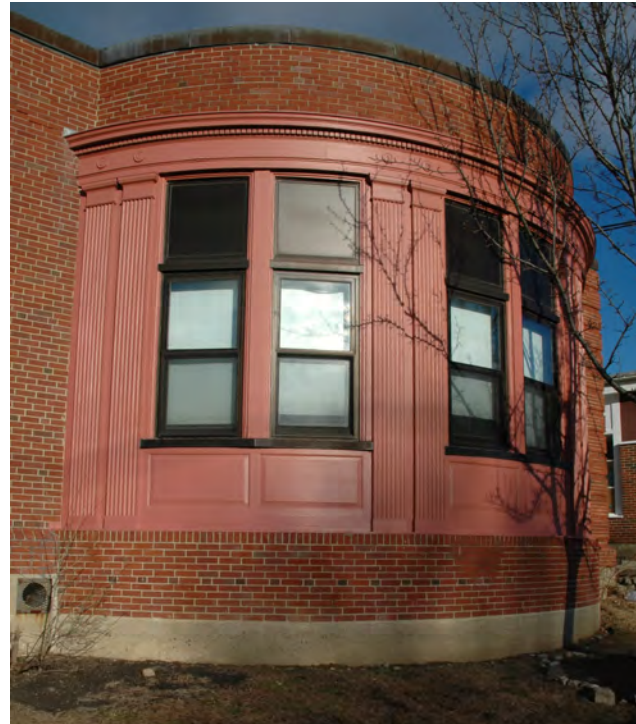
Figure 2: the bowed, single-story front projection with wood detailing is distinctive to this school

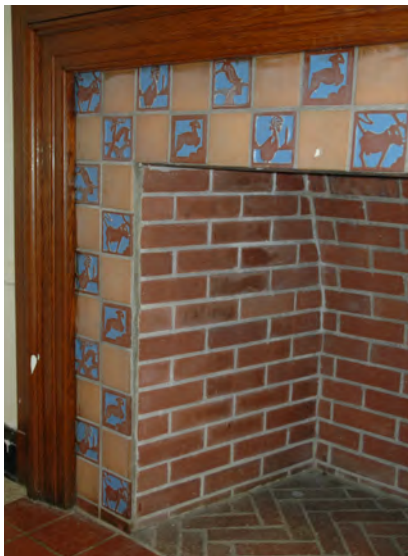
Figure 3: decorative fireplace on the first floor is characterized by the animal print ceramic tiles on the surround.

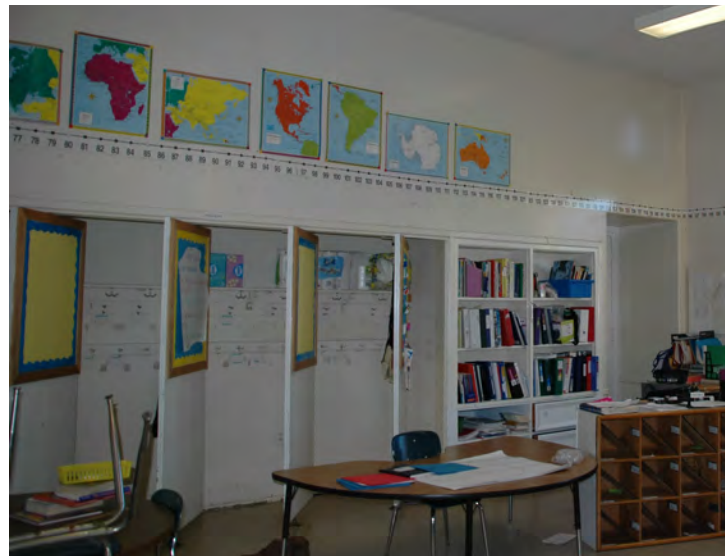
Figure 4: original set of pivot doors at a wide, shallow coat closet, typical in each classroom. The doors have been removed from many classrooms, but in many cases the hardware remains.

- Refinish the wood stairs and stage floor; the proscenium and paneled wainscot appear to be in good condition.
- Survey the built-in cabinets in classrooms. Repair and restore as required.
- Inventory the sets of pivoting closet doors in the classrooms. Repair and restore as required extant doors and hardware to good working order.
- Clean glazed tile walls at interior wall surfaces.
- Analyze paint to determine original paint colors, especially where currently painted light blue. Restore original paint schemes at next repainting.
