**NEWTON PUBLIC BUILDINGS SURVEY
PHASE II – ANALYSIS OF HISTORICAL SIGNIFICANCE**

Building Analysis

Jackson Homestead

Address: 527 Washington Street

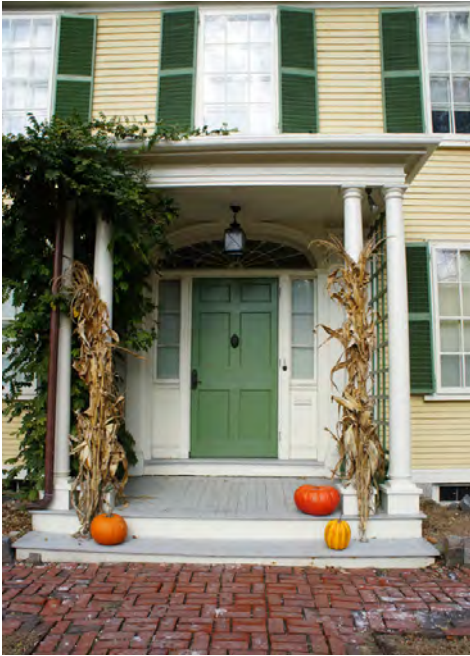
Figure 3: Main entrance door with Federal Style surround and porch.

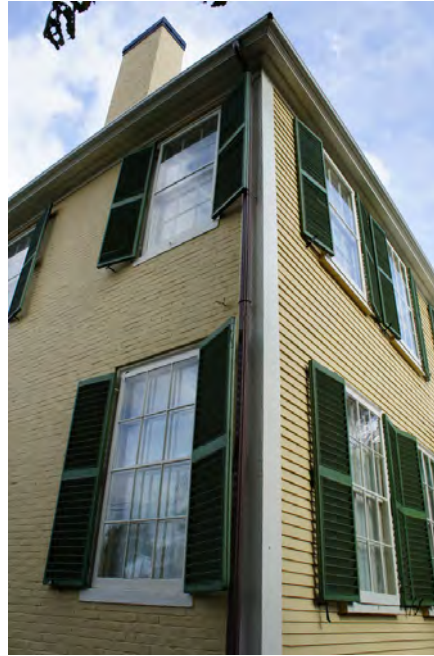
Figure 4: Transition from wood clapboard to brick at the southwest corner of building.

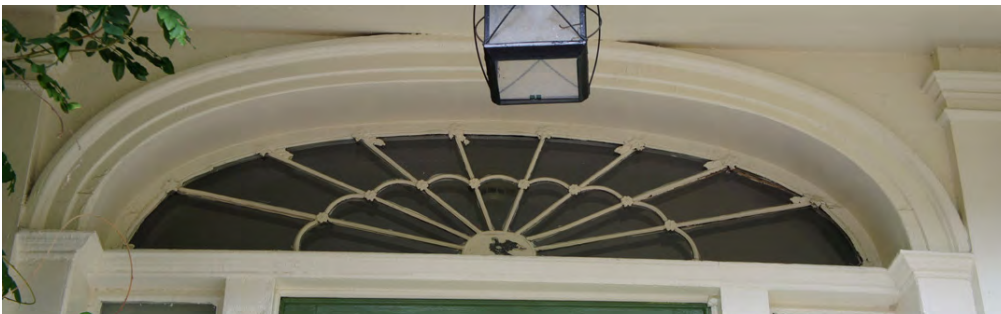
Figure 5: Detail of elliptical fanlight.

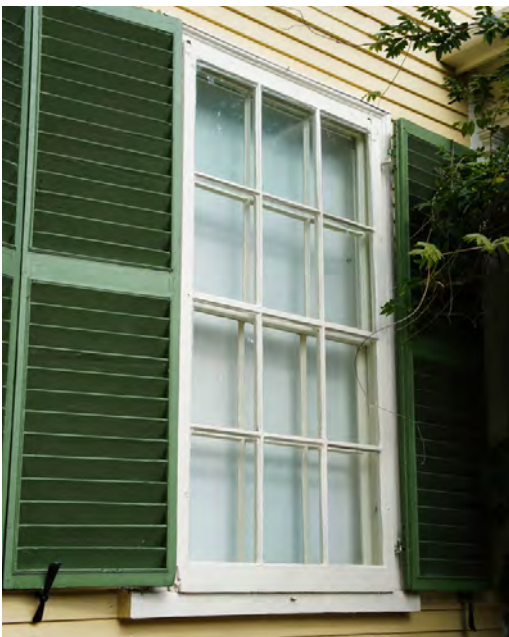
Figure 6: Window with exterior storm.

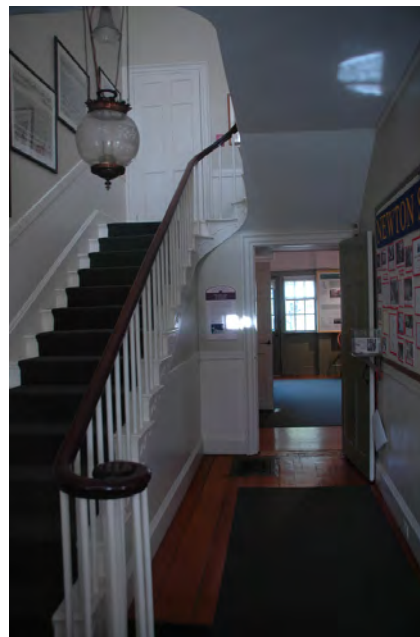
Figure 7: Interior stair hall.
