**NEWTON PUBLIC BUILDINGS SURVEY
PHASE II – ANALYSIS OF HISTORICAL SIGNIFICANCE**

Building Analysis

Jeannette Curtis West Recreation Center

Address: 69 Tyler Terrace
Year of Construction: 1892

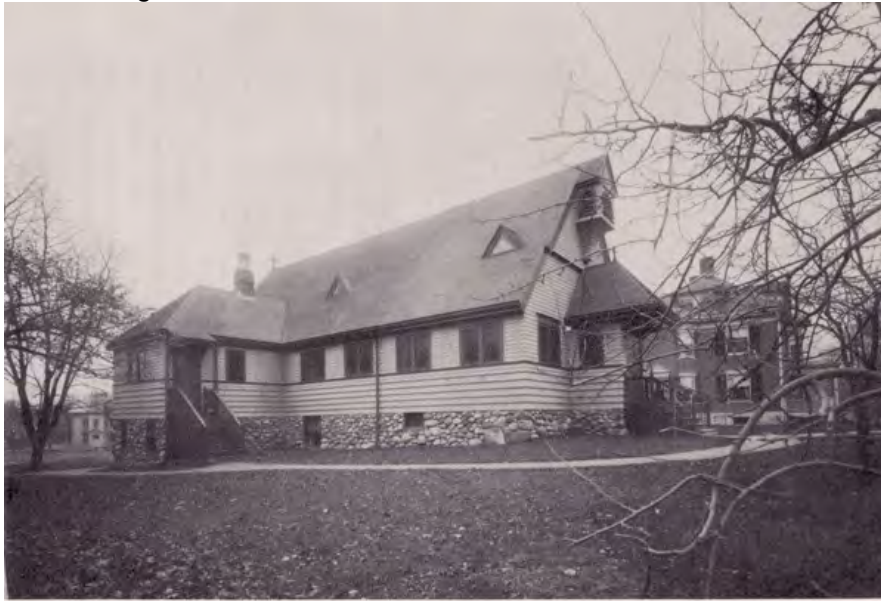
THE FIRST CHURCH BUILDING (1893-1916)

Figure 1: Image from 1916. Old Trinity Episcopal Church, prior to being relocated. (Credit: Historic Newton)

- Replace wood porch at west entry with more historically appropriate, code-compliant porch. Refer to stairs in 1916 image, or coordinate with wrap-around porch in 1915 plan.

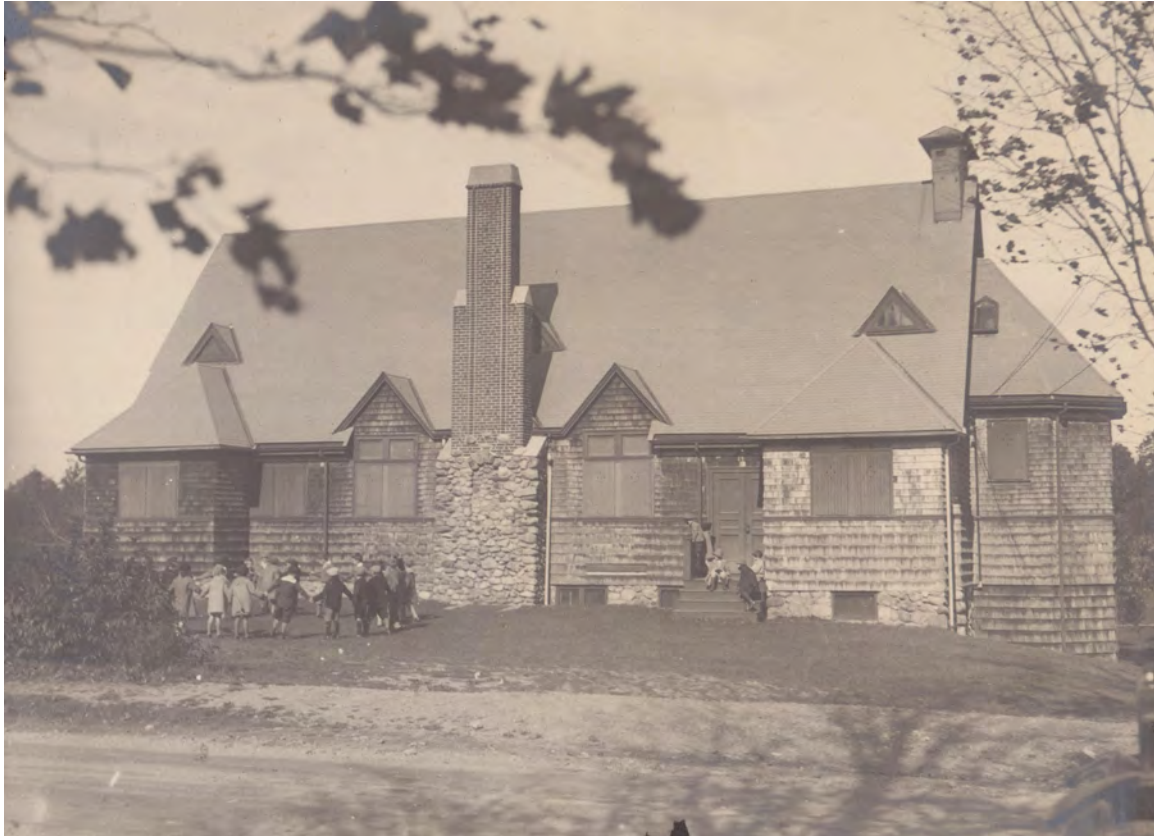
Figure 2: Image from 1925. Note the shingles, which appear to have been unpainted, and the no longer extant dormers. (Credit: Historic Newton)

- Reconstruct missing triangular dormers and projection at the top of the west gable, to match original. Coordinate with HVAC strategy, not in the scope of this survey.

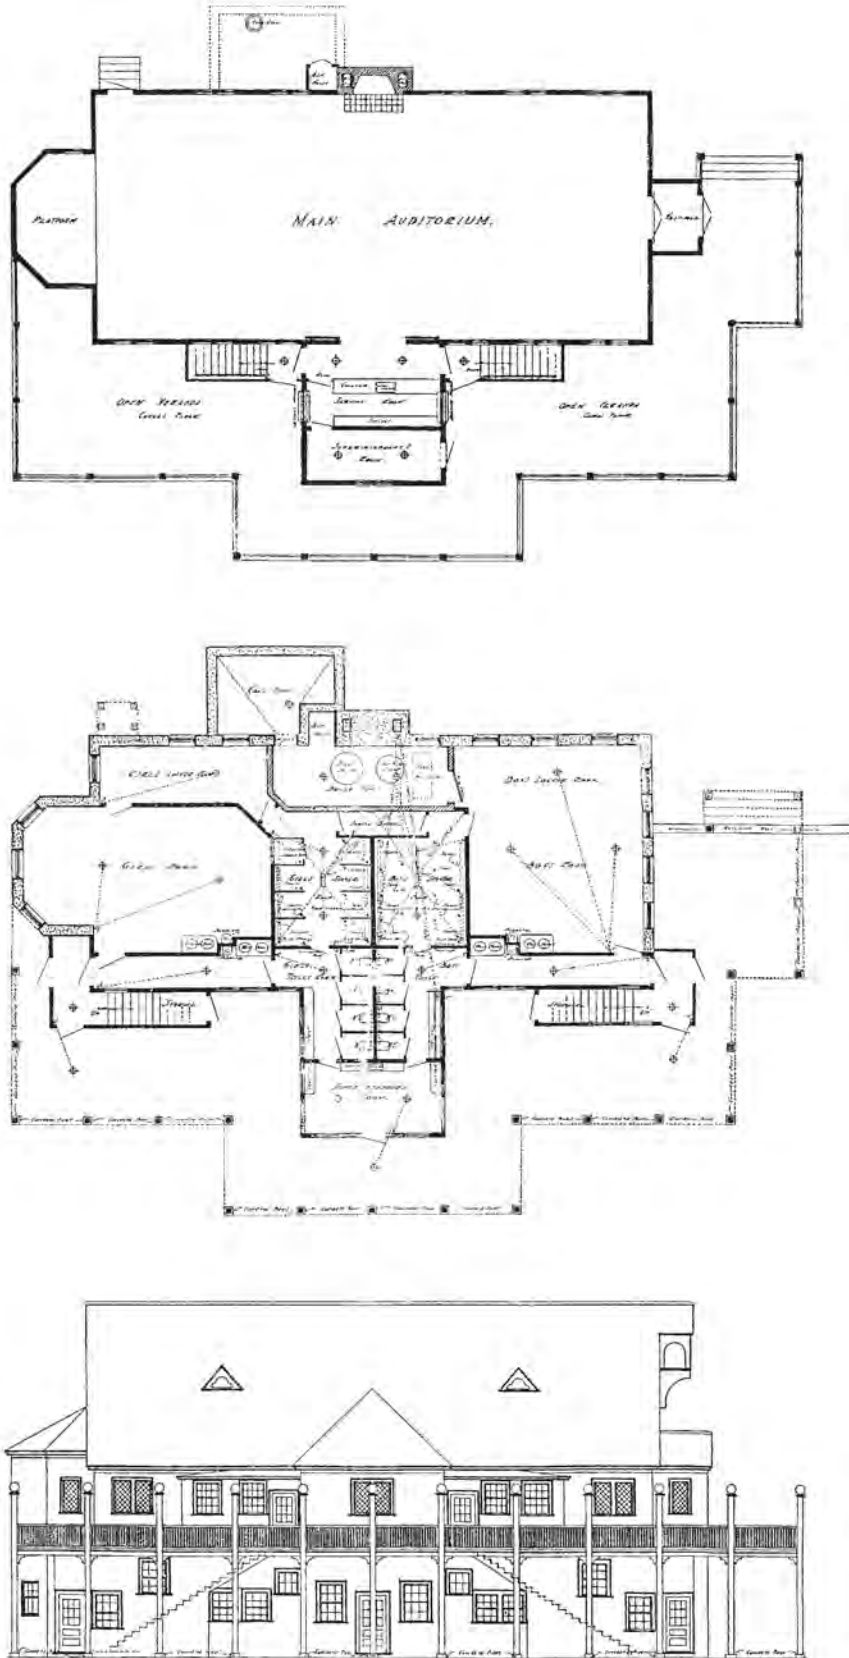
Figure 3: 1915 drawings for the proposed design of recreation center. Top: Floor Plan for upper level. Center: Floor Plan for lower level. Bottom: Playground-side elevation. It is unclear whether the shown alterations were ever constructed. (Credit: Newton Historical Society)

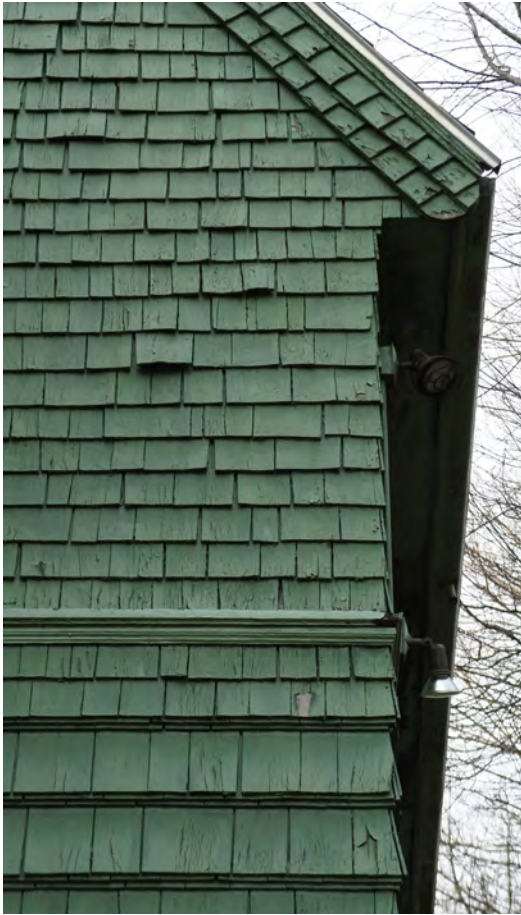
Figure 4: the shingle detailing was well-considered to create different effects at different parts of the building.

- Replace all missing, severely deteriorated, and poorly matched replacement wood elements. Repair components as necessary. Includes eaves, gutters, shingle siding and belt course between shingle coursing types. Retain historic size, spacing and detailing. Paint all wood elements.

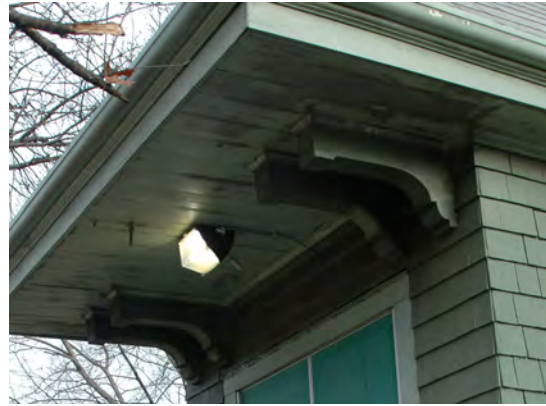
Figure 5: ornamental wood brackets at the west entry vestibule

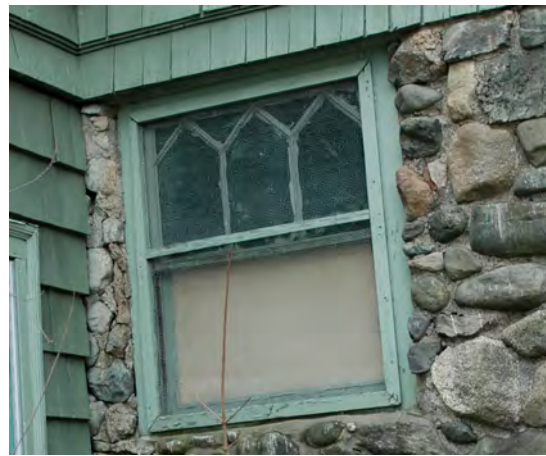
Figure 6: original windows with ornamental muntins still extant at lower level

- Restore original wood windows with ornamental muntin patterns. Reglaze, repaint.
- window directly to east of north door missing a muntin. Repair.
- Check all wood shutters for operability. Repair wood shutters at main level, including missing elements at the north side. Replace missing shutter dogs.

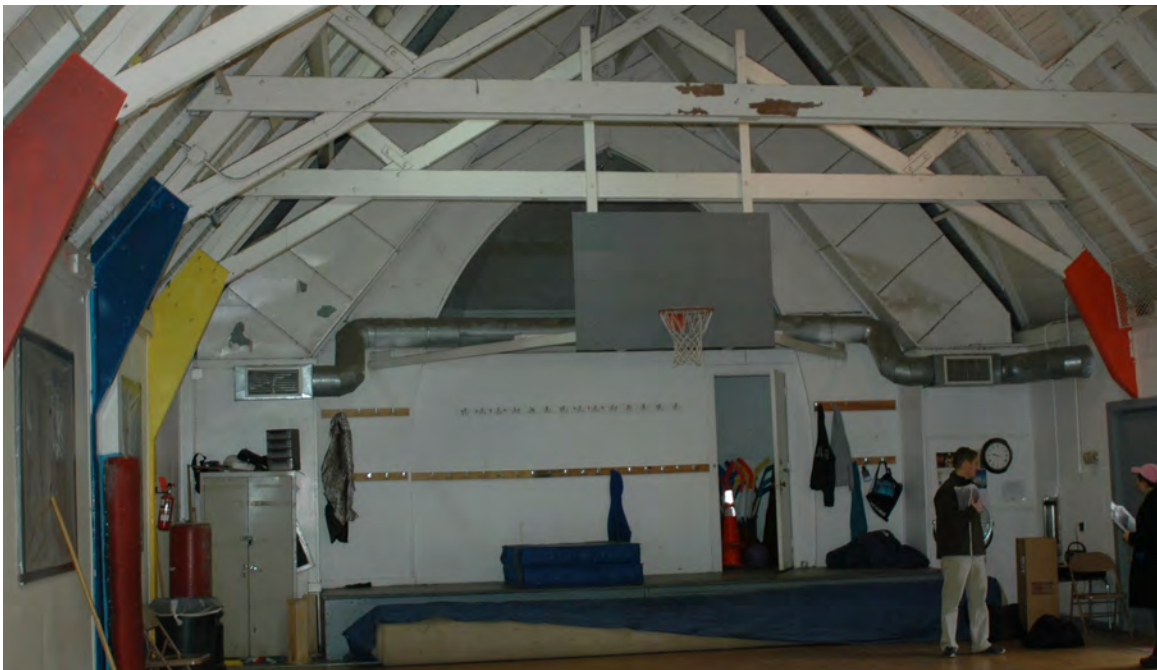
Figure 7: although now used as a gymnasium, vestiges of the original chapel can still be seen, including the open trusses, high ceiling, and the pointed arched opening at the apse.

- Large air ducts at east side of main space are very prominent; compromises use of stage/apse. Reevaluate HVAC strategy to improve appearance and use of main space. Coordinate with window repair and dormer replacement.
- Locations of missing dormers are visible in the roof framing. Their replication could assist in daylighting or ventilation. Coordinate with daylighting and ventilation strategies.

- Repaint ceiling, trusses, walls.
- Repair and repaint peeling plaster at apse and at stairs to lower level. Investigate roof for possible leaks.
- Refinish the partially painted handrail at stairs.
