**NEWTON PUBLIC BUILDINGS SURVEY
PHASE II – ANALYSIS OF HISTORICAL SIGNIFICANCE**

Kennard Estate

Address: 246 Dudley Road
Year of Construction: 1907

Recommended Treatment Level: Rehabilitation

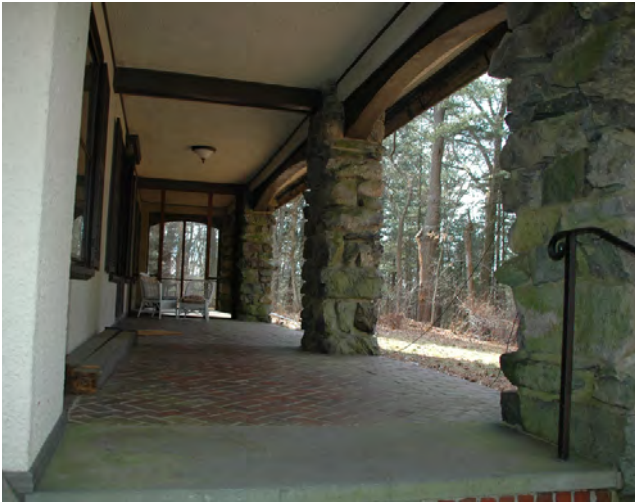
Figure 3: Main exterior porch at west elevation. Note stone columns and wood beams.

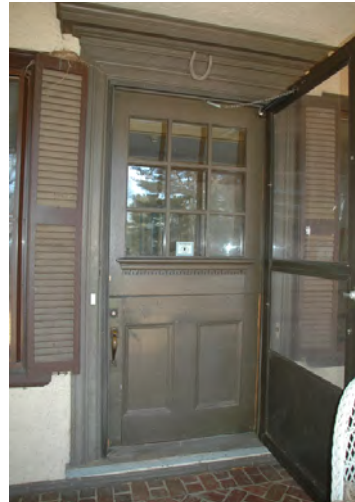
Figure 4: Exterior wood door with original hardware.

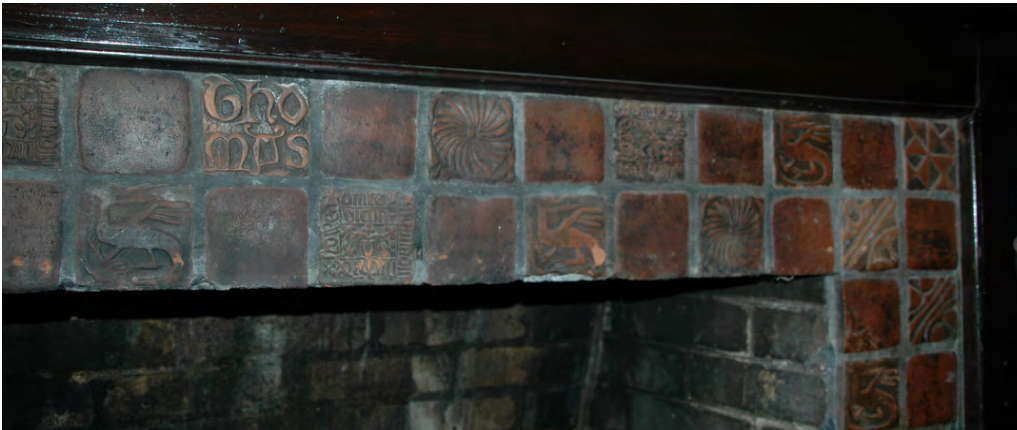
Figure 5: Decorative tile work at library fireplace.

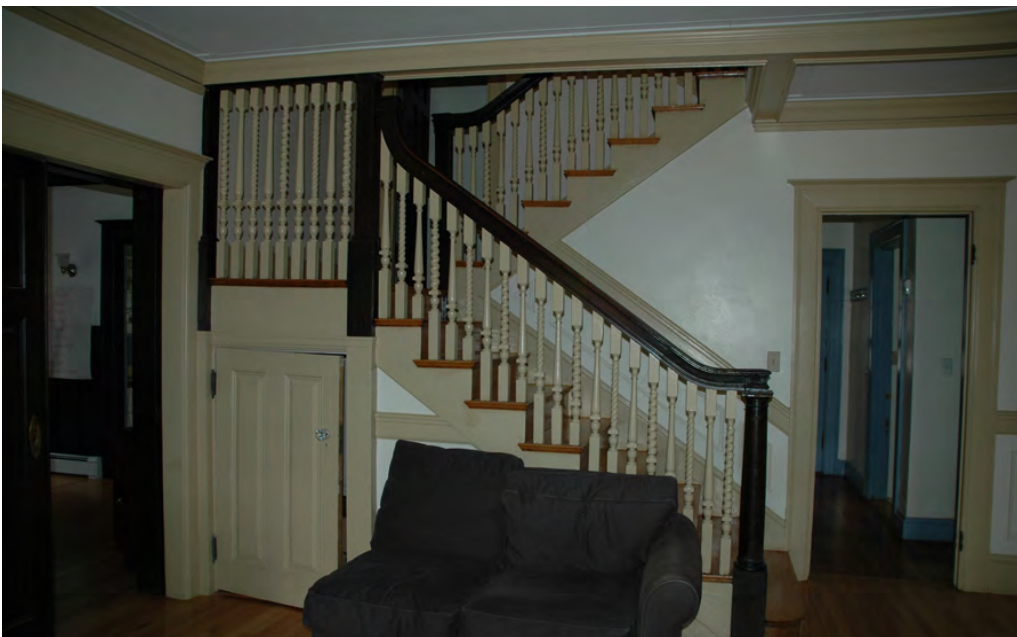
Figure 6: Main staircase and entrance hall.
