**NEWTON PUBLIC BUILDINGS SURVEY
PHASE II – ANALYSIS OF HISTORICAL SIGNIFICANCE**

Building Analysis

Nonantum Library

Address: 144 Bridge Street
Year of Construction: 1957

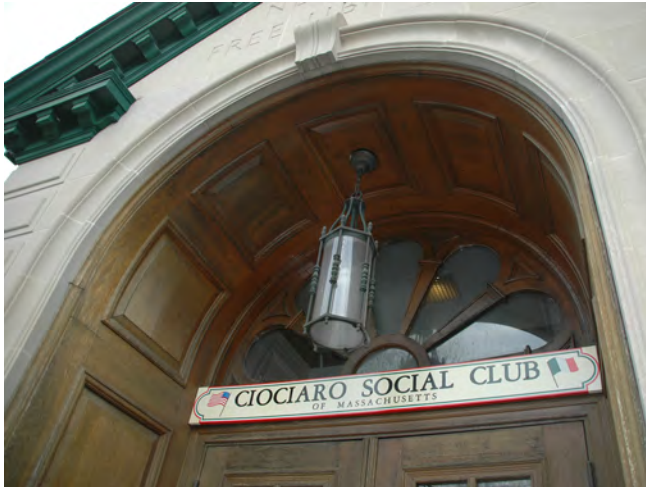
Figure 3: detail of the front entrance

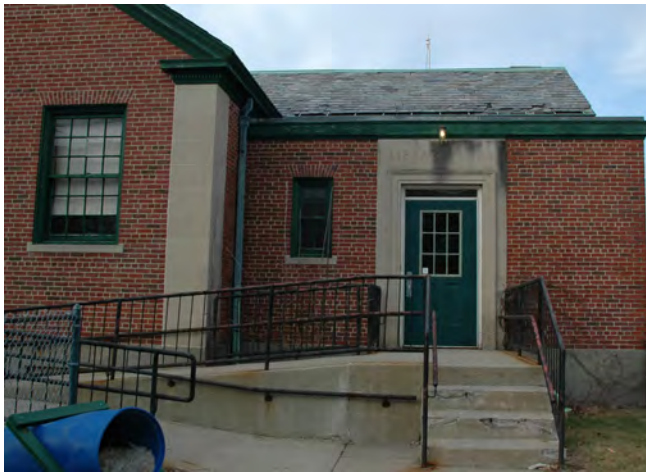
Figure 4: the side entry echoes the front in materials, but is appropriately less prominent in detailing.

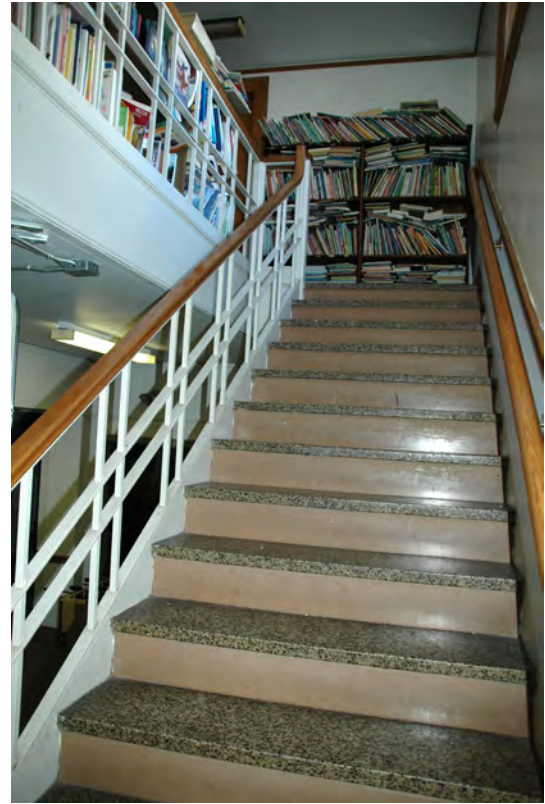
Figure 5: the stairs are carefully designed as an understated yet important design element.

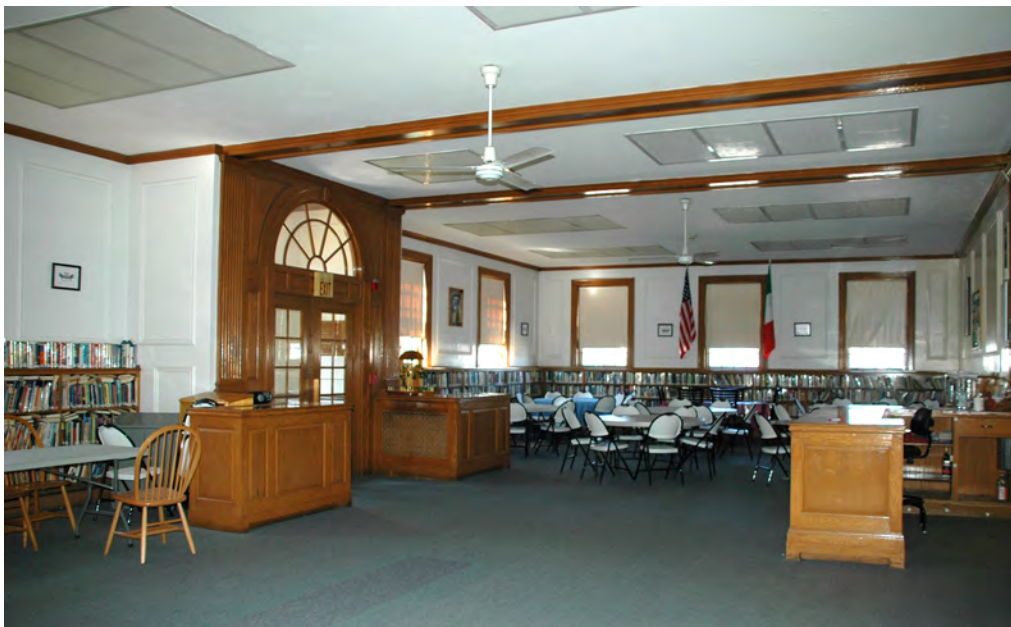
Figure 6: the main reading room retains its character while functioning well as a general purpose gathering space.
