**NEWTON PUBLIC BUILDINGS SURVEY  
PHASE II – ANALYSIS OF HISTORICAL SIGNIFICANCE**

**Building Analysis**

**Police Annex**

Address: 25 Chestnut Street

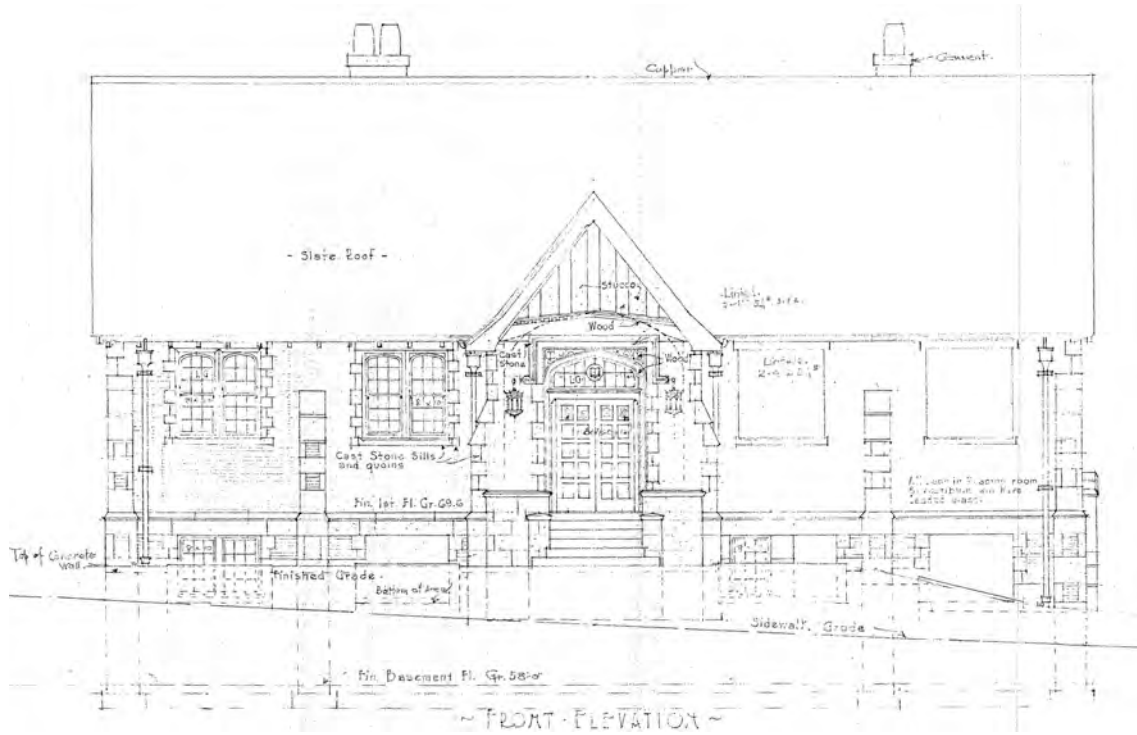
Figure 1: front elevation as designed by Stratton. Note the front doors, the leaders with conductor heads and the front entry prior to the construction of the ramp.

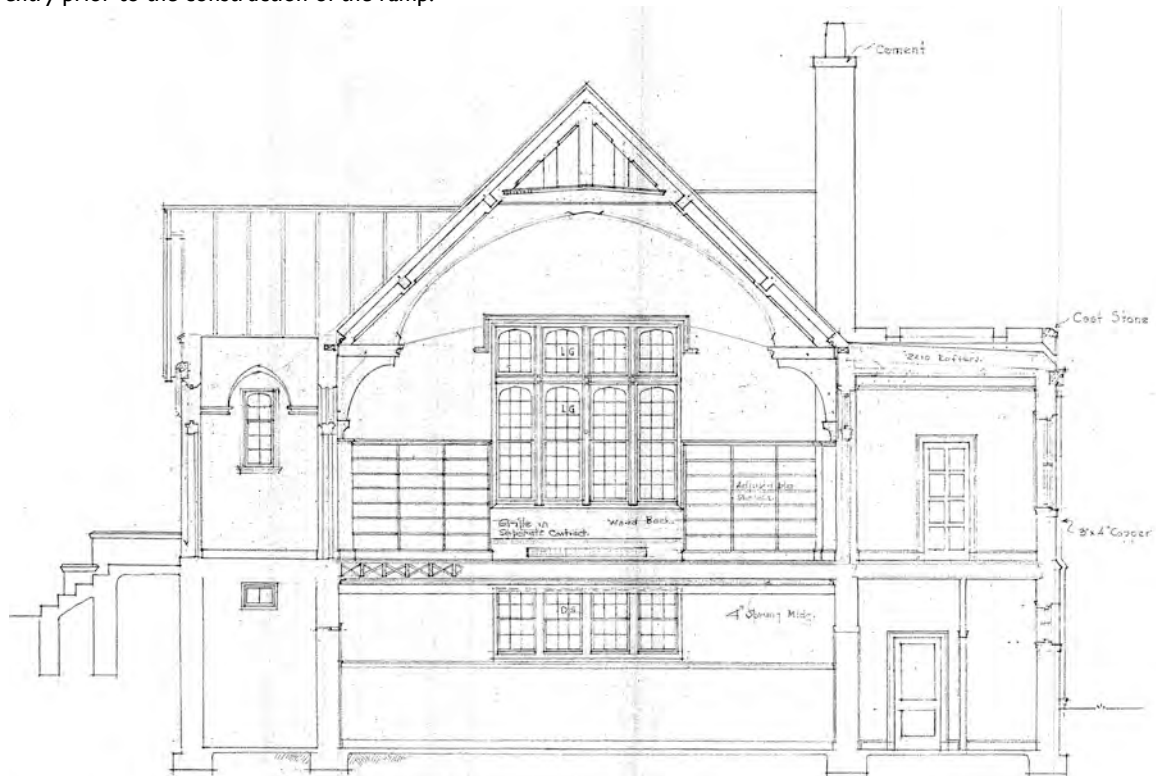
Figure 2: section as designed by Stratton. Note the vaulted ceilings with prominent trusses and brackets. The bookshelves along the gable wall have been removed.

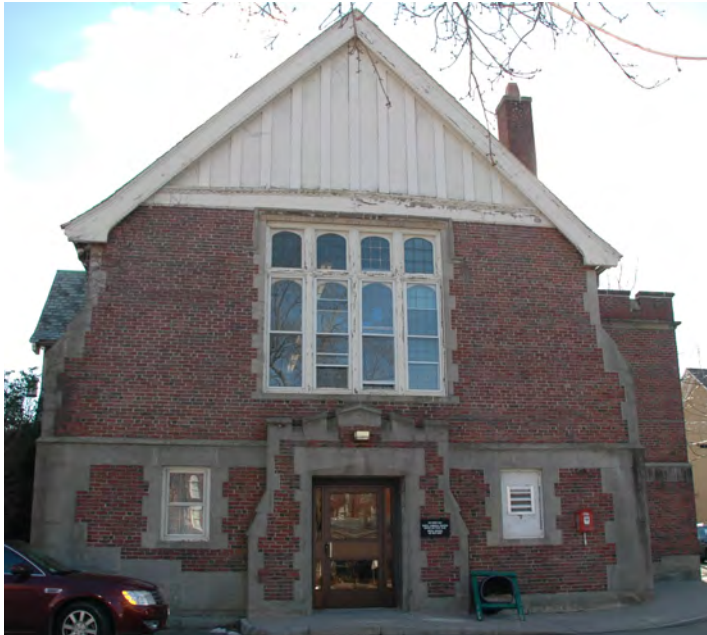
Figure 3: the north gable end exhibits many character-defining features. Note the roofline with the subtle splay at the eaves; the wood and stucco pediment; the large set of leaded glass wood windows set within a cast stone surround; the buttresses shaping the north and south profile of the building; the projecting basement entryway.

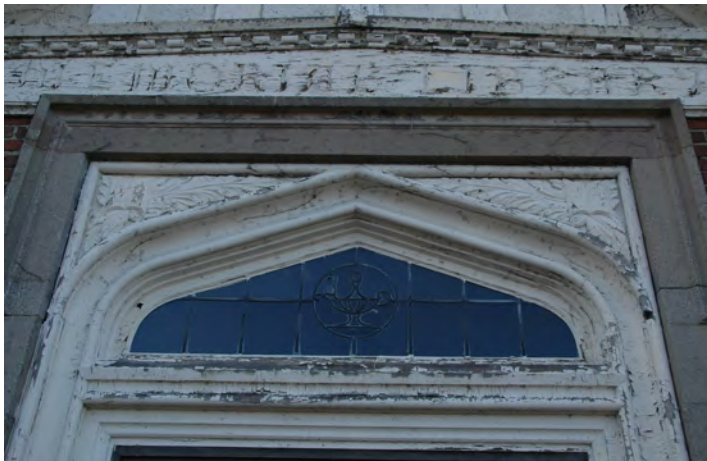
Figure 4: "Memorial Library" carved into the wood above the front door. Note also the oil lamp image in the leaded glass transom.

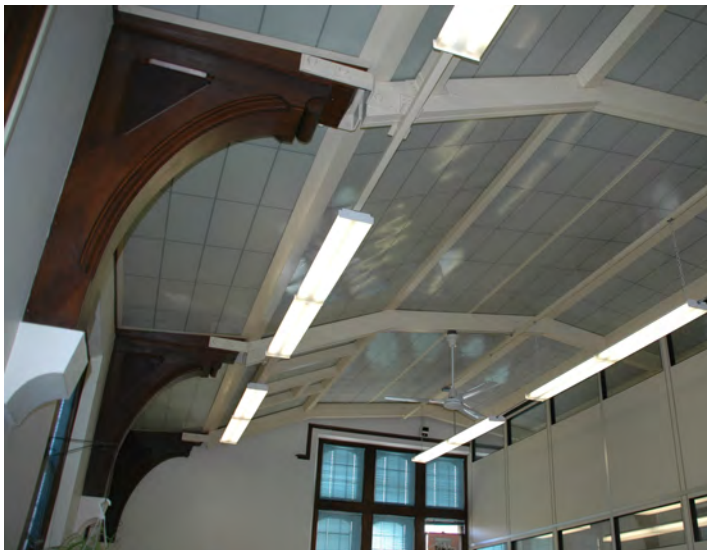
Figure 5 (left): (rotate/straighten and reinsert) original wood brackets on plaster corbels still extant. Inappropriate steel and Kalwall dropped ceiling obscures rest of trusses and ceiling

- Water damage at plaster ceiling and walls of vestibule, northwest corner appears to be related to similar damage on the exterior. Repair roof. (See exterior recommendations). Repair and repaint damaged plaster surfaces.
- Remove non-original, inappropriate and sound-reflective Kalwall dropped ceiling and its frame. Coordinate with the reevaluation of the HVAC system, beyond the scope of this study. Restore space back to its original ceiling height. Repair any damage caused by or hidden by dropped ceiling, including where steel frame was fastened to wood brackets and trusses.
  - The acoustics are currently very poor for a work environment; there is no sound privacy. Removal of the dropped ceiling and its framing would help to ameliorate this problem. Investigate further, appropriate acoustical measures, such as the plaster finish at the restored, original ceiling height.

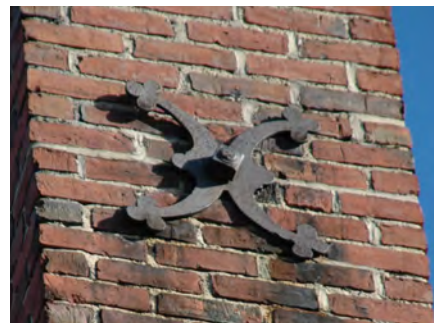
Figure 6 (below): ornamental wrought iron chimney wall tie

- Replace rotted wood elements in kind, including rotten rafter tails below leak at entrance roof. Paint all wood elements.
- Paint all ferrous elements, including pipe rail at basement stairs, west elevation and decorative tiebacks at chimney.
