**NEWTON PUBLIC BUILDINGS SURVEY
PHASE II – ANALYSIS OF HISTORICAL SIGNIFICANCE**

Police Headquarters

Phase II: Analysis of Historically Significant City Buildings, Newton, Massachusetts
Police Headquarters
DRAFT 3/23/2012

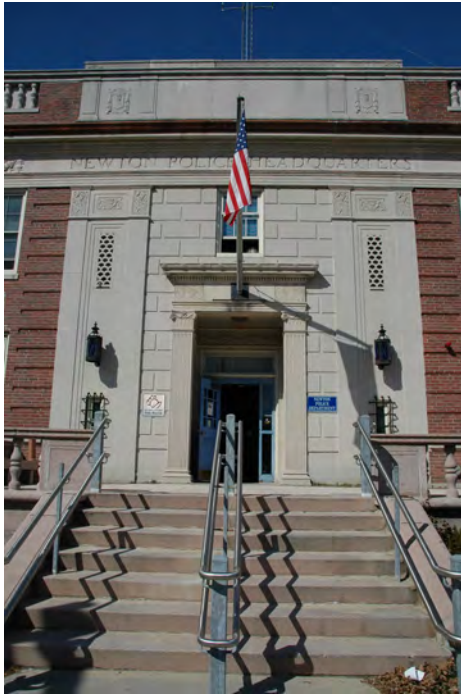
Figure 2 (top left): main entrance

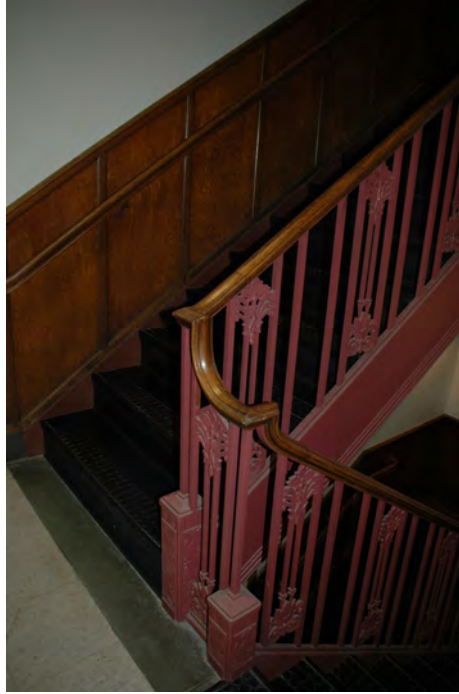
Figure 3 (top right): front stairs

- The painted metal pan stairs are clad with non-original resilient flooring, and have painted ornamental metal balusters and a profiled wood handrail.
- The ceiling and walls are plaster, with a stained plywood-paneled wainscot.
- The stairs open directly to the second floor reception space.

- Determine and remediate the cause of water damage:
 - at the exterior wall of front stairs
 - at the exterior wall of rear stairs
 - at the skylight
 - at the first floor kitchen ceiling
 - at the second floor corridor ceiling
- Replace the missing resilient flooring tread at the front stair.

- Repair and repaint water damaged plaster at exterior wall of front stairs.
- Repaint the glazed door and window walls at the rear stair.
- Repair and repaint the water-damaged plaster at the skylight.
- Replace the missing pieces of roping at the entry vestibule wood cornice.
- Replace water-damaged acoustic ceiling tiles.

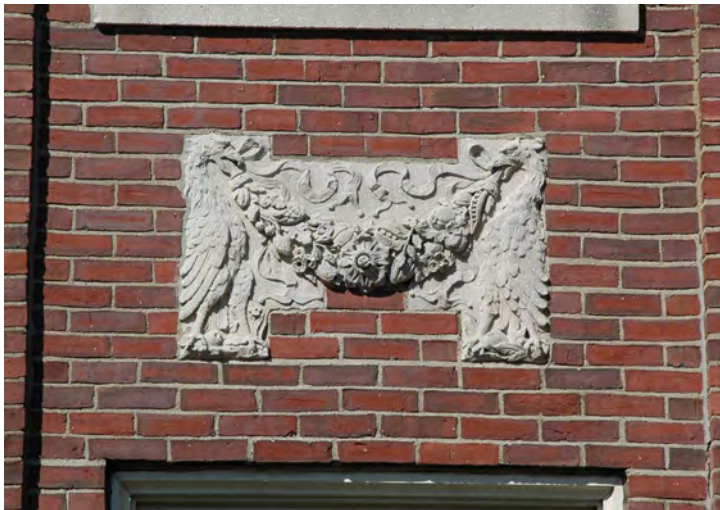
Figure 4 (center): ornamental cast stone panel centered between the first and second floor windows

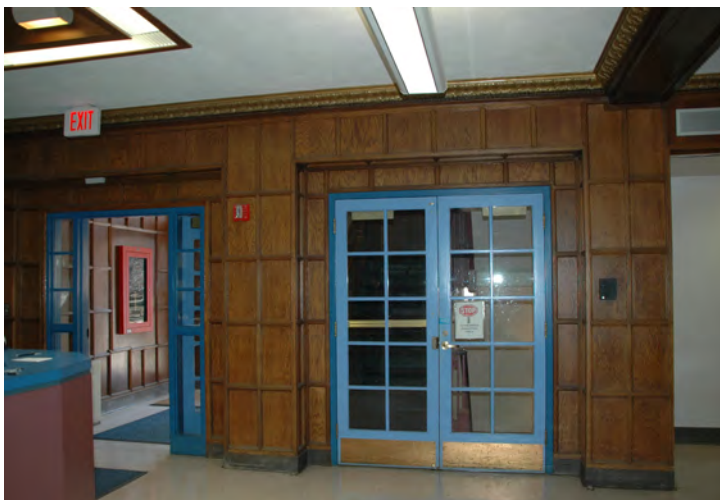
Figure 5 (bottom): main lobby, looking south towards the entry vestibule (left) and the front stairs (center)
