**NEWTON PUBLIC BUILDINGS SURVEY  
PHASE II – ANALYSIS OF HISTORICAL SIGNIFICANCE**

**Building Analysis**

**Senior Center**

Address: 345 Walnut Street  
Year of Construction: 1938

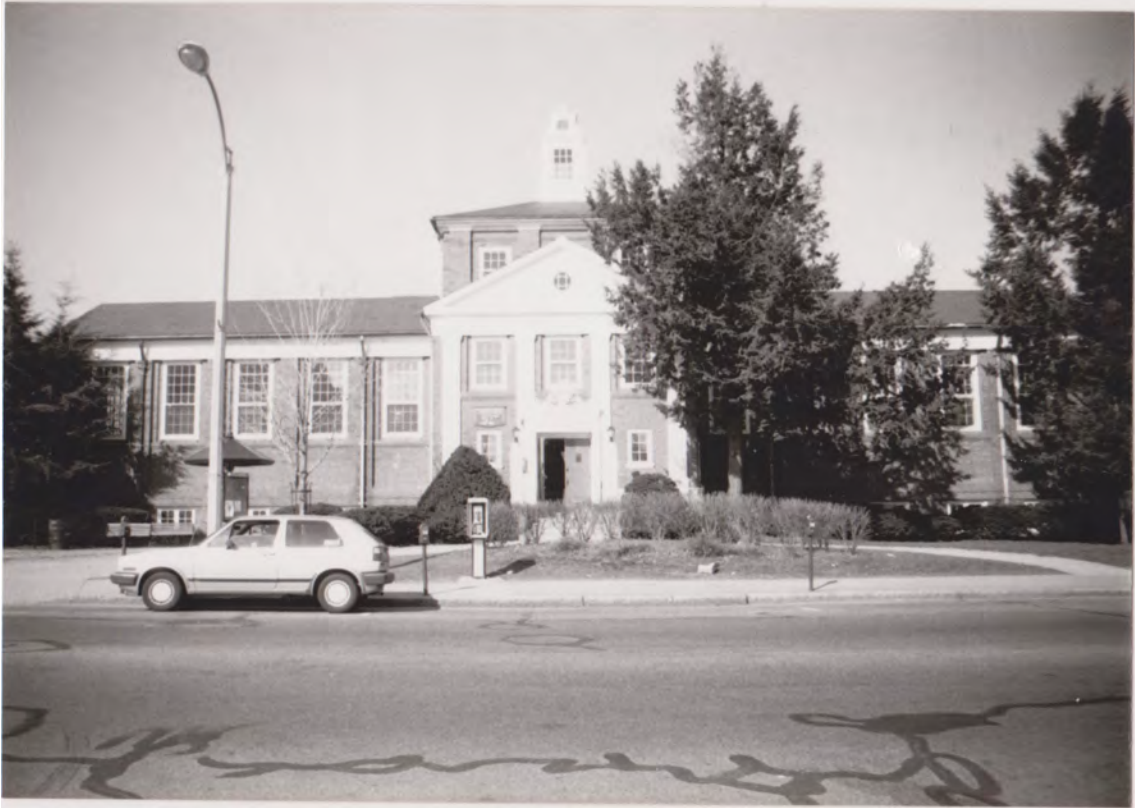
Figure 1: East elevation of Newtonville Branch Library, 1987. The landscaping of the site has changed considerably since then. The light fixtures on the limestone standards have also been changed. (Credit: Historic Newton)

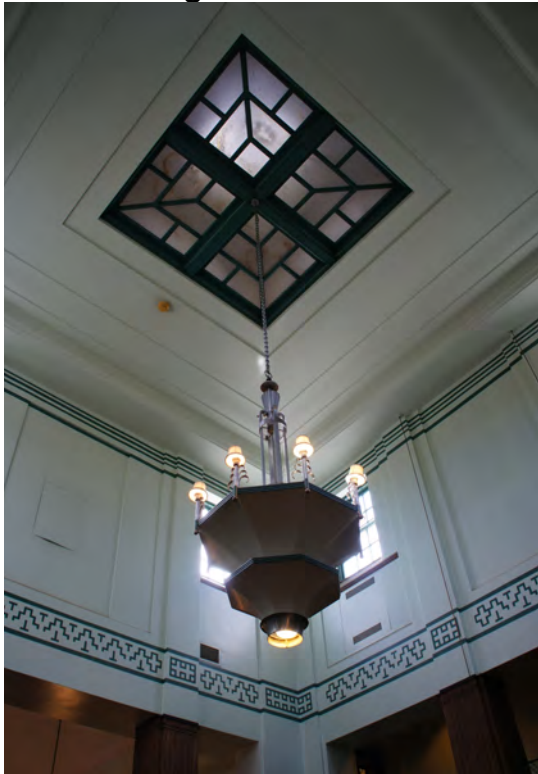
Figure 2: Laylight and chandelier in Main Lobby. Note stepped plaster detail at walls and ceiling.

- Clean laylight. Investigate original functionality and possibility of opening up to cupola. Coordinate with work at cupola and HVAC system.

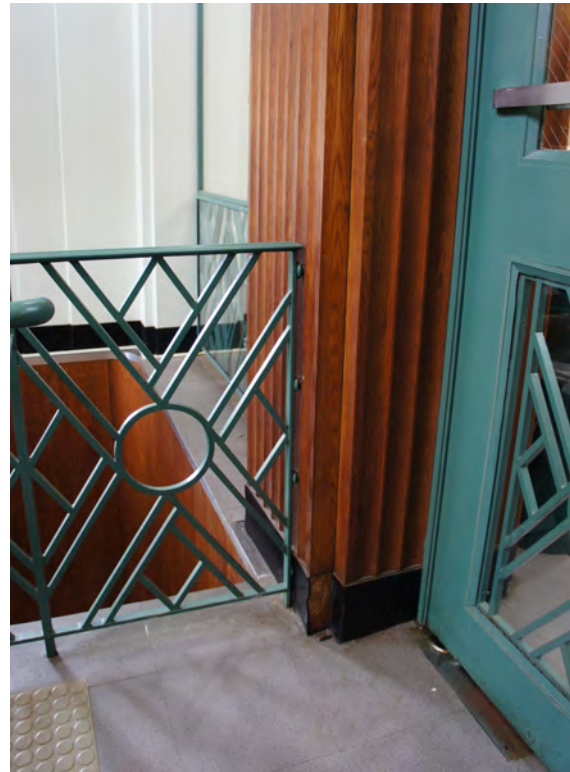
Figure 3: fluted wood column and ornamental metal panels at Entry Vestibule balustrade and door.

- Locate and repair source of water damage at entry vestibule wall and ceiling.

- Repair and repaint entry vestibule wall and ceiling where water-damaged.
- Acoustic tiles affixed to ceilings of significant spaces (reading rooms, entry vestibule, children's room, community room). Determine original surfaces, find more appropriate means of acoustic dampening if necessary.

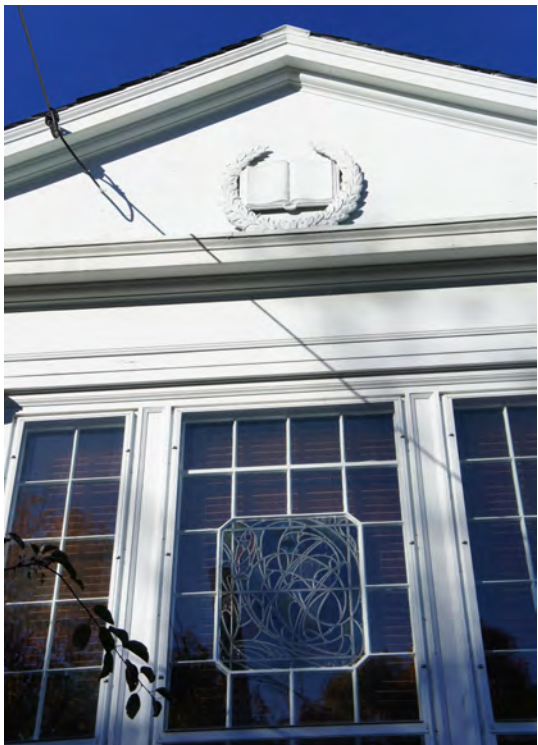
Figure 4: South gable end. Note carved pediment ornament and stained glass panel behind storm windows.

- Protect and continue to maintain stained glass medallions in north and south window bays.
- The other character-defining features are in generally good condition. Continue regular maintenance.

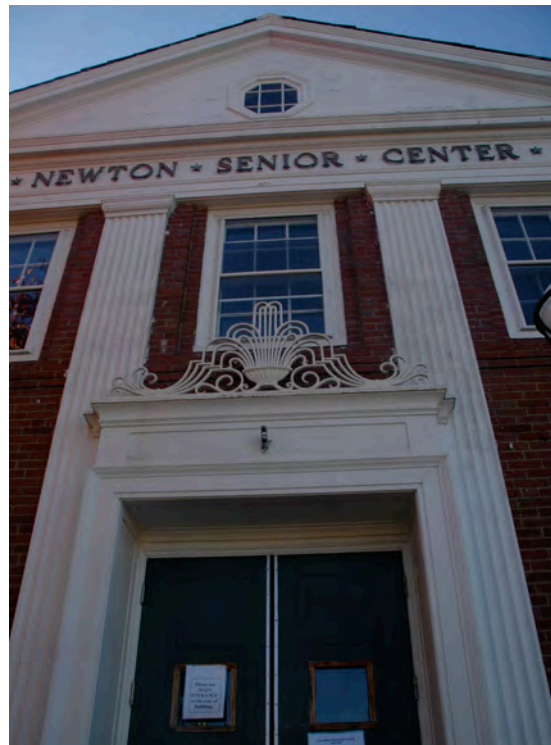
Figure 5: East (historic main) entrance.

- At the projecting entrance bay: repair the spalling limestone bases, including dutchman repairs as required. Remove ferrous elements, clean and repoint. Repaint all wood surfaces.
