**NEWTON PUBLIC BUILDINGS SURVEY
PHASE II – ANALYSIS OF HISTORICAL SIGNIFICANCE**

Building Analysis

Waban Library

Address: 1608 Beacon Street
Year of Construction: 1929

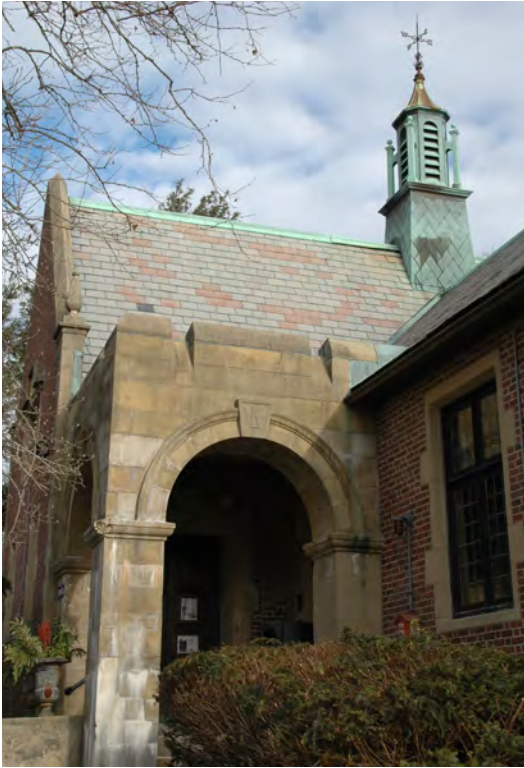
Figure 4: Cupola, entry pavilion, typical window.

- The flat roof above the entry pavilion was not accessible to survey. The one copper leader emptying this roof is visibly clogged, possibly due to a convoluted run through entry portico and a bottom run which is too shallow and bent. Ponding water on this roof may be directly related to the severe water damage and efflorescence in the cast stone below. Survey roof condition and repair as necessary. Unclog and repair this and all other gutters and leaders, and replace bottom segment of this leader.
- The cast stone modillion block at the southwest corner is missing. Surrounding bricks are pushing out of the wall plane. Rebuild this corner. Repair and reconnect disconnected leader.

- Severe efflorescence and spalling were noted at the cast stone entry portico, along with evidence of multiple generations of failed patches. Identify the source of moisture infiltration in this area (see Critical/Urgent list). Repair and clean cast stone, including cast stone dutchmen as required.

- Remove rust and repaint all ferrous elements, including windows and handrails.
- Determine source of staining at cupola. Repair as necessary and clean.
- Clean the building exterior (general). Includes: ivy removal, biological growth, rust staining and general staining.

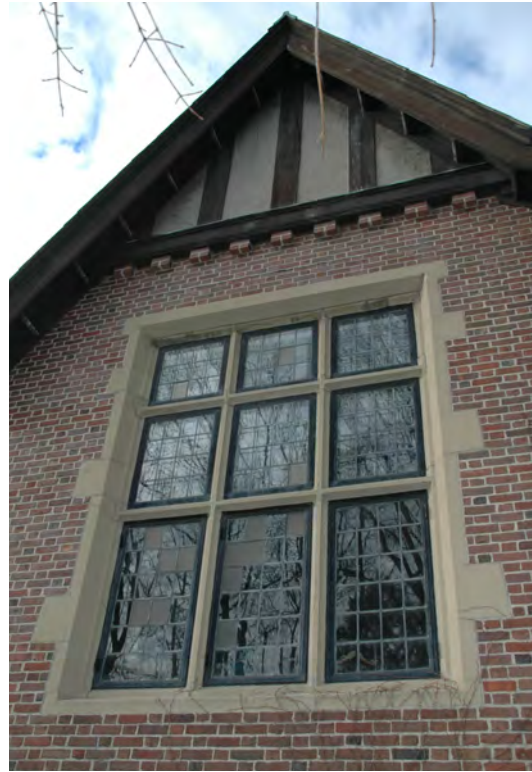
Figure 5: Rear gable- half-timbered detail at top with brick dentils, typical gable-end window.

- Conduct a thorough survey of window conditions, including sash, frame and hardware. The original windows should be retained to the largest extent possible, repaired and made weathertight. The steel window sash, wood frames and lead caming are generally in good condition. A few windows, in particular the rear gable window, need repair and repainting. Replace missing comes and broken/discolored panes of glass as necessary.

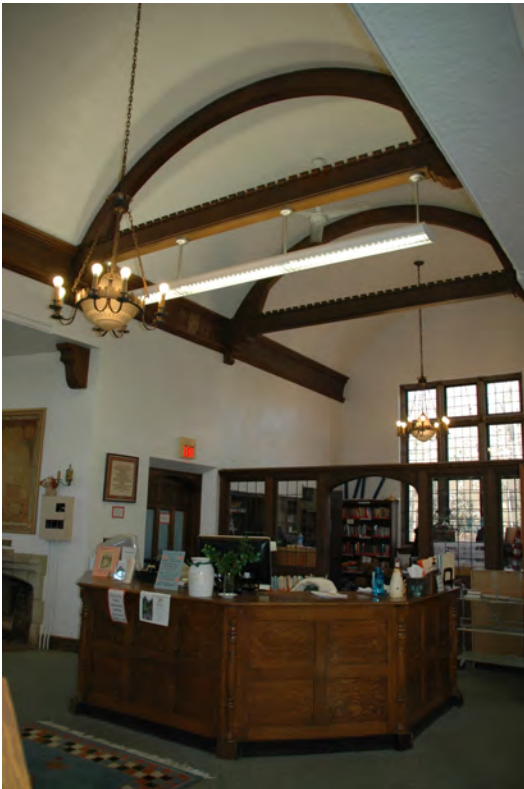
Figure 6: central circulation area is intact, including the desk, screen wall, and decorative woodwork at the barrel-vaulted ceiling

- Repair broken wood dentil on bottom chord of one of the decorative trusses in center hall.
- Clean minor staining from the interior side of the stone mullions at the gable ends.

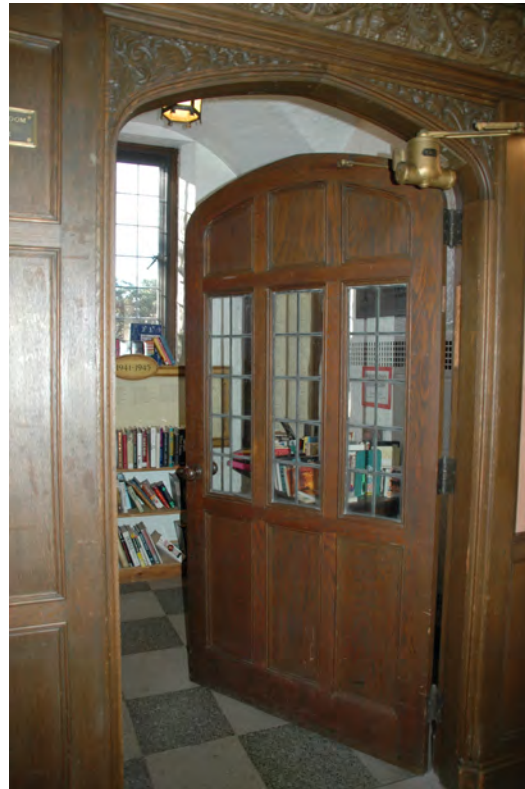
Figure 7: wood paneled door from center hall to the entry vestibule. Lead-camed lights at three panels, arched doorway in wood paneled screen wall with elaborate carvings.
