**NEWTON PUBLIC BUILDINGS SURVEY  
PHASE II – ANALYSIS OF HISTORICAL SIGNIFICANCE**

**Building Analysis**

**Williams Elementary School**

Phase II: Analysis of Historically Significant City Buildings, Newton, Massachusetts  
Williams Elementary School  
DRAFT 4/6/2012

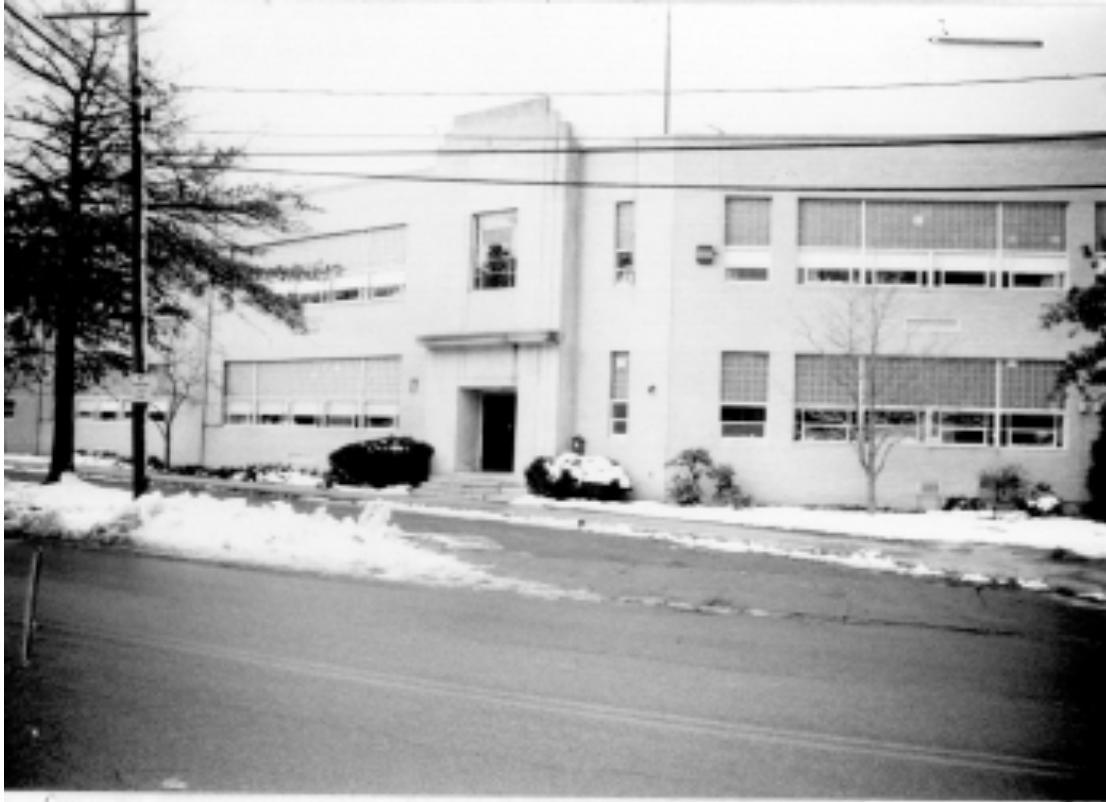
Figure 1: Williams Elementary School circa 1987 showing the original glass block and steel strip windows. (Credit: MACRIS)

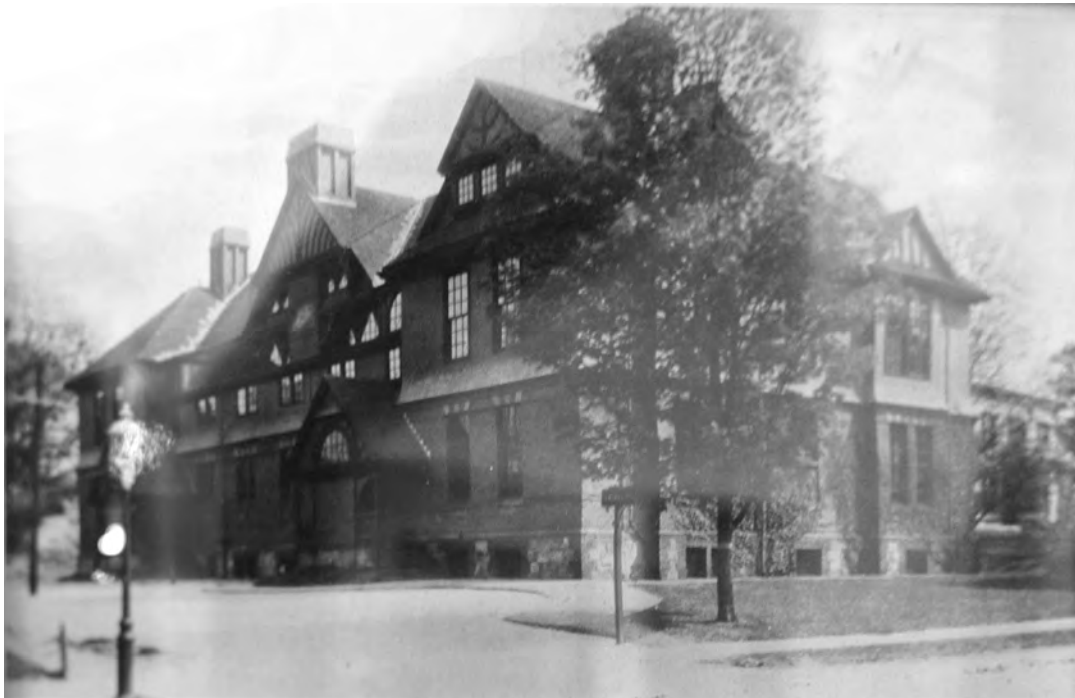
Figure 2: Previous Thomas S. Williams School on Hancock Street, replaced by the current school building. (Credit: Auburndale Library)

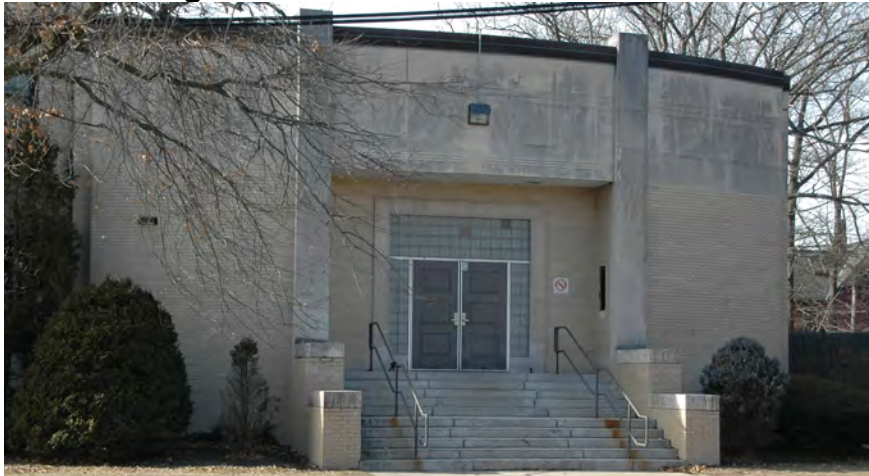
Figure 3 (top): auditorium entrance

- Remove ivy growth.
- Weatherproof the wide gap between the exterior doors to the auditorium vestibule.

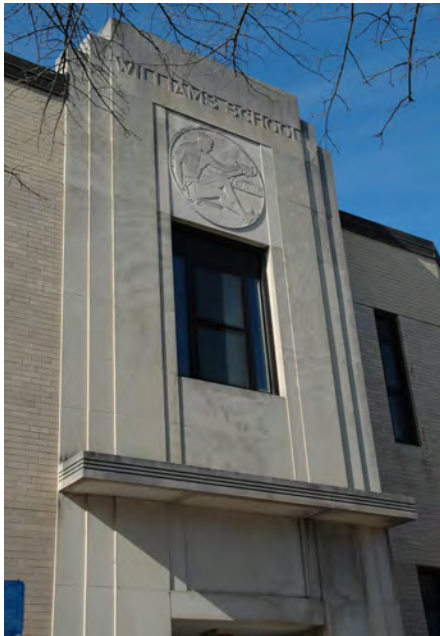
Figure 4 (center left): limestone panel at main entrance

- Structural cracks. Determine cause, remediate if still active, and repair. Includes: limestone at main entry projection, at the top right and at the overhang; step cracking at north windows;

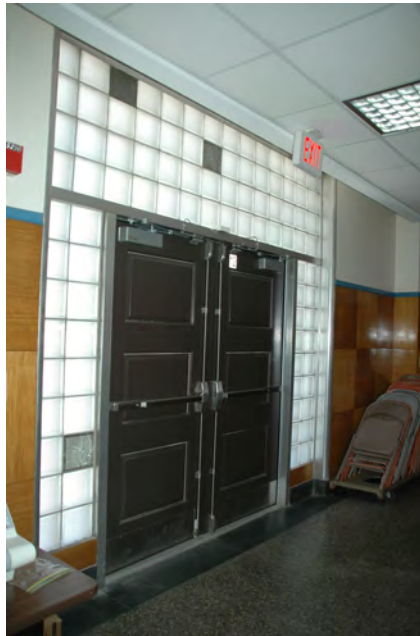
Figure 5 (center right): glass block-surrounded doors in auditorium vestibule

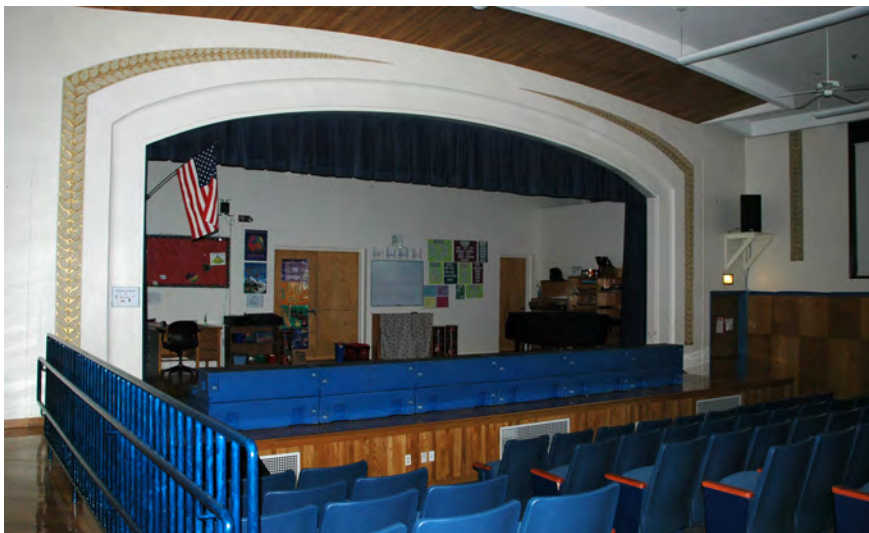
Figure 6 (bottom): auditorium

- Investigate and repair the cause of water damage. Includes:
  - acoustic ceiling tiles in front of the west stair window
  - scattered tiles, mostly on the west side of the auditorium ceiling , and the plaster walls below
  - acoustic ceiling tiles in the hall in front of the gymnasium
  - severe damage at the acoustic tiles and plaster ceiling at east end of the auditorium vestibule
