**NEWTON PUBLIC BUILDINGS SURVEY
PHASE II – ANALYSIS OF HISTORICAL SIGNIFICANCE**

Building Analysis

Winchester Street Garage

Address: 525 Winchester Street
Year of Construction: 1938

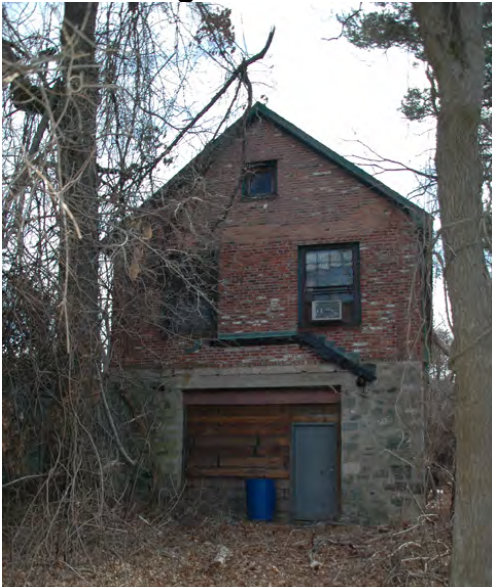
- There are charred remnants of what appear to have been a wood-framed roof with copper flashing over the north door, lower level.
- A tall, narrow brick chimney projects from the center of the west roof.

Figure 3: North elevation of garage. Note the remnants of the projecting roof above the opening.

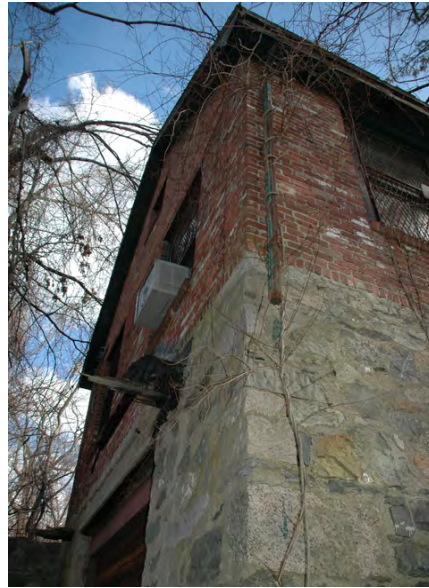
Figure 4: Close up view of the fieldstone foundation.

- Repoint mortar joints at the brick and stone walls.
- Clean the building exterior, including:
 - smeared mastic at window openings
 - biological growth at grade, at the east elevation, and at the north elevation next to site wall. Remove ivy from the west elevation.

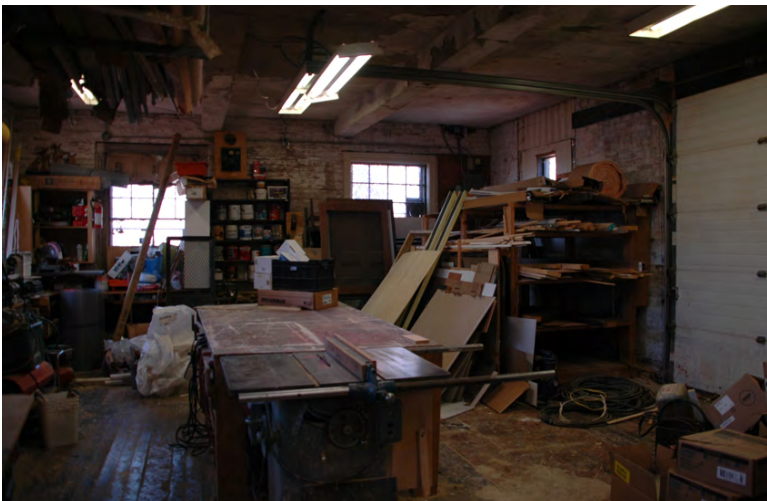
Figure 5: Interior of main level. Note the wood floor and exposed ceiling structure.

- There is evidence of previous water damage to the plaster ceiling in workshop (staining, exposed metal lath), and also at the southwest corner of the office ceiling. After verifying that these are no longer active leaks repaint the walls, replace the damaged ceiling tile, and repair the damaged plaster.
- Replace the missing wood panel on the original door to the attic (currently replaced with plywood).
- Clean graffiti from attic structural elements and stairs.

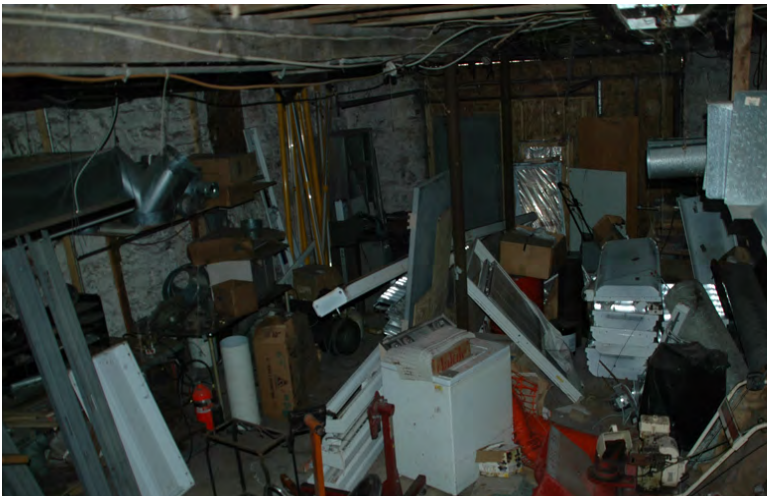
Figure 6: Interior of the basement level.

- Remove flammable material from basement and attic. Inventory stored items in case there are materials related to the almshouse and store any found in a more secure location.
- Store flammable and combustible materials belonging to the carpentry shop work in an appropriate storage cabinet.

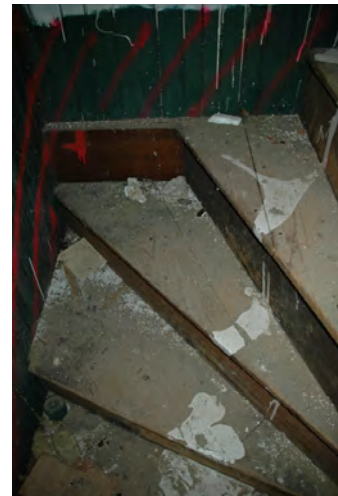
Figure 7: Stairway to the attic with beadboard walls.
