FARLOW – CHAFFIN PARK

HISTORIC PLANNING AND DESIGN

Landscape Restoration Report, June 2006

Prepared by
Brown, Richardson & Rowe, Inc.
Landscape Architects and Planners
with
Ammann & Whitney, Structural Engineers
CMS Collaborative, Fountain Consultants

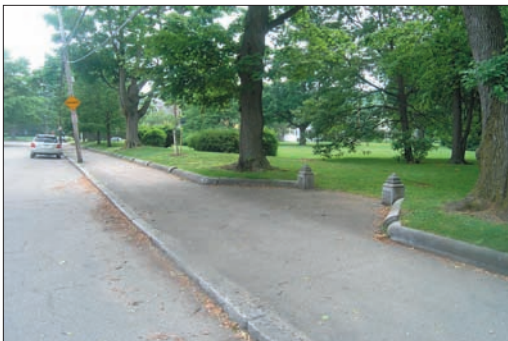
The walkway from the historic entrance on Eldridge Street, which had served as a connection between Eldridge and Church Streets, has been removed.

Missing walkway at the historic entrance on Eldridge Street

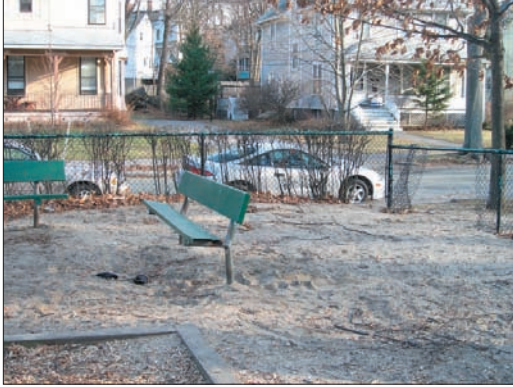
Three sides of the active area of Farlow Park are enclosed with chain link fence. The fourth side, along Vernon Street, is only fenced near the baseball infield. The fence fabric is in generally poor-fair condition. Near the new entrance on Eldridge Street, a huge hole has been broken through the fence fabric. As an additional edge buffer, a shrub hedge was planted next to the chain link fence along Eldridge Street and along the chain link fence that divides the active and historic areas of the Park. Volunteer vegetation has become established in several areas along the chain link fence.

Chain link fence in disrepair

- Replace existing chain link with historic-style ornamental fence.
- Remove vegetation along fences. Shrub hedges must be regularly pruned and weeded of volunteer vegetation. Hedges that are planted next to fences impede the maintenance of both the hedge and the fence.

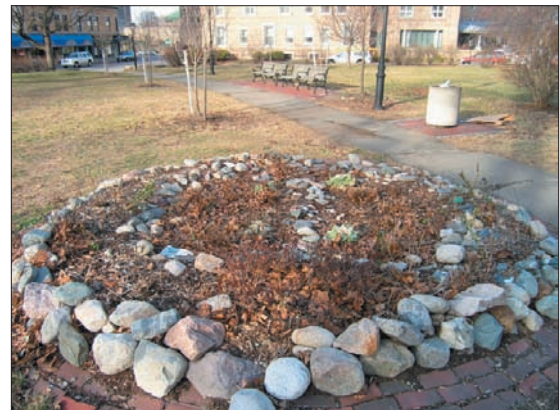
Memorials need a policy

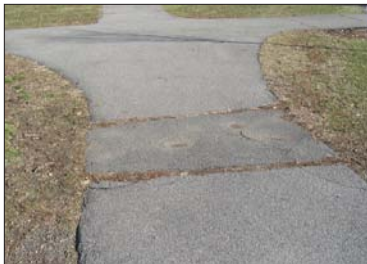
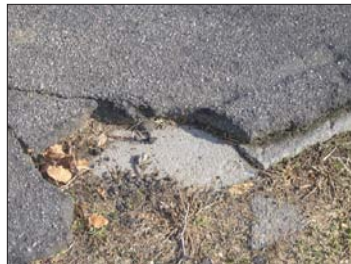
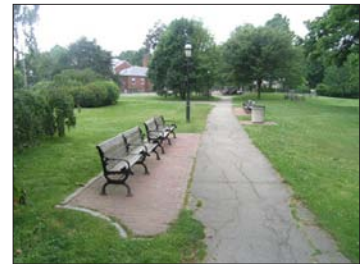
All of the park walks are paved in asphalt. Walkways that were installed or upgraded as part of the Newton Community Development Program improvements in 1979-1980 are edged with granite. These new walks are in generally good condition. However, most of the older walks are in need of repair - there are many cracks, uneven surfaces and ragged edges. In one area, the asphalt has chipped away, revealing a concrete base underneath. Since this is not a standard construction method for asphalt walks, it may be that these were once concrete walks which fell into disrepair and were subsequently covered with a layer of asphalt as a quick fix.

Pathway problems in Farlow Park

At the eastern side of the bridge, the asphalt walk that connects to the new entrance on Eldridge Street has subsided, causing an extreme cross-slope on the walkway that is unsafe and does not meet accessibility guidelines.

- Reconstruct the older walks. Uneven walkway surfaces could cause an injury to park users and cracked asphalt will continue to deteriorate. Remove all concrete bases underneath the asphalt. If the concrete is not removed, the asphalt will continue to crack at every control and expansion joint location.

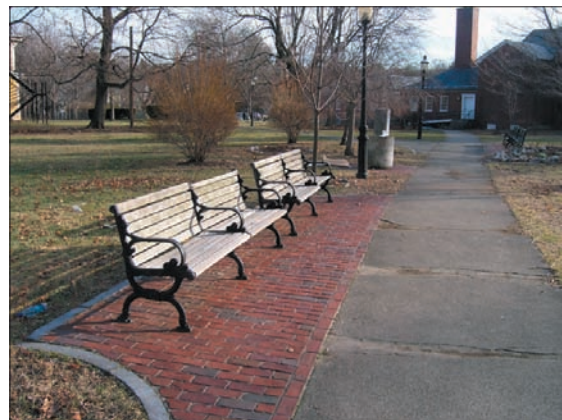
The main walkway is constructed of asphalt and is in poor condition. The surface is cracked, uneven and the edge of the asphalt is ragged. The connecting walk to Farlow Park is in generally good condition. However, some low points have developed at the edge of the walkway which allow water to puddle, and this will eventually compromise the walkway if not taken care of.

Pathway problem in Chaffin

- Reconstruct the older walks. Uneven walkway surfaces could cause an injury. Cracked asphalt will continue to deteriorate. Remove all concrete bases underneath the asphalt. If the concrete is not removed, the asphalt will continue to crack at every control and expansion joint location.
- If possible, install flush granite edging to match the existing granite at the edge of the newer walkways. Granite will strengthen the edge of the asphalt walk and provide a neat, clean edge.
- Rehabilitate the newer walks by resurfacing the asphalt. This will fill in all the low points that have developed at the edge of the walkway.
- Construct a new walkway to connect the park with the Newton Corner Library.

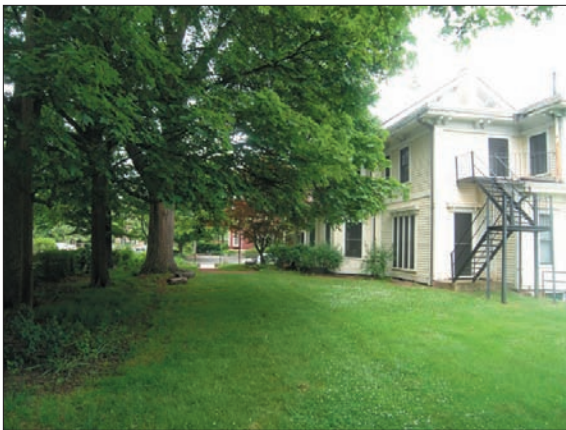
Several large trees line the western and eastern edges of the park. The large trees on the western edge, along Centre Street, provide a visual buffer from the busy street and commercial businesses on the other side. However, the large trees on the eastern edge, between the park and the Newton Corner Library, obscure the beautifully restored building façade. Only a couple of medium-sized trees exist along the Vernon Street edge. These trees are located too close to the stone wall and their root systems may compromise the integrity of the wall as the trees mature.

Mature trees at Chaffin need pruning.

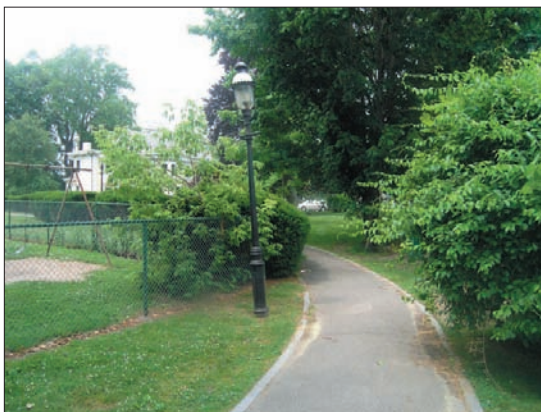
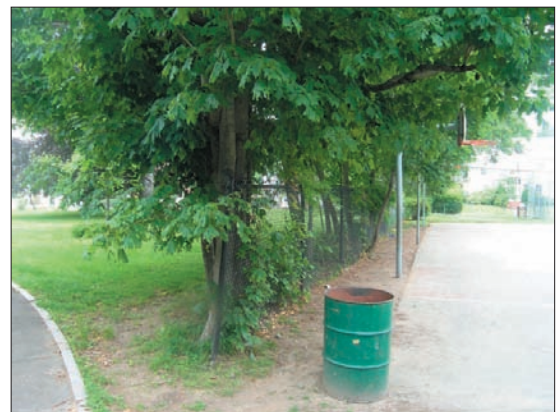
Shrubs along fences need maintenance

- Create defined plant beds around all existing shrubs and perennials to remain. Perform soil tests to determine condition of existing soil and amend soils as recommended. Each Spring, apply mulch to maintain a three-inch minimum coverage on all plant beds.
- If a Bandstand is installed, eliminate the large shrub mass near the corner of Church and Eldridge Streets to improve surveillance and provide more open lawn area for gatherings and events.
- Remove shrub hedges adjacent to all fencing. Shrub hedges must be regularly pruned and weeded of volunteer vegetation. Hedges placed next to fences impede the maintenance of both the hedge and the fence.

- Remove all shrubs whose roots have begun to push through and move the granite edging.
- Until a long-term plan is established to ensure plant beds are regularly maintained, keep the number of plant beds to a minimum.

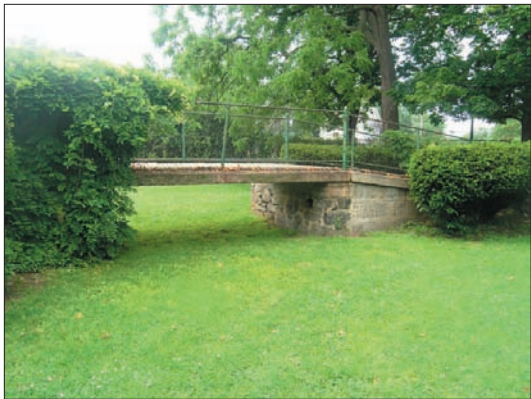
Bridge today

The existing bridge superstructure spans the two stone masonry piers with a clear span of approximately 20 feet. The superstructure is an eight-inch deep reinforced concrete slab with a bituminous concrete wearing surface. There are chain link fence bridge rails on either side of the bridge anchored into the concrete slab. The reinforced concrete slab is in poor condition, with spalling of the concrete on the underside of the slab and numerous exposed and corroded reinforcing bars.

There are two reinforced concrete approach slabs on either side of the bridge that rest on the stone masonry piers. The construction of the approach slabs is similar to the existing construction, except that they are slabs-on-grade. The earth under the approach slabs is retained by concrete block masonry wingwalls, which are in generally fair to good condition. There is some vegetation growing out of the joints in the wingwalls.

- Although the existing bridge does not appear to be in danger of imminent structural failure, it is most likely reaching the end of its expected lifespan. A strategy for the bridge's future needs to be agreed upon. See Feasibility Study, prepared by Ammann & Whitney, for possible bridge reconstruction alternatives.

- Should a new bridge be constructed, we recommend that the bridge and its approaches be accessible for all park users. A reconstruction of the historic Adirondack-style bridge would not be compliant with current ADA guidelines and we do not recommend installing a bridge that bars any users.

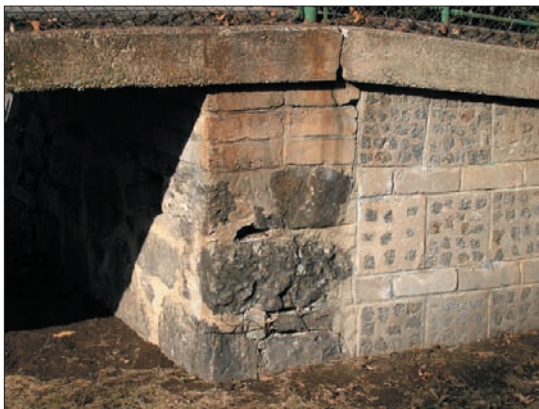
Bridge footings

The piers are a combination of the original stone masonry construction for the lower two-and-a-half feet and concrete block masonry for the upper one foot. The concrete block masonry appears to date from the time the bridge superstructure was replaced with the existing bridge superstructure. The piers are wider than the bridge superstructure by approximately two feet, which indicates that the existing bridge is narrower than the original bridge. The piers appear to be very stable, and the condition of the older stone masonry is generally fair. The joints have been repointed, but up to 25% of the joints are in poor condition with loss of mortar. Most of the deteriorated joints are towards the end not covered by the bridge superstructure. The newer concrete block masonry is in good condition. No test pits were performed to determine the type and depth of footings.

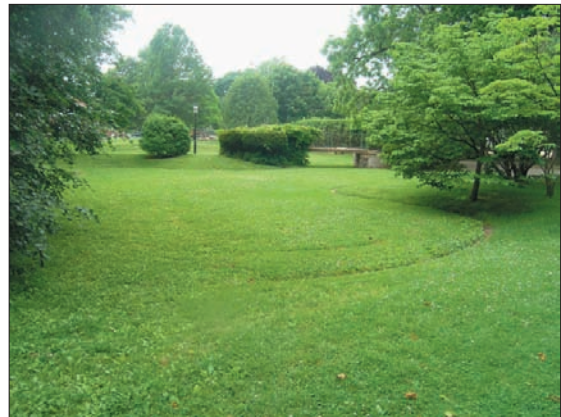
The pond today

The previously existing pond in Farlow Park was drained, filled with loam and seeded with grass at some point in the mid-1900s. Old photographs of the pond, taken not long after the park was constructed, show what appears to be a concrete-lined pond. The concrete extends up the side slope of the pond and is exposed to varying degrees, depending on the water level at the time the photograph was taken. A later photograph shows the pond having an edge treatment that appears more like an eighteen-inch wide curb with a bullnose edge, rather than a paved slope, suggesting that improvements were made to the pond somewhere between the time it was built and the time it was filled. Today, a distinct outline of the previously existing pond edge can be seen in the lawn, and in some areas a horizontal band of what appears to be concrete has been exposed, indicating that some of the pond edge may still remain.

- A strategy for the pond's future needs to be agreed upon. See Feasibility Study, prepared by CMS, for possible pond treatment alternatives.
- Although some of the pond edge and pond lining may still remain under the existing lawn, it is unlikely that either of them could be reused.
- Excavate several test pits in the pond area to determine the condition and material of the pond bottom.
