TO: Stephanie Pelkowsky
FROM: Cheri Ruane
DATE: June 16, 2011
SUBJECT: Farlow Park Pond Executive Summary

TO: Stephanie Pelkowsky
FROM: Cheri Ruane, RLA, Team Leader
DATE: 3.23.10
SUBJECT: Farlow Park Field Investigation

On March 22, 2010 at 8:30 A.M., field investigation efforts within the confines of the former pond at Farlow Park commenced.. Weston & Sampson retained Sequoia Construction, a Whitman, Massachusetts site construction Company to assist with the excavation of test pits at the former pond. Sequoia Construction furnished an operator, laborer and a backhoe for this purpose. Project representatives agreed to excavate at five locations as illustrated on the diagram to the right.

TO: Stephanie Pelkowsky
FROM: Cheri Ruane, RLA
Project Manager
DATE: 10.4.10
UPDATED 6.16.11
SUBJECT: Farlow Park Pond Engineering Summary

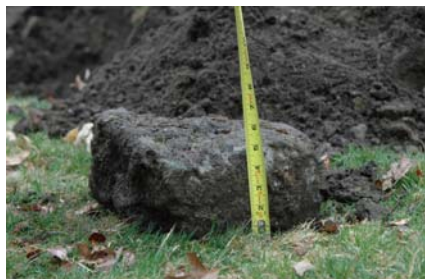
Upon initial excavation, gravel and pieces of concrete debris were encountered at 18” depth. The concrete debris was assumed to be broken up pieces of the original pool bottom. Measurements and photographs were taken to record the conditions, a piece of the concrete debris was salvaged for further investigation. Subsequent excavations in other areas revealed that the original pool bottom was actually at a depth of 24” below existing grades. It was then assumed that the concrete debris discovered at the 18” depth was most probably fill that was placed at the time that the pond was removed. To confirm this assumption, Area 1 was re-excavated. Re-excavation confirmed an intact concrete pool bottom 24” below existing grades.

Area 1 debris findings

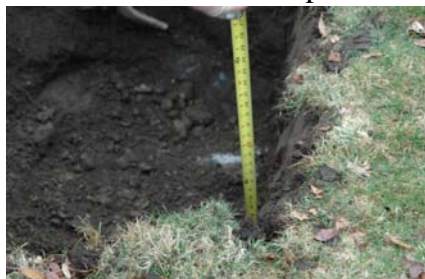
Area 1 initial excavation depth of 18”

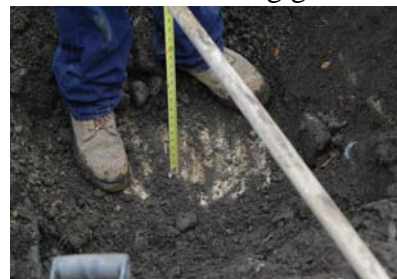
Area 1 second excavation depth of 24” with concrete basin visible

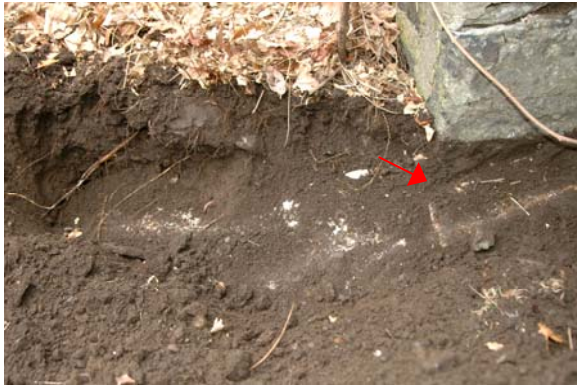
The goal of the excavation in this location was to determine the interface between the former concrete pond bottom and the existing bridge footings. Excavation revealed a series of joints (one is marked below with a red arrow) between concrete edge segments at the corner of the bridge abutment. The profile of the pond basin at the bridge was an even slope from the top edge / coping (at finished grade) to the bottom of the pond which was 24” total depth.

Area 2 masonry footing and jointed basin material

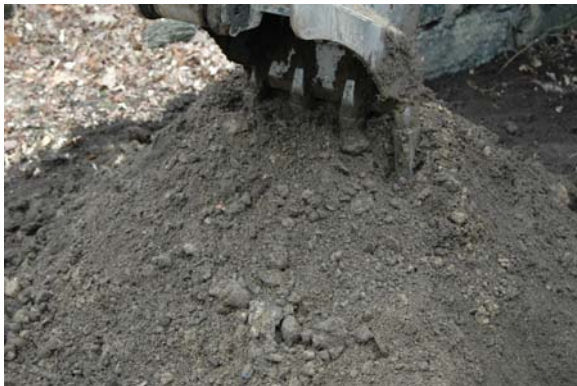
Area 3: typical fill characteristics of whole pond area

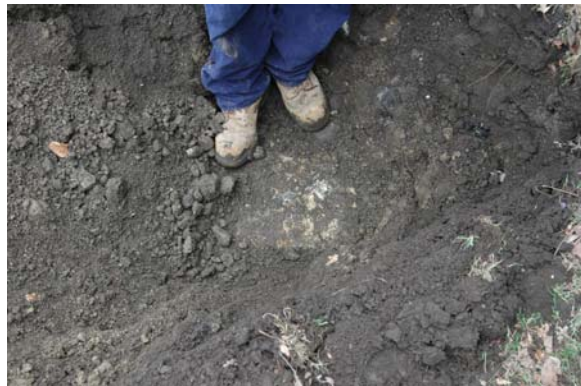
This area is located next to the existing bridge, at the center line of the arch. Old plans show a drain outlet near this general vicinity and it was thought that the pond bottom might be deepest at this location to facilitate the draining of the former pond. However, excavations confirmed a 24” total depth from existing grade to the former pond bottom. The concrete pool bottom was consistent with previous findings and appeared to be completely intact with no cracking or spalling evident.

Area 3: intact concrete pond basin, 24” below existing grade

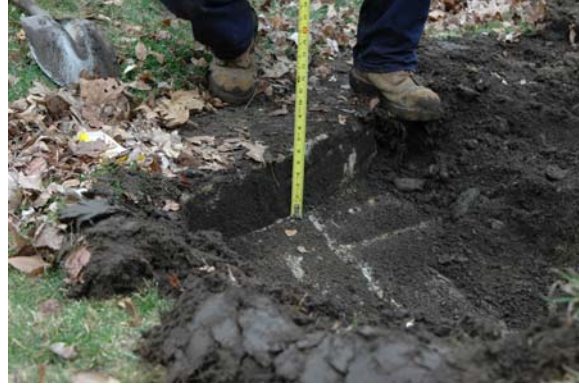
Area 4: 6" vertical reveal of pond edge / coping

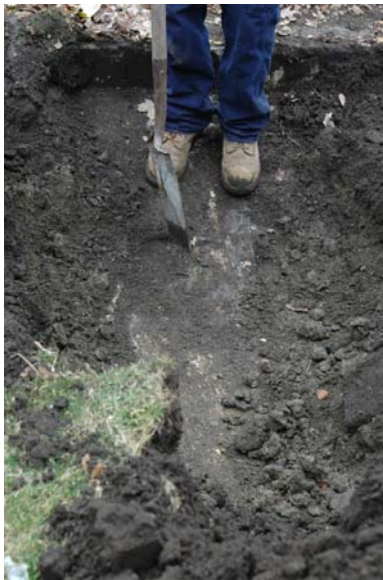
Area 4: sloped edge of former pond bottom

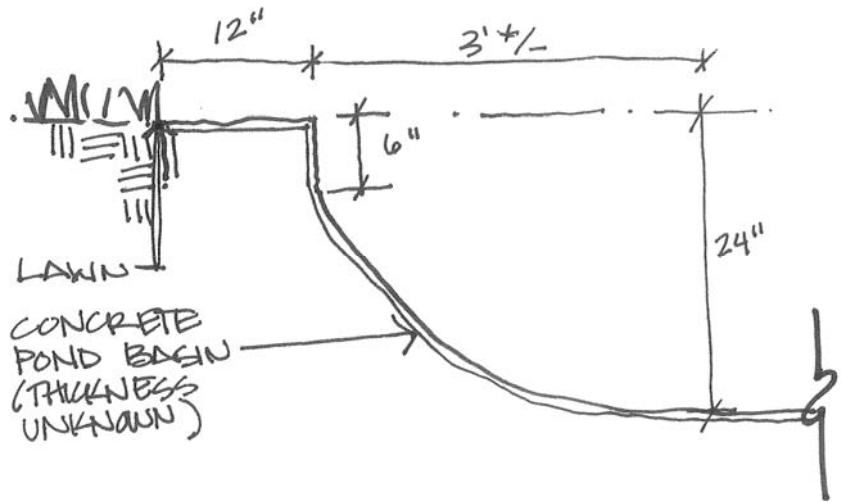
Area 4 was excavated in hopes of locating the drain outlet structure shown on old plans to confirm existence and condition. While no drain outlet was discovered, the full profile of the pond basin was revealed and measured. The sketch below illustrates the findings of a 6" vertical reveal of the former pond edge / coping, then a rounded sloping edge which transitions to a flat bottom 24" below existing grade.

Sketch of pond basin profile, not to scale.

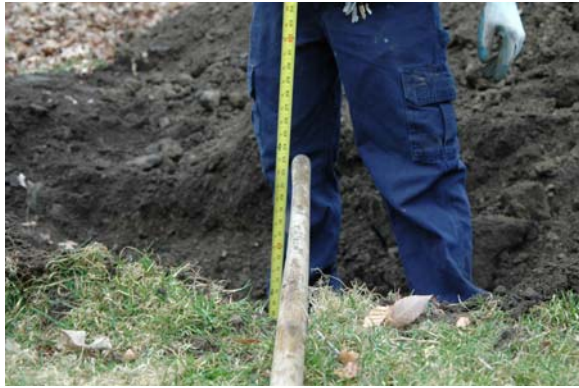
Area 5: 24” depth at center of the pond

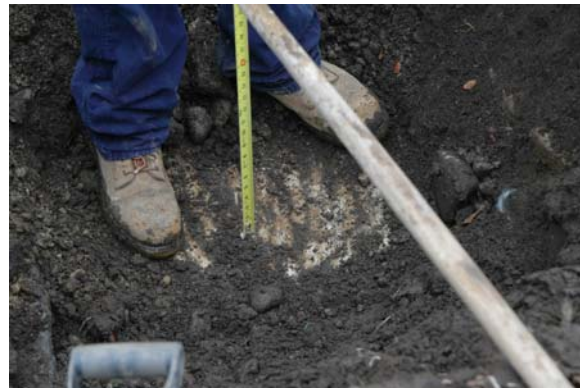
All findings in Area 5 were consistent with the conditions observed at the previous excavations. The bottom of the former concrete bottom was 24” down from finished grade, the characteristics of the fill included 12” of good loam then 12” of gravel and larger pieces of debris, and the pool bottom was concrete and fully intact with no cracking or visible spalling.

Area 5: intact concrete pool basin 24” below existing grade

Soil borings are recommended to establish thickness of the pond basin, presence of reinforcement (if any), and the characteristics of the soil materials beneath the concrete slab.

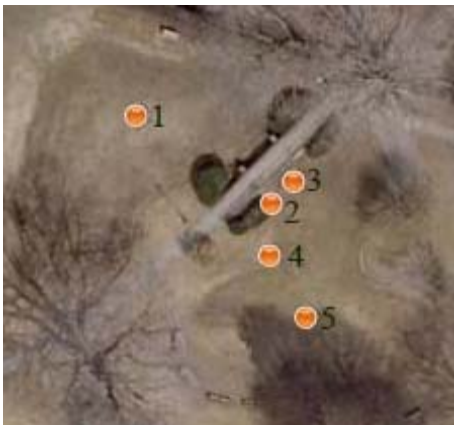
As shown at the picture below, the former pond was bisected by a foot bridge that still remains. The first soil boring was conducted in what is considered "Area 5" in the memorandum dated 3.23.10 by Cheri Ruane, also shown to the right. The pond fill at this location is approximately 24 inches. The depth of the concrete pool bottom is 6 inches. No concrete core was obtained, as the sampler used by NHB crushed the concrete in to small pieces. Underlying the concrete pool bottom, from approximately 3 feet to 5 feet below ground surface, is medium dense gravel. Below this concrete layer, from approximately 5 feet to 7 feet below ground surface, there were two distinct loose soil layers in the 12 inches of soil recovered. The top 8 inches of the 12 inch recovery was fine sand with trace silt and trace coarse sand. The bottom 4 inches was organic silt.

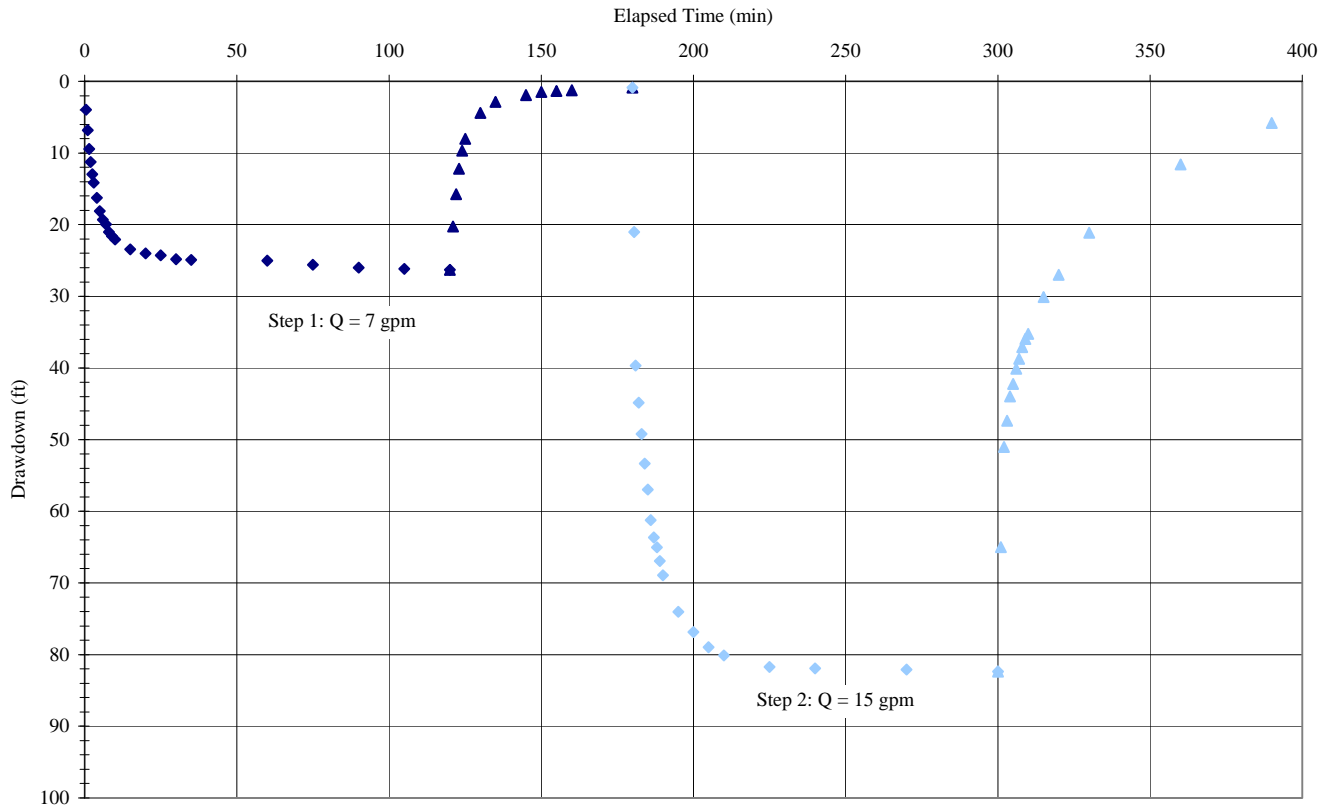
Farlow Park Step-Rate Pumping Test - Drawdown vs Time

A controlled pumping test was conducted on May 27th consisting of two different pumping rates. This type of test is considered a step rate pumping test and can provide an indication of well efficiency at varying rates and design requirements related to well yield. The pumping test data is provided in attachment B and graphically depicted in Figure 1. The first test was conducted at a rate of 7 gpm. With a static or non-pumping level of 21.05, final drawdown levels were 47.36 feet. The ratio of the pumping rate per foot of drawdown is known as the specific capacity. Calculated specific capacity at 7 gpm was 0.27 gpm/ft. A second step was conducted at 15 gpm and revealed 103.41 feet of drawdown. As anticipated, specific capacity values dropped with increased pumping rate. Calculated specific capacity at 15 gpm was 0.18 gpm/ft. Thus for every 7-8 gpm increase in pumping rate we would expect an additional 50% decline in specific capacity.

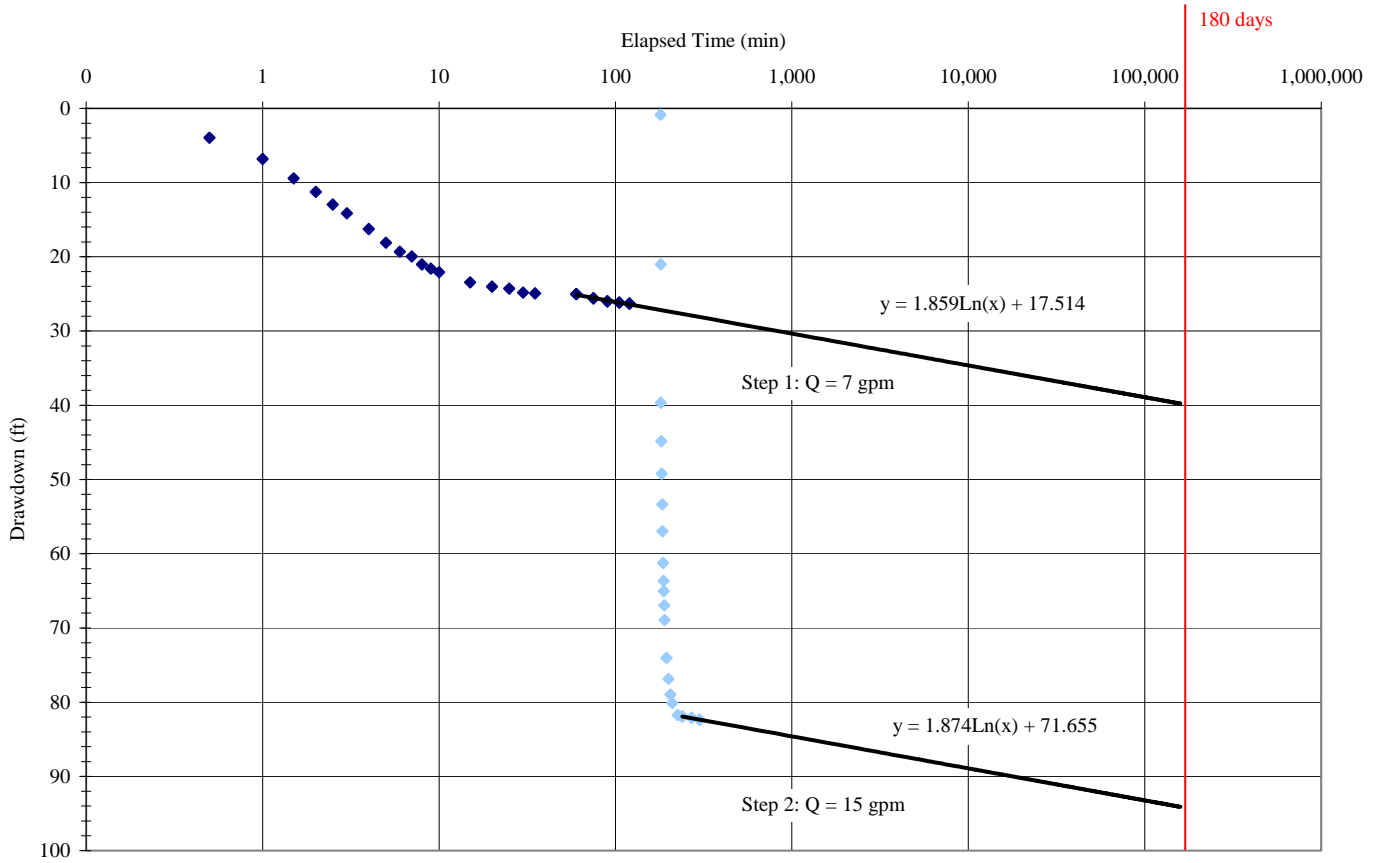
Farlow Park Step-Rate Pumping Test - Drawdown vs Time (180 days)

Recharge rates to the aquifer and well are much harder to predict in an urban environment due to the presence of impermeable surfaces and storm water conveyance systems. Both limit the ability for precipitation to recharge the aquifer. Recovery rates following each pumping step showed adequate but not robust recovery for the well. Without full recovery, it is prudent to apply a modest safety factor to the final pump design and anticipated long-term production capacity of the well.

Based on the test data we would suggest the selection of a pump capable of producing a maximum of 25 gpm against the desired system pressures. Although long-term yield may be on the order of 20 gpm, short term yields of 25 gpm may be anticipated. The pump should be set at 350 feet to maximize well yield. At this depth, a motor shroud is recommended in the event that cascading occurs in the bore hole. The well pump should be controlled using a variable frequency drive (VFD) to allow automatic adjustments to the flow rate. This drive should be linked to a pressure transducer set within 5 feet of the pump. Based on water levels sensed by the pressure transducer, set points for the pumping rate can be programmed in the VFD to decrease flow rates as water levels decline. A final setting allowing the pump to shut off should water levels fall within 15 feet of the pump is recommended. This type of system is a common setup for irrigation systems and helps to protect against pump and motor burnout.
