**NEWTON PUBLIC BUILDINGS SURVEY
PHASE II – ANALYSIS OF HISTORICAL SIGNIFICANCE**

Building Analysis

Newton Corner Library

Address: 124 Vernon Street
Year of Construction: 1848

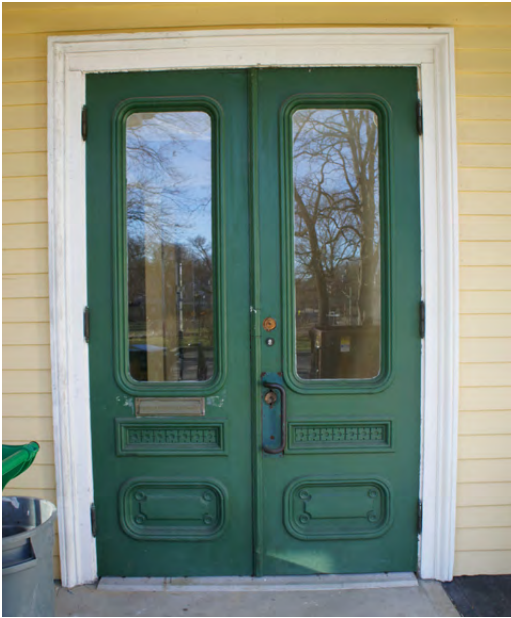
Figure 3: Double entrance door at east porch.

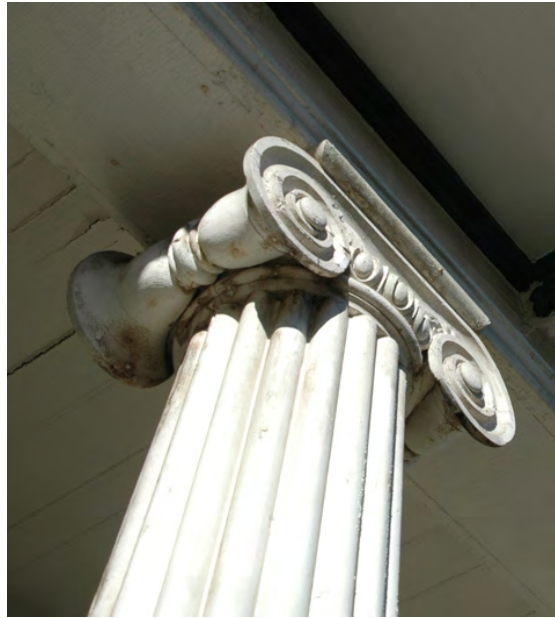
Figure 4: Close up view of ionic column capital at east porch.

- Determine the source of moisture that is causing the porch decking to warp and address. Repair or replace the porch floorboards in kind.
- Remove biological growth and peeling paint from porch columns and repaint.

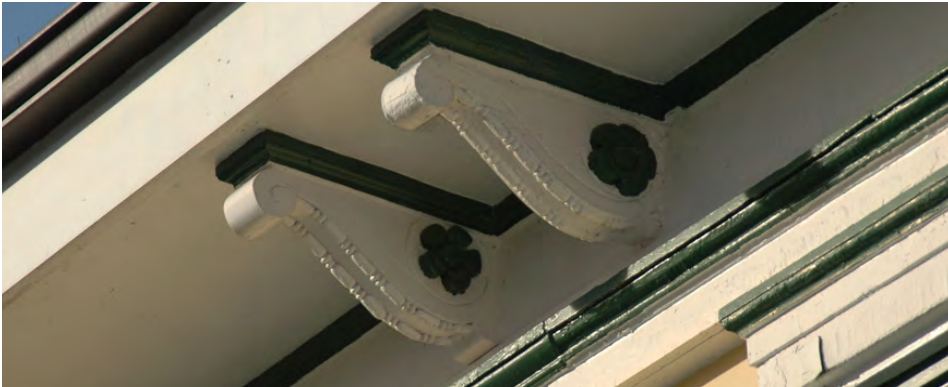
Figure 5: Eave brackets at main building roof.

- Scrape existing paint from chimneys and repaint.
- Remove multiple layers of built up paint from decorative wood elements and repaint. It is recommended that paint analysis be performed prior to stripping to identify historic paint colors.
- Replace the deteriorated modified bitumen roof over the first floor ell entrance door canopy with a more historically appropriate material.

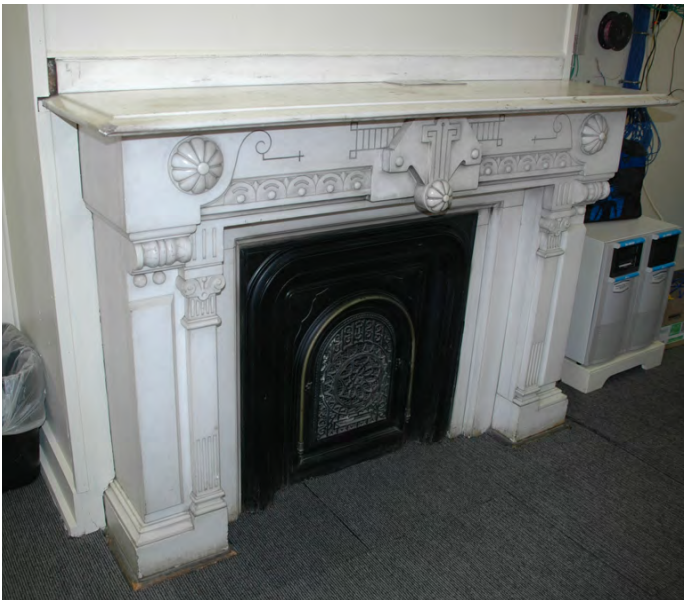
Figure 6: Stone fireplace surround in ground floor reading room.

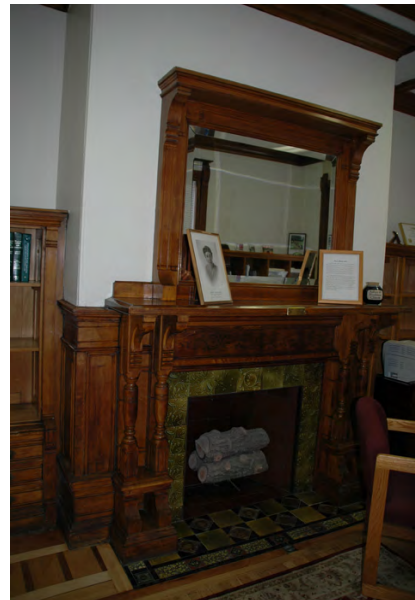
Figure 7: Wood fireplace surround and overmantle in Sloan Study.
