APPENDIX I – PHOTOGRAPHS OF EXISTING CONDITIONS

Building Envelope Study
Newton Health Department Building
Newton, MA

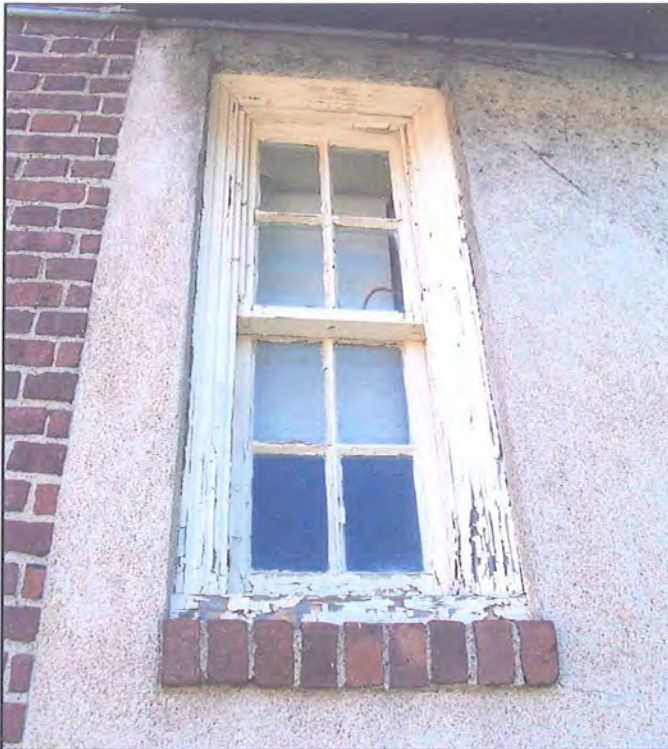
W-1

Window Type E- South Elevation

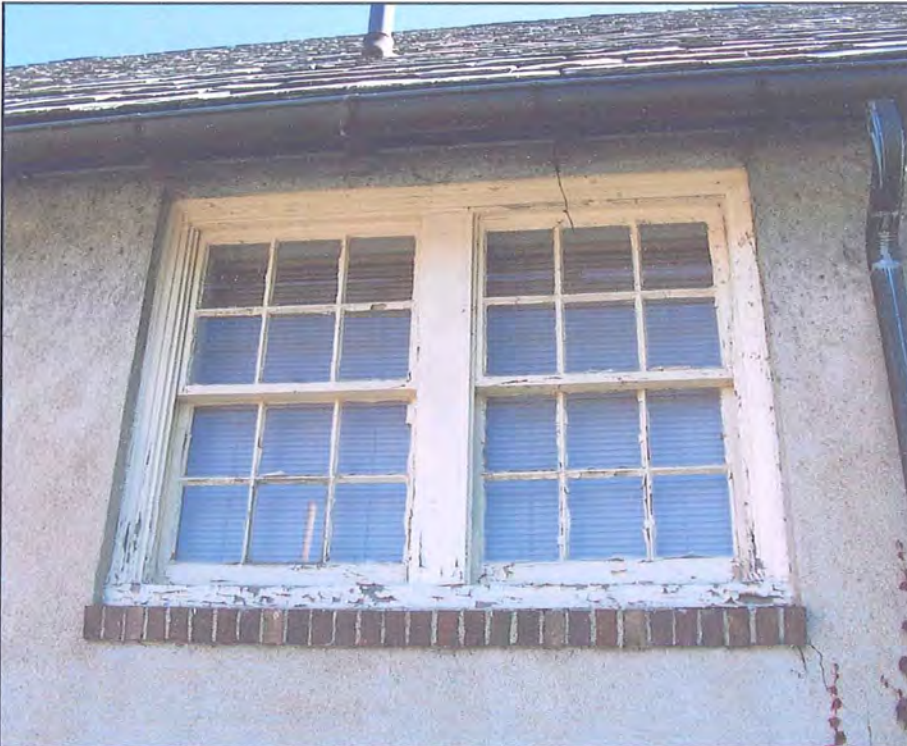
W-2

Window Type F- South Elevation

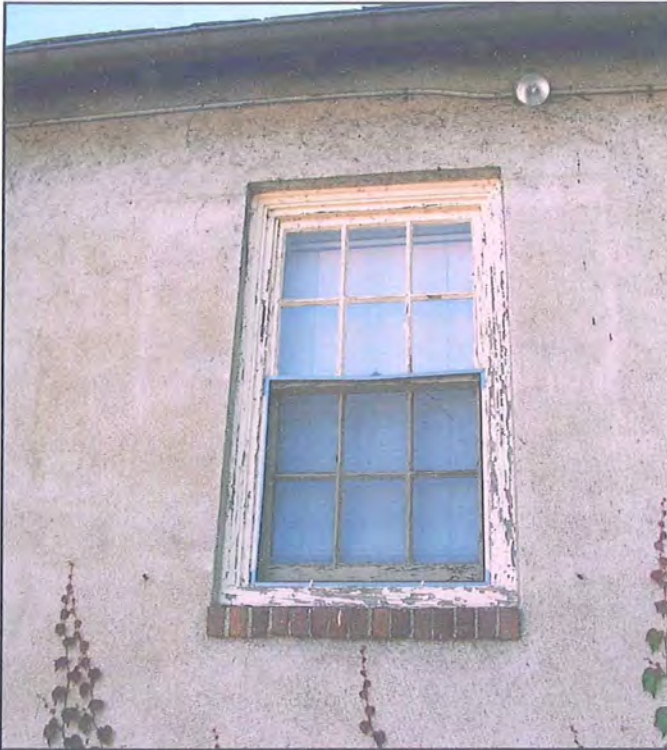
W-3

Window Type A - South Elevation

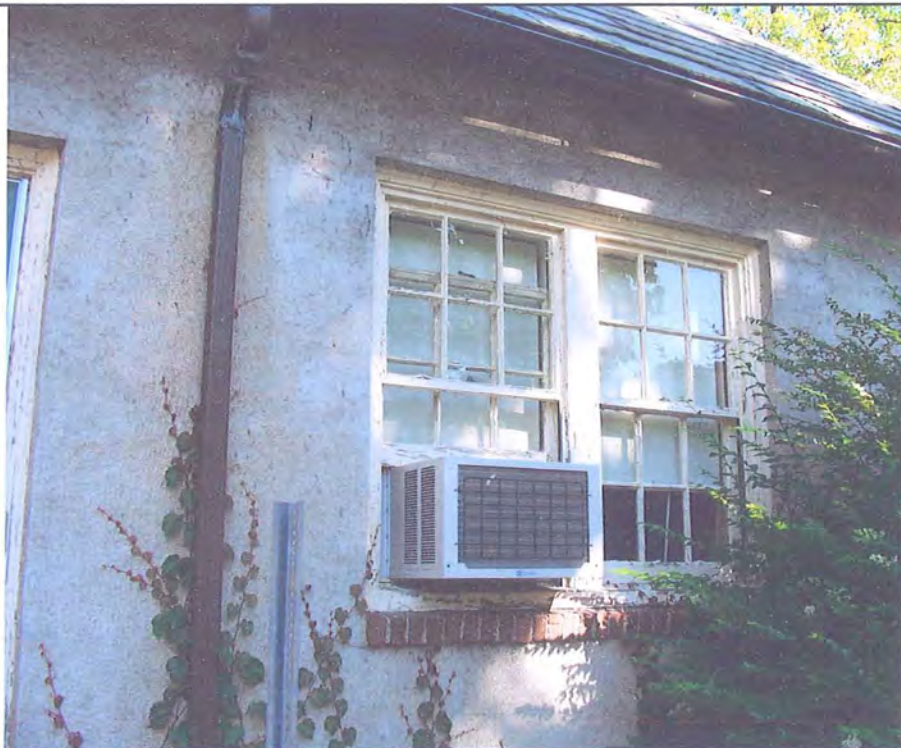
W-4

Window Type A-7 - East Elevation

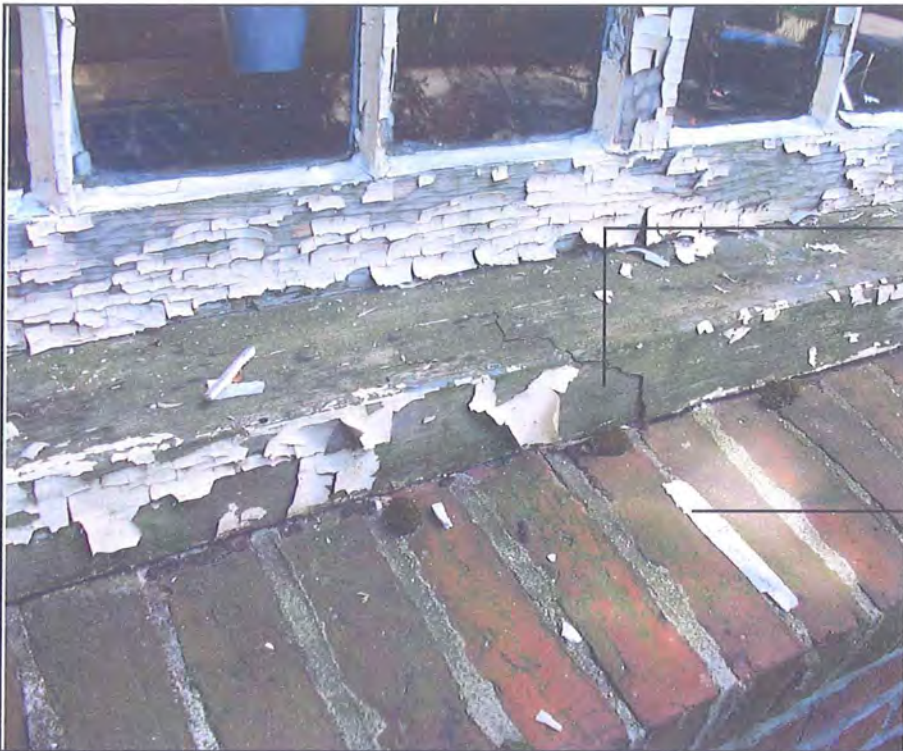
W-5

Rotted Sill

Loose Repointing Grout

Window Type B1 - North Elevation- Sill
Rot

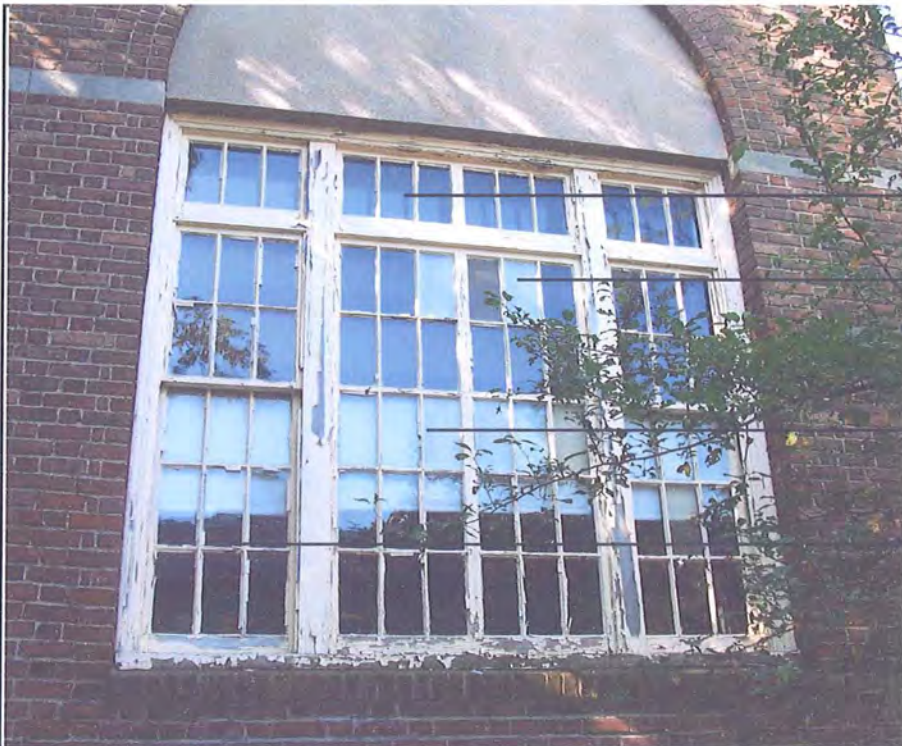
W-6

Missing Panes

Window Type B1- North Elevation

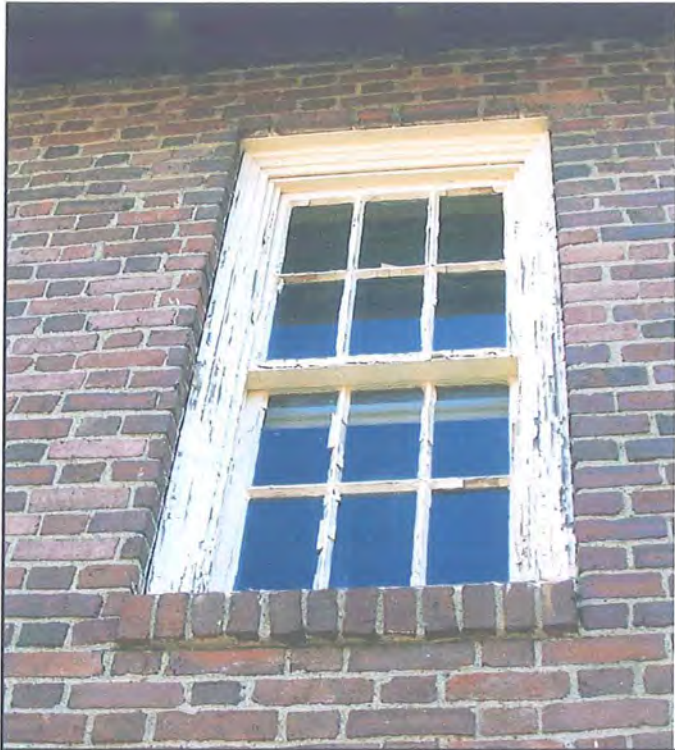
W-7

Window Type C - South Elevation

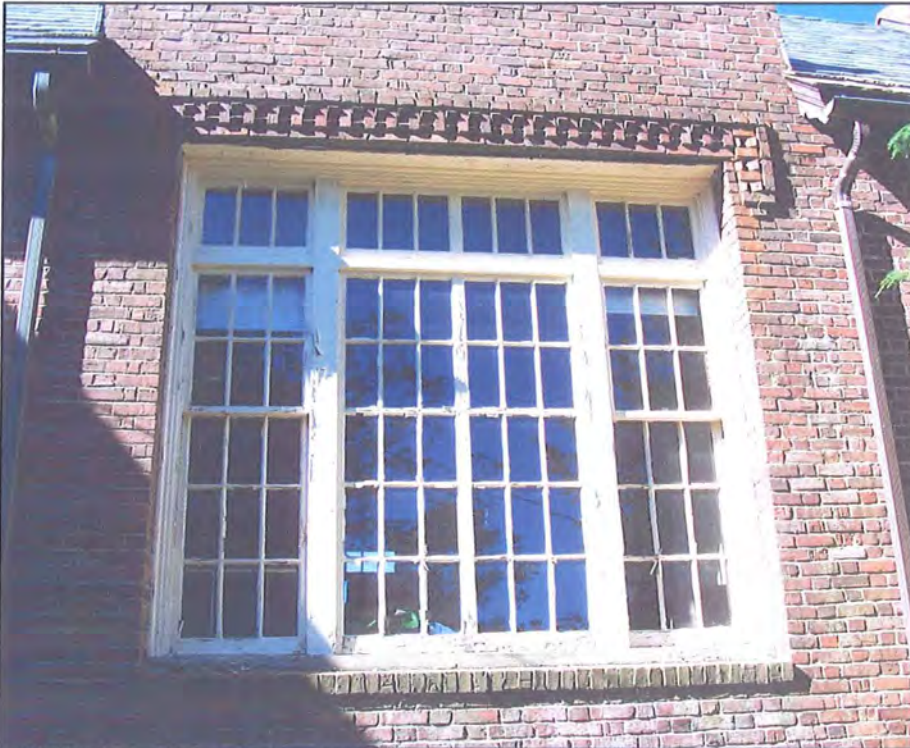
W-8

Window Type B-2 - North Elevation

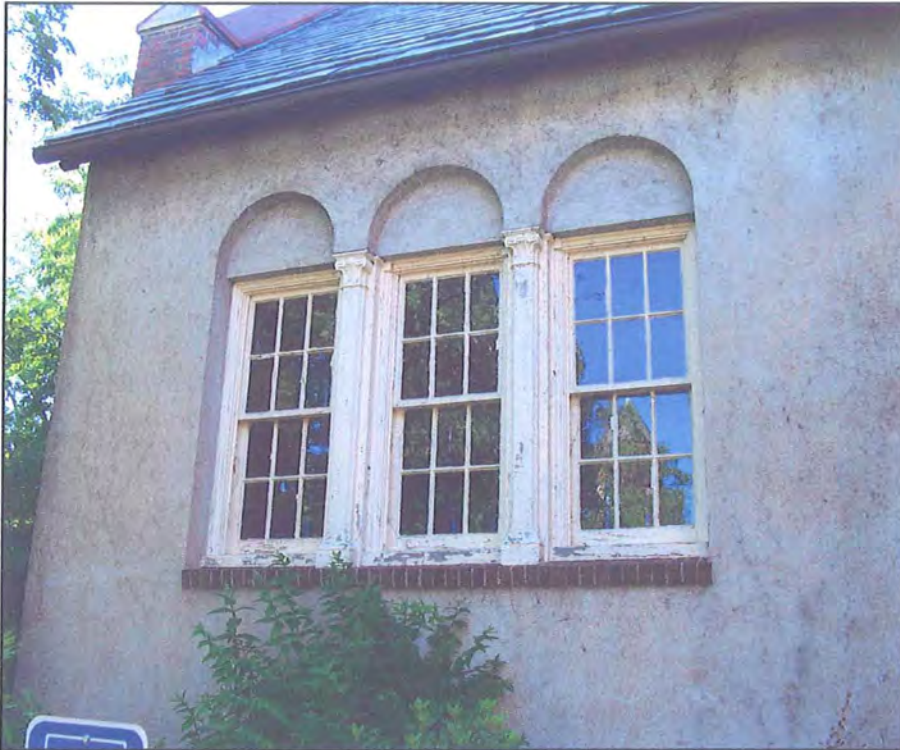
W-9

Window Type C-4 - West Elevation

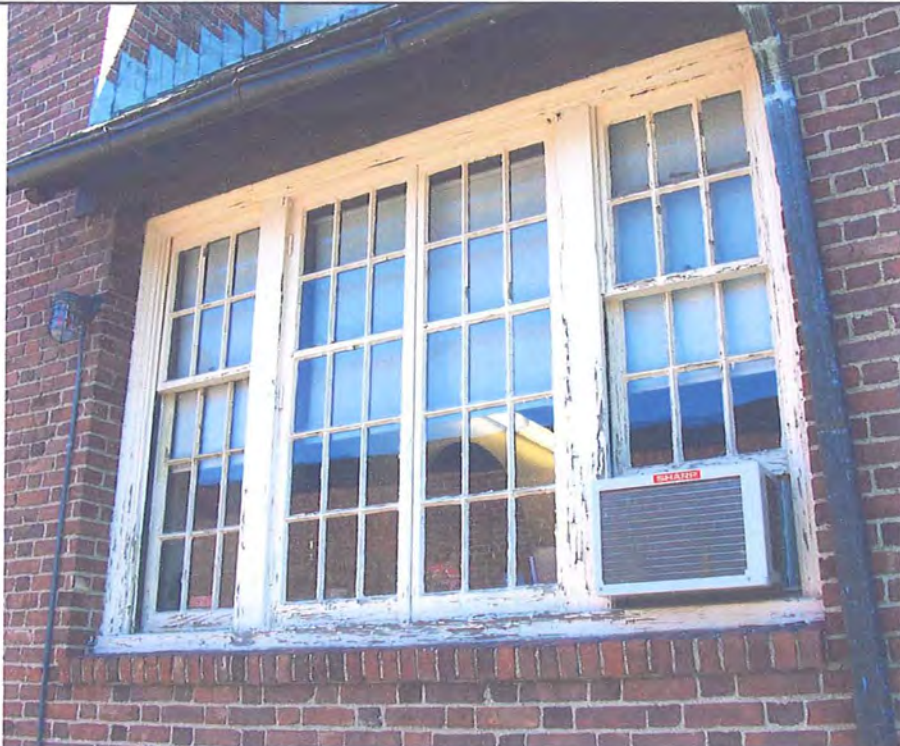
W-10

Window Type B-4 - South Elevation

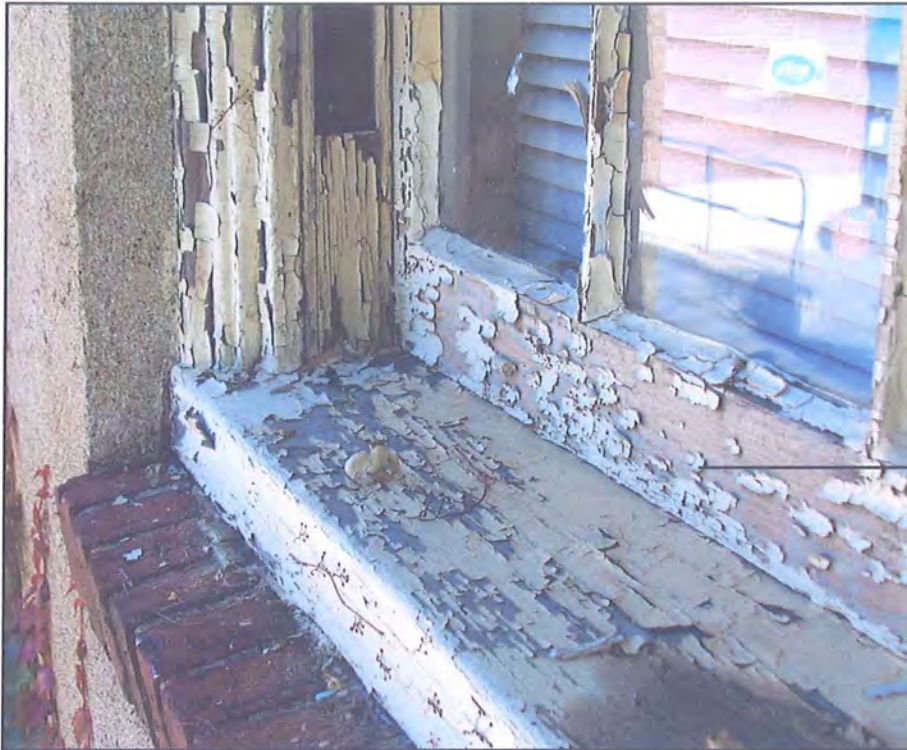
W-11

Paint flaking off to bare wood

Detail of Window Sill-

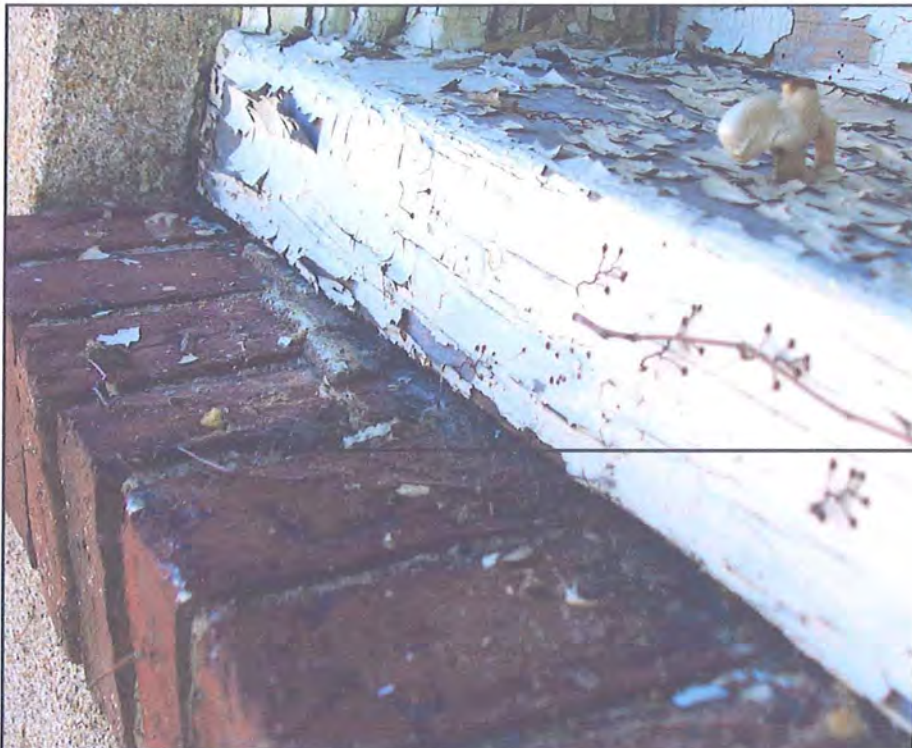
W-12

Brick Sills Need Repointing

Detail of Brick Window Sill-

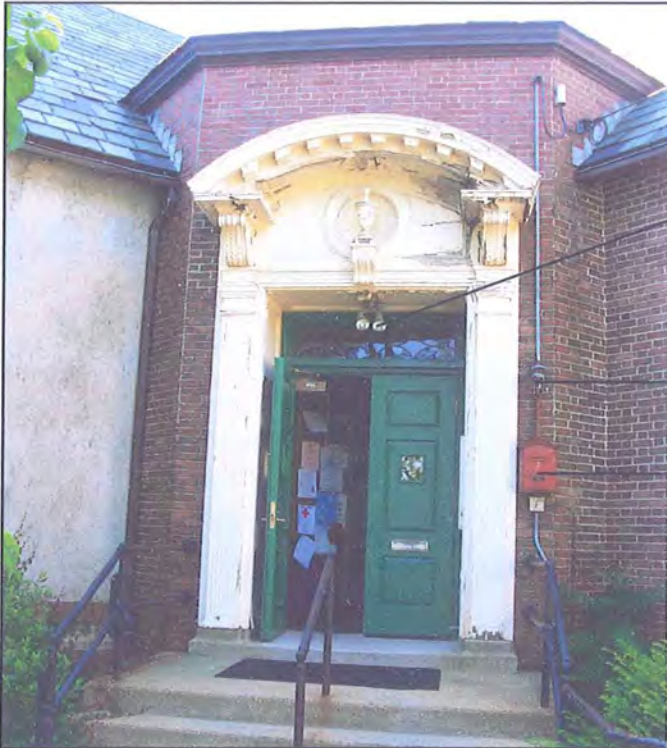
D-01

Fire alarm beacon-broken

Front "Ceremonial" Entry

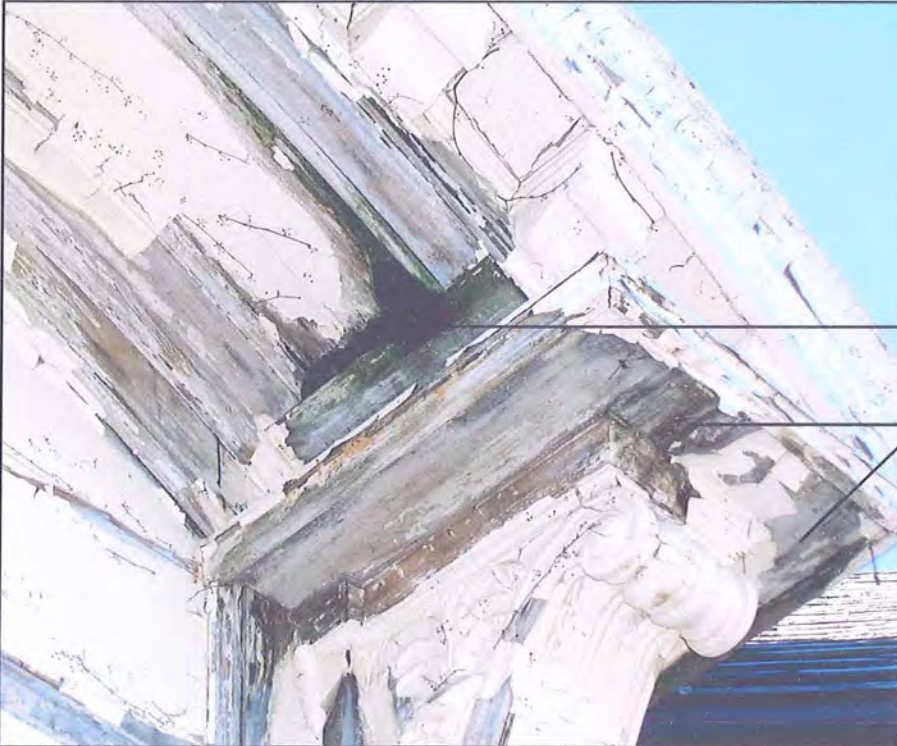
D-02

Rotted soffit

Rotted Console

Detail of Curved Entry Hood

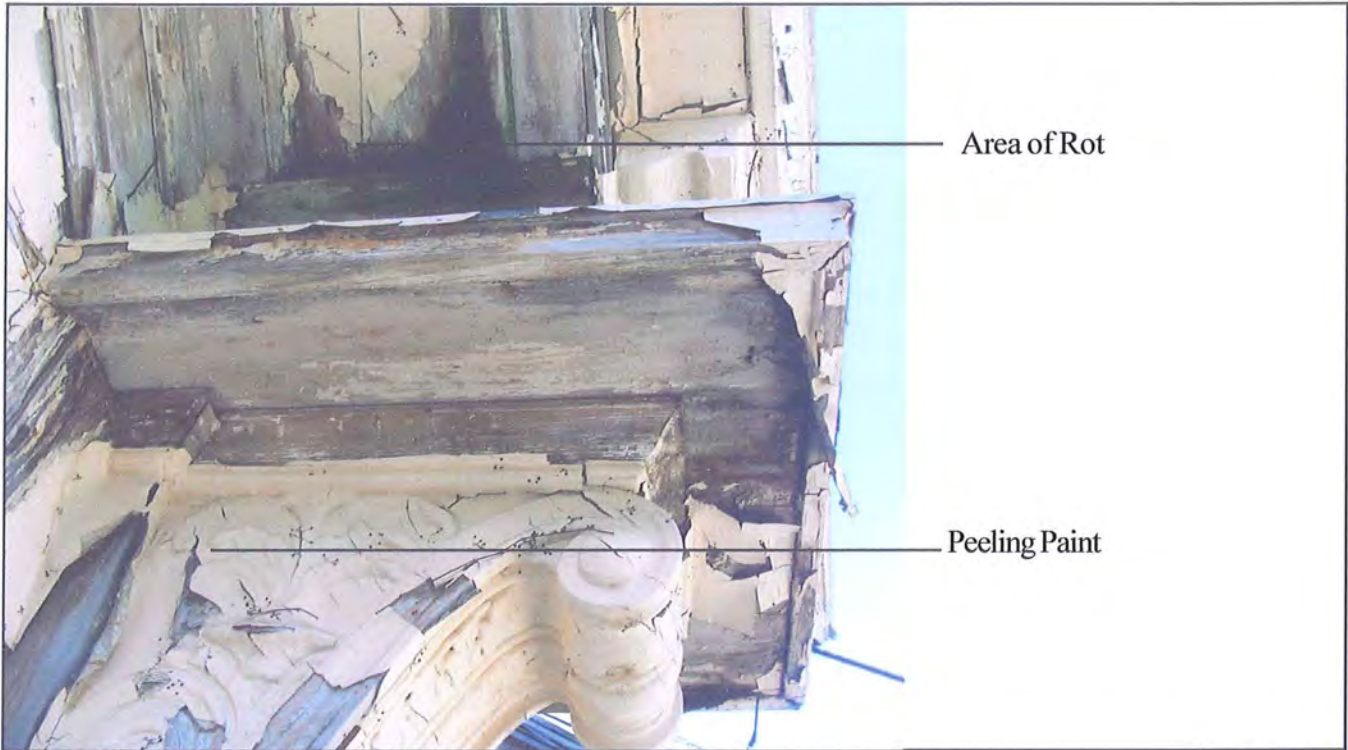
D-03

Area of Rot

Peeling Paint

Detail of Carved Wood Console

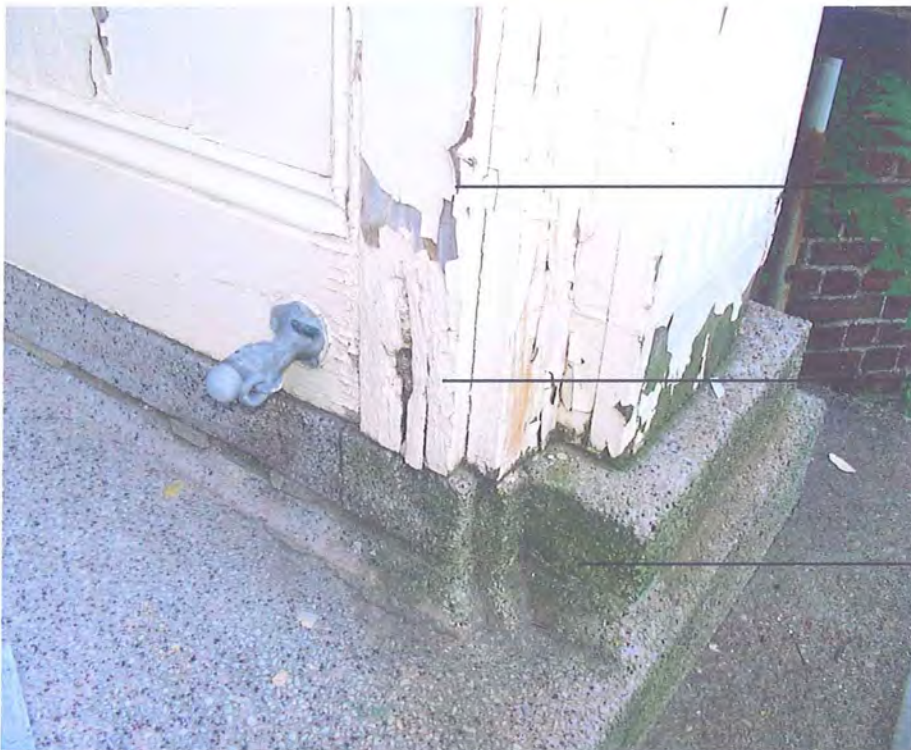
D-04

Peeling Paint

Deteriorated wood pilaster

Detail of Wood Pilaster and Stone Plinth

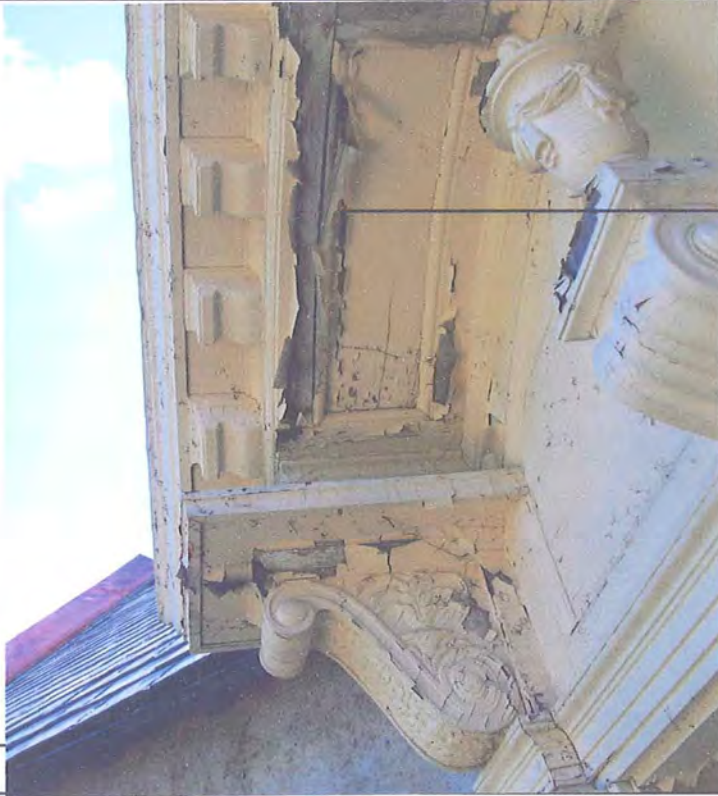
D-05

Rotted Soffit

Left Side of Curved Entry Hood

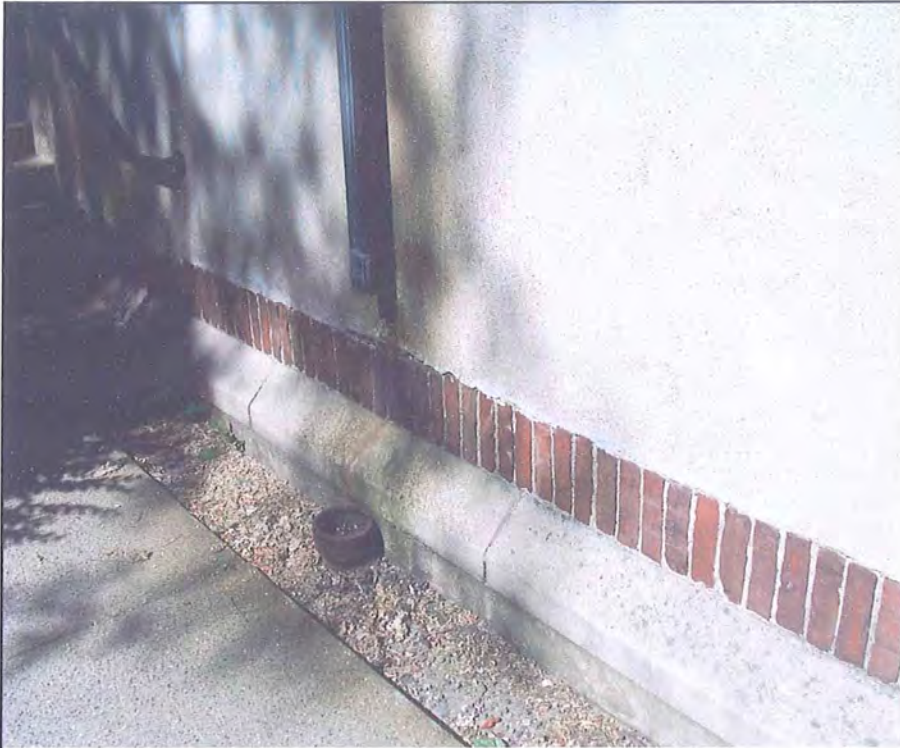
M-01

Missing Downspout

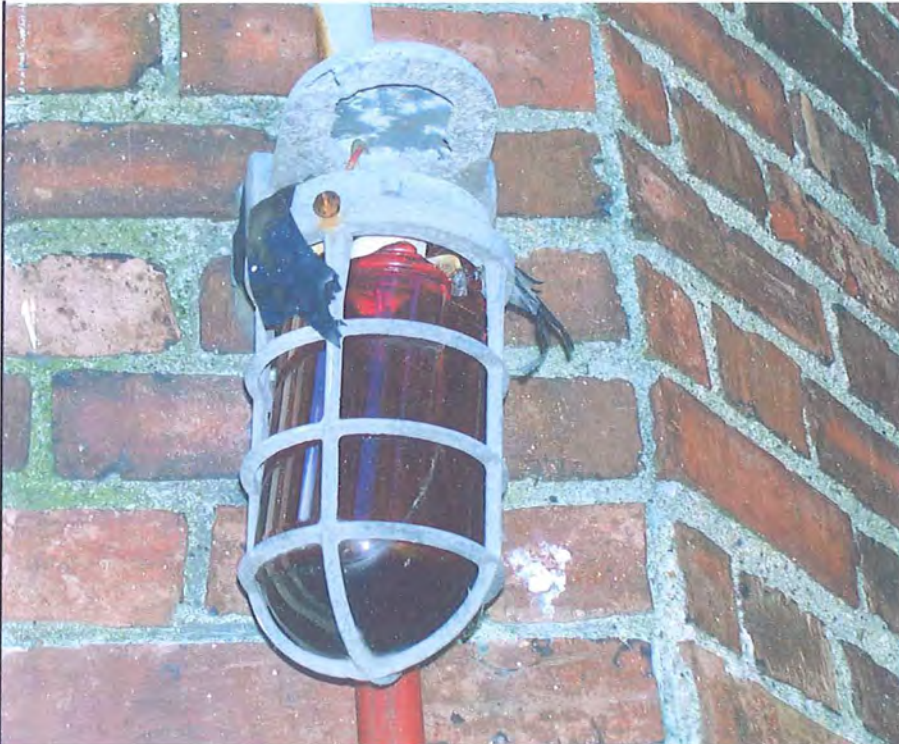
M-02

Broken Fire Alarm Beacon

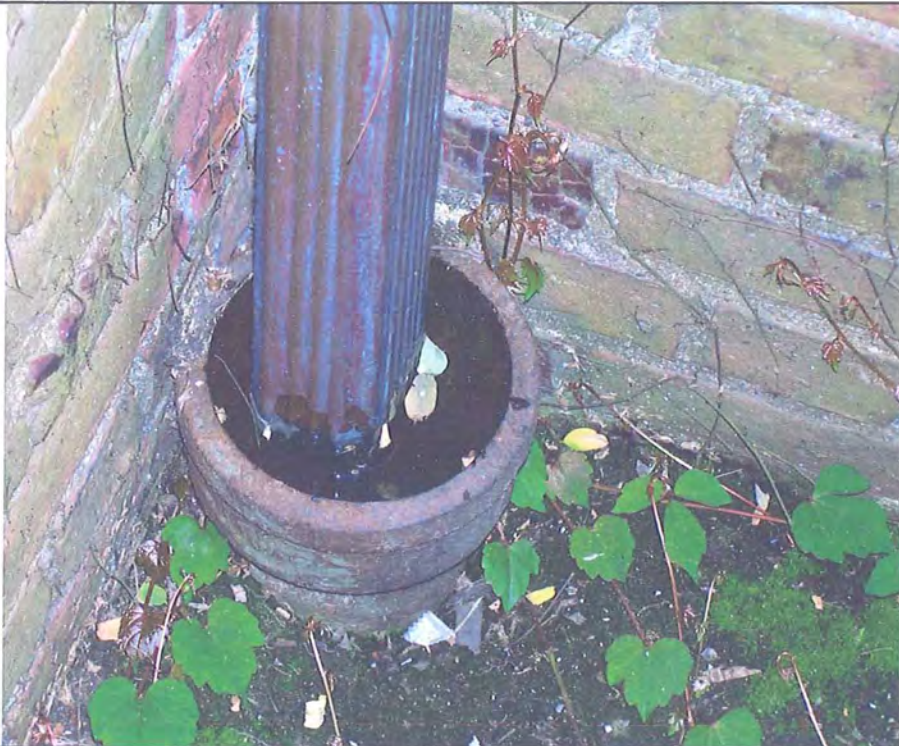
M-04

Blocked Vitrious Clay Drain Conduit

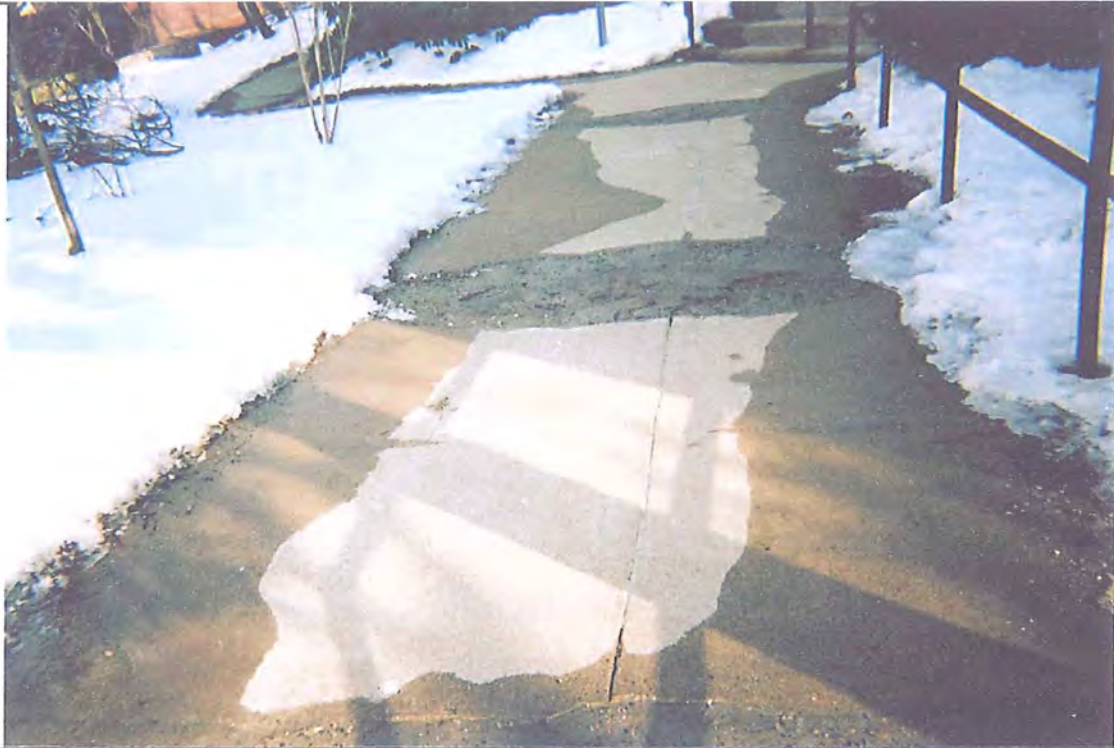
M-05

Deterioration of Sidewalk

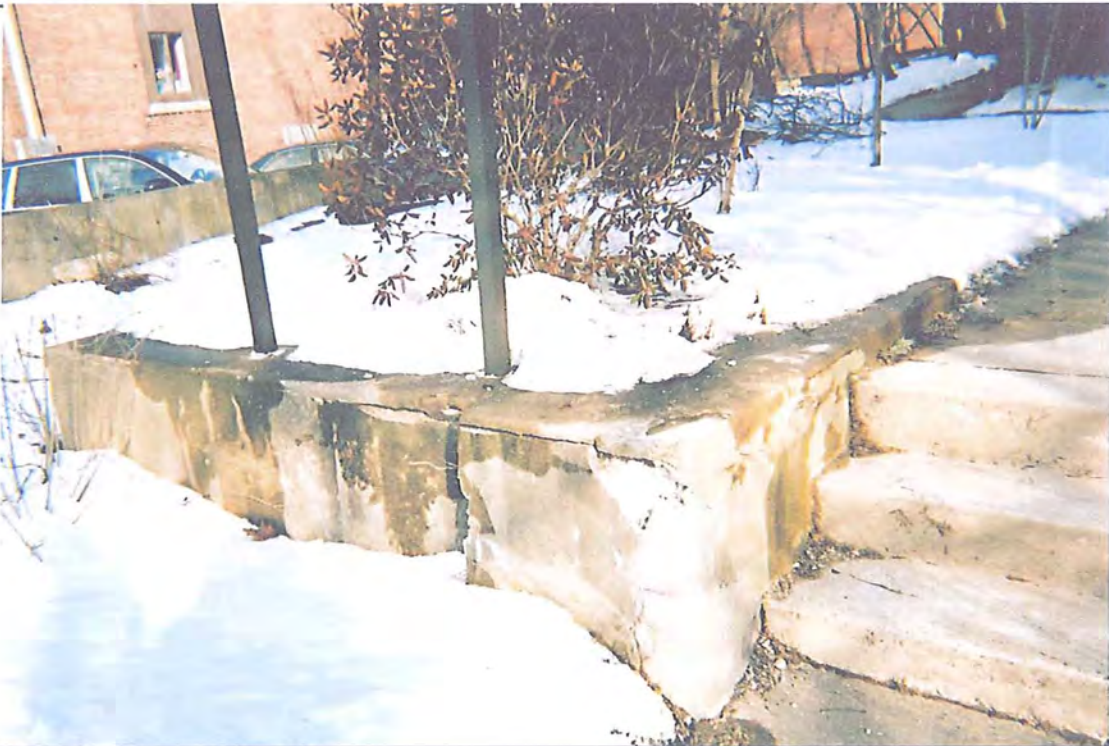
M-

Deterioration of Concrete
