**CSS Architects, Inc.  
Wakefield, Massachusetts**

**EVALUATION OF BUILDING ENVELOPE**

**Newton Health Department Building  
Newton, Massachusetts**

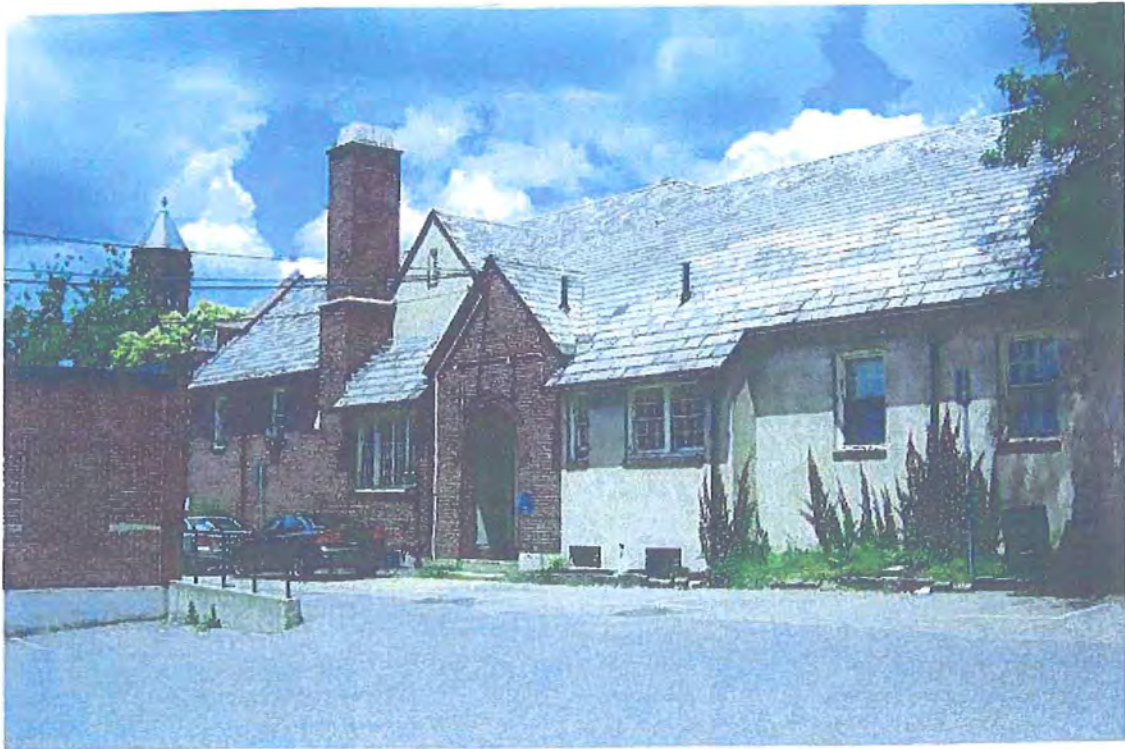
↑ PHOTOGRAPH 1

General view of south elevation.

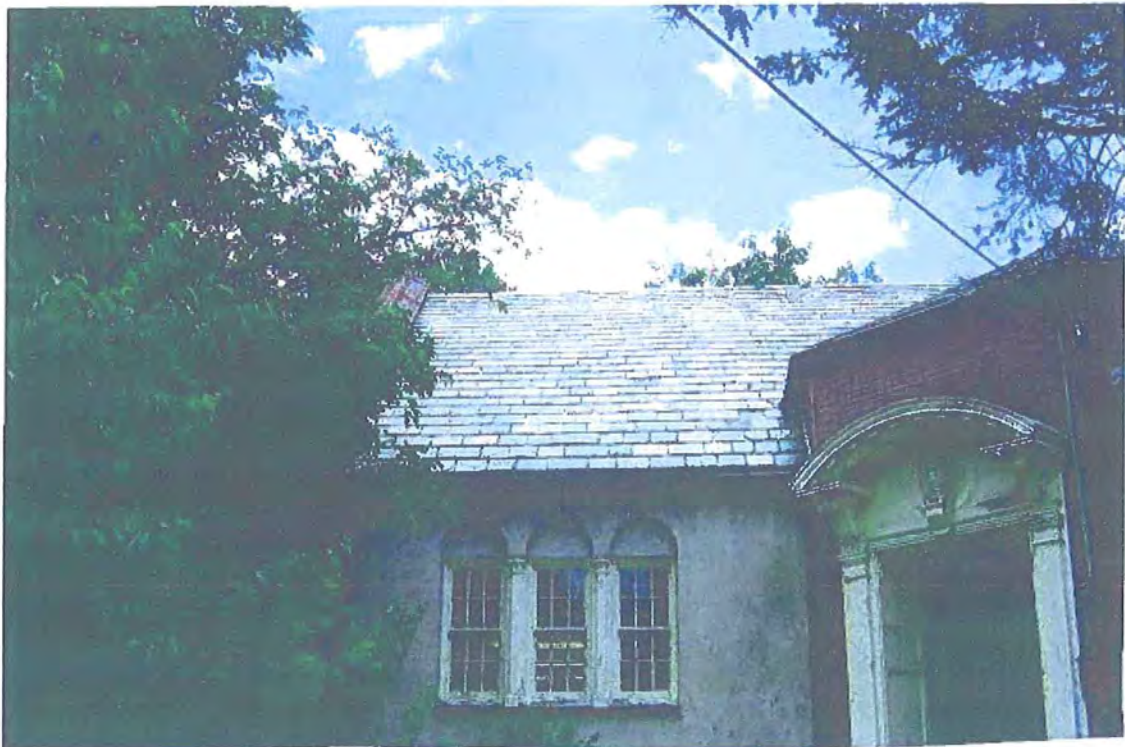
↑ PHOTOGRAPH 2

Partial view of west elevation.

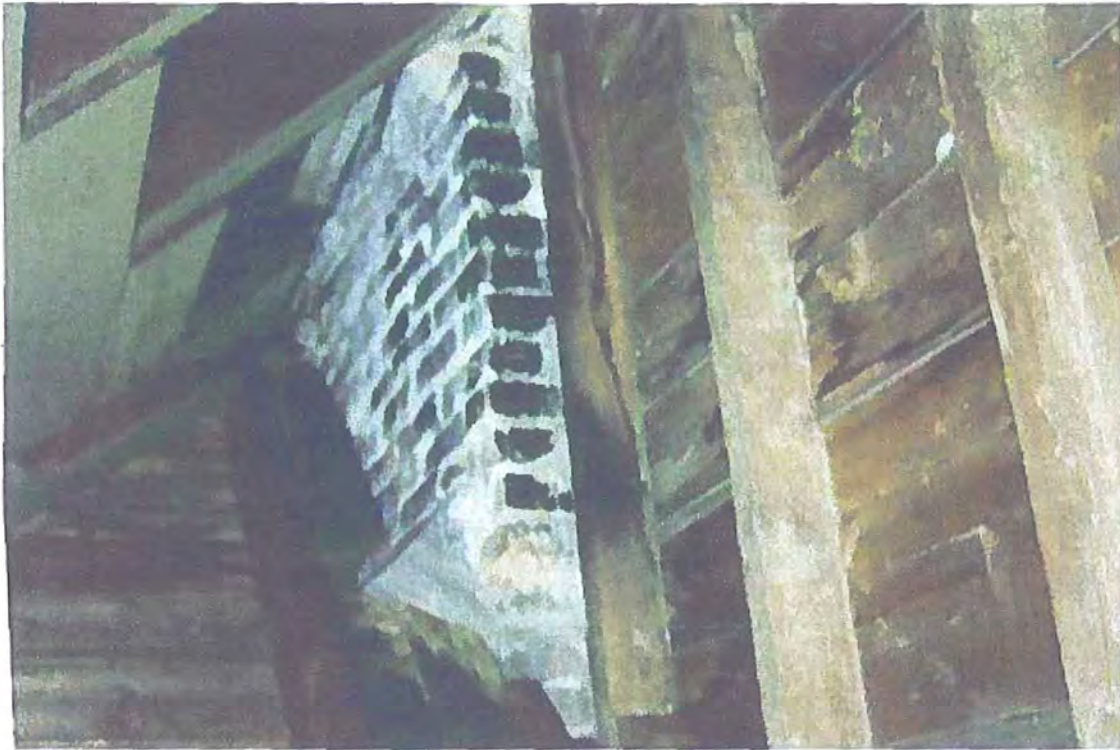
↑ PHOTOGRAPH 3

View in attic of efflorescence on the wall of the chimney and water stains on the roof decking, walls, and framing.

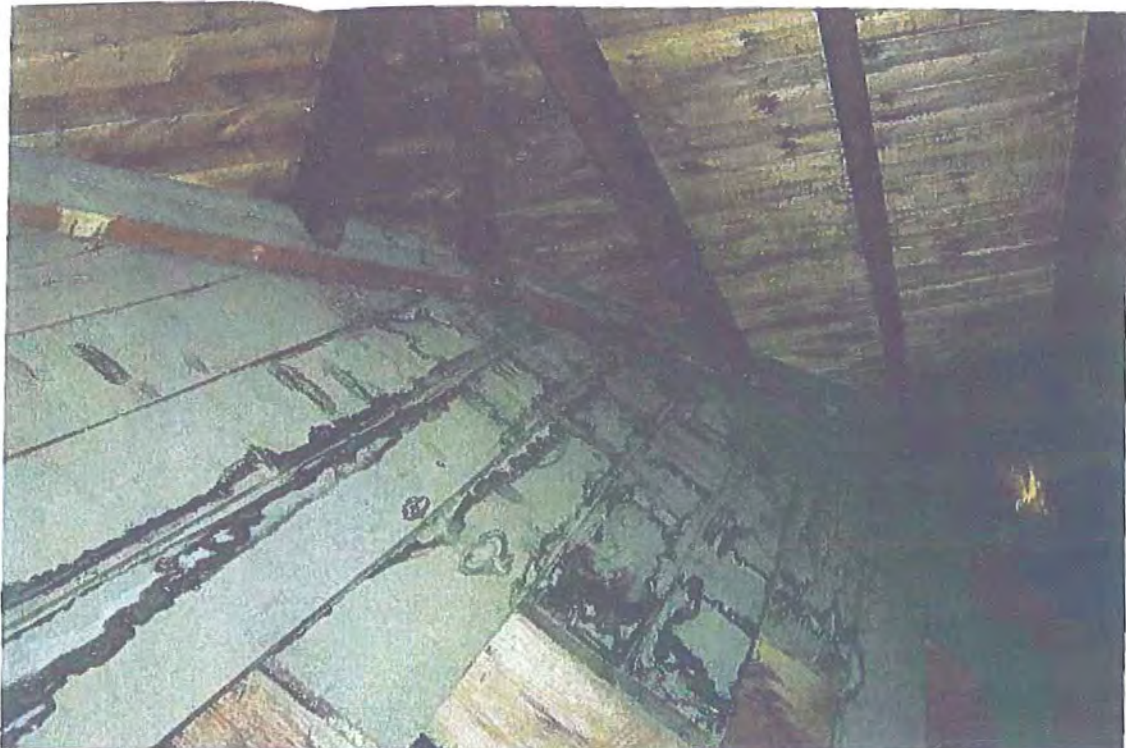
↑ PHOTOGRAPH 4

View in attic of water staining on the roof decking along the valley and hip of the roof above the northwest entrance.

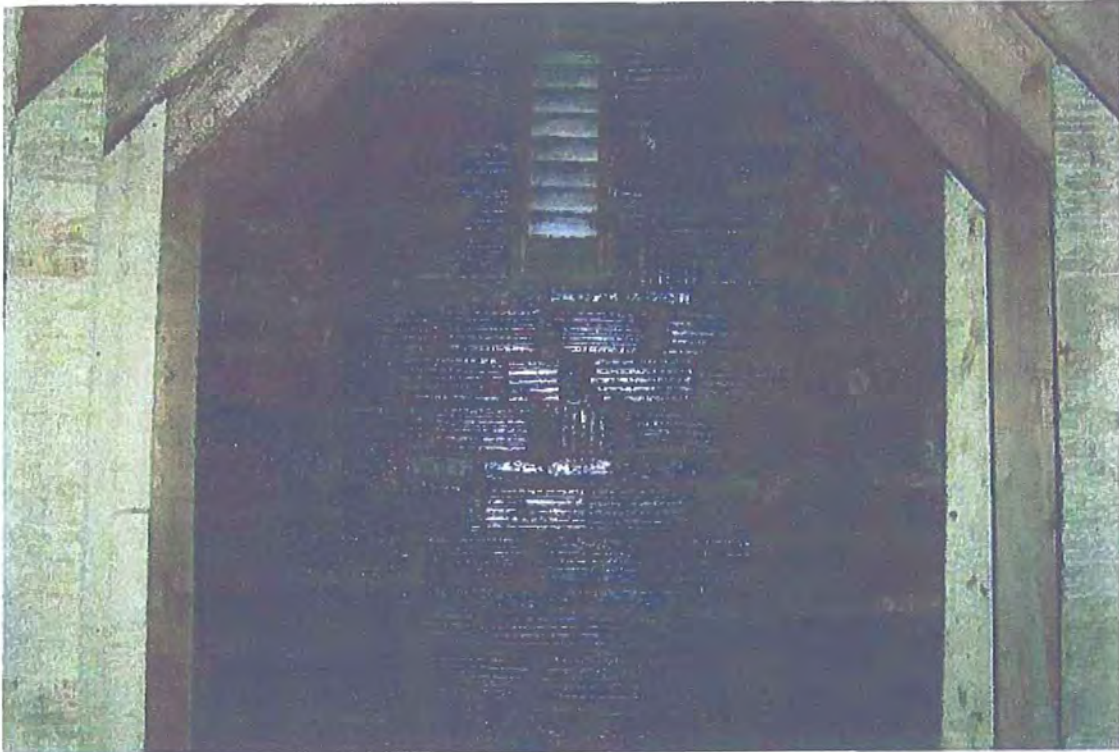
↑ PHOTOGRAPH 5

View of west end wall with discoloration of the mastic on the terra cotta back-up wall due to water penetration.

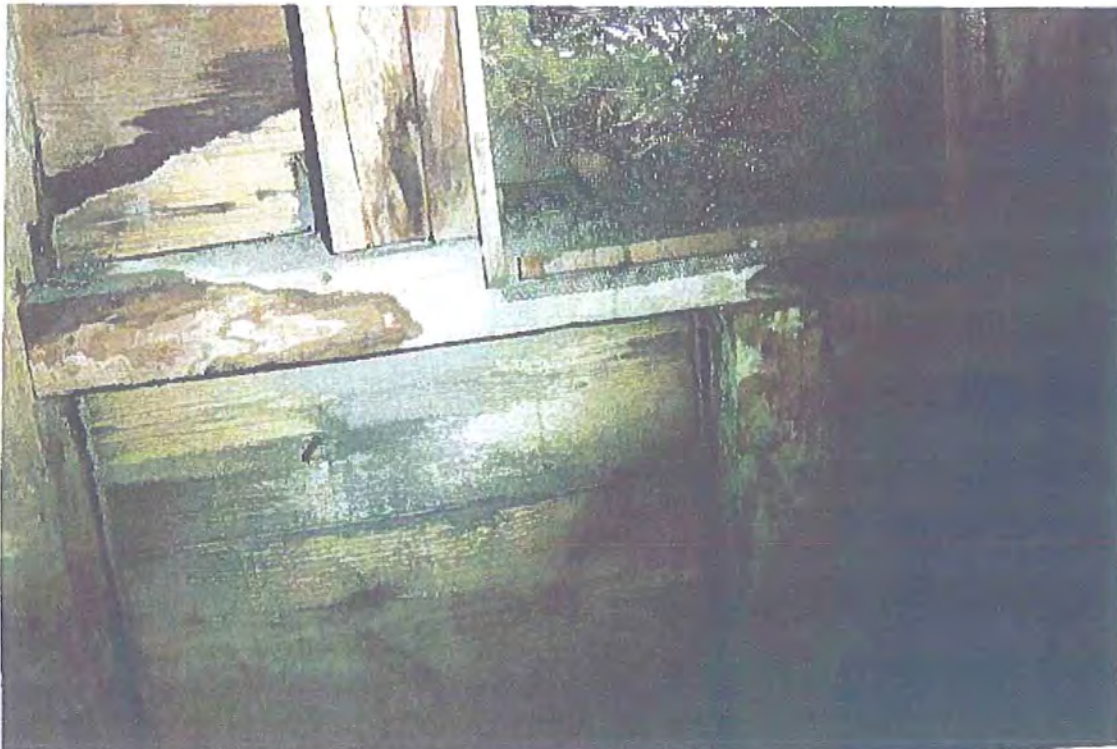
↑ PHOTOGRAPH 6

View of water staining on the boarding and framing around the bottom of the attic vent.

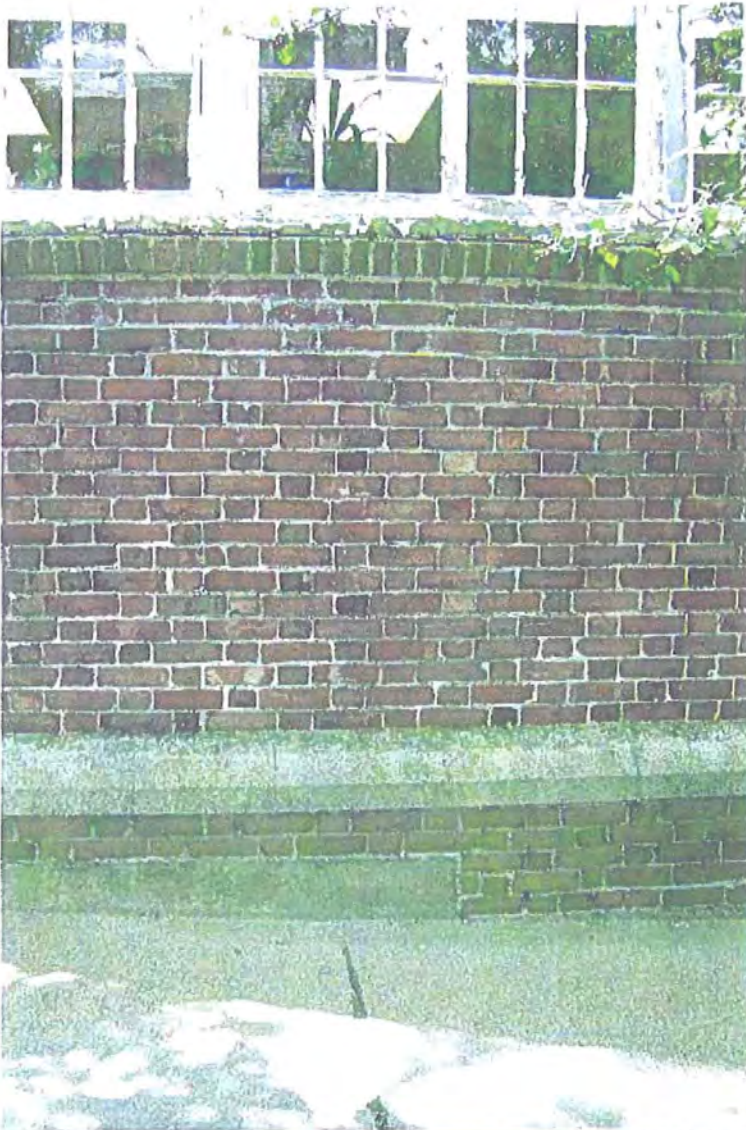
← PHOTOGRAPH 7

View of deteriorated mortar joints at a rowlock in the wall below a window sill.

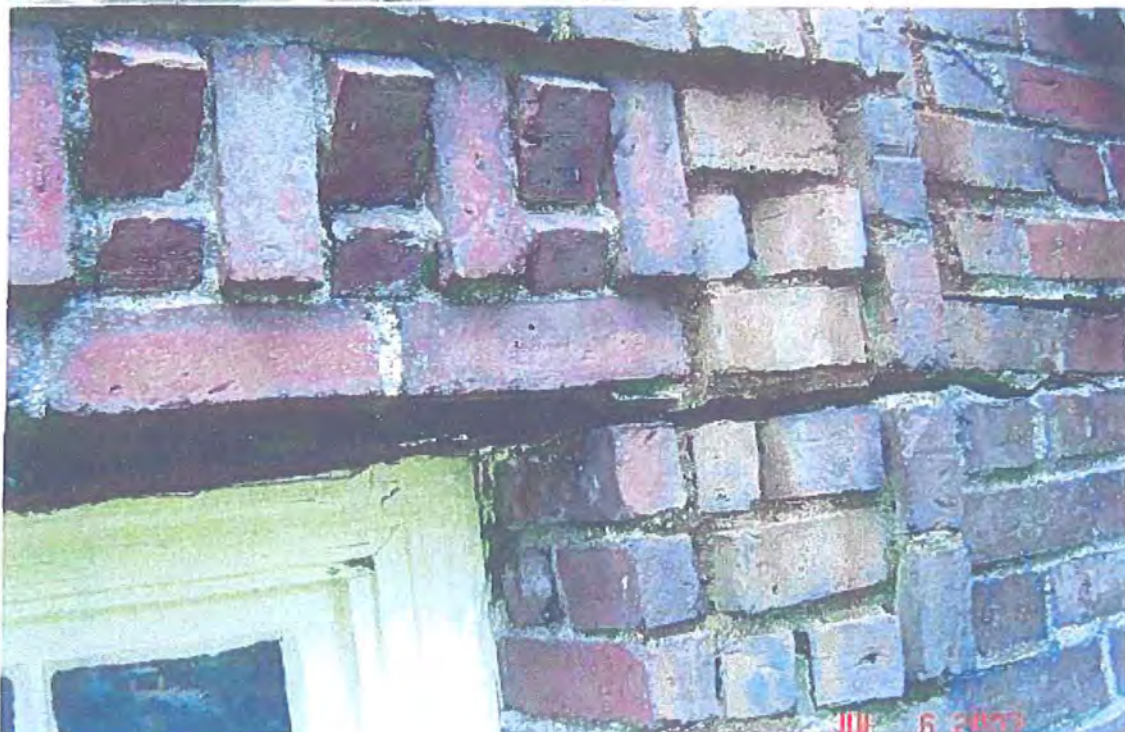
↓ PHOTOGRAPH 8

View of rust scale on a lintel and cracks in the mortar joints in the brick wall beyond the window opening at the lintel.

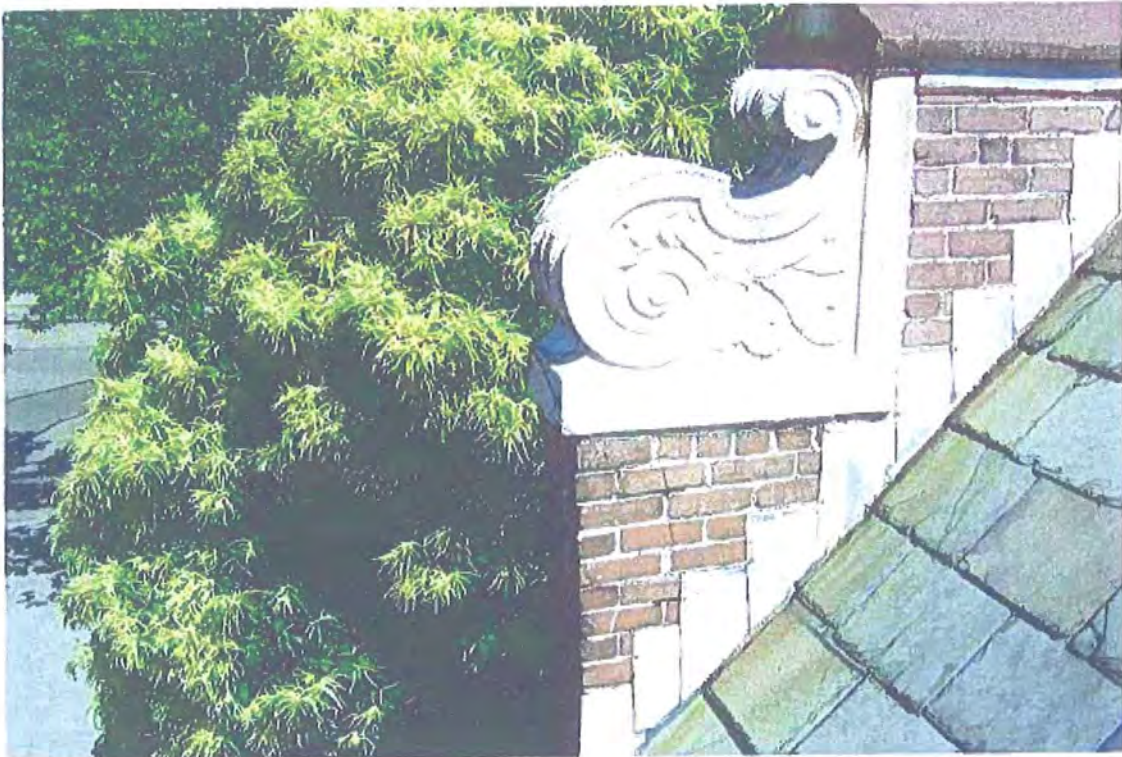
↑ PHOTOGRAPH 9

View of cracking and deteriorated mortar joints below a scrolled capstone on top of the west end wall.

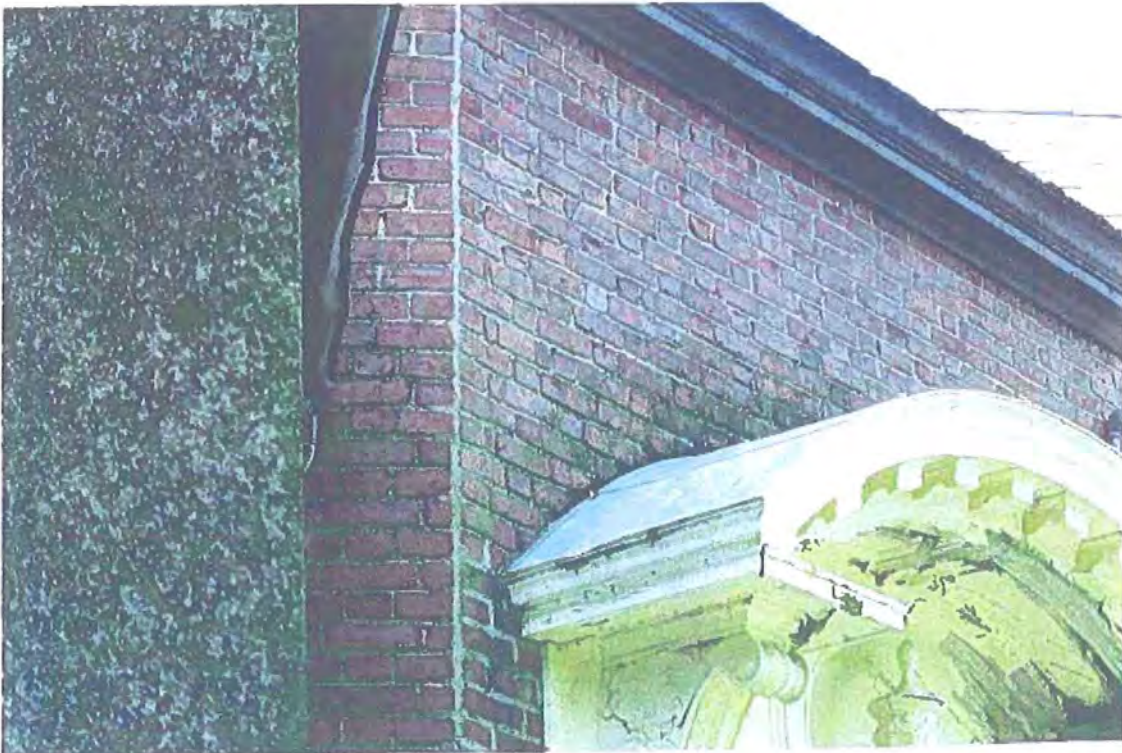
↑ PHOTOGRAPH 10

View of missing mortar between the brick wall and copper roofing where the roofing enters the brick masonry wall.

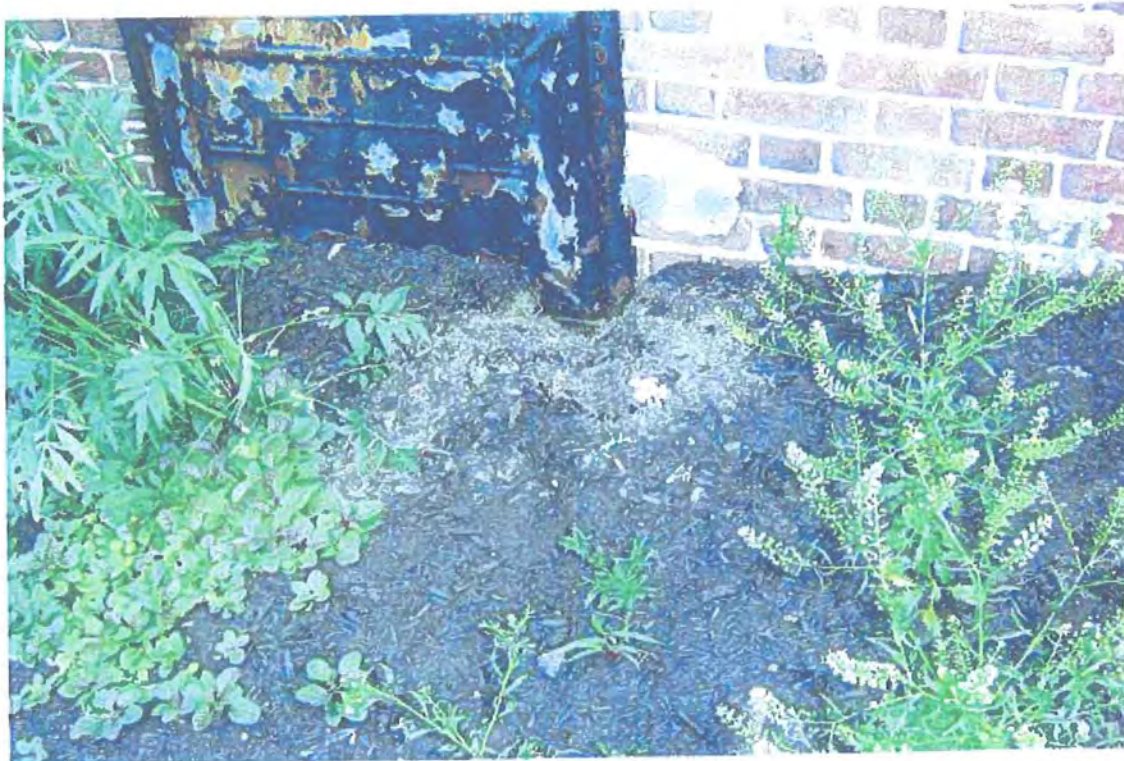
↑ PHOTOGRAPH 11

View of mortar patched brick and the bottom of the coal chute door covered by landscaping mulch.

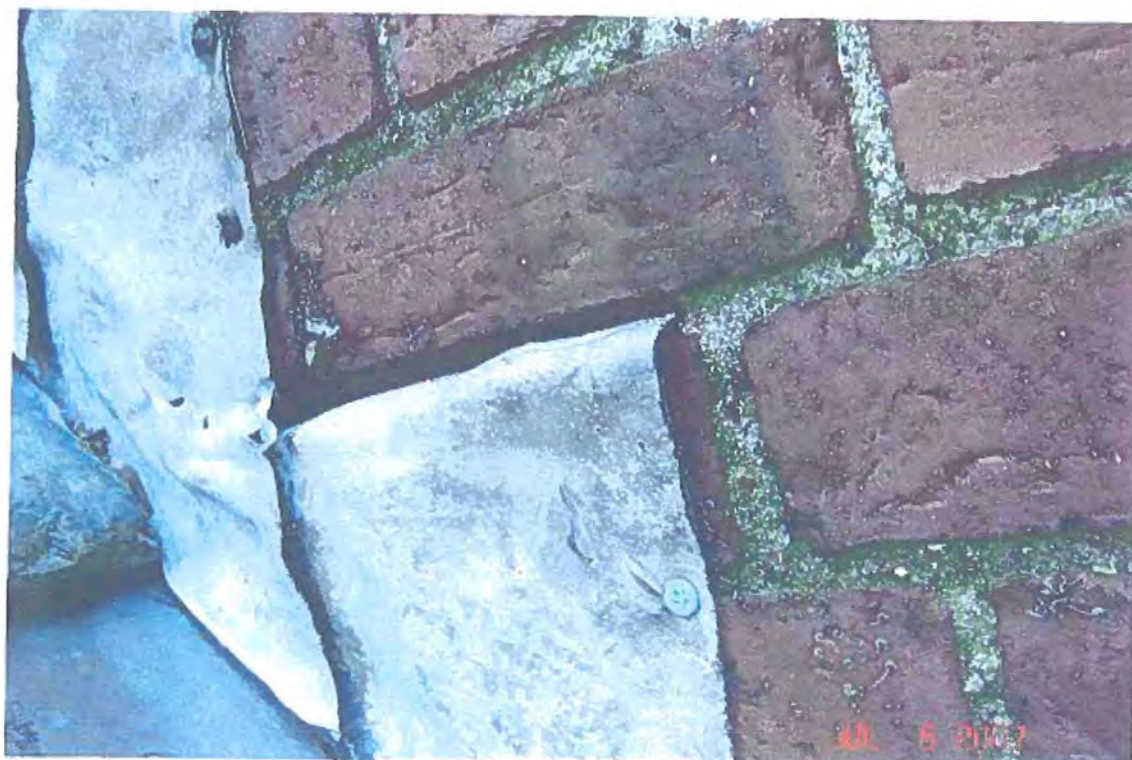
↑ PHOTOGRAPH 12

View of missing mortar above step flashing, and holes in the step flashing.

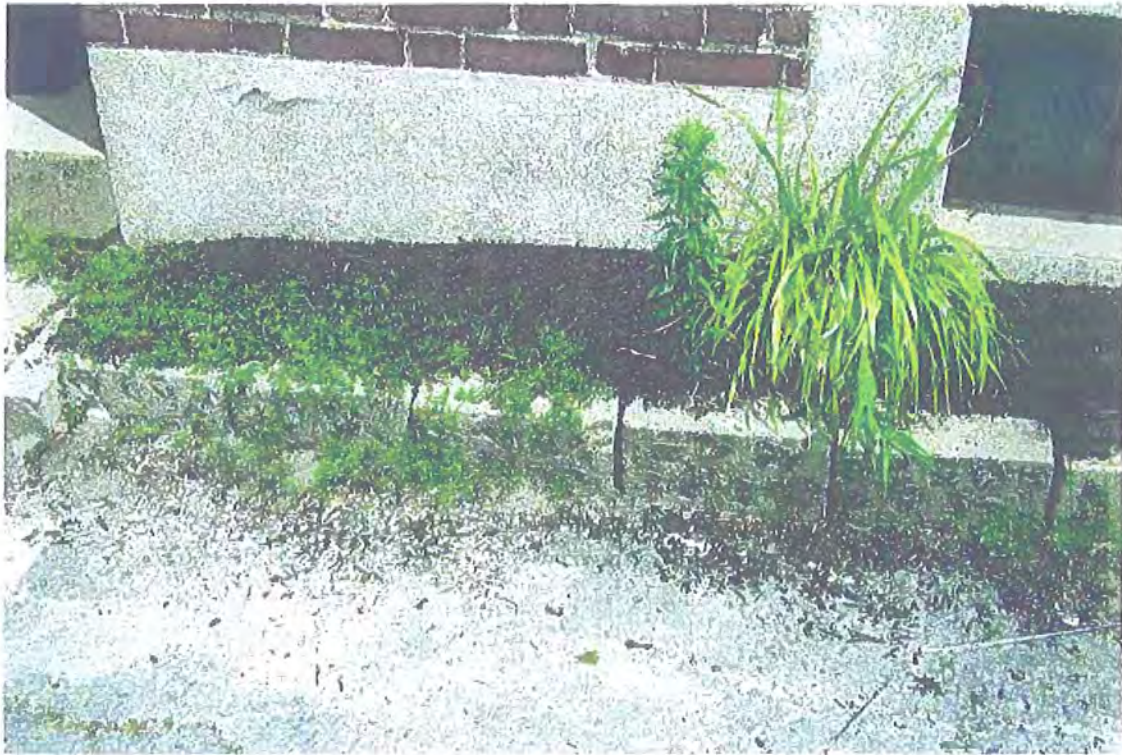
↑ PHOTOGRAPH 13

View of a small spall in the stucco at ground level.

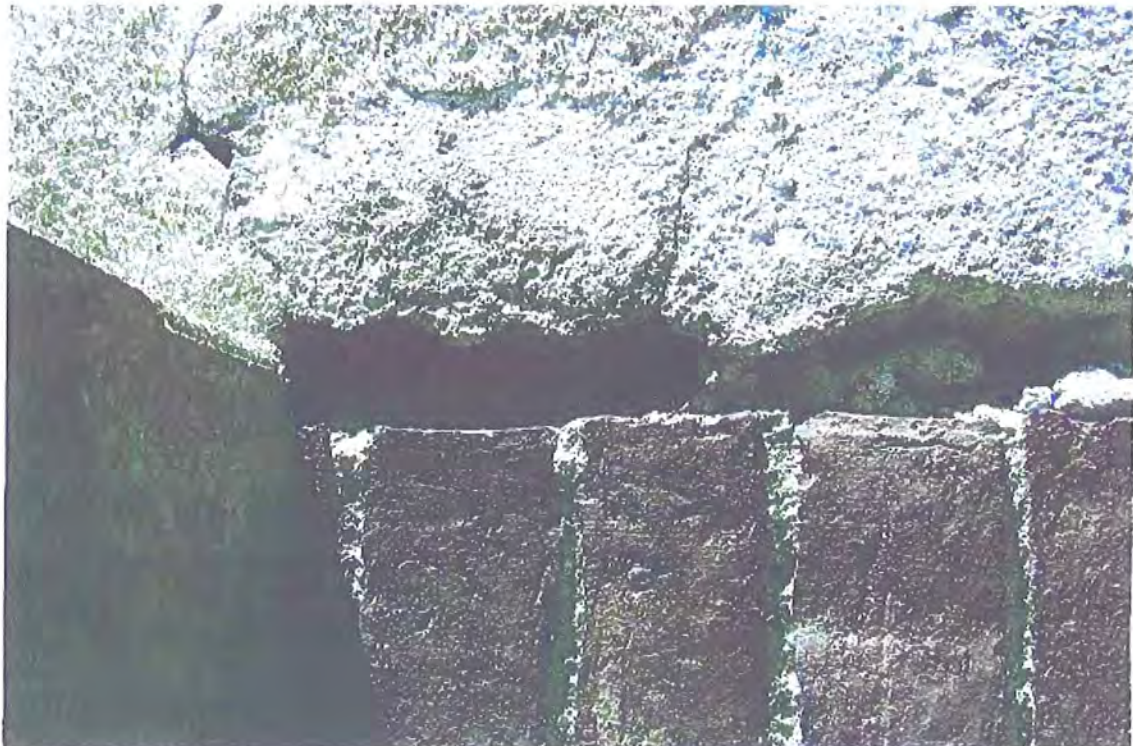
↑ PHOTOGRAPH 14

View of deteriorated stucco above the sidewalk steps on the west elevation.

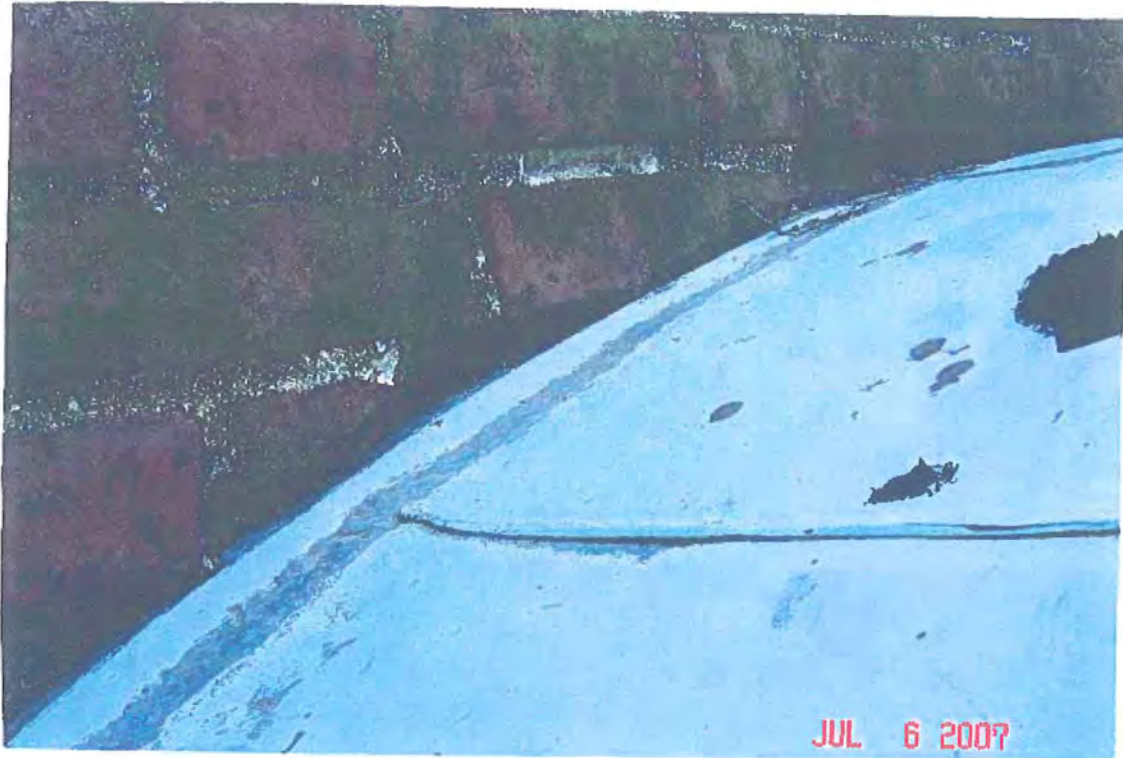
↑ PHOTOGRAPH 15

View of holes in the copper barrel roofing at the front entryway.

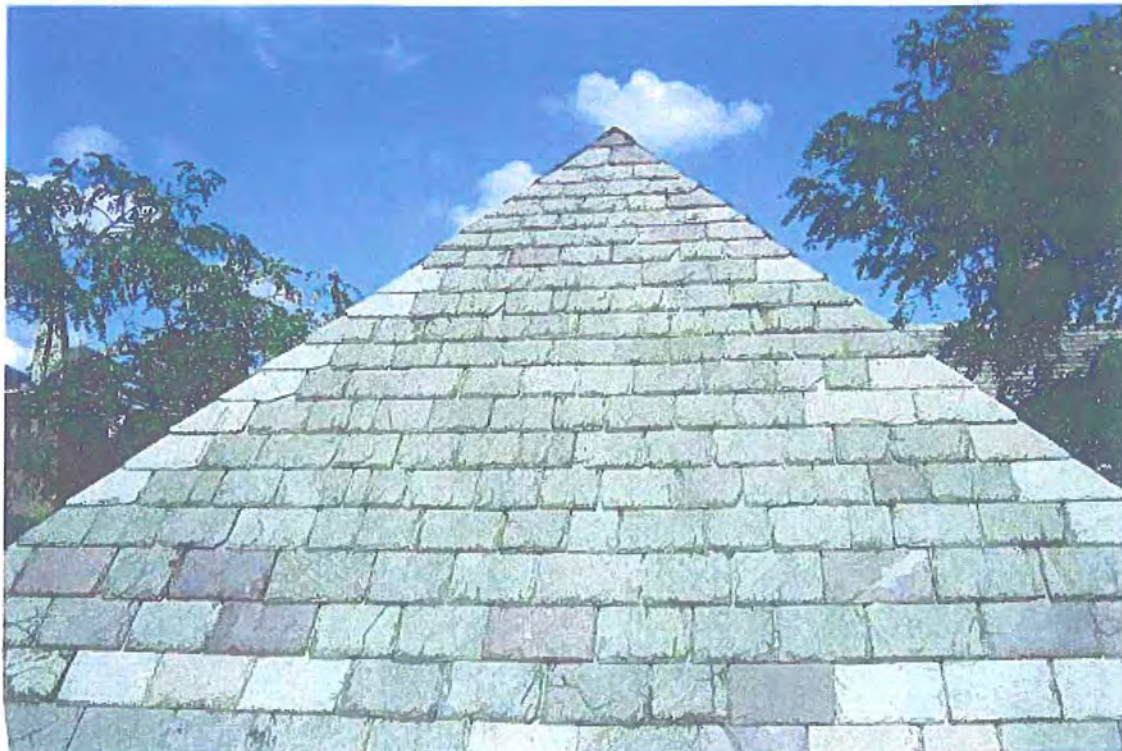
↑ PHOTOGRAPH 16

View of east-sloped roof area at the end of the east-west wing with replacement slates along the hips and cracked and broken slates with flaking surfaces in the roof field.

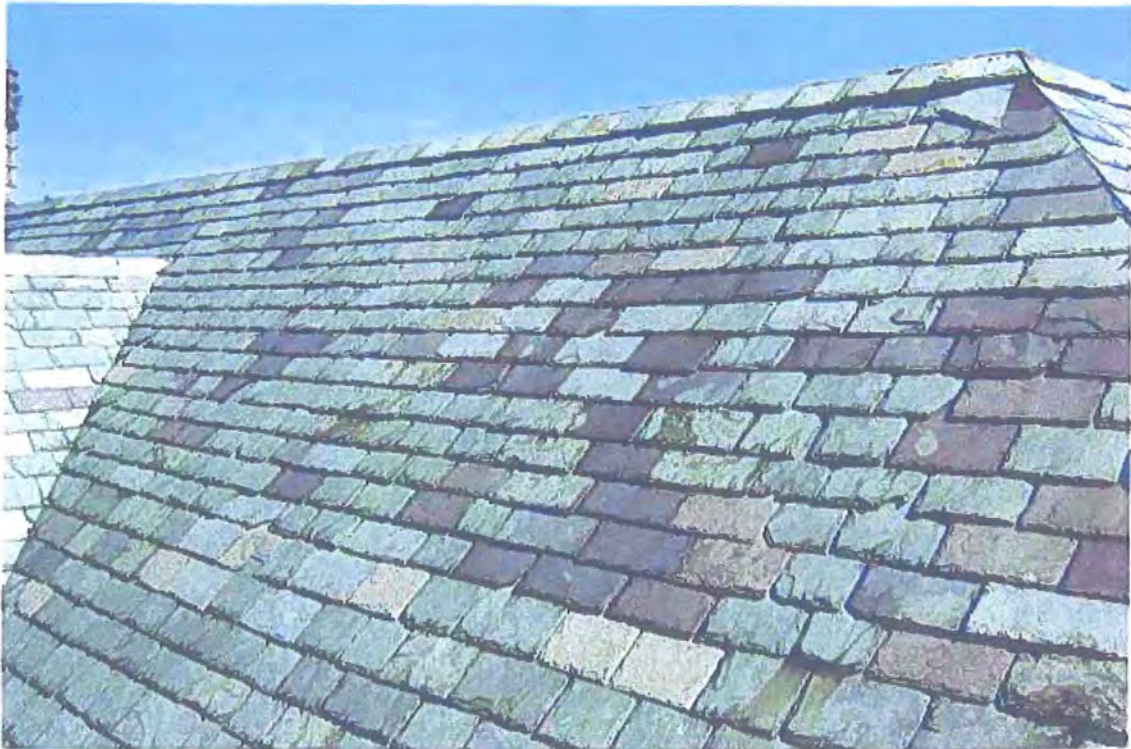
↑ PHOTOGRAPH 17

View of south-sloped roof area on the east half of the east-west wing, showing groups of slates with delaminating surfaces, cracked and broken slates, and an out of position slate at the hip.

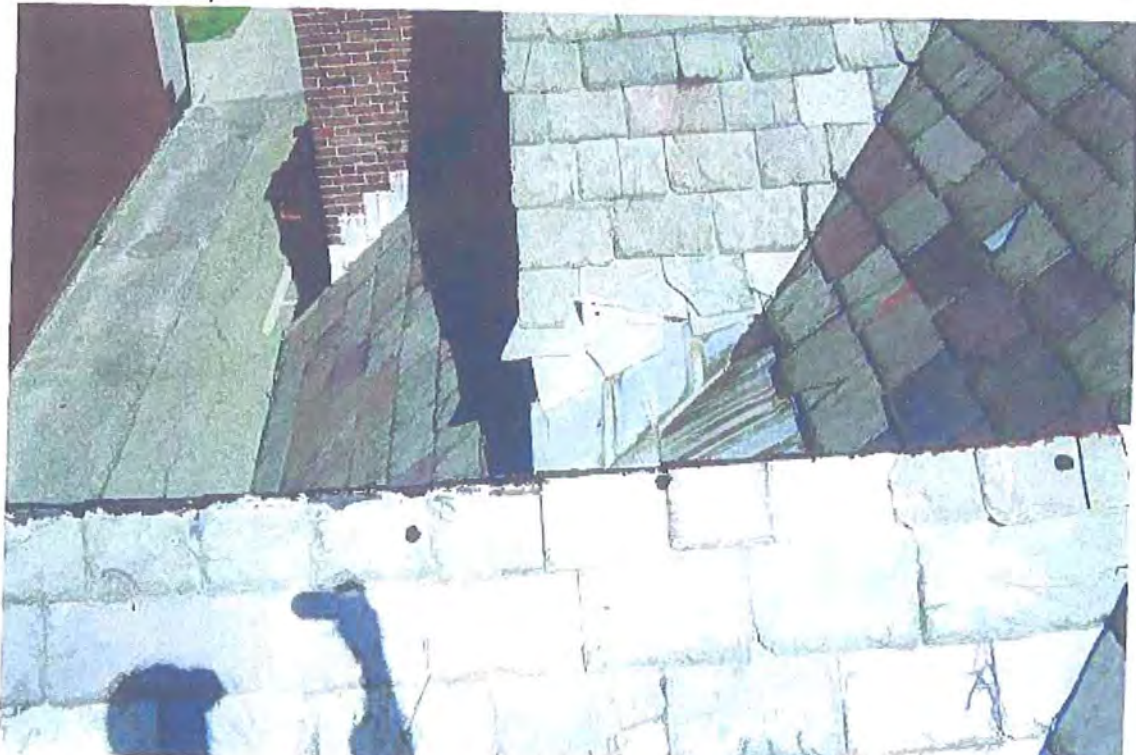
↑ PHOTOGRAPH 18

View of a section of the slate roofs between dormers on the south elevation, showing broken and dislodged slate and deteriorated copper flashing with pin holes.

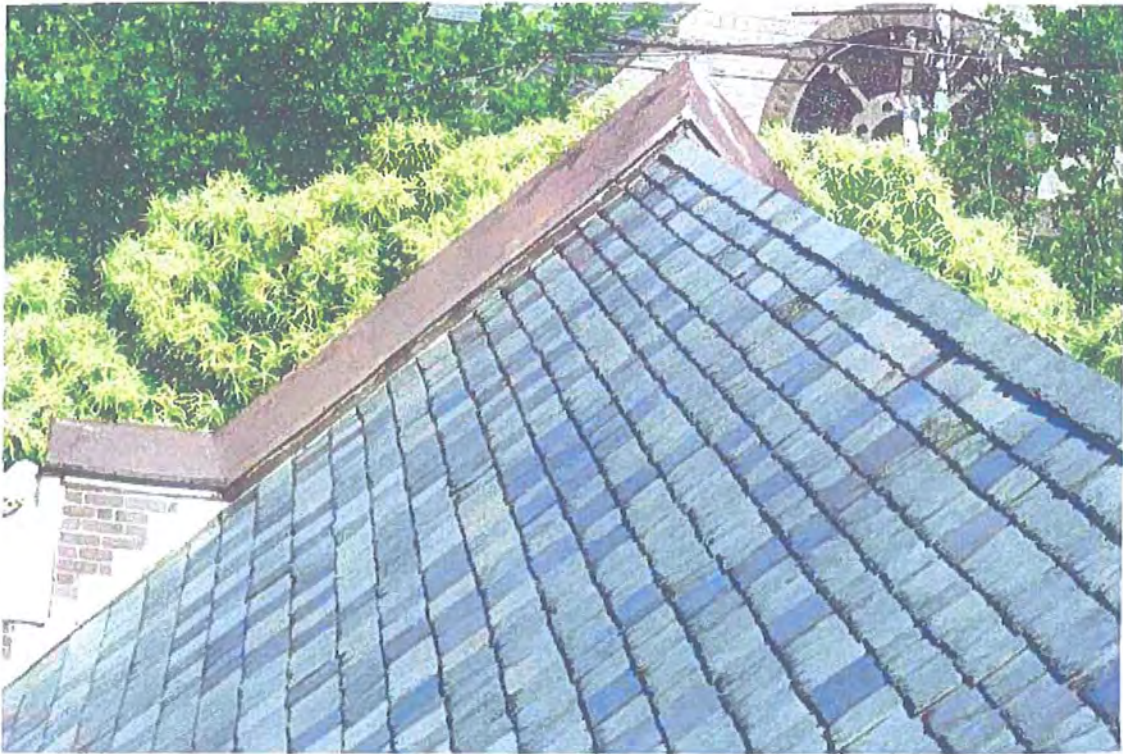
↑ PHOTOGRAPH 19

View of the south slope on the west half of the east-west wing, showing some deteriorated and cracked slate and a rusted cap on the west end wall.

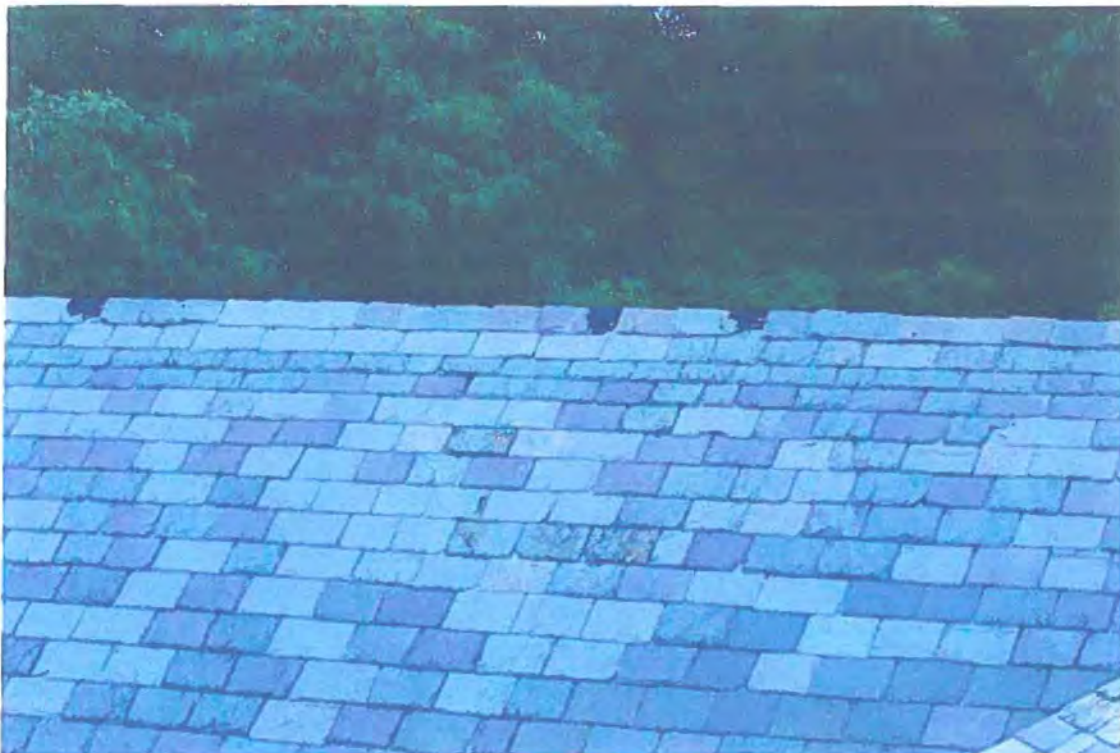
↑ PHOTOGRAPH 20

View of the west slope on the north wing, showing delaminated, cracked, broken, and missing slates.

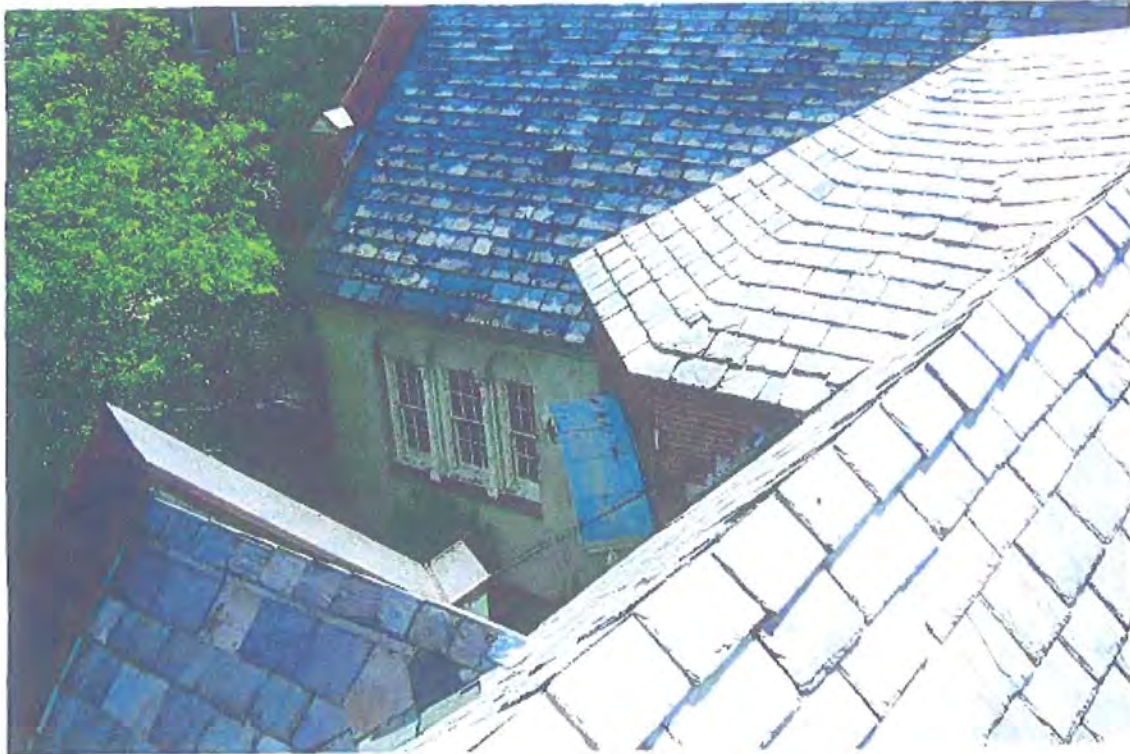
↑ PHOTOGRAPH 21

View of delaminated and broken slates on the fan roof above the main entryway.

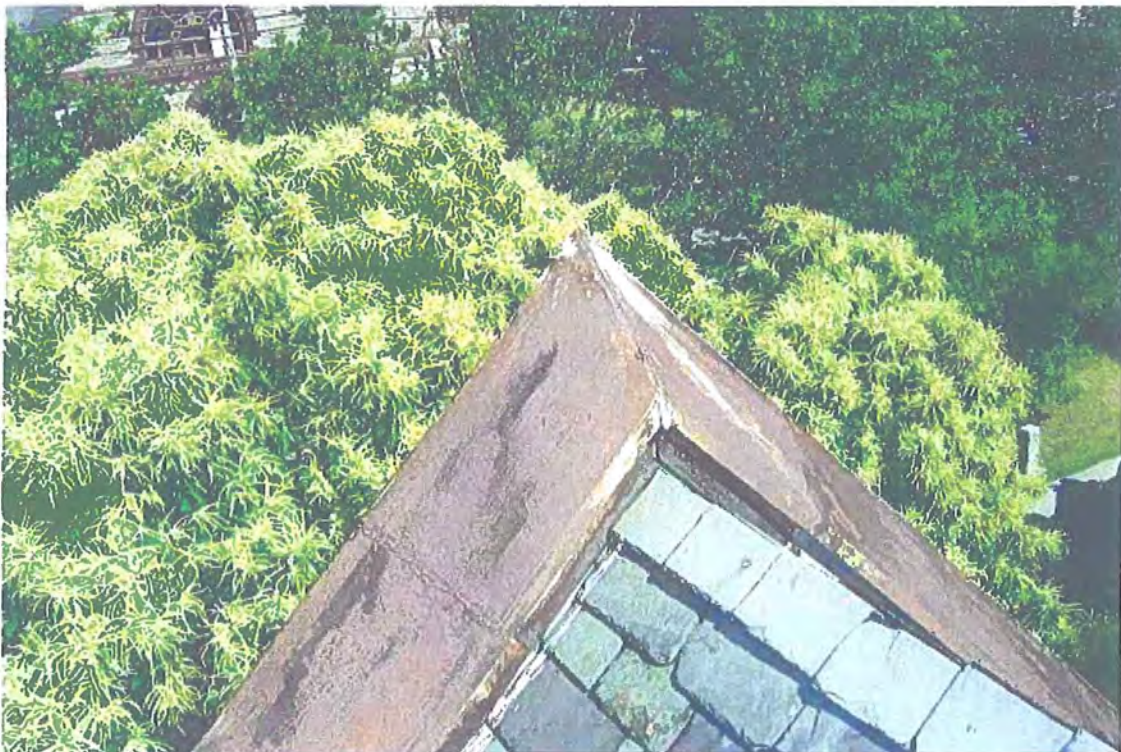
↑ PHOTOGRAPH 22

View of holes in the rusted cap flashing on the end of the north dormer on the west half of the east-west wing.

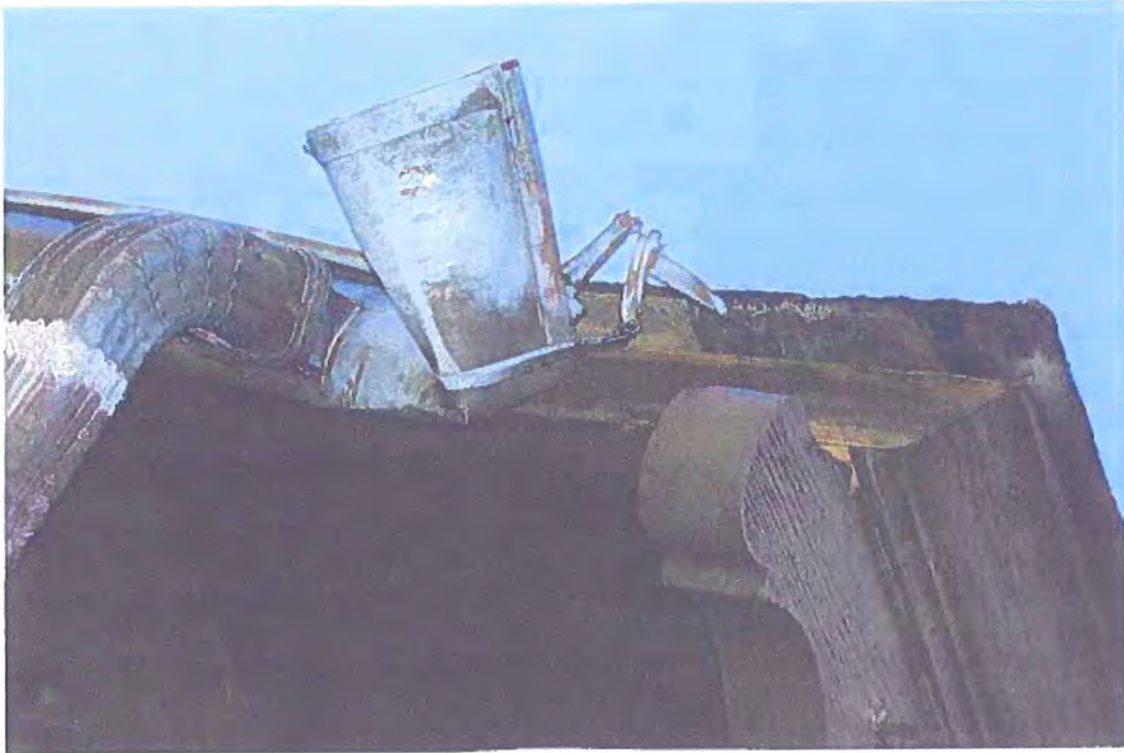
↑ PHOTOGRAPH 23

View of damaged end of gutter on the south elevation between the chimney and south entrance.

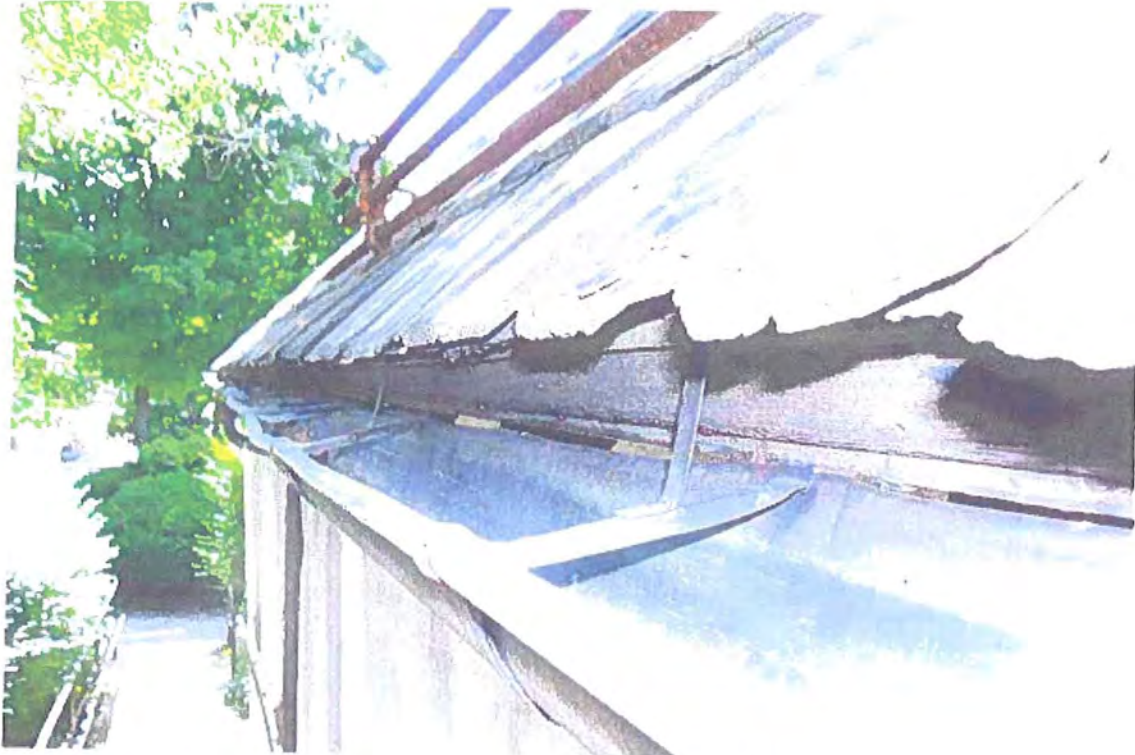
↑ PHOTOGRAPH 24

View of gutter along the north elevation of the east wing, including a view of unpainted wood trim and an open joint between the back of the gutter and the building.
