**NEWTON PUBLIC BUILDINGS SURVEY
PHASE II – ANALYSIS OF HISTORICAL SIGNIFICANCE**

Health Department Building

Address: 1294 Centre Street
Year of Construction: 1927

Phase II: Analysis of Historically Significant City Buildings, Newton, Massachusetts
Health Department Building
DRAFT 3/9/2012

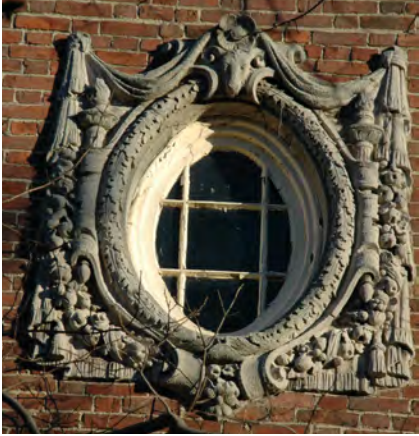
Figure 1: ornamental window at the west gable elevation.

- Remove ivy from building exterior.
- Remove rusting ferrous cap flashing at the west gable. Repair coping and install weather caps at skyward facing joints. If not feasible, replace with non-ferrous cap flashing.

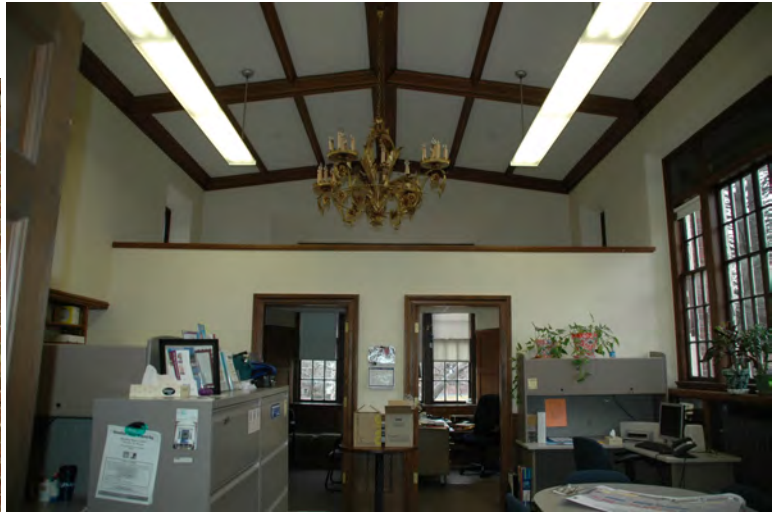
Figure 2: the former west reading room has been subdivided into offices at the west end.

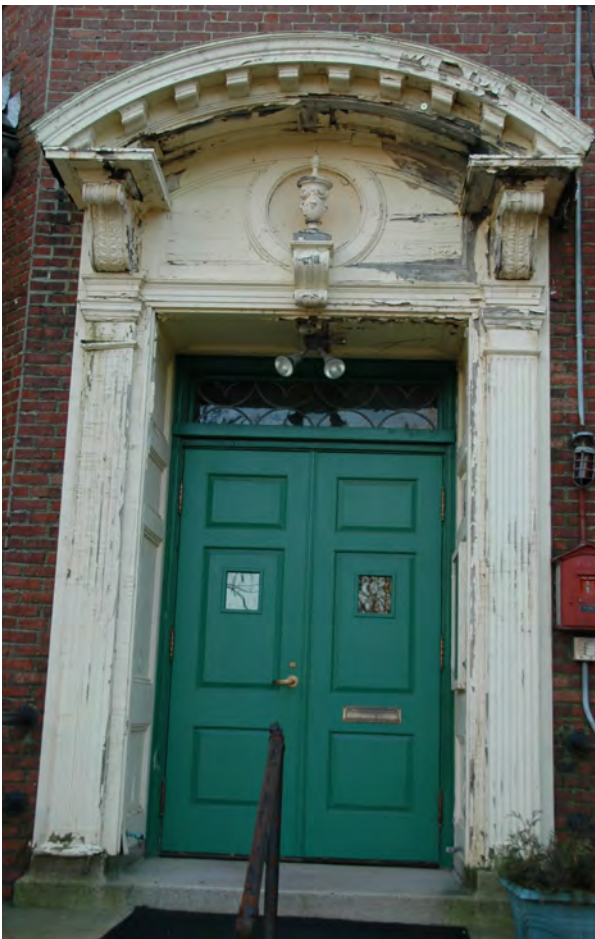
Figure 3: the main entry doorway, with a pair of wood paneled doors and ornamental leaded glass transom within a detailed wood architrave.
x

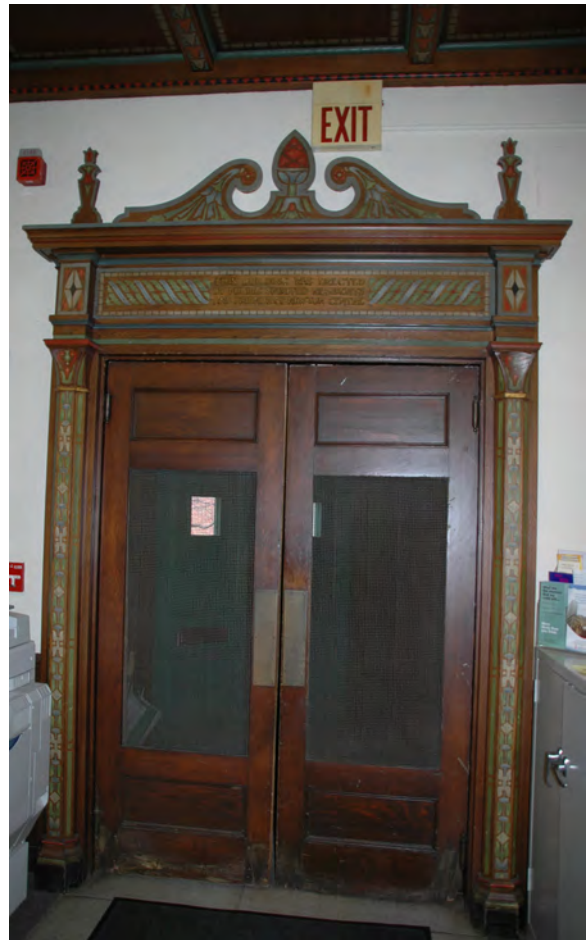
Figure 4: the ornamental wood architrave surrounding the pair of wood doors from the center room to the entry vestibule is stenciled in a multi-colored pattern. Note the wood ceiling above, which is similarly stenciled.
