# Paul Cornell and Associates

**Inspection Report  
prepared for:**

**Property Address:  
61 Pearl Street  
Newton, MA 02458**

<b>Date of Inspection :</b> 10/14/2010 <b>Time Started</b> 08:25 AM		<b>Time Finished</b> 02:35 PM
<b>Property Address :</b> 61 Pearl Street Newton, MA 02458	<b>Report Prepared For :</b> Joesphine McNeil	<b>Report ID :</b> OCT10_61 Pearl St_Newton

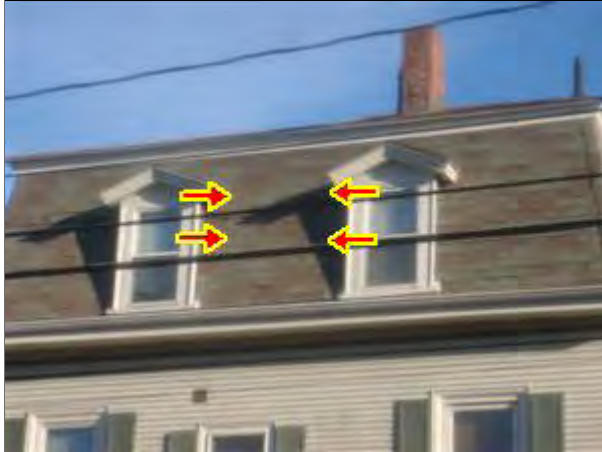
1.1 Picture 1

(3) Several shingles on the front of the main mansard roof are loose, falling off and need repair(Pictures 1&2). This may indicate improper nailing and may continue to be problematic in other areas as well.

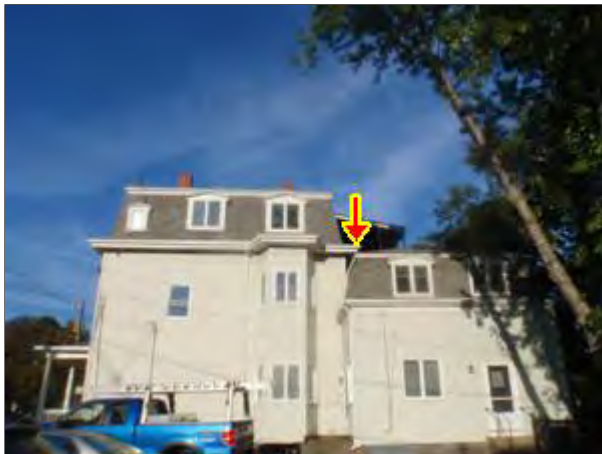
1.1 Picture 3

(4) The front of the hip roof of the rear addition slopes and directs water into the rear wall of the main house(Picture 3&4). This is poor design and will be problematic with water penetration and decay issues. This roof needs to be redesigned. A connecting gable roof or a flashing cricket needs to be created at this point to direct water away from the rear wall of the building.

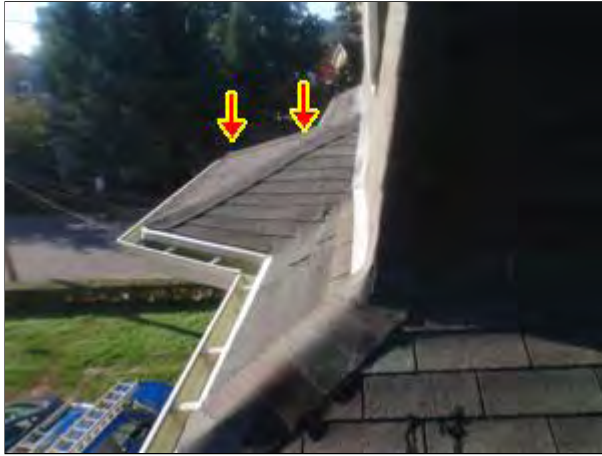
1.1 Picture 5

(5) Asphalt shingles on the right and left side of the lower mansard roofs are worn out, dried out and need to be replaced. Asphalt shingles on a lower pitch roof will be problematic. Replacement with metal or rubber roofing is recommended.

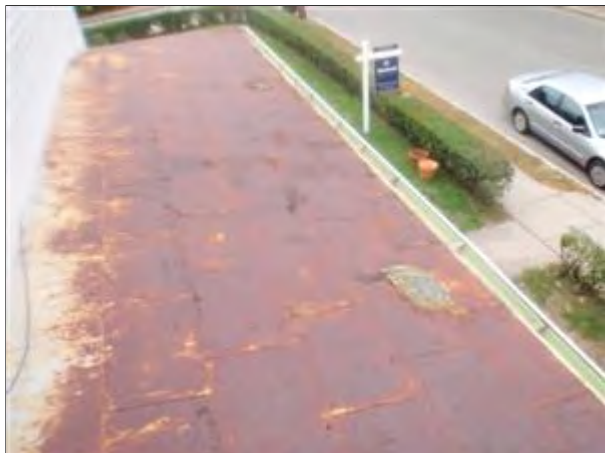
1.1 Picture 11

(6) The metal roof on the front porch is rusted, damaged and is not water tight. It needs to be replaced. Replacement with rubber membrane is recommended.

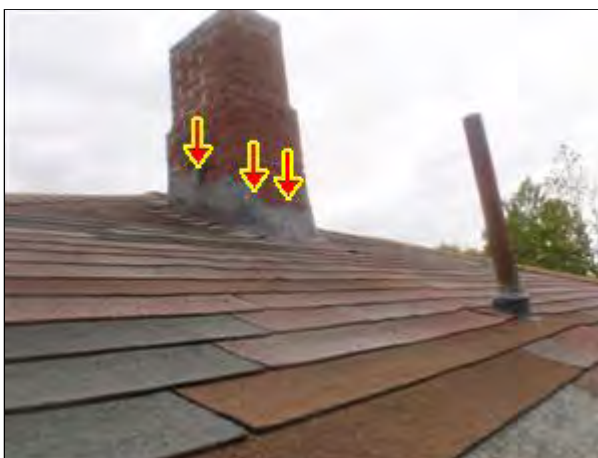
1.2 Picture 1

**1.2 FLASHINGS** : Chimney and plumbing vent flashings have been coated with roof cement/tar. This typically indicates that the flashing was damaged, worn and is no longer water tight. This type of application is a temporary repair, at best, and must be periodically repeated to prevent water intrusion.

New flashing should be installed.

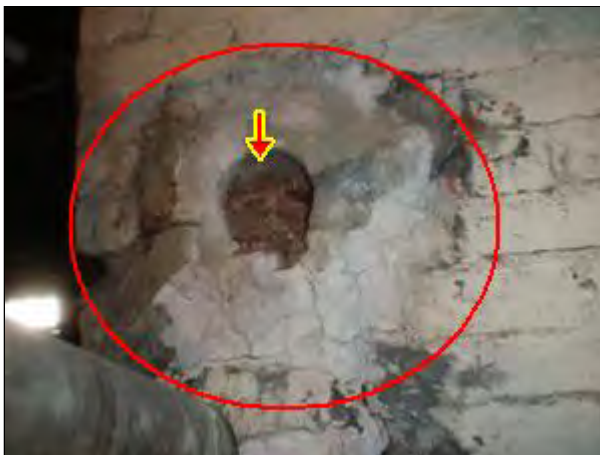
2.1.B Picture 1

**2.1.B FLUE LINING(S)** : Flue lining condition could not be evaluated as the chimney top was not safely accessible. This chimney is used to vent the gas fired water heater. The chimney base in the cellar is full of debris and is completely obstructed. This poses a grave life safety hazard as flue gases from the water heater are spilling at the draft hood. Immediate correction is needed. The flue in this chimney needs to be lined to allow for continued safe operation of the water heater. A certified chimney sweep should be consulted at once.

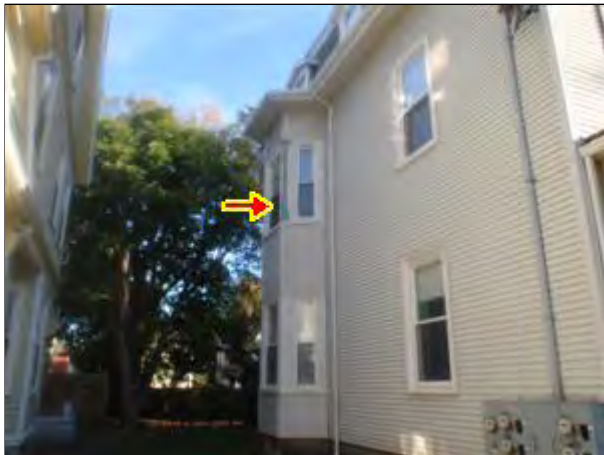
3.0 Picture 1

**3.0 (1) SIDING :** Vinyl siding installation on the left side 2nd floor bay is incomplete(Pictures 1&2). Repair is needed.

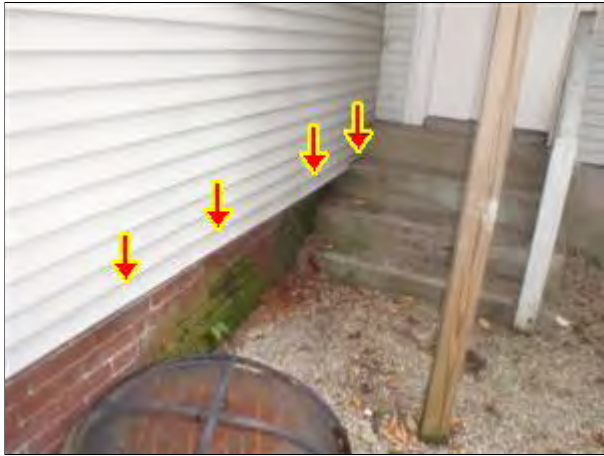
3.0 Picture 3

(3) Evidence of significant water damaged and decay was found behind the lower course of siding on the left side wall of the rear addition. The sill, sheathing and wall framing behind siding is rotted. Repairs are needed. The extent of damage is unknown. Further investigation is needed as concealed damage to framing behind is suspected. The lower 2 to 3 feet of siding on this wall will need to be removed to allow for evaluation. Damage may extend higher up the wall.

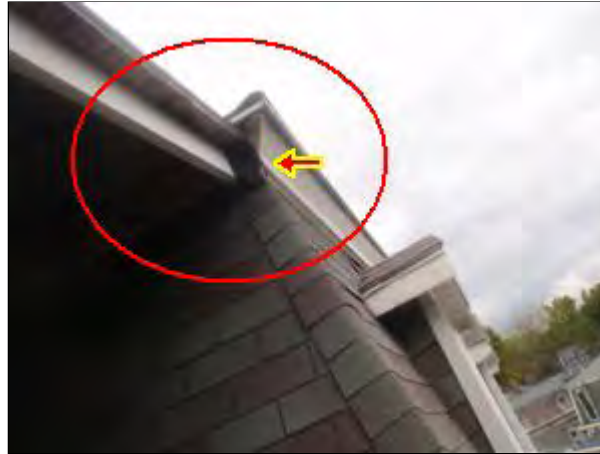
3.3 Picture 1

(2) The soffit at the left rear corner of the main hip roof shows signs of squirrel damage and has been more recently patched. There was a wildlife trap on the 3rd floor deck in this area. The owner should be consulted as to any history of problems.

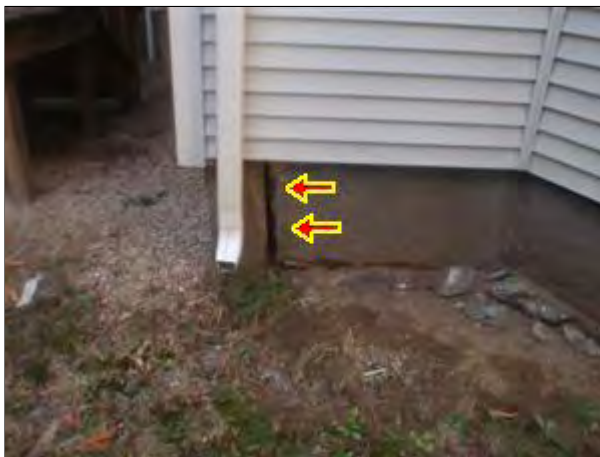
3.5 Picture 1

**3.5 (1) SOLID MASONRY** : Mortar between stones on the exposed portions of the stone foundation is spalling, cracked and loose. Loose and missing mortar will allow for cold air infiltration, water penetration, can allow for rodents to easily enter the house and can affect the structural integrity of the foundation. Foundation walls need to be cleaned of all loose mortar and re-grouted. Concrete aprons should be poured.

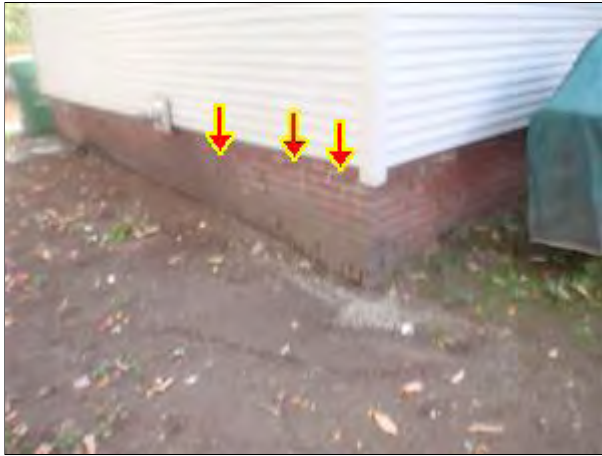
3.5 Picture 3

(2) Mortar between bricks on the exposed portions of the foundation around the rear addition is soft, spalling, cracked and loose. Loose and missing mortar will allow for cold air infiltration and can affect the structural integrity of the foundation. Foundation walls need to be cleaned of all loose and spalling mortar and re-pointed. The rear foundation wall is loss, falling apart needs to be rebuilt(Pictures 3&4).

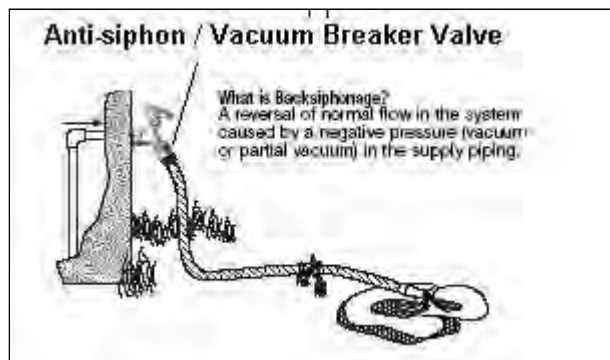
3.8 Picture 1

**3.8 EXTERIOR FAUCET(S)** : Exterior faucets have no handles. Exterior faucets should be replaced with modern frost free faucets, with integral back flow preventers.

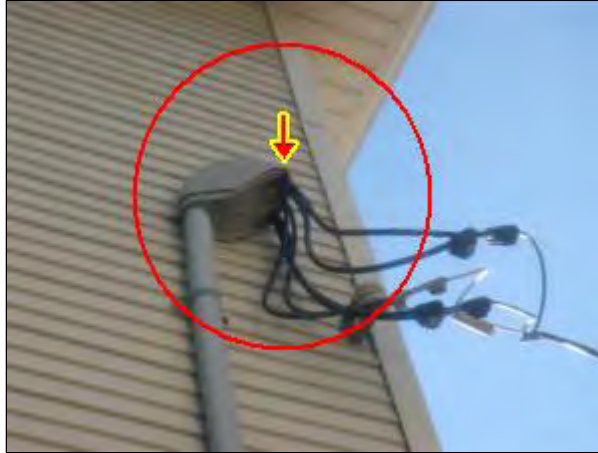
3.10 Picture 1

**3.10 SERVICE DROP AND ELECTRIC ENTRY CABLES** : Openings where service cables enter the weather head are allowing birds to nest and need to be sealed off(Picture 1).

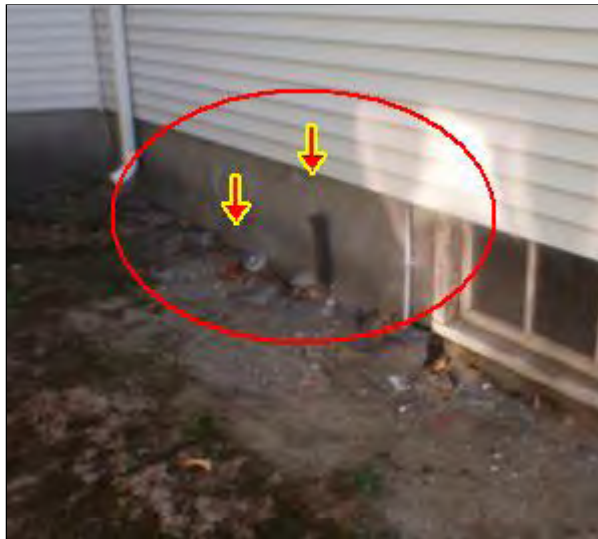
3.11 Picture 1

**3.11 OTHER OBSERVATIONS** : The abandoned oil fill and vent pipes through the left side foundation wall need to be removed(Picture 1).

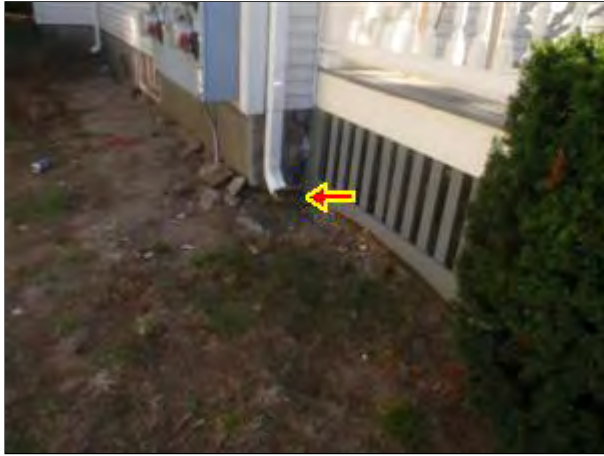
4.2 Picture 1

**4.2 EXTENSIONS** : Downspouts are discharging against the foundation. This can contribute to cellar water entry and other moisture related issues. Extensions need to be installed and maintained at all points where downspouts discharge to direct water away from the house. Extensions should be at least 3 to 5 feet in length.

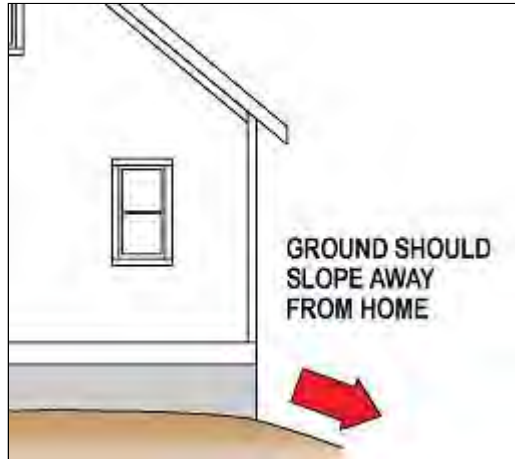
4.4 Picture 1

**4.4 FOUNDATION GRADING** : Negative grading around most of the house slopes and directs water into the foundation. This can contribute to basement dampness and water issues. For proper drainage, grading against the foundation needs to be built up to slope away for a minimum of 1" per foot for at least 5 feet wherever possible.

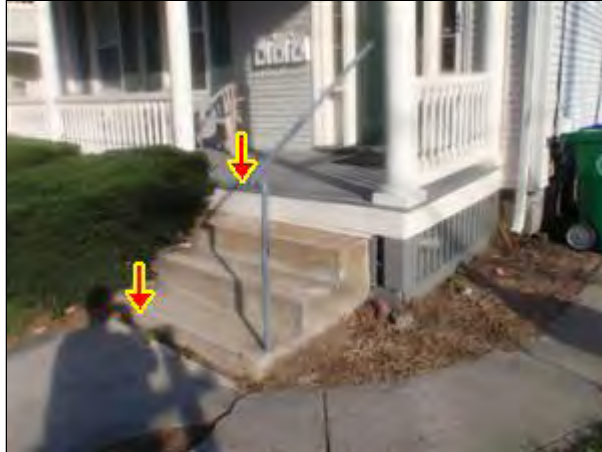
4.6 Picture 1

**4.6 (1) STAIRS AND LANDINGS** : Front porch steps have inconsistent rise(Picture 1). This is a trip hazard. Correction is needed as this poses a risk for personal injury. These steps should be torn out and replaced.

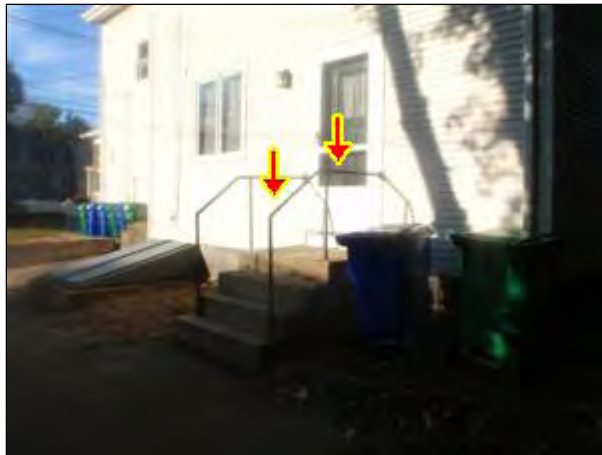
4.7 Picture 1

(2) Railings on the right side steps have excessive and unsafe openings. Rebuilding to current safety standards is strongly recommended.

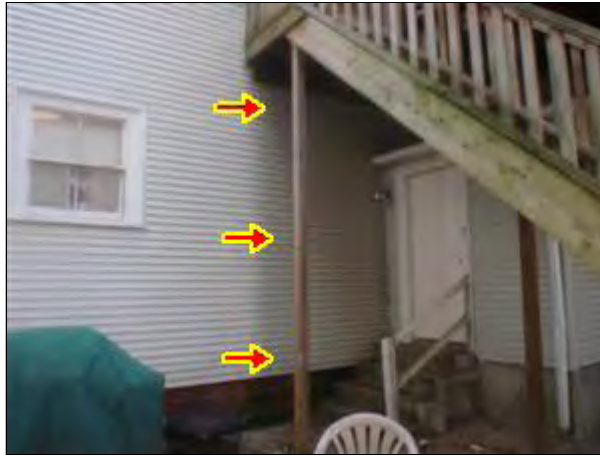
4.8 Picture 1

(2) 4" X 4" posts supporting the 2nd floor deck are over spanned, are warped, twisted and cracking. Replacement is needed. Base plates connecting posts to footings are rusted, failing and need to be replaced.

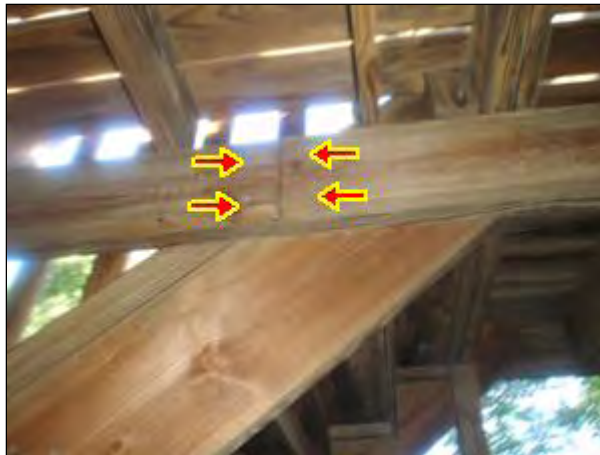
4.8 Picture 2

(3) Beams supporting the 2nd and 3rd floor decks are under sized and are not supported at splices. Repairs are needed. Beams should be tripled, through bolted and supported and supported at splices.

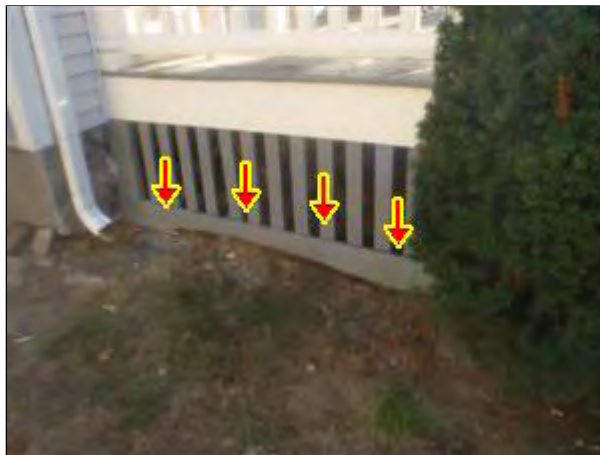
4.9 Picture 1

(2) Lattice, trim and framing around the perimeter of the porch is decaying where in ground contact and needs to be replaced. Pressure treated lumber should be used.

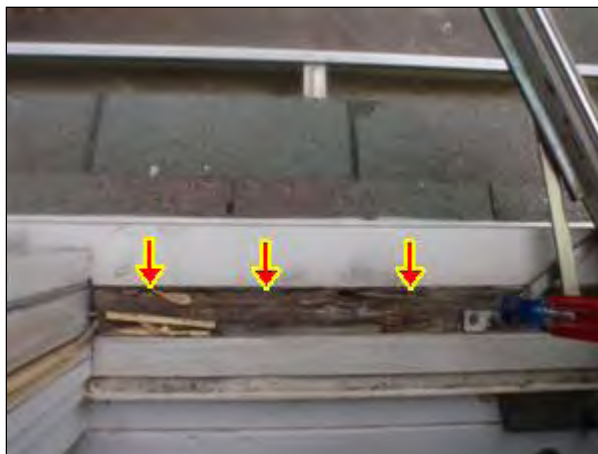
5.1 Picture 1

(2) Metal coverage installed on window sills is not water tight. Metal does not extend under sashes. This has allowed for water penetration and decay to wooden sills. Sills of casement windows in unit # 4 are rotted under metal coverage. Repairs are needed. Replacement of these windows is needed.

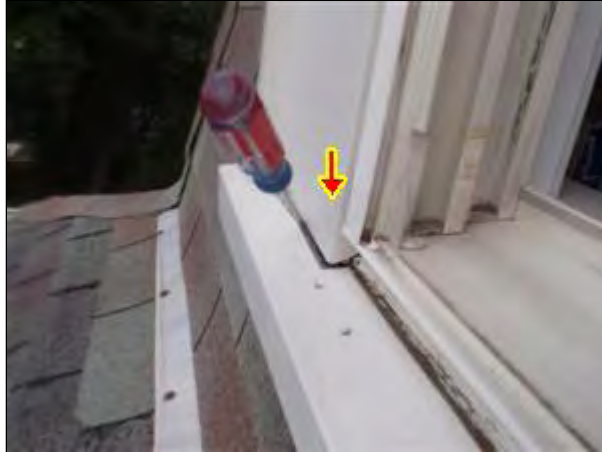
5.1 Picture 2

(3) Sills of unit # 3 windows also show signs of decay under metal coverage as well. Repairs are needed.

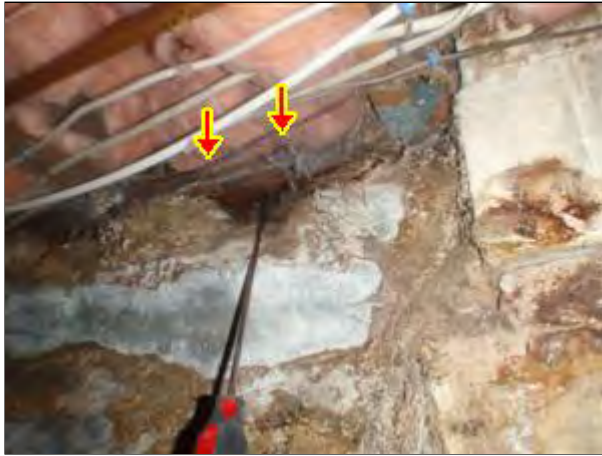
6.4 Picture 1

(2) The sill behind the right side entry steps is water damaged, rotted and needs to be replaced as well. This appears to be a result of no flashing where the exterior steps are attached. Further investigation is needed.

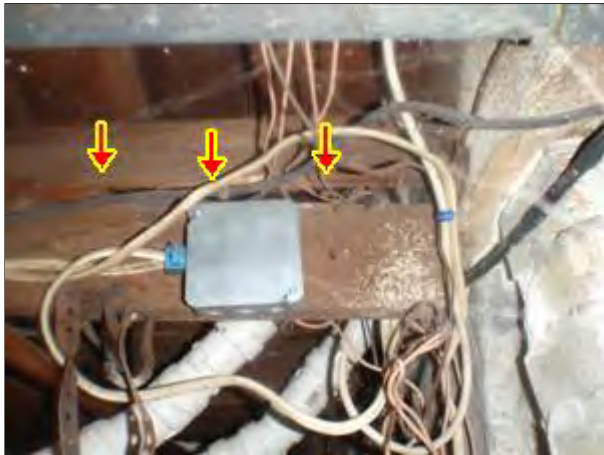
6.4 Picture 6

(3) Many of the floor joists at the main beam mortise and tenon connections are cracked and failing. Joist hangers need to be installed to arrest cracking and failure.

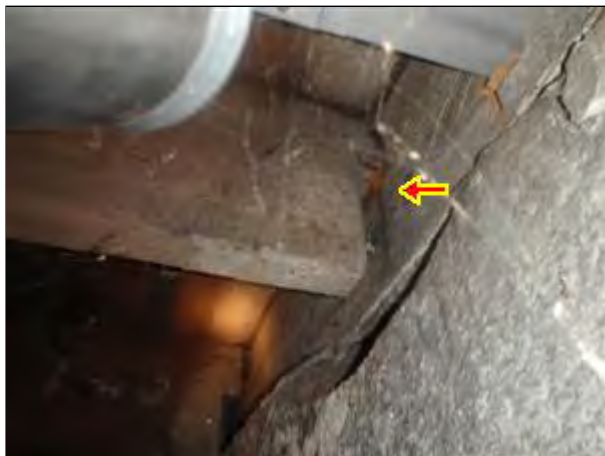
6.4 Picture 9

(4) Joist ends at mortise and tenon connections along the front and rear of the main cellar have separated from sills and have very little bearing. This appears to be a result of foundation movement. Repairs are needed. A structural engineer should be consulted for recommendations.

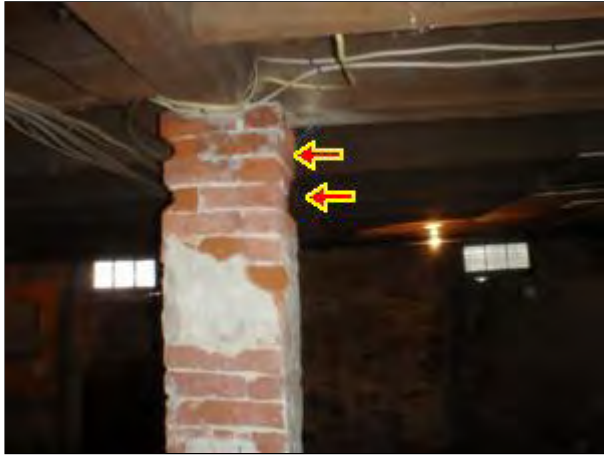
6.7 Picture 1

6.7 (1) **PIERS / COLUMNS** : Brick piers supporting the main beam in the main cellar have deteriorated mortar, spalling bricks and are leaning. These piers need to be replaced. Replacement with Lally columnal is recommended. Proper footings will be needed.

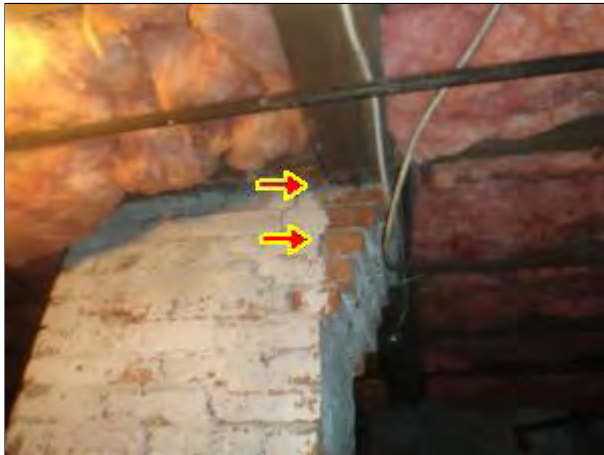
6.7 Picture 3

(2) Corbeled bricks supporting beams off both of the chimneys are cracked and failing. Beams at these points need to be re-supported.

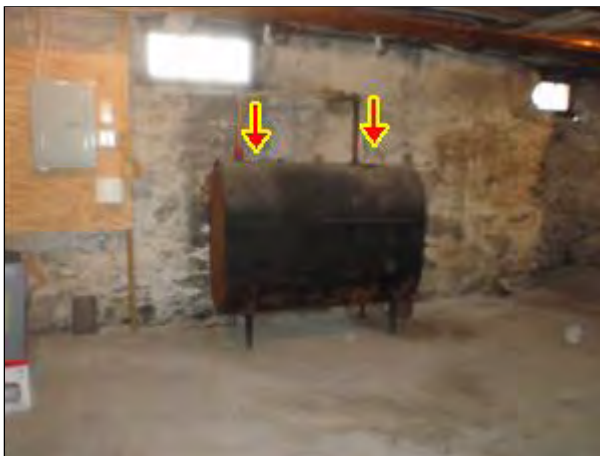
6.11 Picture 1

**6.11 OTHER OBSERVATIONS** : The abandon oil tank at the front left corner of the cellar needs to be removed as it can no longer be used(Picture 1).

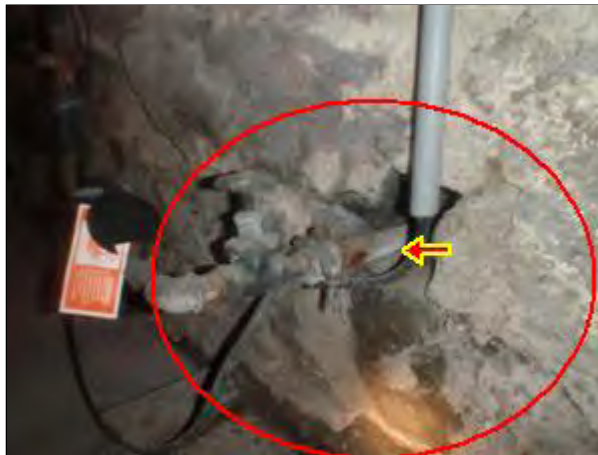
11.0 Picture 1

(2) The main water line in from the street is iron. This type of piping tends to rust internally as it ages and can restrict water volume and pressure. Replacement is typically the responsibility of the home owner.

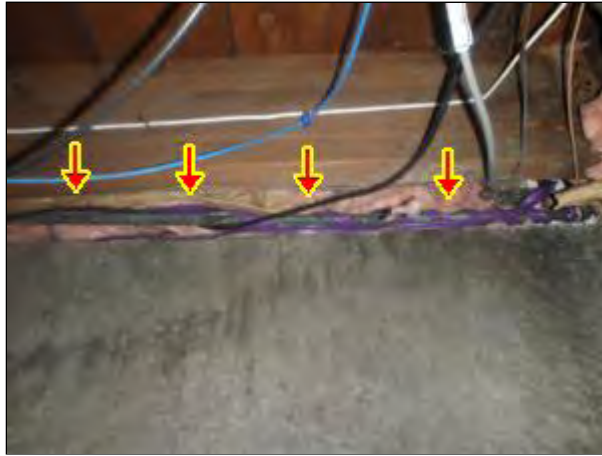
11.0 Picture 2

(3) Supply pipes at the right front of the main cellar have been wrapped with electric heat tape to help prevent freezing problems. The owner should be questioned as to any history of past problems. These pipes should be relocated or insulated.

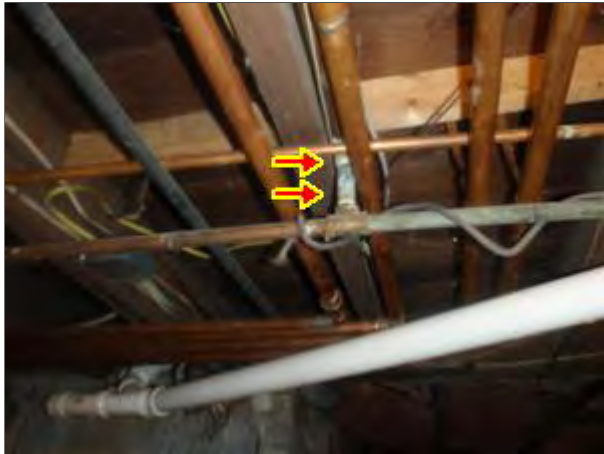
11.0 Picture 3

(4) Several supply stops in the basement are corroded. Repair or replacement is needed. Replacement with modern ball style valves is recommended.

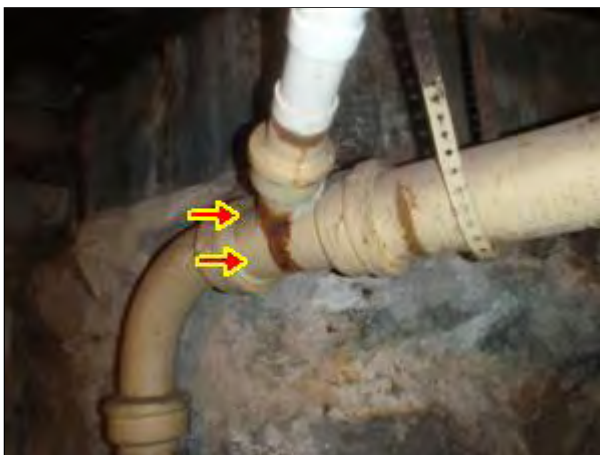
11.1 Picture 1

**11.1 (1) VISIBLE WASTE AND VENT PIPES :** There is a fair amount of older waste plumbing still in service. Repairs and updating should be expected. Several sections of cast iron waste pipes in the basement are corroded, shows signs of leakage and will need to be replaced in the near future.

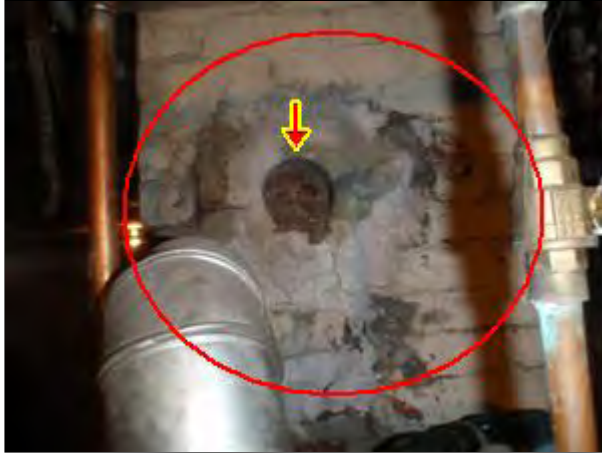
12.6 Picture 1

**12.6 FLUE PIPE CONNECTOR** : The flue pipe is completely obstructed where it ties into the chimney(Picture 1). The chimney is not lined. The interior of the chimney is collapsed. This poses a grave life safety hazard as flue gases are spilling at the draft hood(Picture 2). **IMMEDIATE CORRECTION IS NEEDED.** The owner of the property was informed of this condition at the time of the inspection.

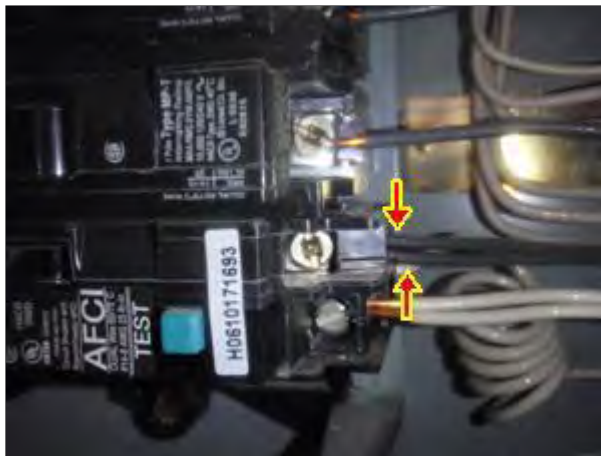
13.3.B Picture 1

**13.3.B CIRCUIT BREAKERS :** Two circuit breakers in the panel are double tapped(Pictures 1& 2). This is typically not permitted as terminals on breakers are designed to secure only one wire. Loose wires could result in overheating. This could also result in nuisance tripping of the breakers if both circuits are being used simultaneously. These wires should be broken up to individual breakers. The panel is rated for 24 circuit breakers, it has 9.

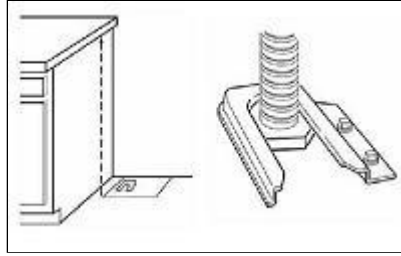
15.14 Picture 1

**15.14 STOVE HOOK UP GAS :** The stove was installed without its required anti tip bracket. The stove is easily tipped as a result and poses a safety hazard. Immediate correction is needed.

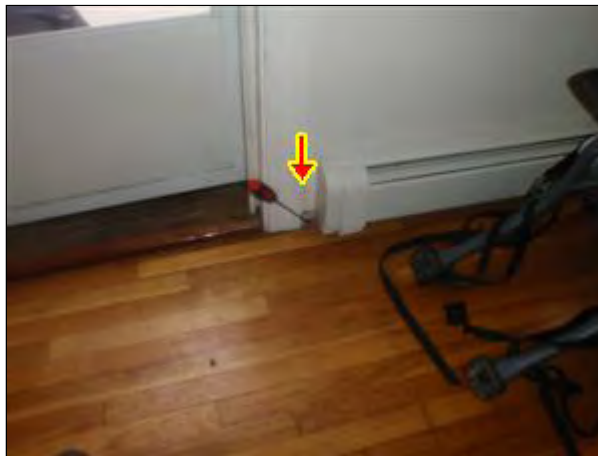
27.0 Picture 1

(2) The wall by the exterior door is water damaged and rotted. The bottom of the wall is loose and shows signs of compression into the floor. Sill decay below this wall is suspected. This appears to be a result of the lack of flashing where the exterior steps meet the house. Further investigation is needed.

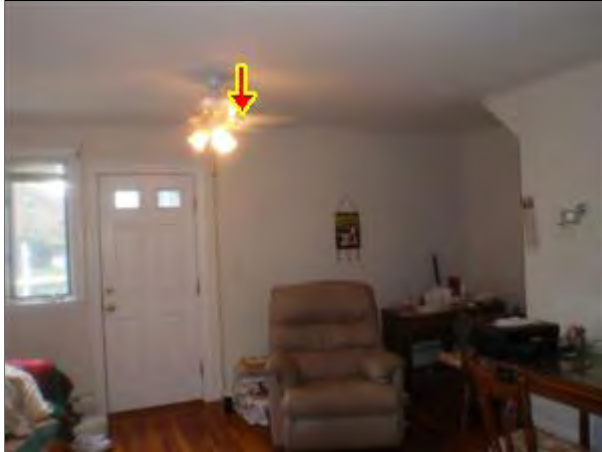
27.0 Picture 2

(3) The ceiling by the front entry door is water stained. This appears to be a result of the roof design.

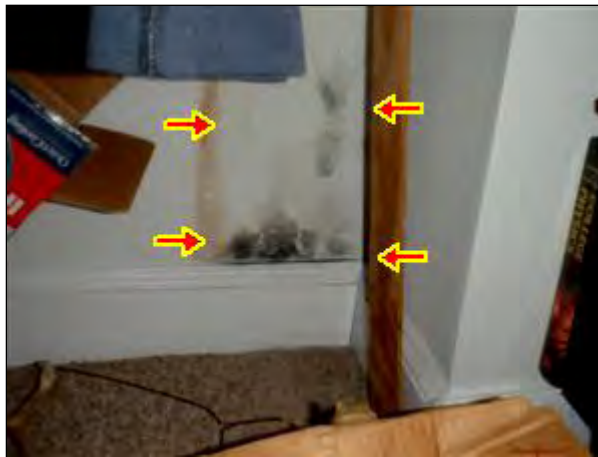
28.5 Picture 1

**28.5** The bottom of the wall in the front closet is water damaged. There is mold growth on the wall at this point(Picture 1). This appears to be a result of the roof design above. Further evaluation is needed.

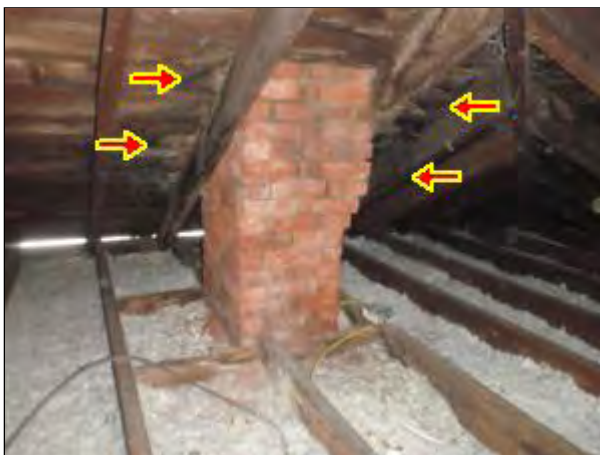
30.3 Picture 1

**30.3** Framing and sheathing around the chimneys is water stained. This can be attributed to the flashing on the roof. Flashings around the chimney have been sealed with tar to resist water penetration. This type of repair is temporary at best. Monitoring is recommended.

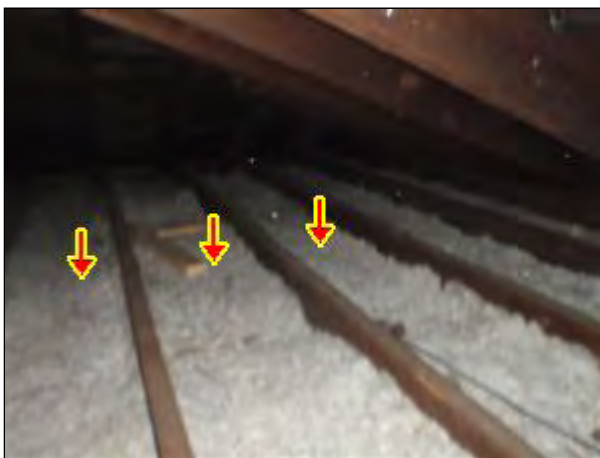
30.4 Picture 1

**30.4** The attic has limited insulation by current standards. Limited insulation will promote heat loss, is a waste of energy and can contribute to ice damming and condensation issues. The attic should be better insulated for energy efficiency. It is recommended that you add additional insulation to bring "R" value to 30 or 40. Penetrations such as plumbing vents, wires and recessed light fixtures are a big source of heat loss and should be sealed with an expanding foam insulation. An insulating contractor or an energy efficiency specialist should be consulted for further evaluation and cost estimates. A well insulated attic can dramatically reduce heating and cooling expenses by nearly 30 %. For more information check the attached link [masssave.com](http://masssave.com).

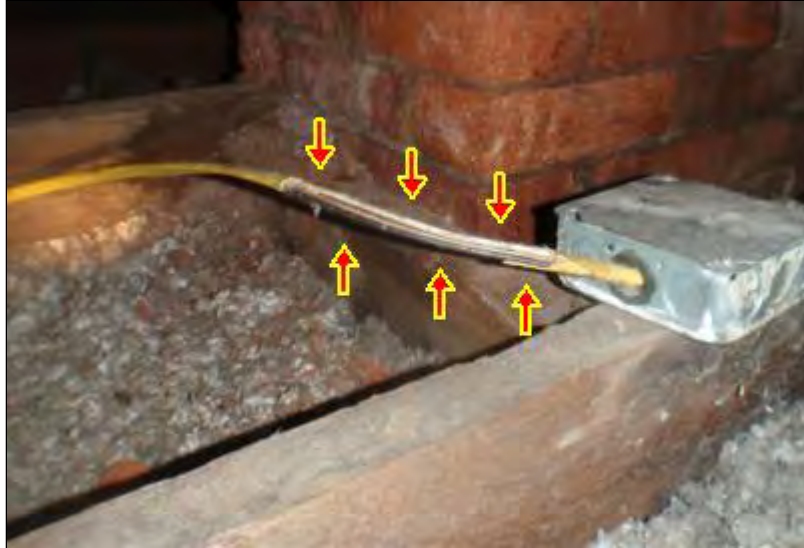
30.6 Picture 1

**30.6** Insulation on several wires has been damaged by squirrels. This poses a fire hazard. Immediate repairs are needed. Any damaged wire must be replaced. A licensed electrician should be consulted for evaluation and needed repairs.

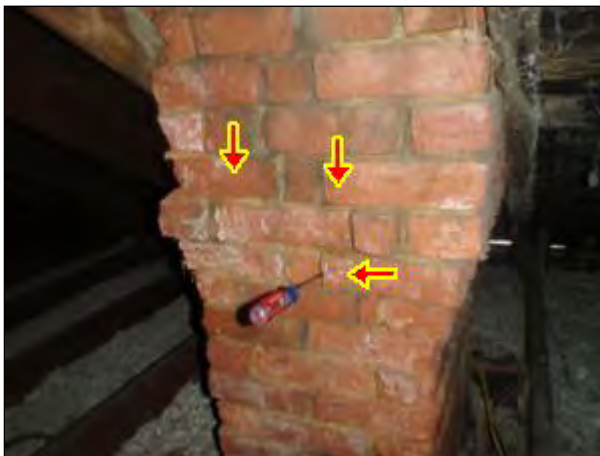
30.8 Picture 1

**30.8** The chimney is severely spalling, flaking and is deteriorated. Holes were visible through to the interior. The chimney is not lined. This will allow for flue gases to enter into the attic. This is a **safety hazard** and needs immediate correction. The chimney needs to be rebuilt from at least the attic floor up. A qualified mason or chimney sweep should be consulted for further evaluation and needed repairs, prior to commitment.

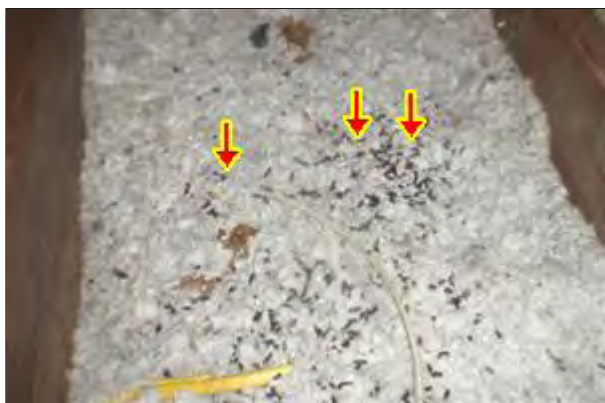
30.10 Picture 1

**30.10** Rodent droppings were noted throughout the attic spaces (Pictures 1 & 2). Squirrels have been nesting in the attic. The owner should be questioned as to any history of problems. Feces was noted on the floor throughout the attic. Decaying feces left in the attic can contribute to odor issues and indoor air quality problems. All droppings need to be properly cleaned out.
