CSS ARCHITECTS, INC.

**BUILDING ENVELOPE EVALUATION  
CRAFT STREET STABLE DPW FACILITY  
NEWTON, MA**

*AUGUST 29, 2008*

### BUILDING ENVELOPE EVALUATION

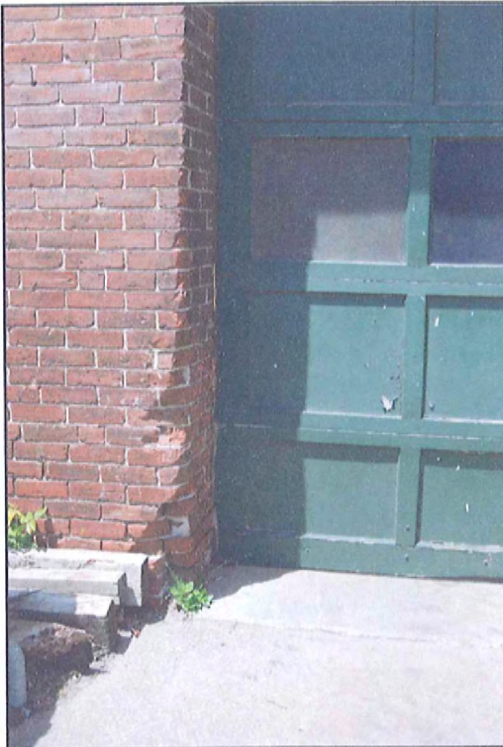
19

Garage Door at Basement - Damaged Brick Jambs

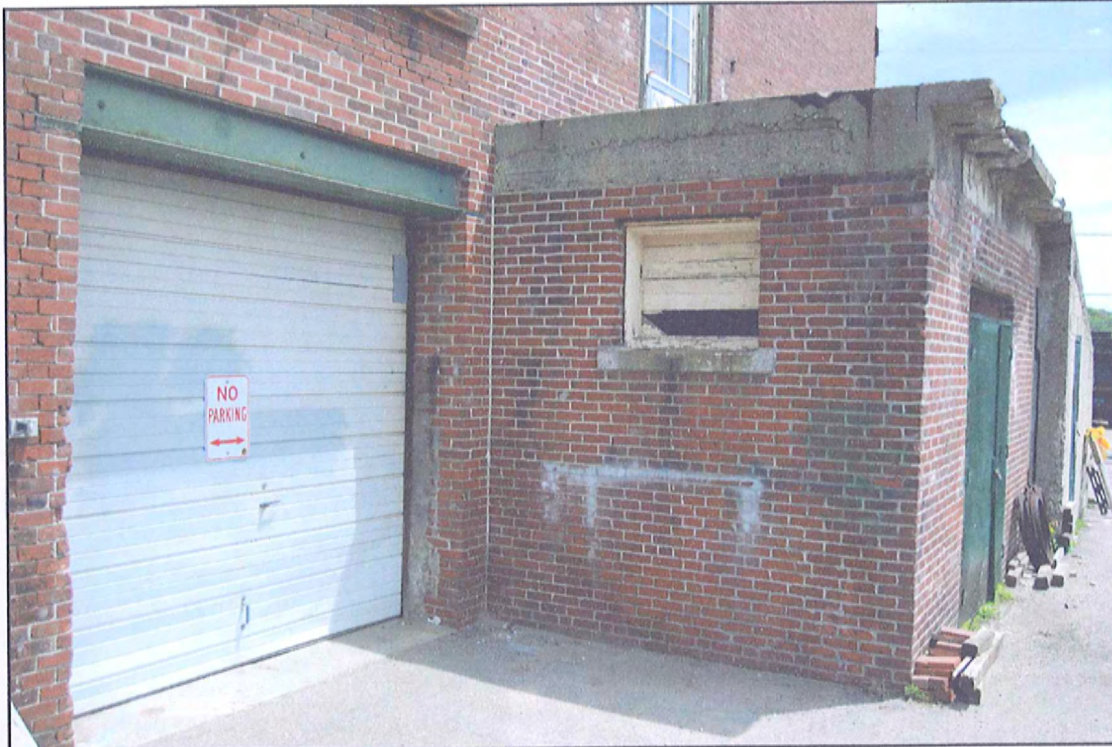
20

New Overhead Door - Concrete Ramp

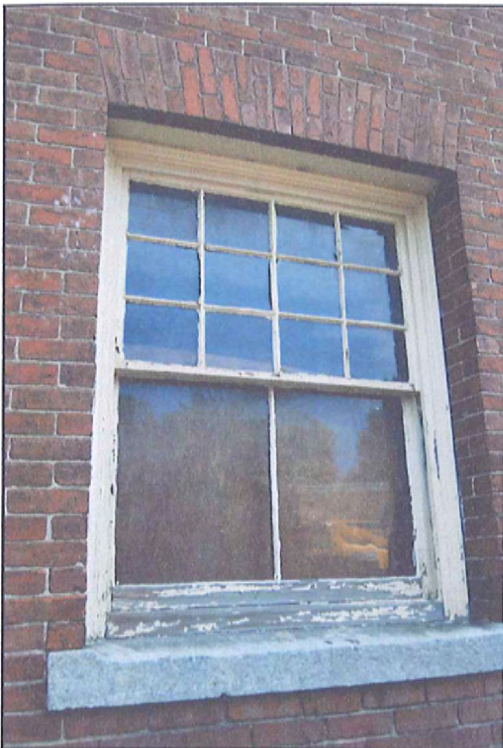
21

Window - Basement - Type 1

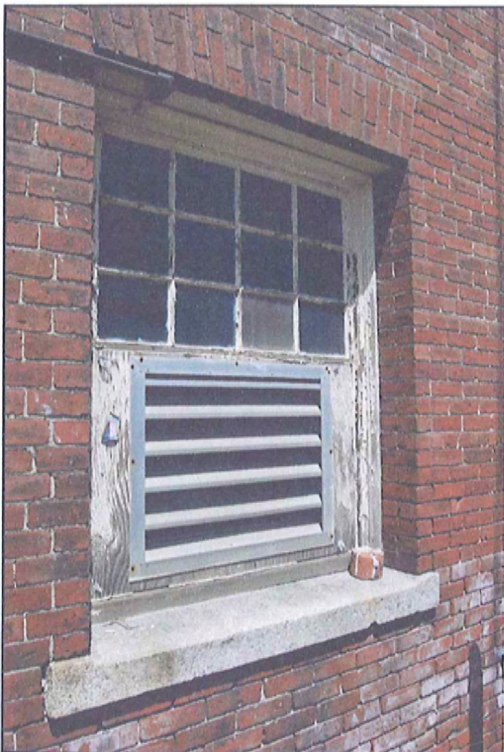
22

Window with Louver - Basement - Type 1

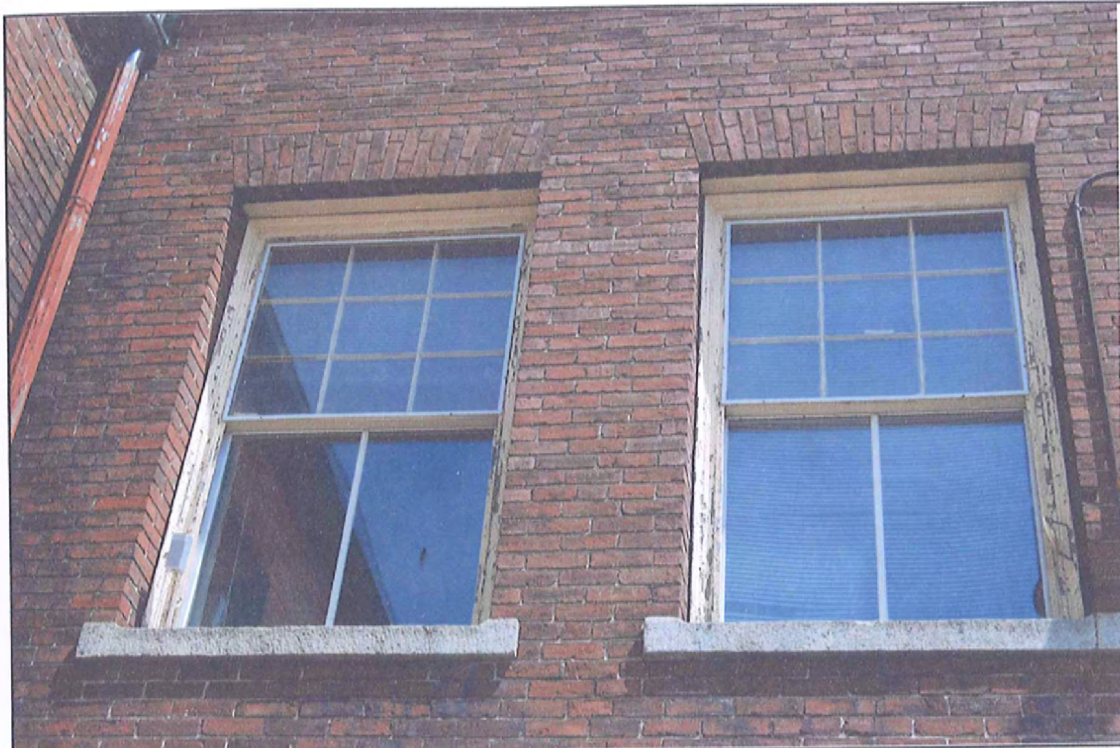
23

Window - First Floor - Type 4

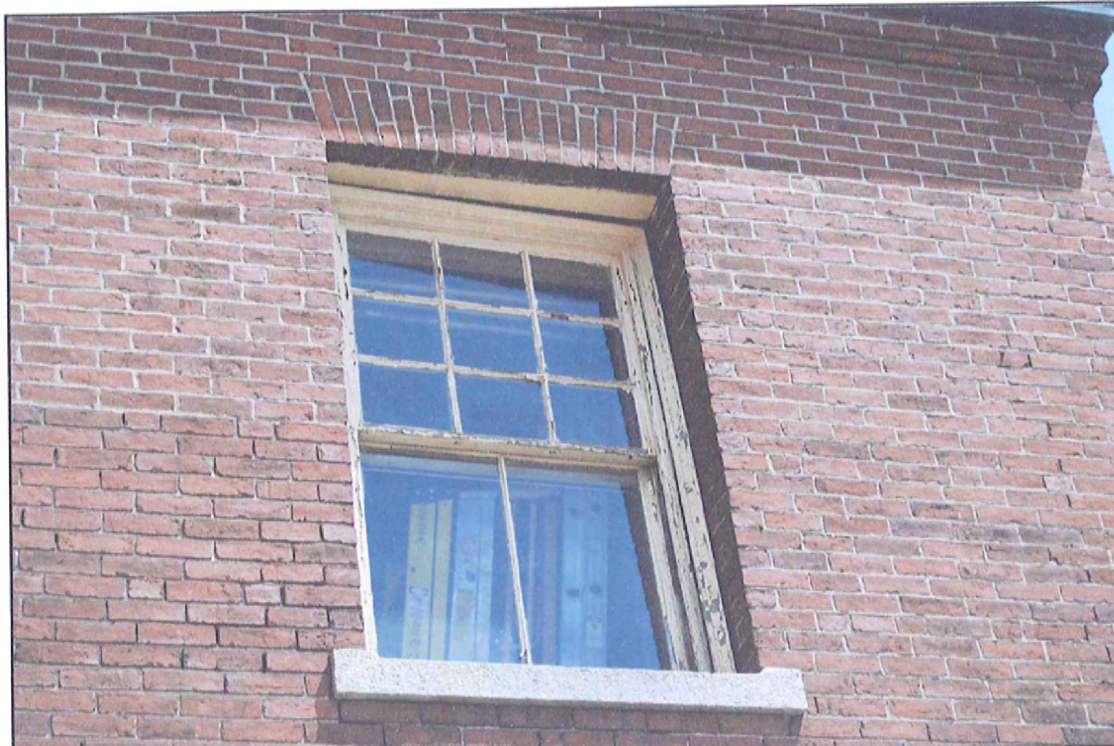
24

Window - First Floor Storage Room - Pushed In - Type 5

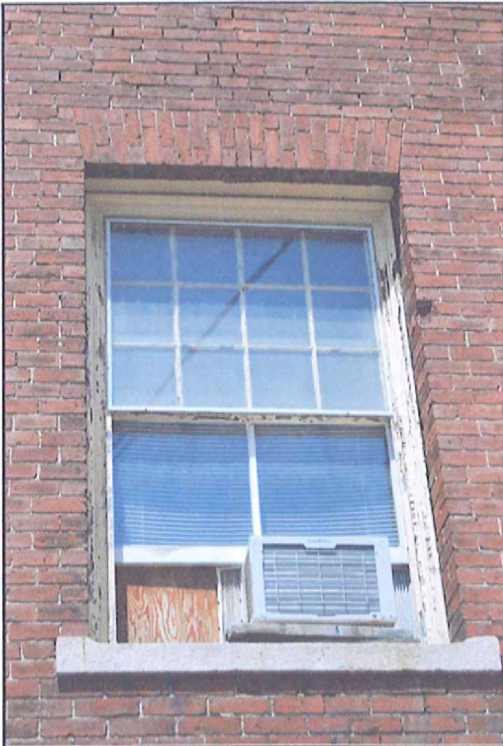
25

Window - Rebuilt Sash - Type 4

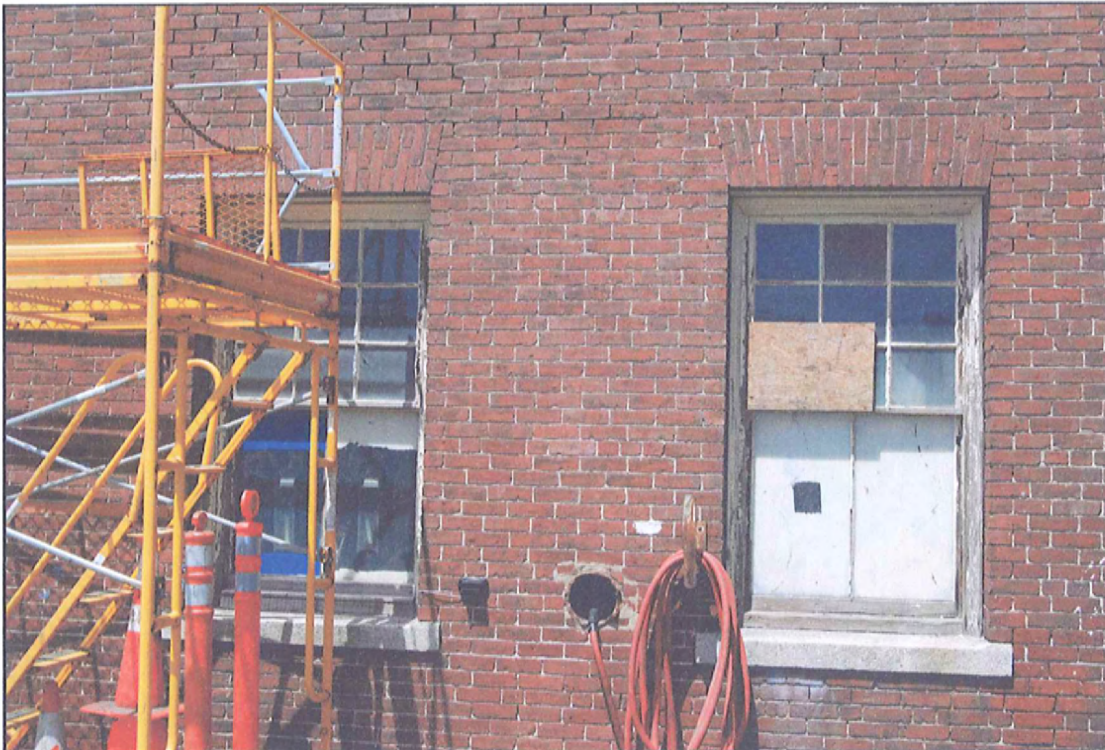
26

Window - Basement - Type 5

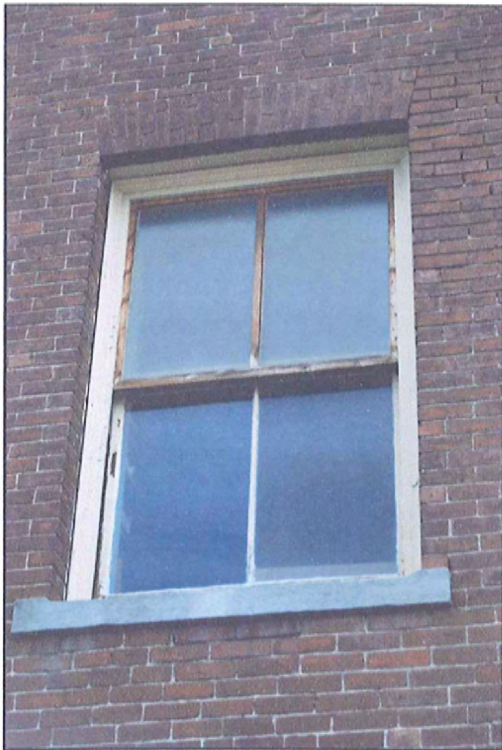
27

Rebuilt Window Sashes at First Floor
