**NEWTON PUBLIC BUILDINGS SURVEY
PHASE II – ANALYSIS OF HISTORICAL SIGNIFICANCE**

Building Analysis

Crafts Street Stable/Garage

Address: 90 Crafts Street
Year of Construction: 1895

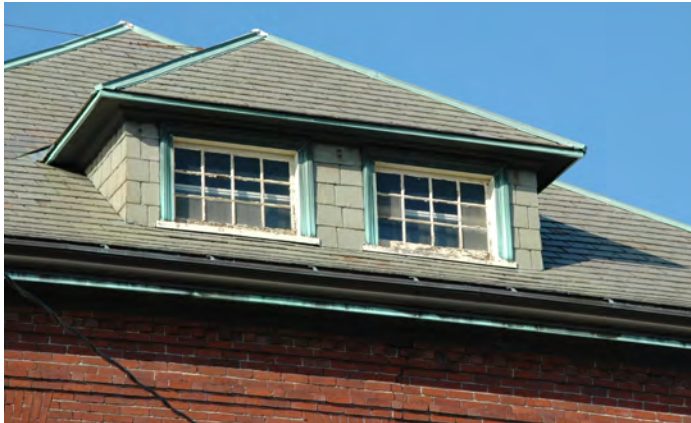
Figure 3: Typical dormer: hip roof and walls clad in slate shingles with copper flashing. Note the two 12-light wood hopper windows

- Inspect the condition of the roof and flashing. Repair broken slates at roof and dormer sidewalls and repair or replace damaged copper flashing elements. Repair the detached flashing over the shed roof at the street elevation entrance
- Address the condition of the extremely deteriorated concrete roof structure of the one-story extension at the rear elevation.

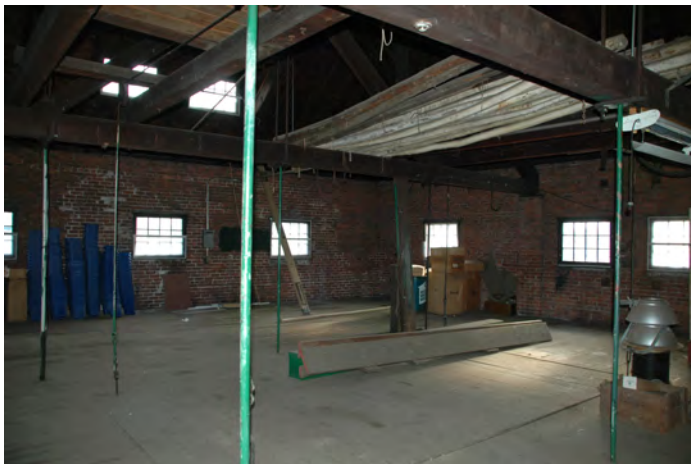
Figure 4: Attic interior. Note large platform lift set into the attic floor.

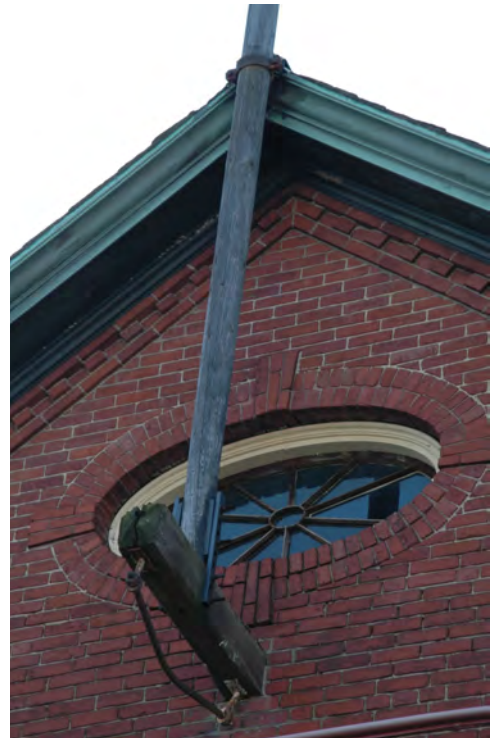
Figure 5: Oval window in brick frame at gable end. Note ornamental dentil brickwork at eave.

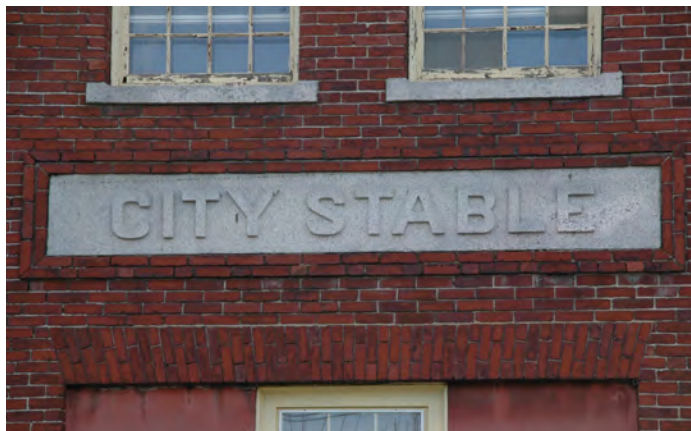
Figure 6: "City Stable" carved into a granite tablet surrounded by a brick frame
