# Paul Cornell and Associates

**Inspection Report  
prepared for:**

**Property Address:  
54 Taft Avenue  
Newton MA**

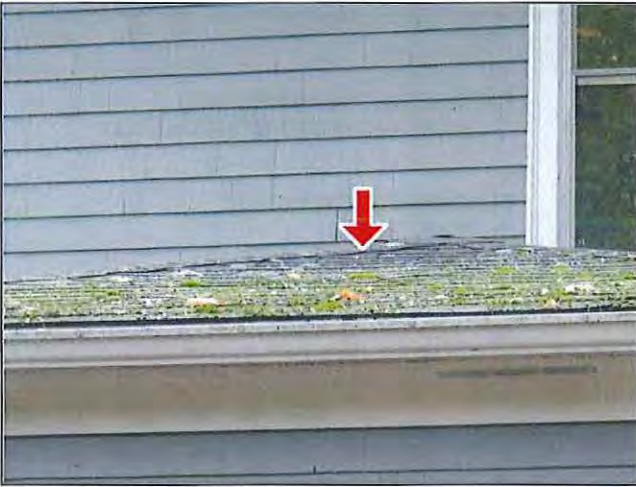
1.1 Item 1(Picture)

1.1 The roof cover has outlived its useful service life and should be replaced.

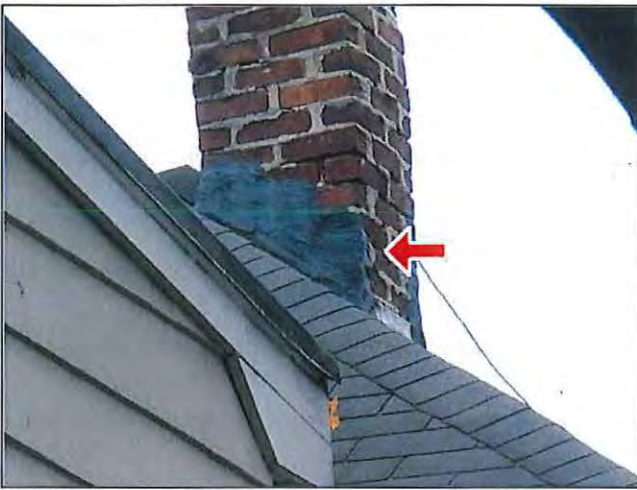
1.2 Item 1(Picture)

1.2 Tar laden chimney and plumbing vent flashings should be replaced.

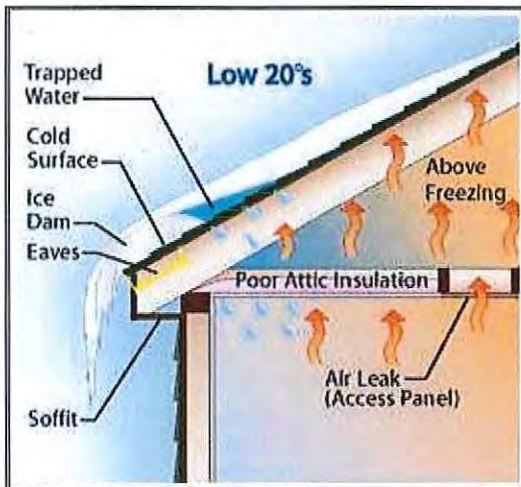
1.5 Item 1(Picture)

1.5 Limited roof ventilation will contribute to ice damming and condensation problems during winter months, and excessive heat build up during warmer months. These conditions can considerably shorten the serviceable life of the roof cover as well as contribute to mold and decay issues. See attic section of report for recommended improvements.

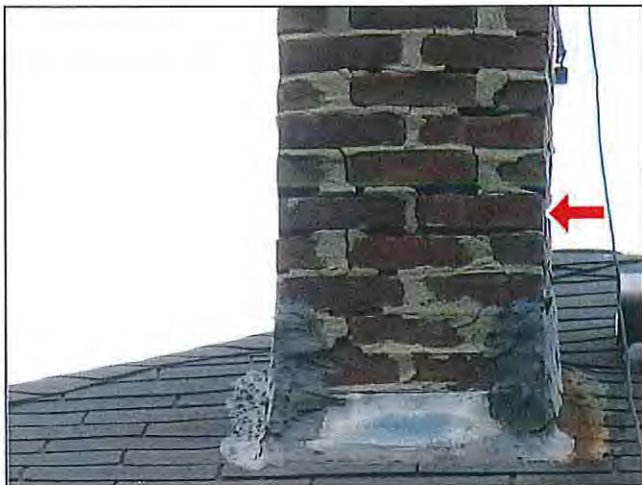
2.0 Item 1(Picture)

**2.0** The chimney shows evidence of deep rooted water damage. It is recommended that the chimney be rebuilt. A qualified mason should be consulted for further evaluation.

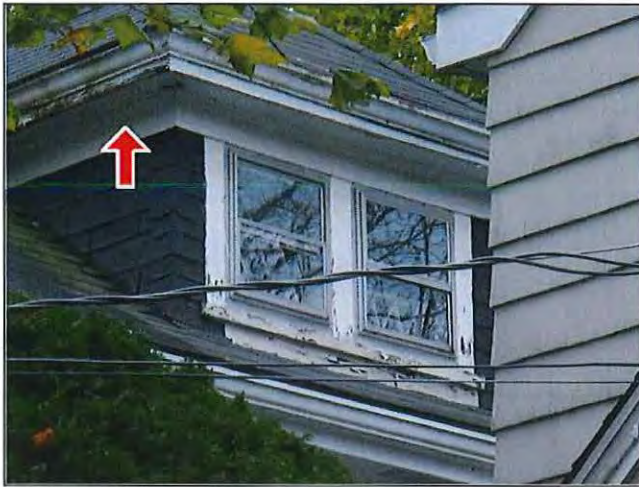
3.2 Item 1(Picture)

3.2 (1) Some of the exterior trim, soffits and fascias show signs of water intrusion and decay. They should be repaired as needed. A qualified contractor should be consulted for cost estimates now.

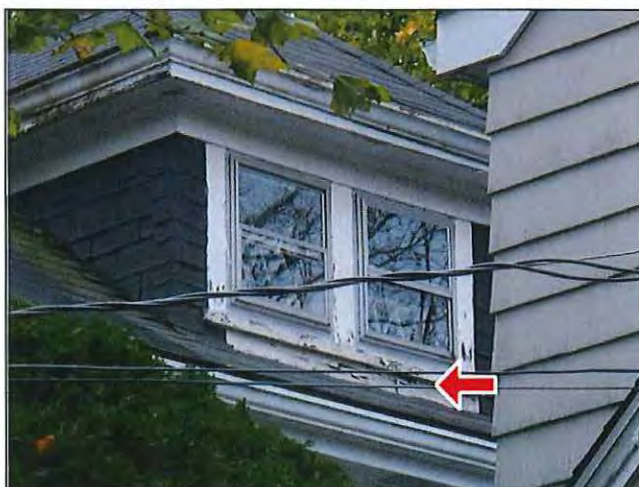
3.2 Item 5(Picture)

3.2 (2) All other exterior trim, soffits and fascias need to be properly prepped and painted.

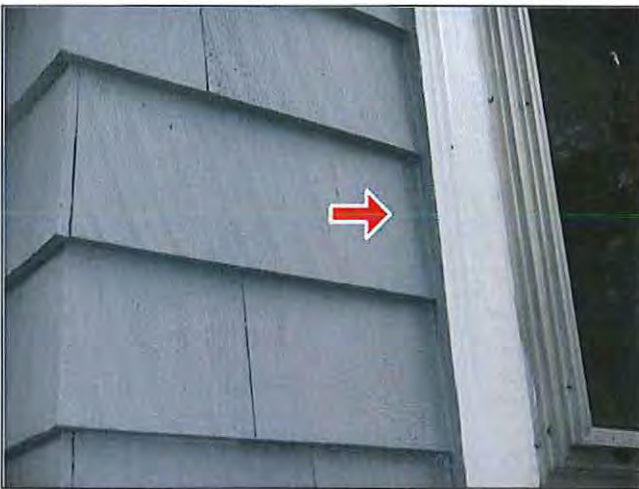
3.5 Item 1(Picture)

3.5 Caulking is needed where siding meets all vertical trim to help resist water penetration and related damages.

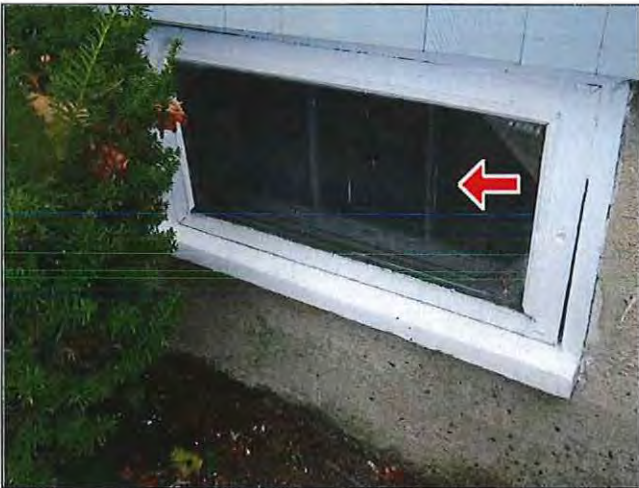
3.6 Item 1(Picture)

3.6 Consideration should be given to updating cellar windows with more energy efficient units.

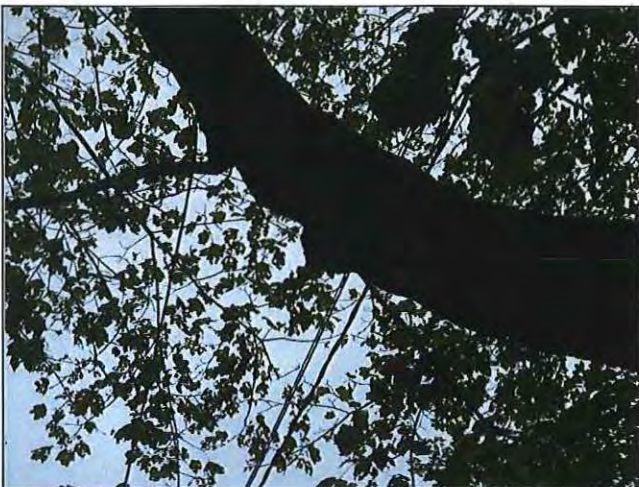
3.7 Item 1(Picture)

3.7 Tree limbs that overhang or are against power lines pose a significant hazard. They should be cut back as needed, at once by qualified personal.

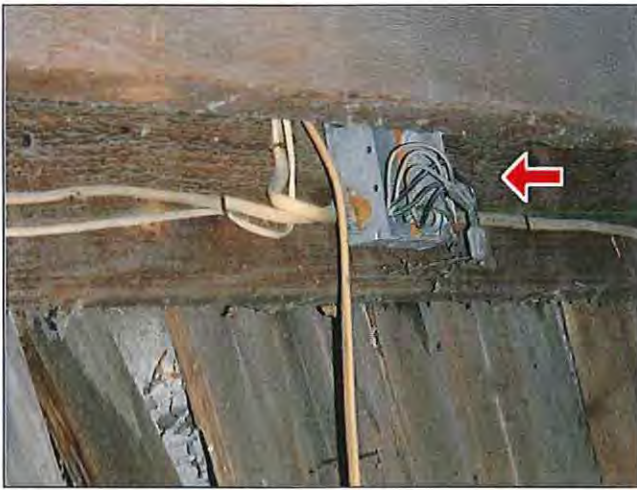
3.8 Item 1(Picture)

**3.8** Sub-standard wiring below the porch should be evaluated by a qualified electrician.

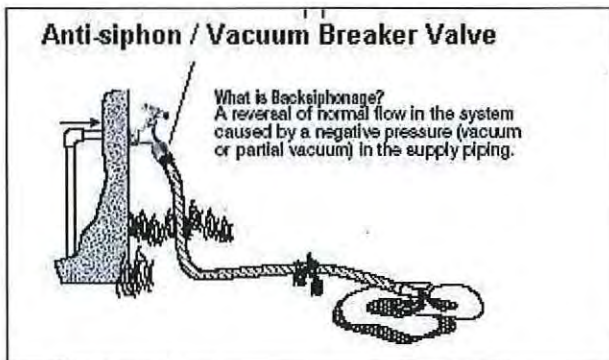
3.9 Item 1(Picture)

**3.9** All exterior sill cocks should be updated with modern frost free anti siphon units to prevent freeze up and potential contamination of the potable water supply system.

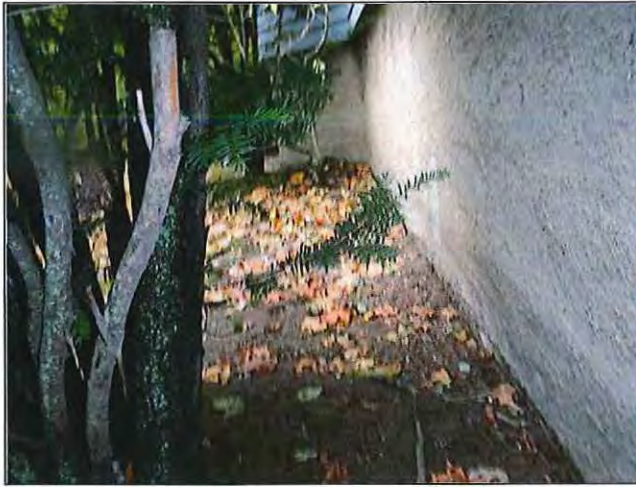
4.3 Item 1(Picture)

**4.3** Negative grading that directs water to the foundation will contribute to basement water issues. For proper drainage, it is recommend that the grade slope away from the foundation a minimum of 1" per foot for 5 feet wherever possible. Periodically, fill will be needed to maintain this grade. If available, clay should be used. Foundation grading should be kept free of wood mulch as it is conducive to wood destroying insect problems such as termites.

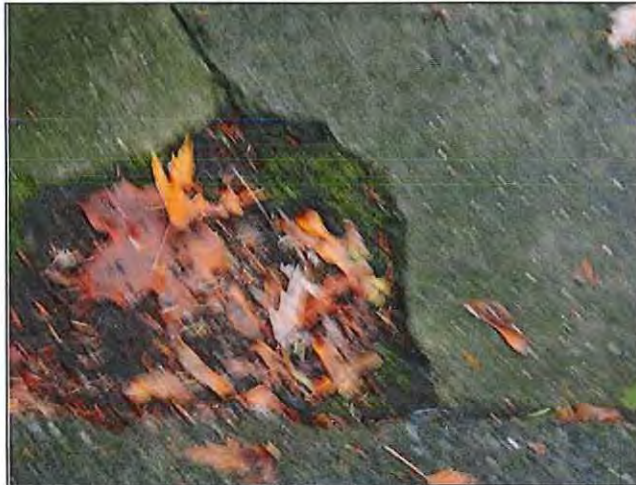
4.5 Item 1(Picture)

**4.5** Uneven settlement and deterioration of walks has created safety hazards. Correction is needed.

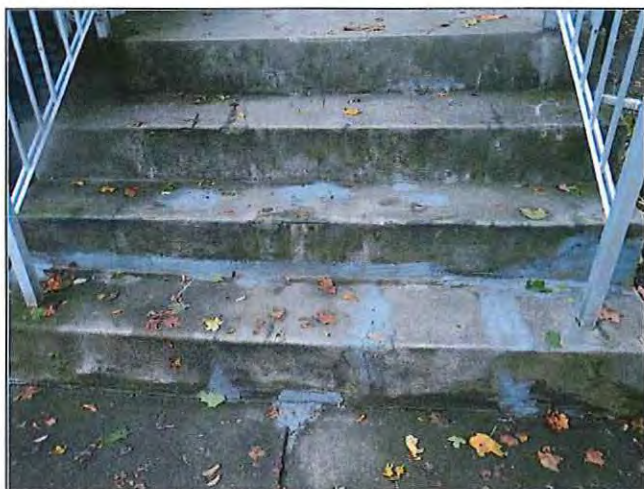
4.6 Item 1(Picture)

4.6 The front stairs need restoration or replacement.

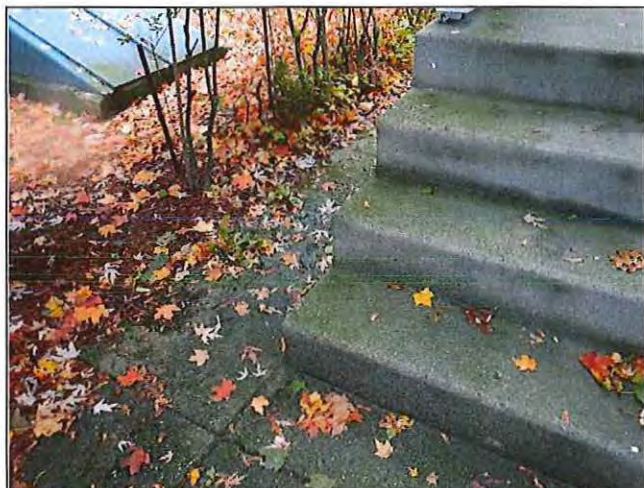
4.7 Item 1(Picture)

4.7 (1) All exterior steps should have a graspable handrail for safety.

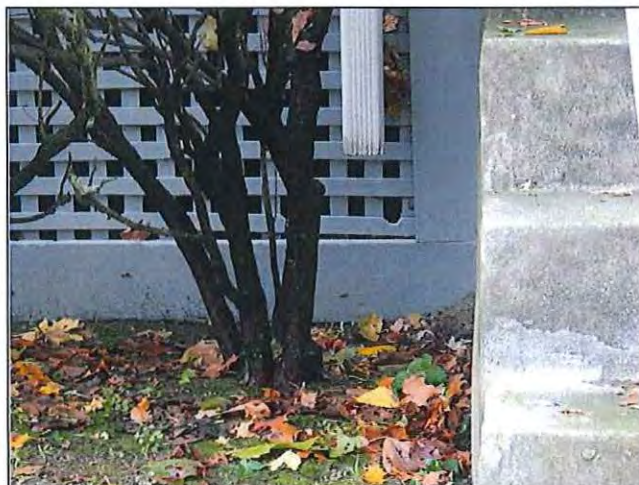
4.8 Item 1(Picture)

4.8 (1) The under side of the front porch was not accessible for inspection. The condition of the structure and the quality of workmanship is unknown. Lattice work in ground contact is conducive to decay and wood boring insects.

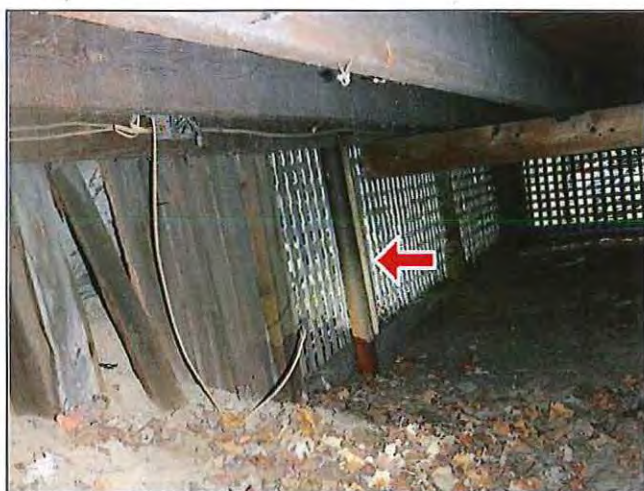
4.8 Item 2(Picture)

4.8 (2) Deteriorated lalley columns below the front porch should be replaced.

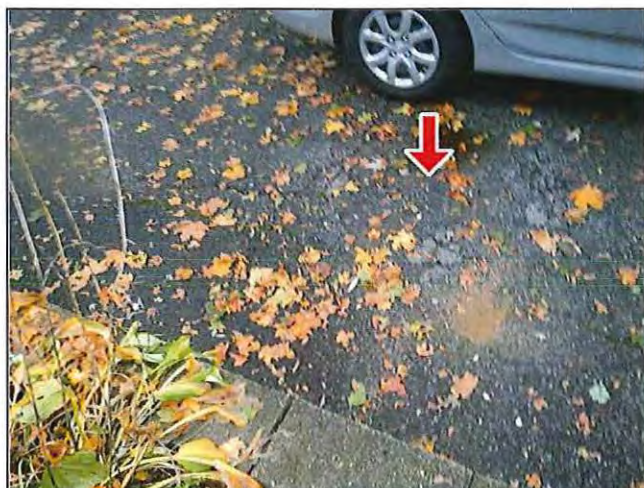
4.9 Item 1(Picture)

4.9 The driveway is worn, settled, is breaking apart and needs to be replaced as it is beyond repair.

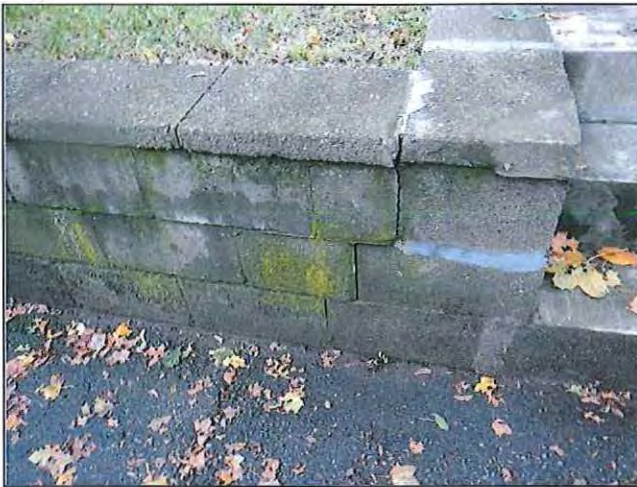
4.10 Item 1(Picture)

**4.10** Block retaining walls have failed and need to be replaced.

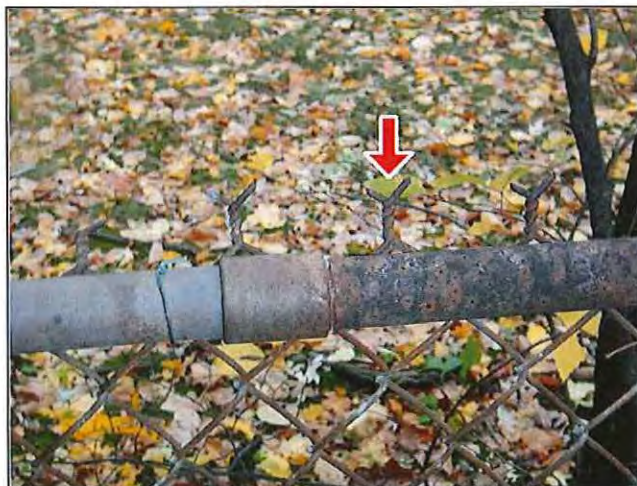
4.11 Item 1(Picture)

**4.11** Barbs at the top of the chain link fencing pose a risk for personal injury. Correction is recommended.

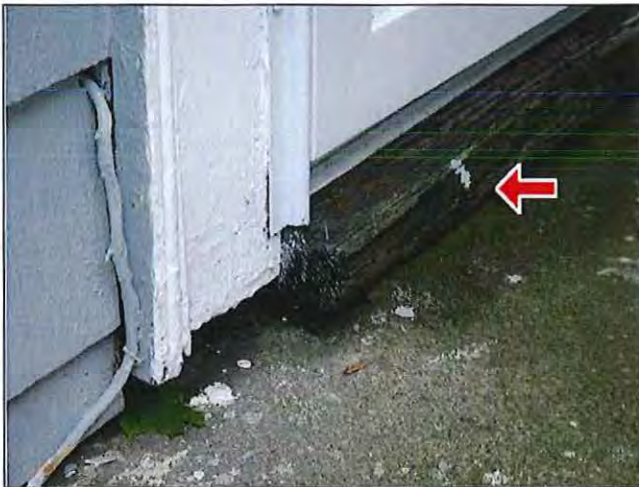
5.0 Item 1(Picture)

5.0 The threshold of the right side entry door is rotted, Replacement is recommended..

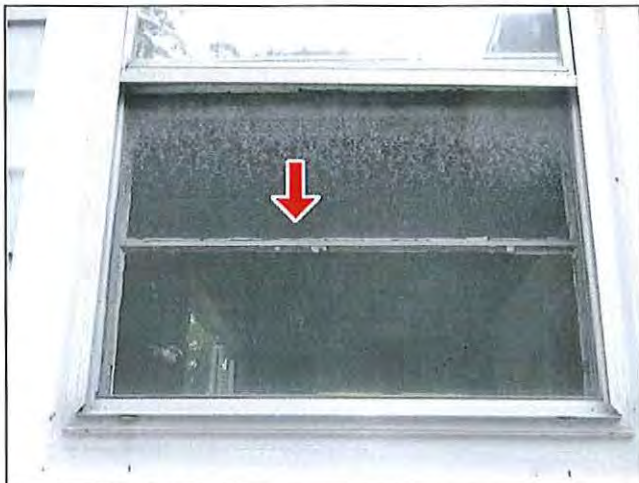
5.1 Item 1(Picture)

5.1 Original wood windows need to be reglazed and painted at least. Front porch windows need to be replaced.

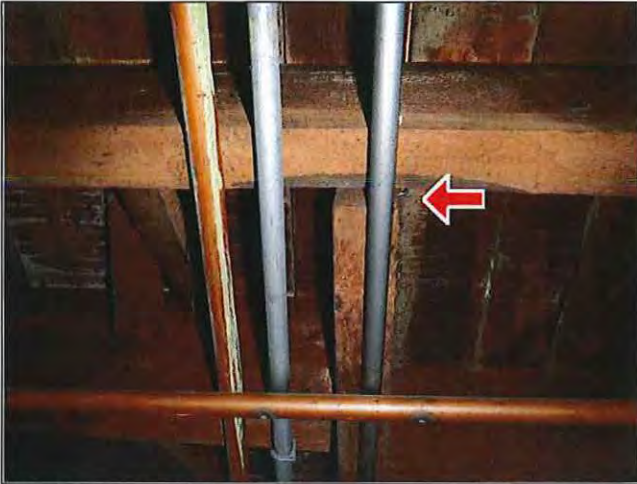
6.3 Item 1(Picture)

**6.3 (1)** Joist end connections at the stairway framing header should be carried by properly sized and fastened hangers to resist any further nail bend, separation or connection failure as is evident.

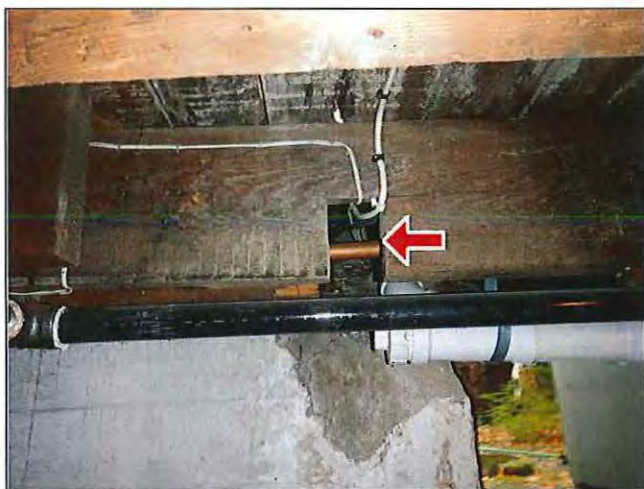
6.3 Item 6(Picture)

**6.3 (3)** Any joist that has been notched is considered compromised and should be sistered.

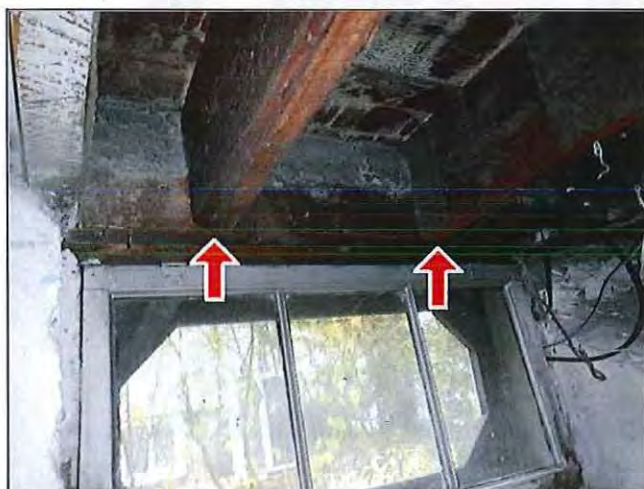
6.3 Item 7(Picture)

**6.3 (4)** Joist end connections in shear should be carried by properly sized and fastened hangers to resist nail bend, separation or connection failure.

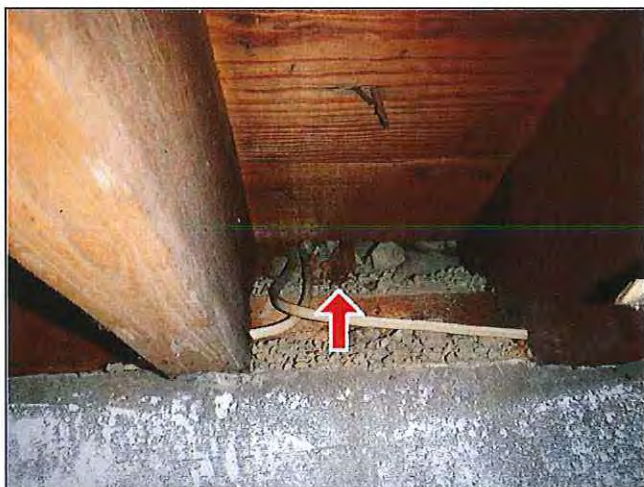
6.11 Item 1(Picture)

**6.11** (1) Balloon framing should be fire stopped as needed.

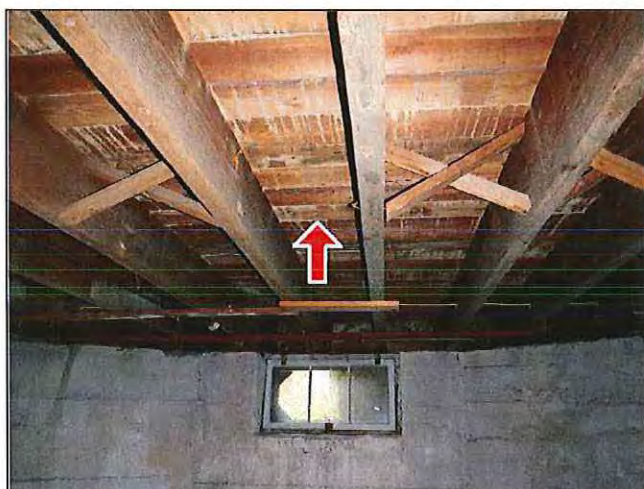
6.11 Item 2(Picture)

**6.11** (2) The underside of the first floor platform should be insulated to help conserve energy.

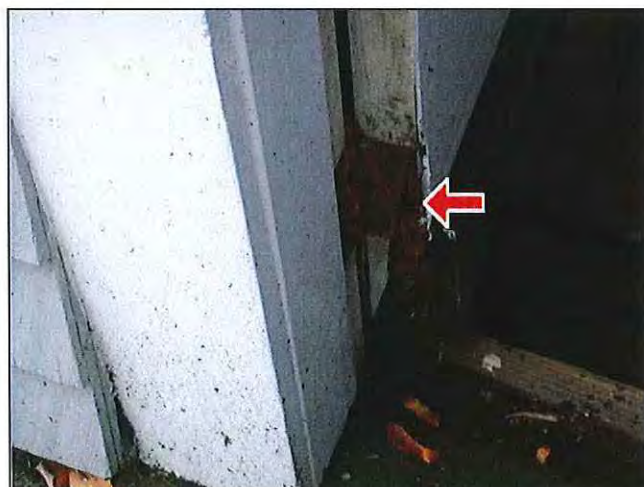
6.12 Item 1(Picture)

**6.12** Corroded bulkhead door hinges need to be replaced

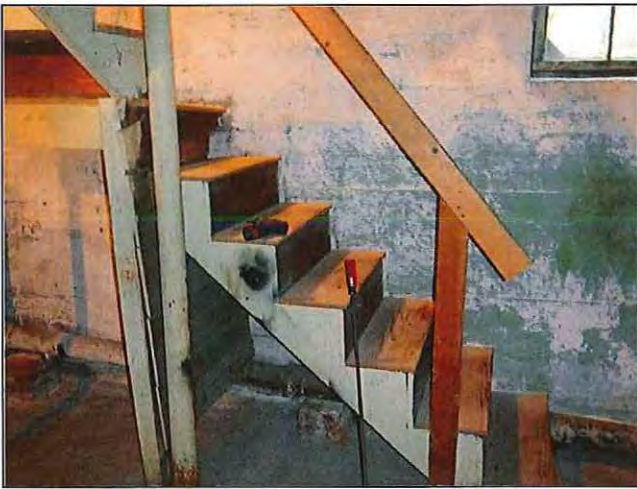
6.13 Item 1(Picture)

6.13 (1) The cellar stairway needs proper hand and guard rails for safety.

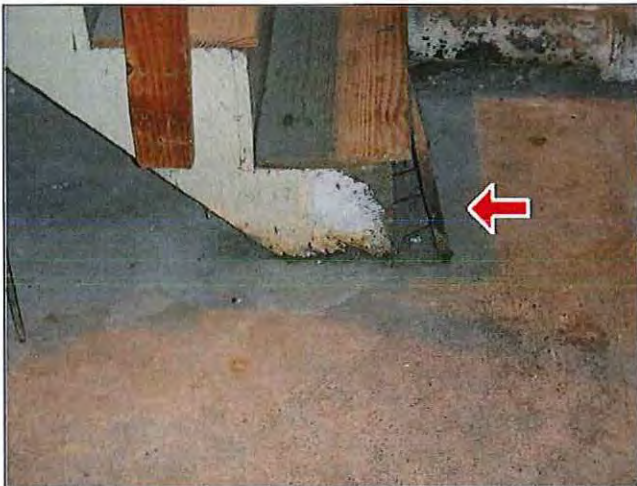
6.13 Item 2(Picture)

6.13 (2) The base of the cellar stairs are decayed. Repair is recommended.

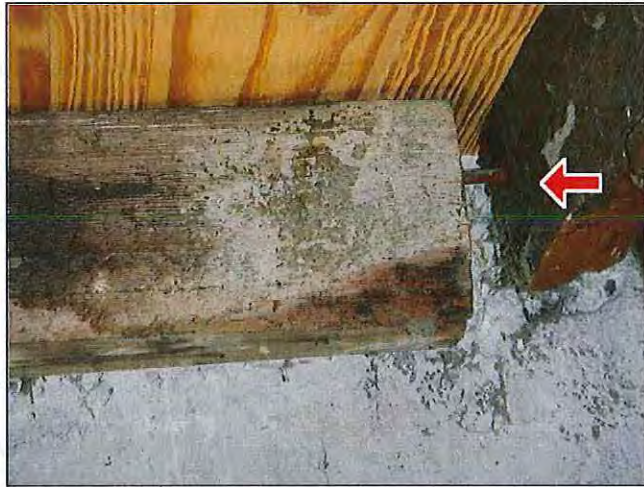
6.13 Item 4(Picture)

6.13 (3) The cellar stairs need to be properly re-supported. Consideration should be given to re-building the stairs.

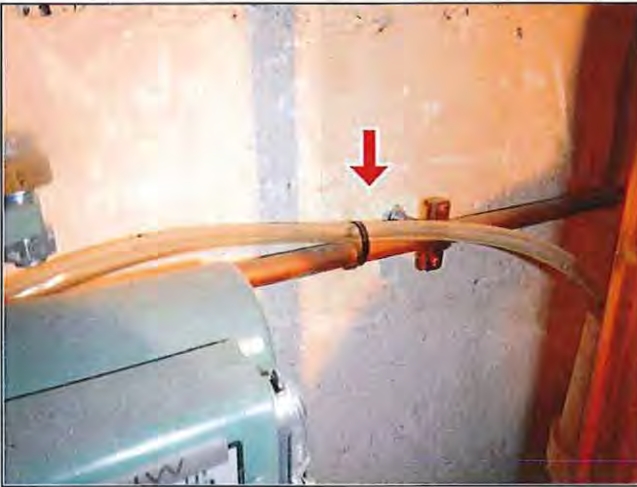
7.14 Item 1(Picture)

7.14 The installation of a condensate neutralizer cartridge is recommended.

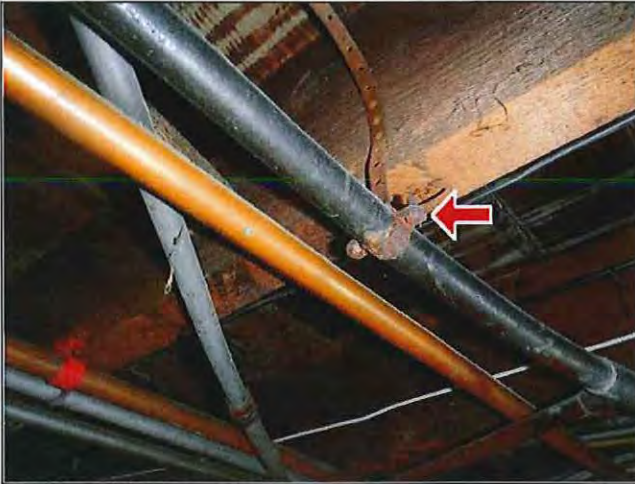
9.0 Item 1(Picture)

9.0 (1) Visible supply plumbing appeared functional as intended at this time. Copper tubing should be supported with proper hangers. Copper or plastic is recommended as steel will and has caused galvanic action to occur.

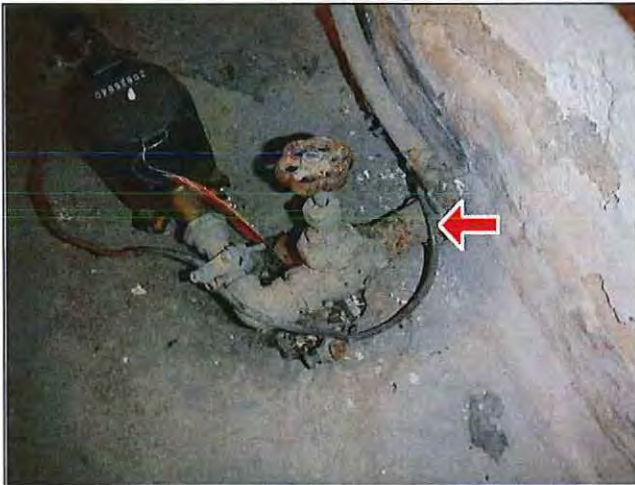
9.0 Item 2(Picture)

9.0 (2) The main water line in from the street is iron. This type of pipe tends to corrode and fail internally. Failure typically occurs with out warning.

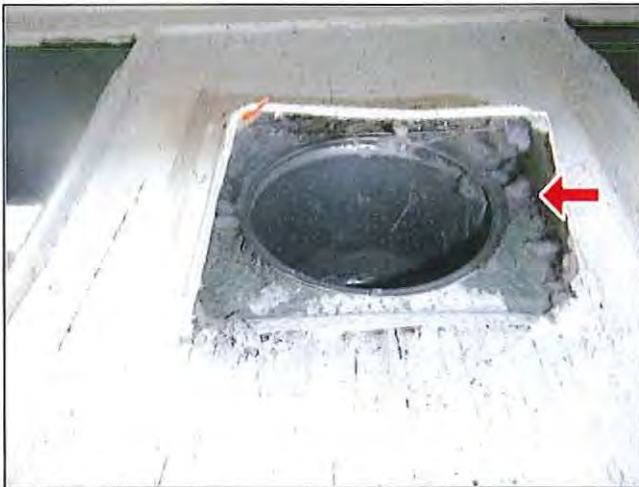
11.2 Item 1(Picture)

**11.2** The dryer vent needs to be cleaned. The dryer vent needs to be cleaned semi-annually. Lint laden dryer vents are a leading cause of residential fires.

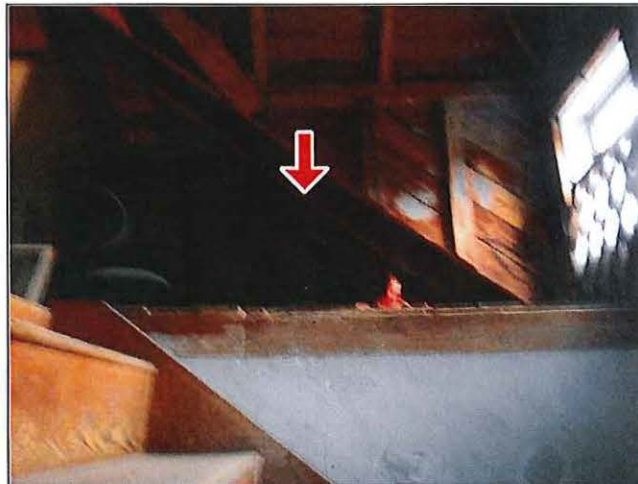
17.0 Item 5(Picture)

17.0 (2) Guard rails are needed around the attic stairway opening for safety.

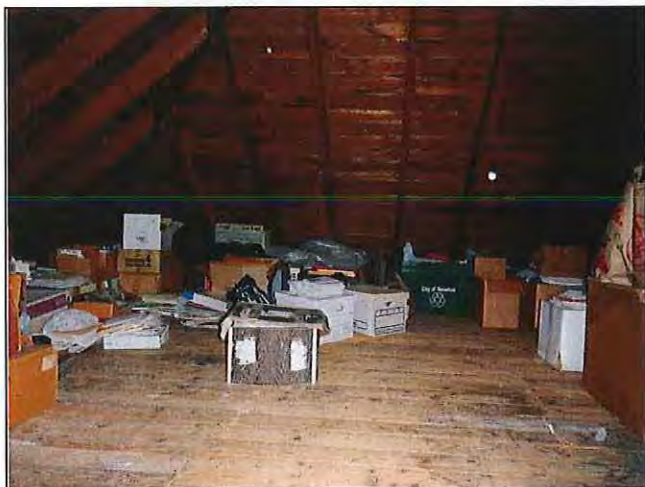
17.0 Item 6(Picture)

**17.0** (3) The attic inspection was limited due to depth of insulation, obstructions/storage, lack of adequate lighting and floor coverings. Unseen conditions may exist.

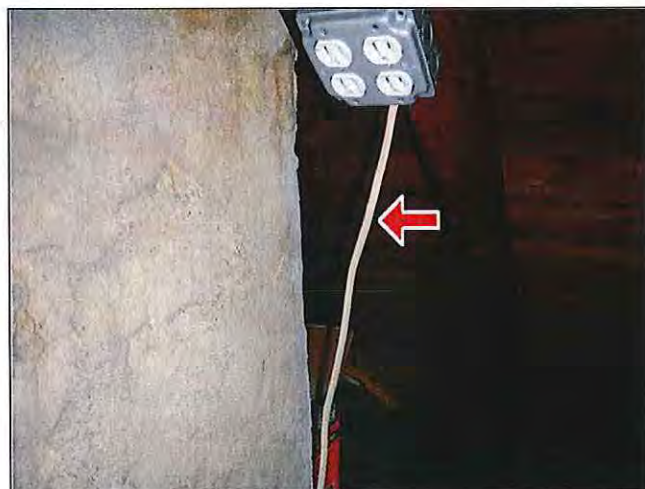
17.5 Item 1(Picture)

**17.5** Wiring to the attic outlet needs to be protected by conduit.

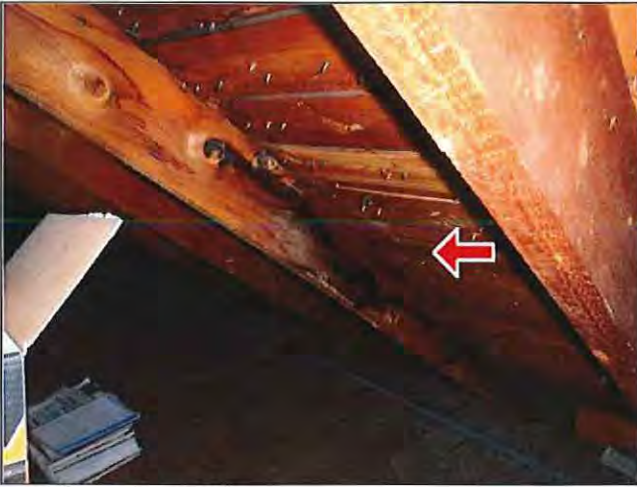
17.9 Item 1(Picture)

17.9 Water stains on sheathing at various points throughout the attic indicate past roof leaks. All was dry at this time.
