**APPENDIX A**

PHOTOGRAPHIC DOCUMENTATION

Warren House  
Newton, MA  
Gale JN 817220

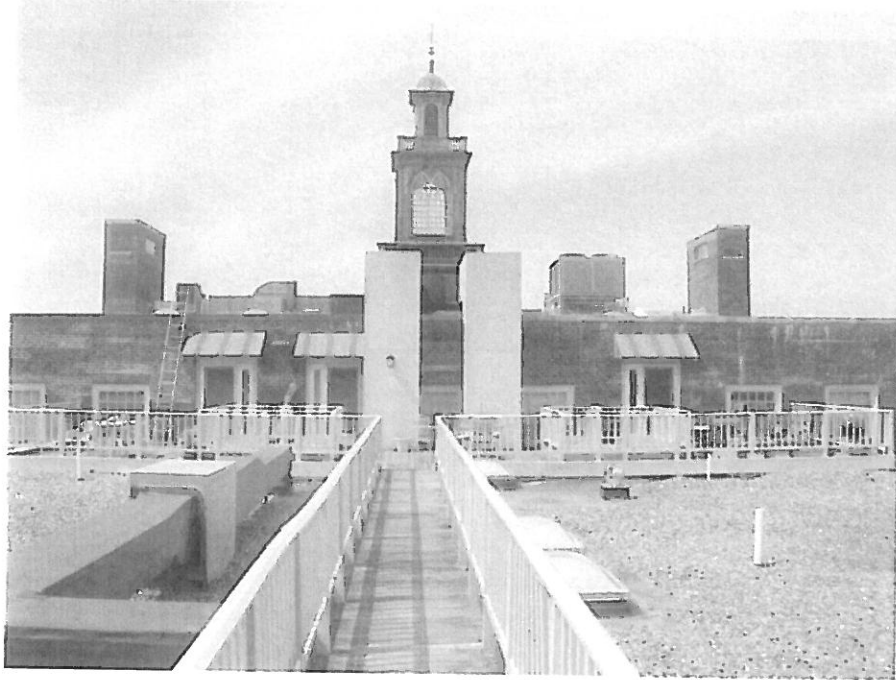
1. Overview of the various roof areas at the Warren House looking from the South Wing. Note that the low slope roof areas are typically ballasted and have wood plaza decks set atop the roof membrane.

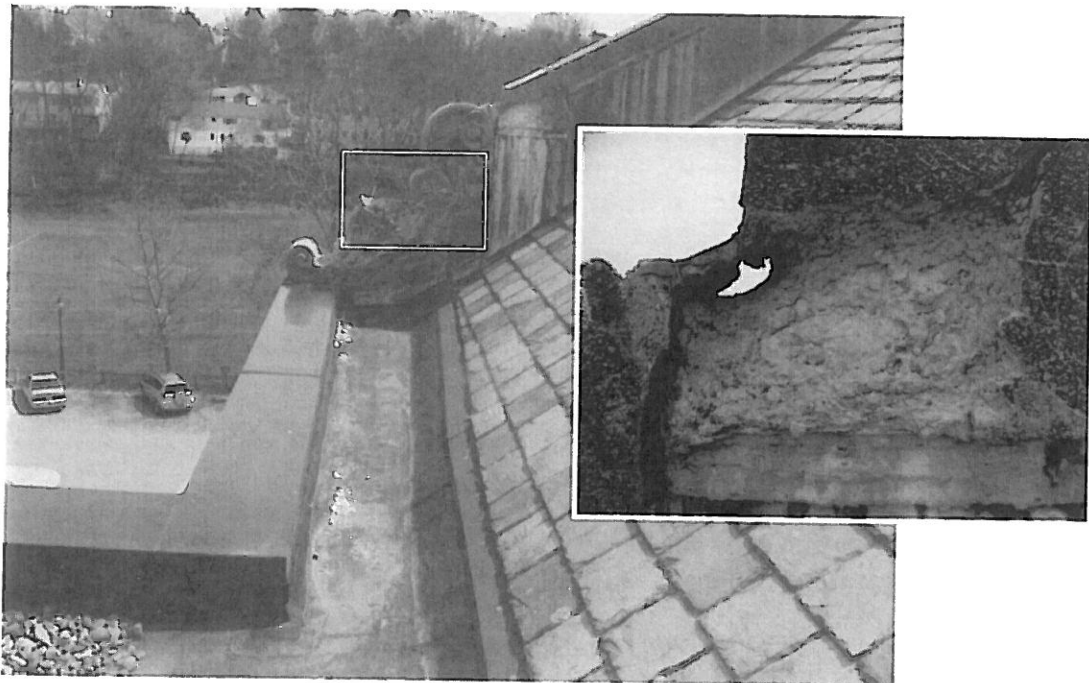
2. Deteriorated cast stone components, such as this decorative gable end can present a potential falling debris hazard.

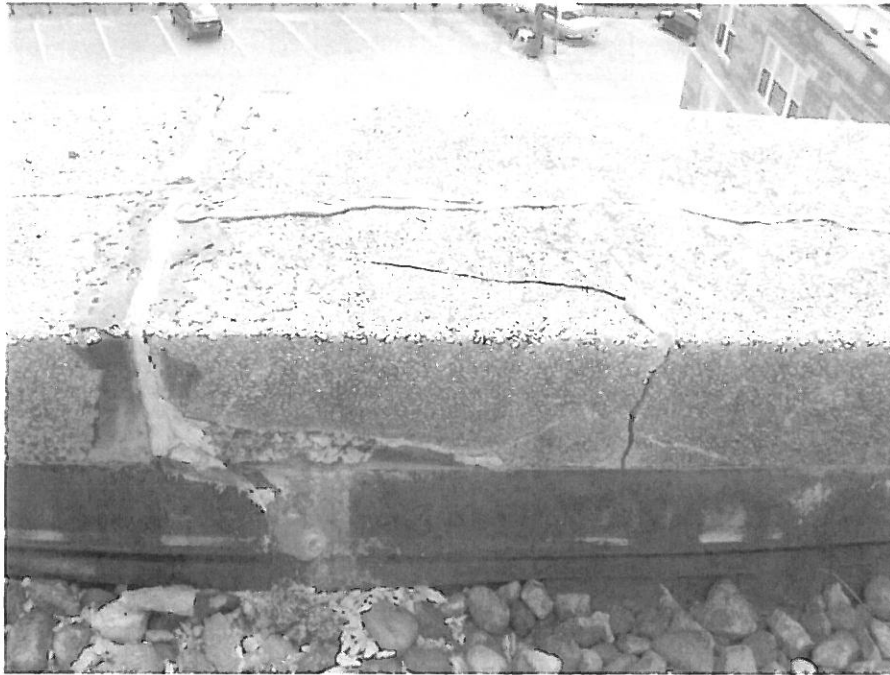
3. Cast stone coping along the parapet is cracked throughout and spalled at one location. It appears that sealant was used in an attempt to seal the head joint and repair cracks.

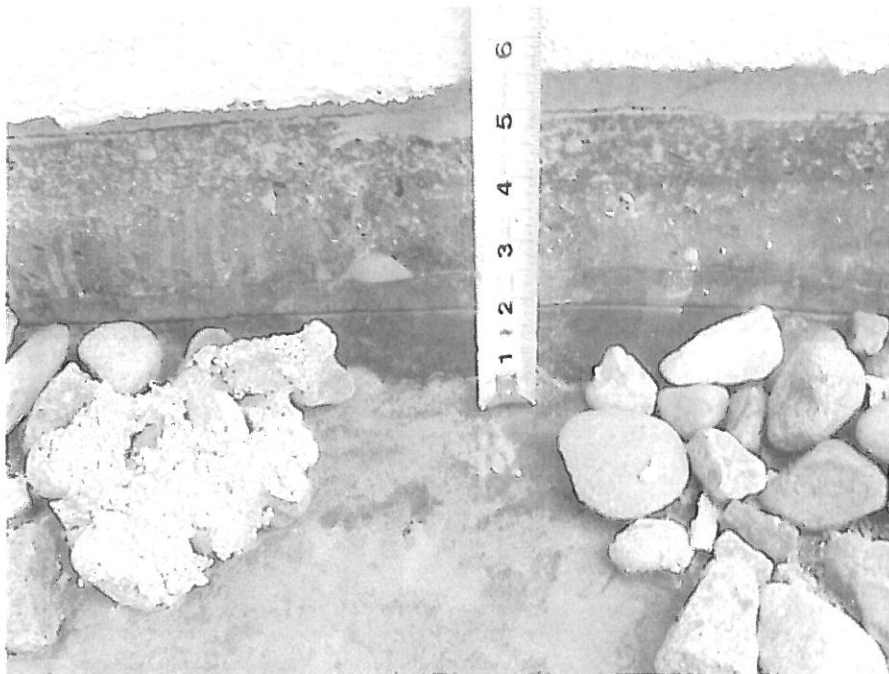
4. Low flashing height at the EIFS wall. Note that 8" is the recommended flashing height above the roof line.

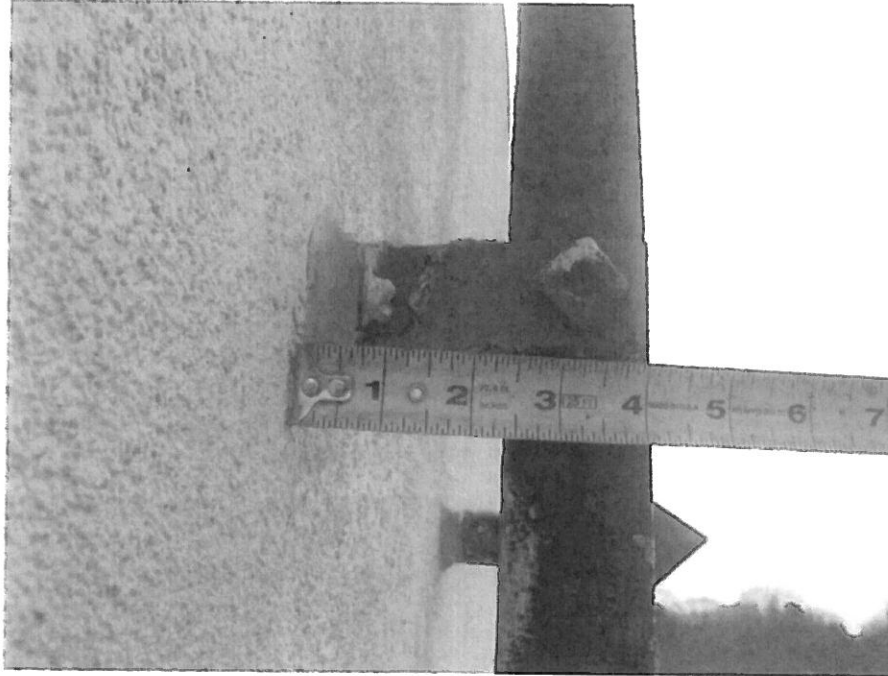
5. Distance from the surface of the wall to the ladder supports/rungs does not comply with the 7" minimum code requirement.

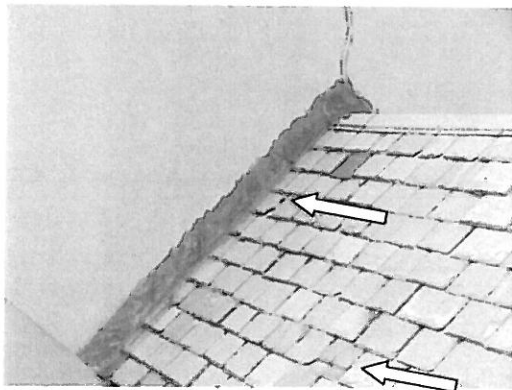
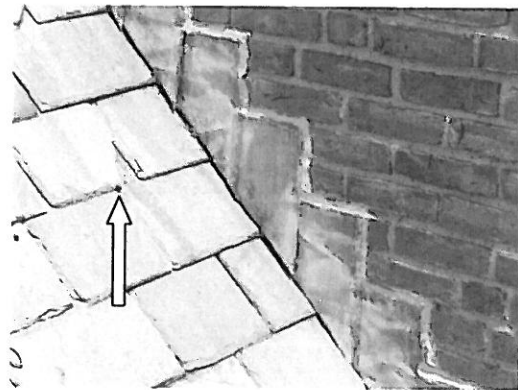
6. Step through-wall flashings at the base of the Tower and at the brick masonry chimneys at the North Wing Roof are typically sealed with sealant. Note cracked and broken slate.

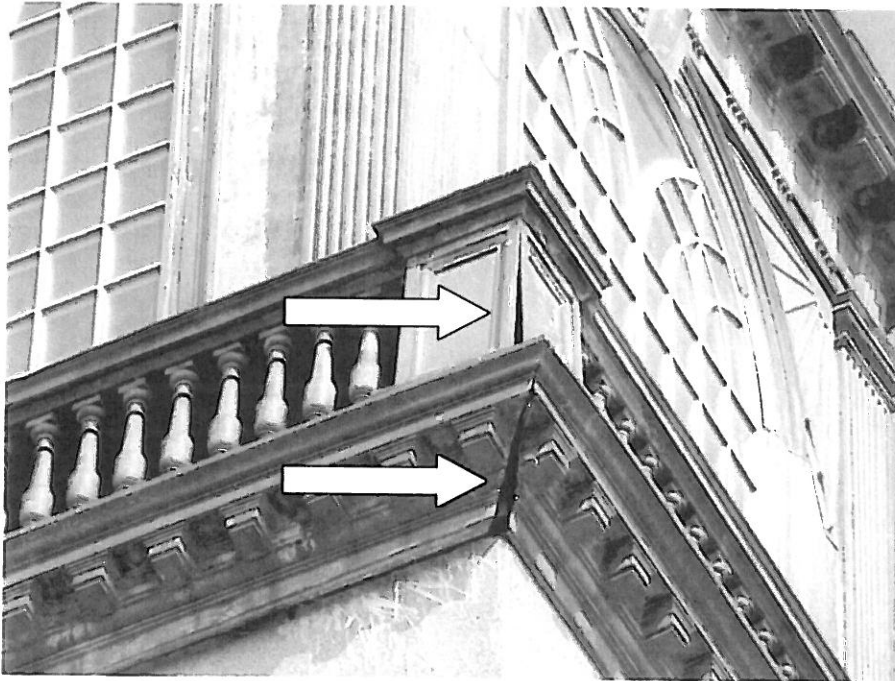
7. Mitered joints at the corners of the cupola are open at several locations, allowing for potential water infiltration and animal/insect infestation.

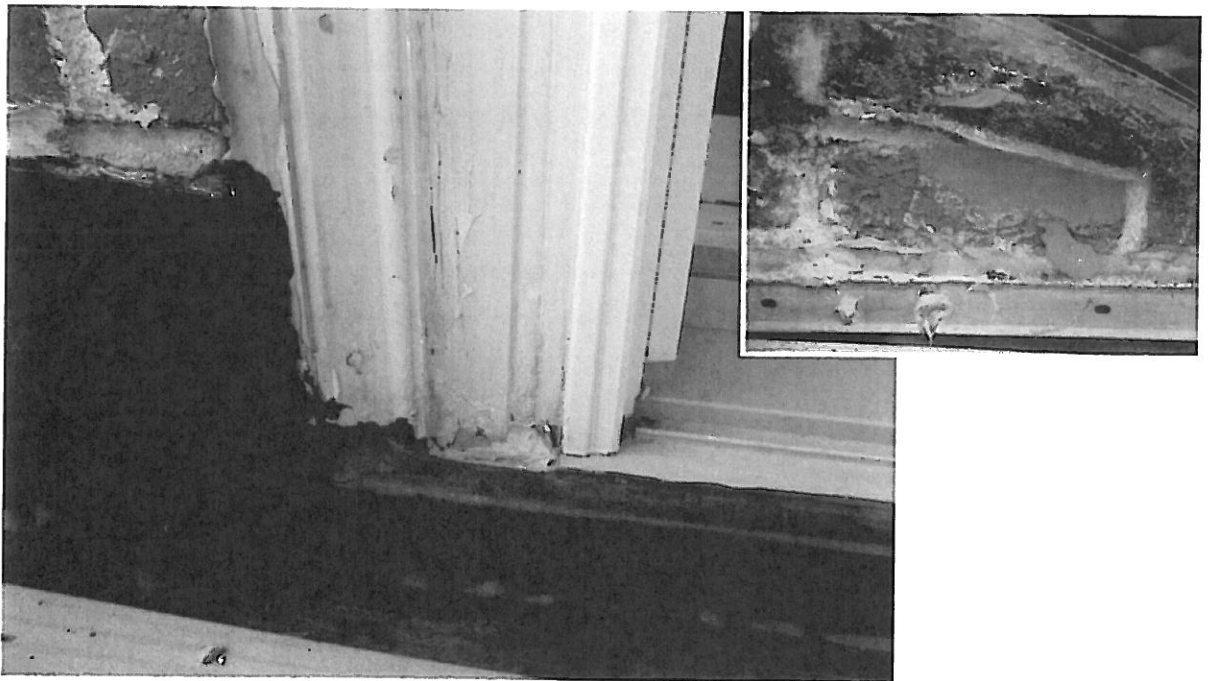
8. South Wing Roof; West Balcony. The through-wall flashings are covered with roof membrane. Brick masonry under the membrane is wet and deteriorated (refer to inset photo).
