Warren House

Newton Community Development Foundation
Request for \$1,080,000 of CPA funds
January 14, 2009

Warren House Deterioration

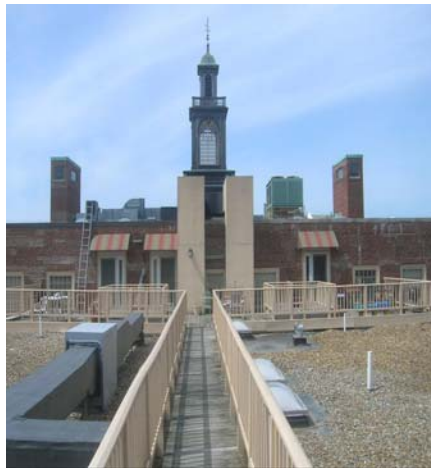
- Various roof areas from South Wing
- Low slope roof areas are typically ballasted and have wood plaza decks set atop roof membrane

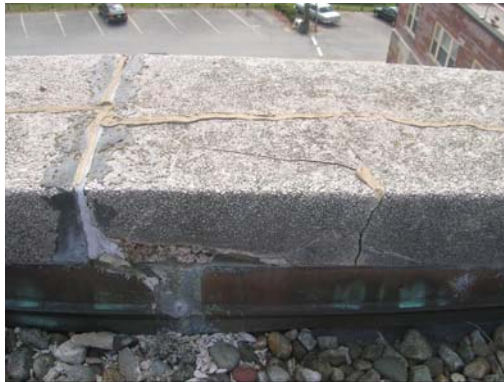
- Cast stone coping along the parapet is cracked throughout and spalled at one location
- Sealant has been used to repair cracks

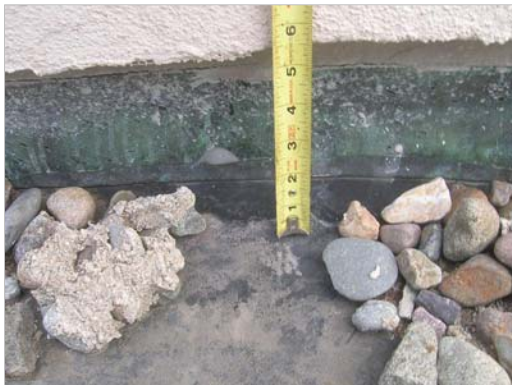
- Low flashing height at the EIFS wall (5")
- 8" is recommended flashing height above roof line

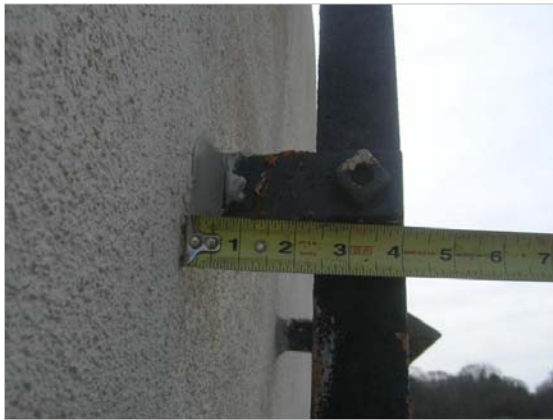
- Distance from surface of the wall to ladder supports does not comply with code requirements (7")

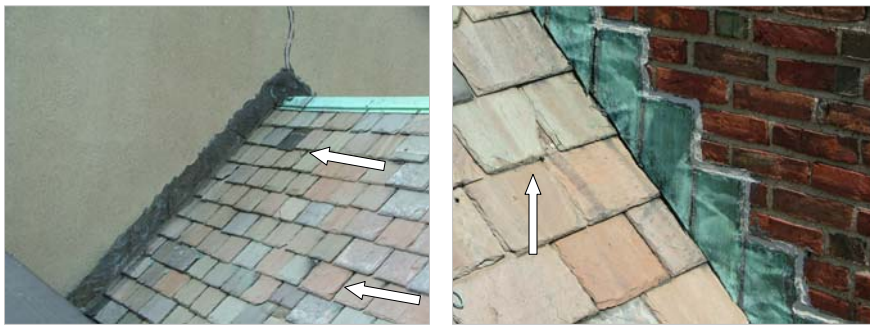
- Step through wall flashings at the base of the Tower and at the brick masonry chimneys at the North Wing Roof are typically sealed with sealant. The slate is cracked and broken

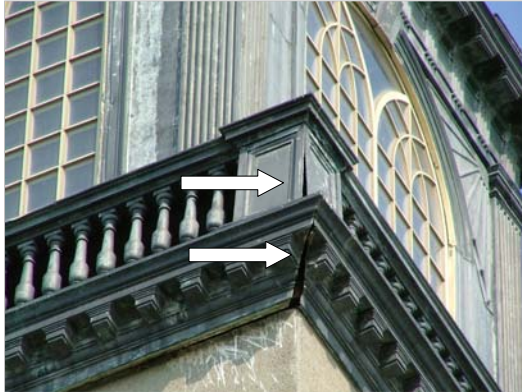
- Mitered joints at the corners of the cupola are open at several locations, allowing for potential water infiltration and animal/insect infestation

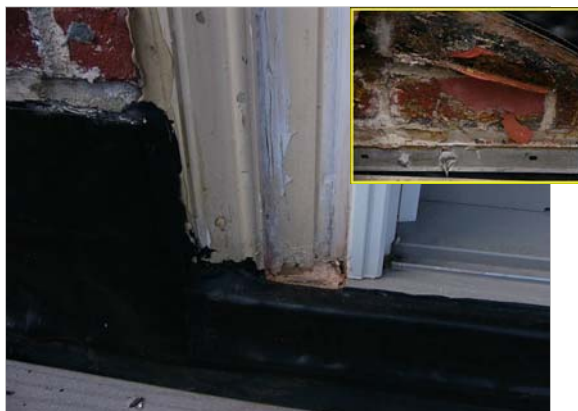
- South Wing Roof; West Balcony, The through-wall flashings are covered with roof membrane. Brick Masonry under the membrane is soft and deteriorated.
