PHASE I - Before

Construction- Phase I: Additional Deterioration Conditions and Treatment Approaches

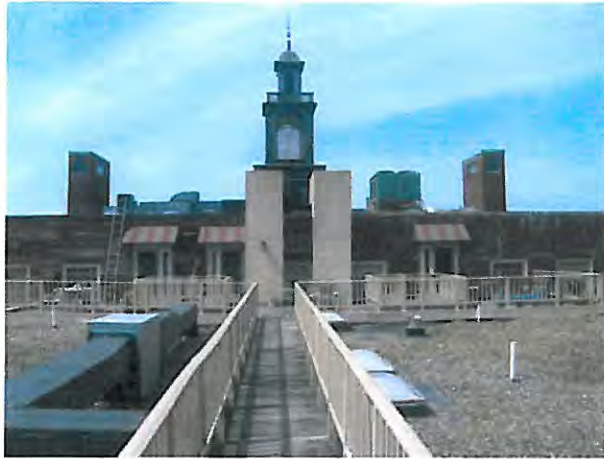
View from the south roof stairwell looking north: ballasted EPDM roofs installed circa 1993 were at the end of their service life with multi areas of ponding and poor drainage. Multiple leaks were reported at the penthouse units. Existing railing systems did not comply with spacing of balusters per the Massachusetts State Building Code (MSBC).

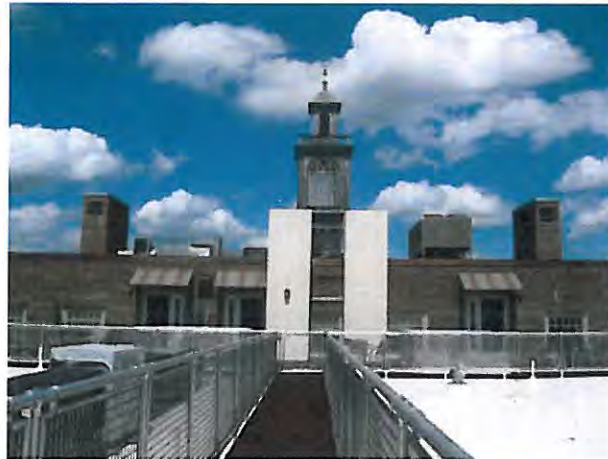
PHASE I – After

View from the south roof stairwell looking north: new thermoplastic roof systems with tapered insulation and overflow drainage accommodations, new railings, walkway and deck systems. Masonry repairs and 100% repointing was performed at all the above roof line components within the Contract limits.

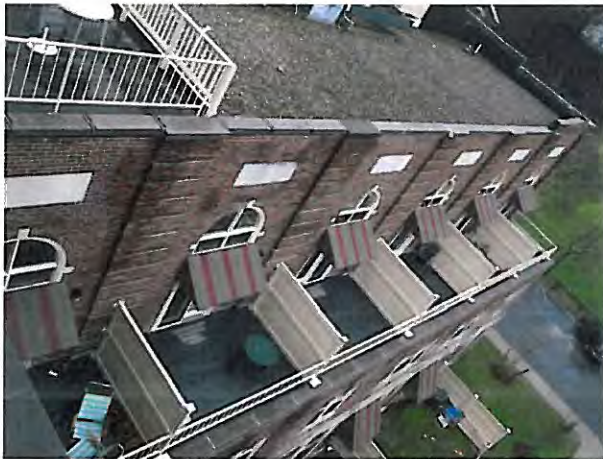
Southwest balcony roof: Existing railing systems did not comply with spacing of balusters per the Massachusetts State Building Code (MSBC). Severe water infiltration was reported at the apartment units below the balconies. Cast stone copings are uncovered with multiple areas of cracked and spalled stone.

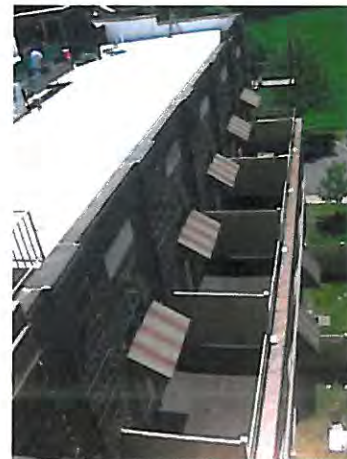
Southwest balcony roof: Refurbished railing systems, new balcony waterproofing systems, new throughwall flashing systems, copper caps over all the existing cast stone copings, repainted wood balcony and transoms including wood repairs of rotted wood components.

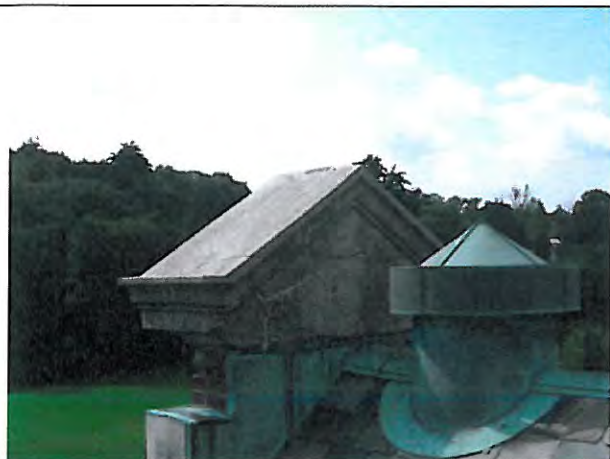
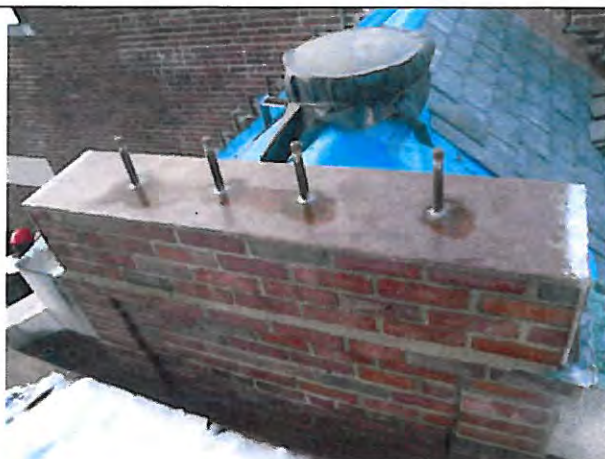
Upper Photo: Existing cast stone pediment over the south entrance was cracked in multiple areas.

Lower Photo: Removal of the pediment revealed that there were no supporting steel elements through the masonry below, and it was set on the flashing in the lower photo. Upon removal of the stone, the brick masonry base was unstable and required rebuilding.

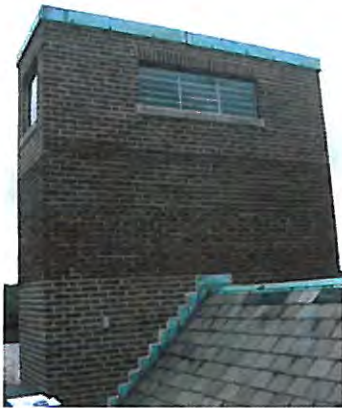
Multiple leaks were reported at the apartments adjacent to the chimney walls. Plexi glass had been installed over the louvers as a temporary waterproofing measure. Spot repointing of the chimneys and sealant and mastic repairs on the adjacent copper flashing and slate roof areas were performed.

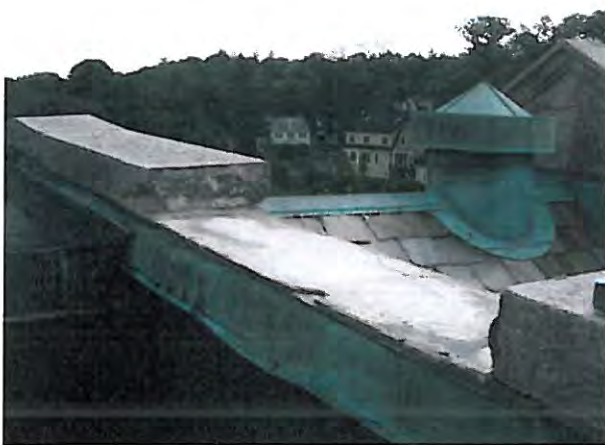
Several cast stone parapet stones were identified in 2009 as being potential fall hazards and removed until renovation work could be performed.

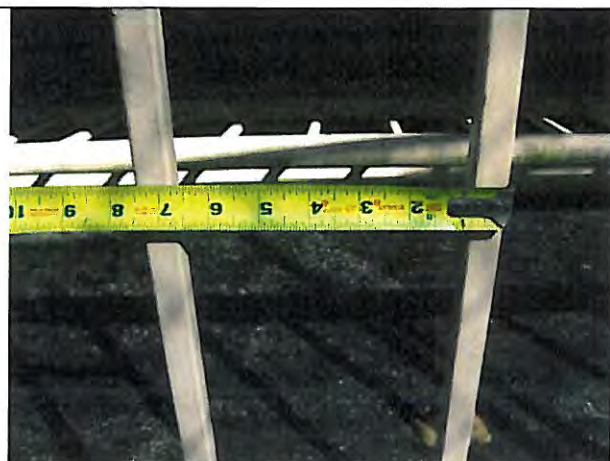
Existing metal rail baluster spacing measured 6.5", MSBC dictates the openings between balusters have to be reduced to prevent a 4" diameter ball from passing through them.

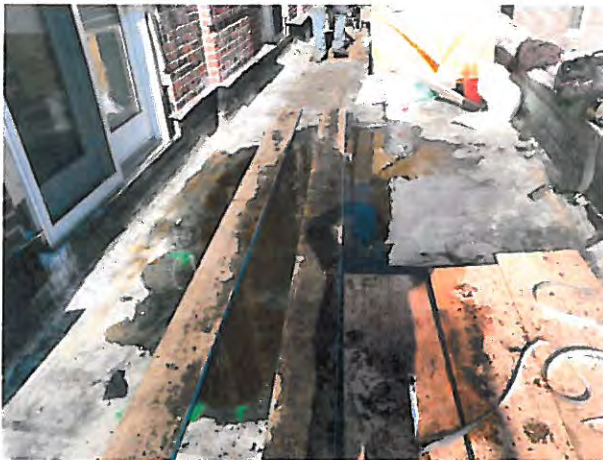
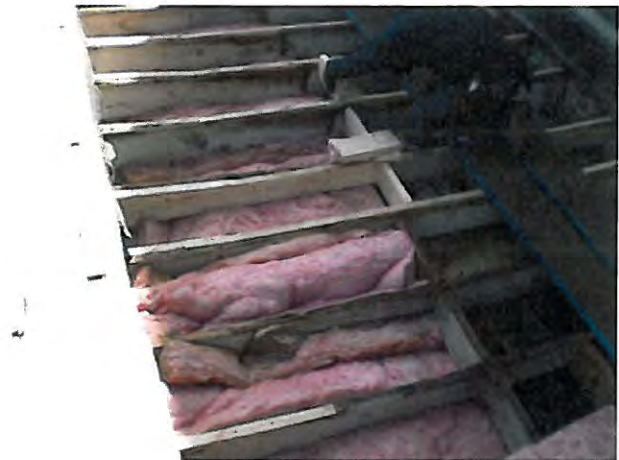
Balcony Roofs

Balcony roof replacement work: The removal of the above roof decks at the southeast balcony revealed that the roof was deflecting/sagging, and the majority of the deck and sections of the wood framing rotted.

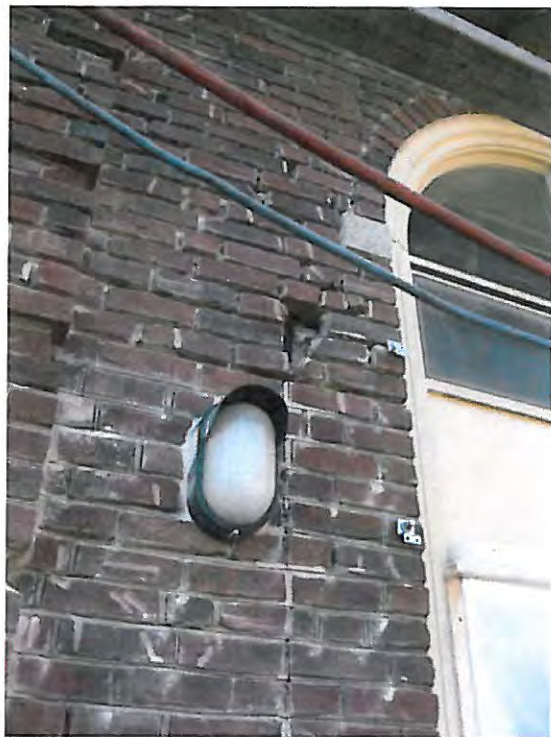
South East Balcony Wall:

Left Photo: Several areas of brick masonry were identified in the evaluation as cracked and were designated for replacement.

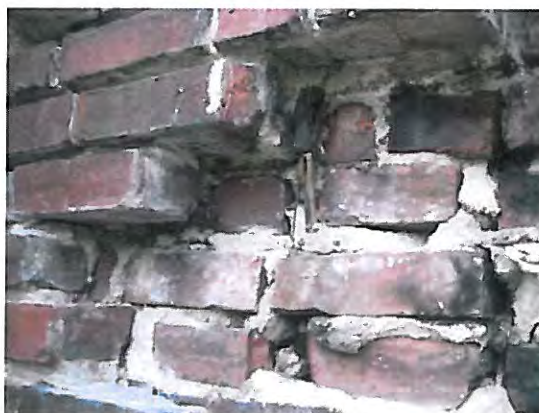
Upper Right Photo: Removal of the cracked brick revealed a conduit in the wall.

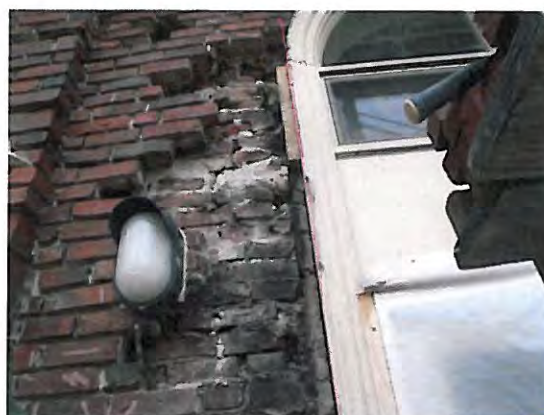
Lower Right Photo: During an effort to expose the conduit and remove it from the wall, a section of approximately eighty (80) brick masonry units collapsed, requiring that the brick wall be stabilized and rebuilt.

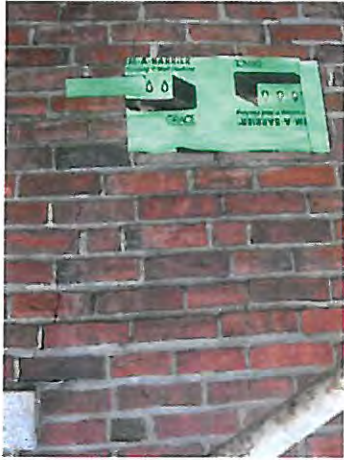
North Wall:

Upper Photo: Modified bitumen protection was applied over a section of removed loose masonry, as part of the temporary stabilization work in 2009. Prior to rebuilding the masonry, rusted steel beams pocketed within the masonry wall were prepared, primed and painted to minimize the potential of additional rusting leading to rust jacking and spalling of the brick masonry.

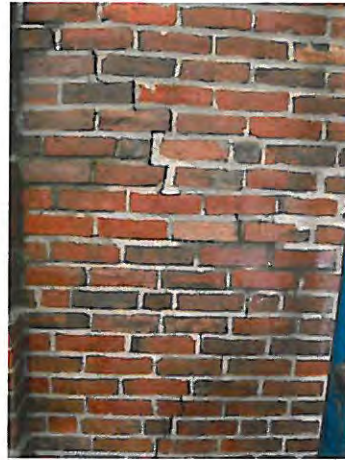
South Wall:

Upper Photo: Step cracking in masonry wall designated for repair.

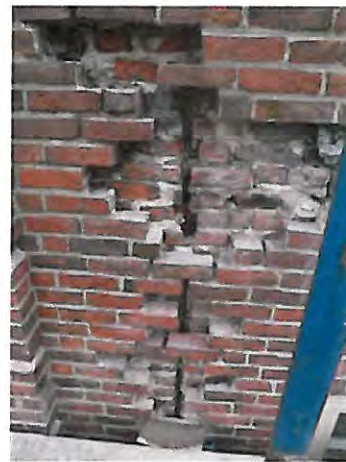
Lower Photo: Removal of the brick masonry for the step crack revealed a metal conduit, encasing a rope which was believed to be for an old school bell. Due to the rusted steel, the masonry had to be removed for the full length of the conduit and rebuilt using a helical tie system.

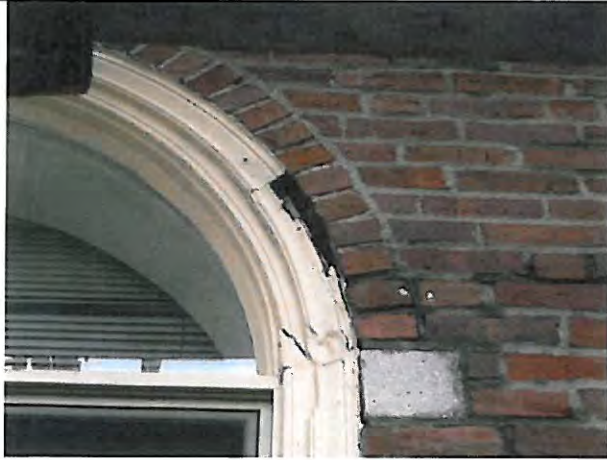
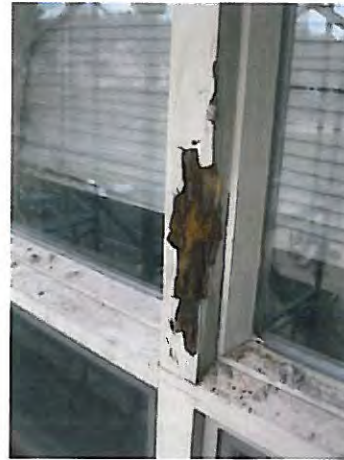
Wood deterioration

Rotted wood framing components at the windows were identified through out. Rotted wood was cut out and replaced. All windows were repainted and new perimeter sealants installed.
