Geotechnical Engineering Evaluation Report EXECUTIVE SUMMARY

**Waban Hill Reservoir Dam
NID # MA 01111
Newton, Massachusetts**

**Prepared for:
City of Newton
1000 Commonwealth Avenue
Newton, Massachusetts 02459**

**Prepared by:
Stantec Consulting Services Inc.
5 LAN Drive, Suite 300
Westford, Massachusetts 01886**

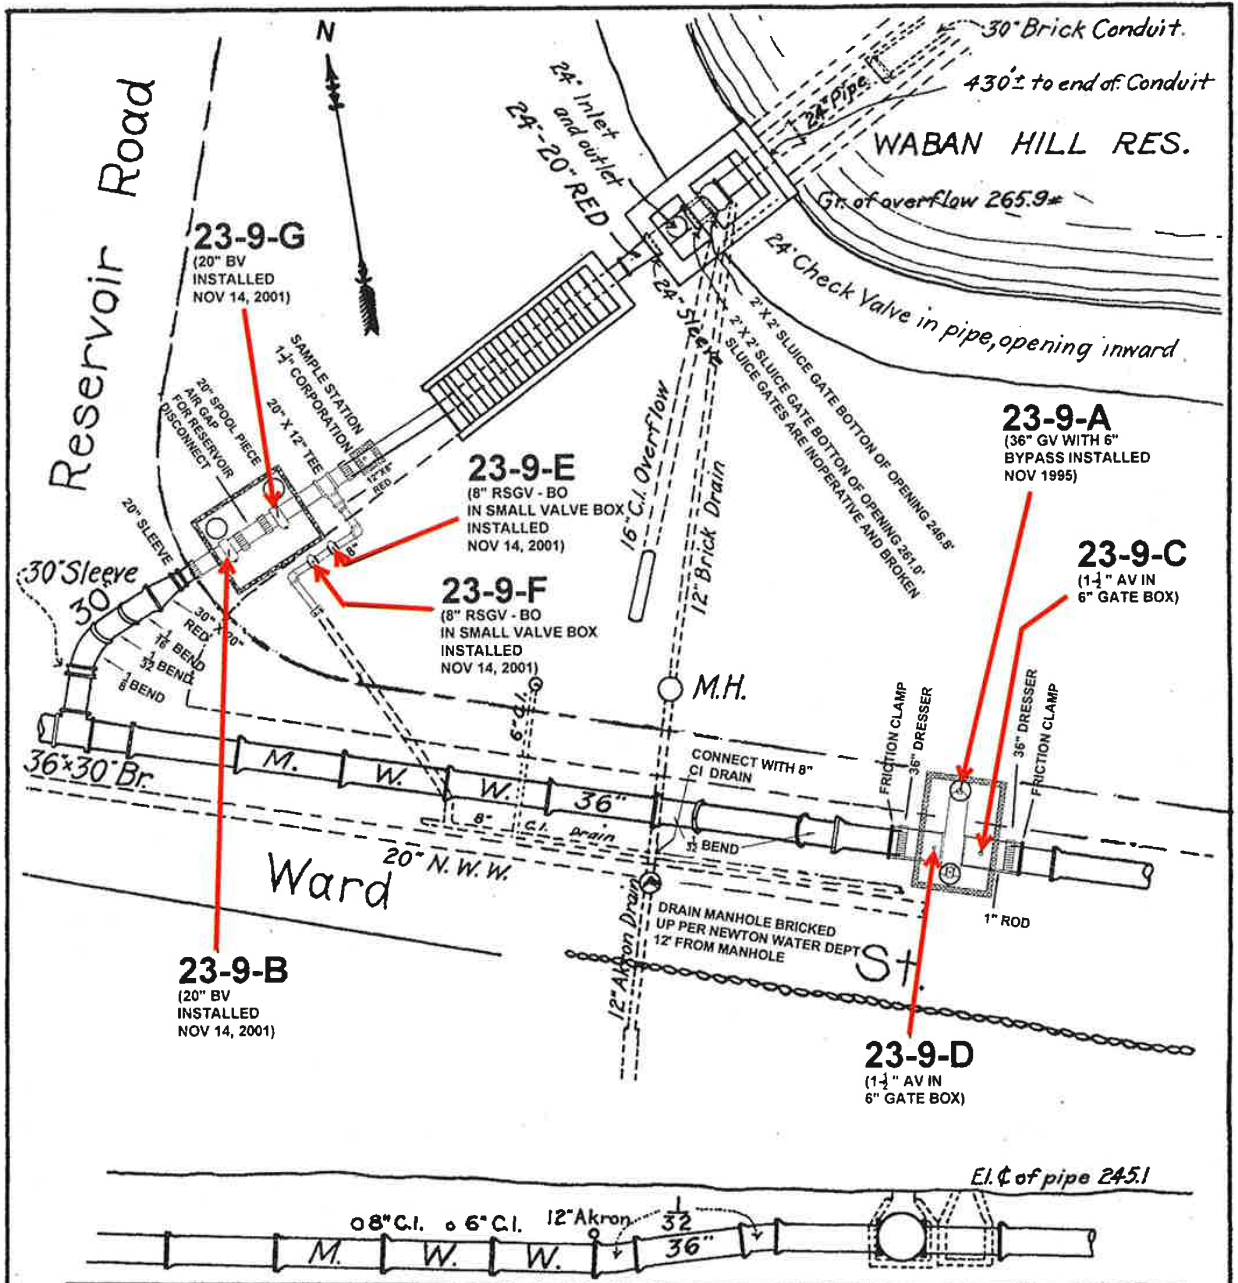
GATE HOUSE AT WABAN HILL RESERVOIR - WARD STREET
NEWTON

36" GATE VALVE WITH 6" BY-PASS INSTALLED NOV 1995
20" BUTTERFLY VALVES, 8" BLOW OFF RETROFIT AND
RESERVOIR DISCONNECT INSTALLED
NOVEMBER 2001

Repairs to the gatehouse would include roof replacement and the installation of a new slide gate to allow the City to maintain a maximum water surface elevation within the reservoir no higher than El 256 (current levels) via the 8-inch diameter drain pipe to the City storm water drainage system in Ward Street. A copy of the gatehouse/valve locations is attached. New resilient seated gate valves were installed along
