Geotechnical Engineering Evaluation Report

Waban Hill Reservoir Dam
NID # MA 01111
Newton, Massachusetts

Prepared for:
City of Newton
1000 Commonwealth Avenue
Newton, Massachusetts 02459

March 20, 2014

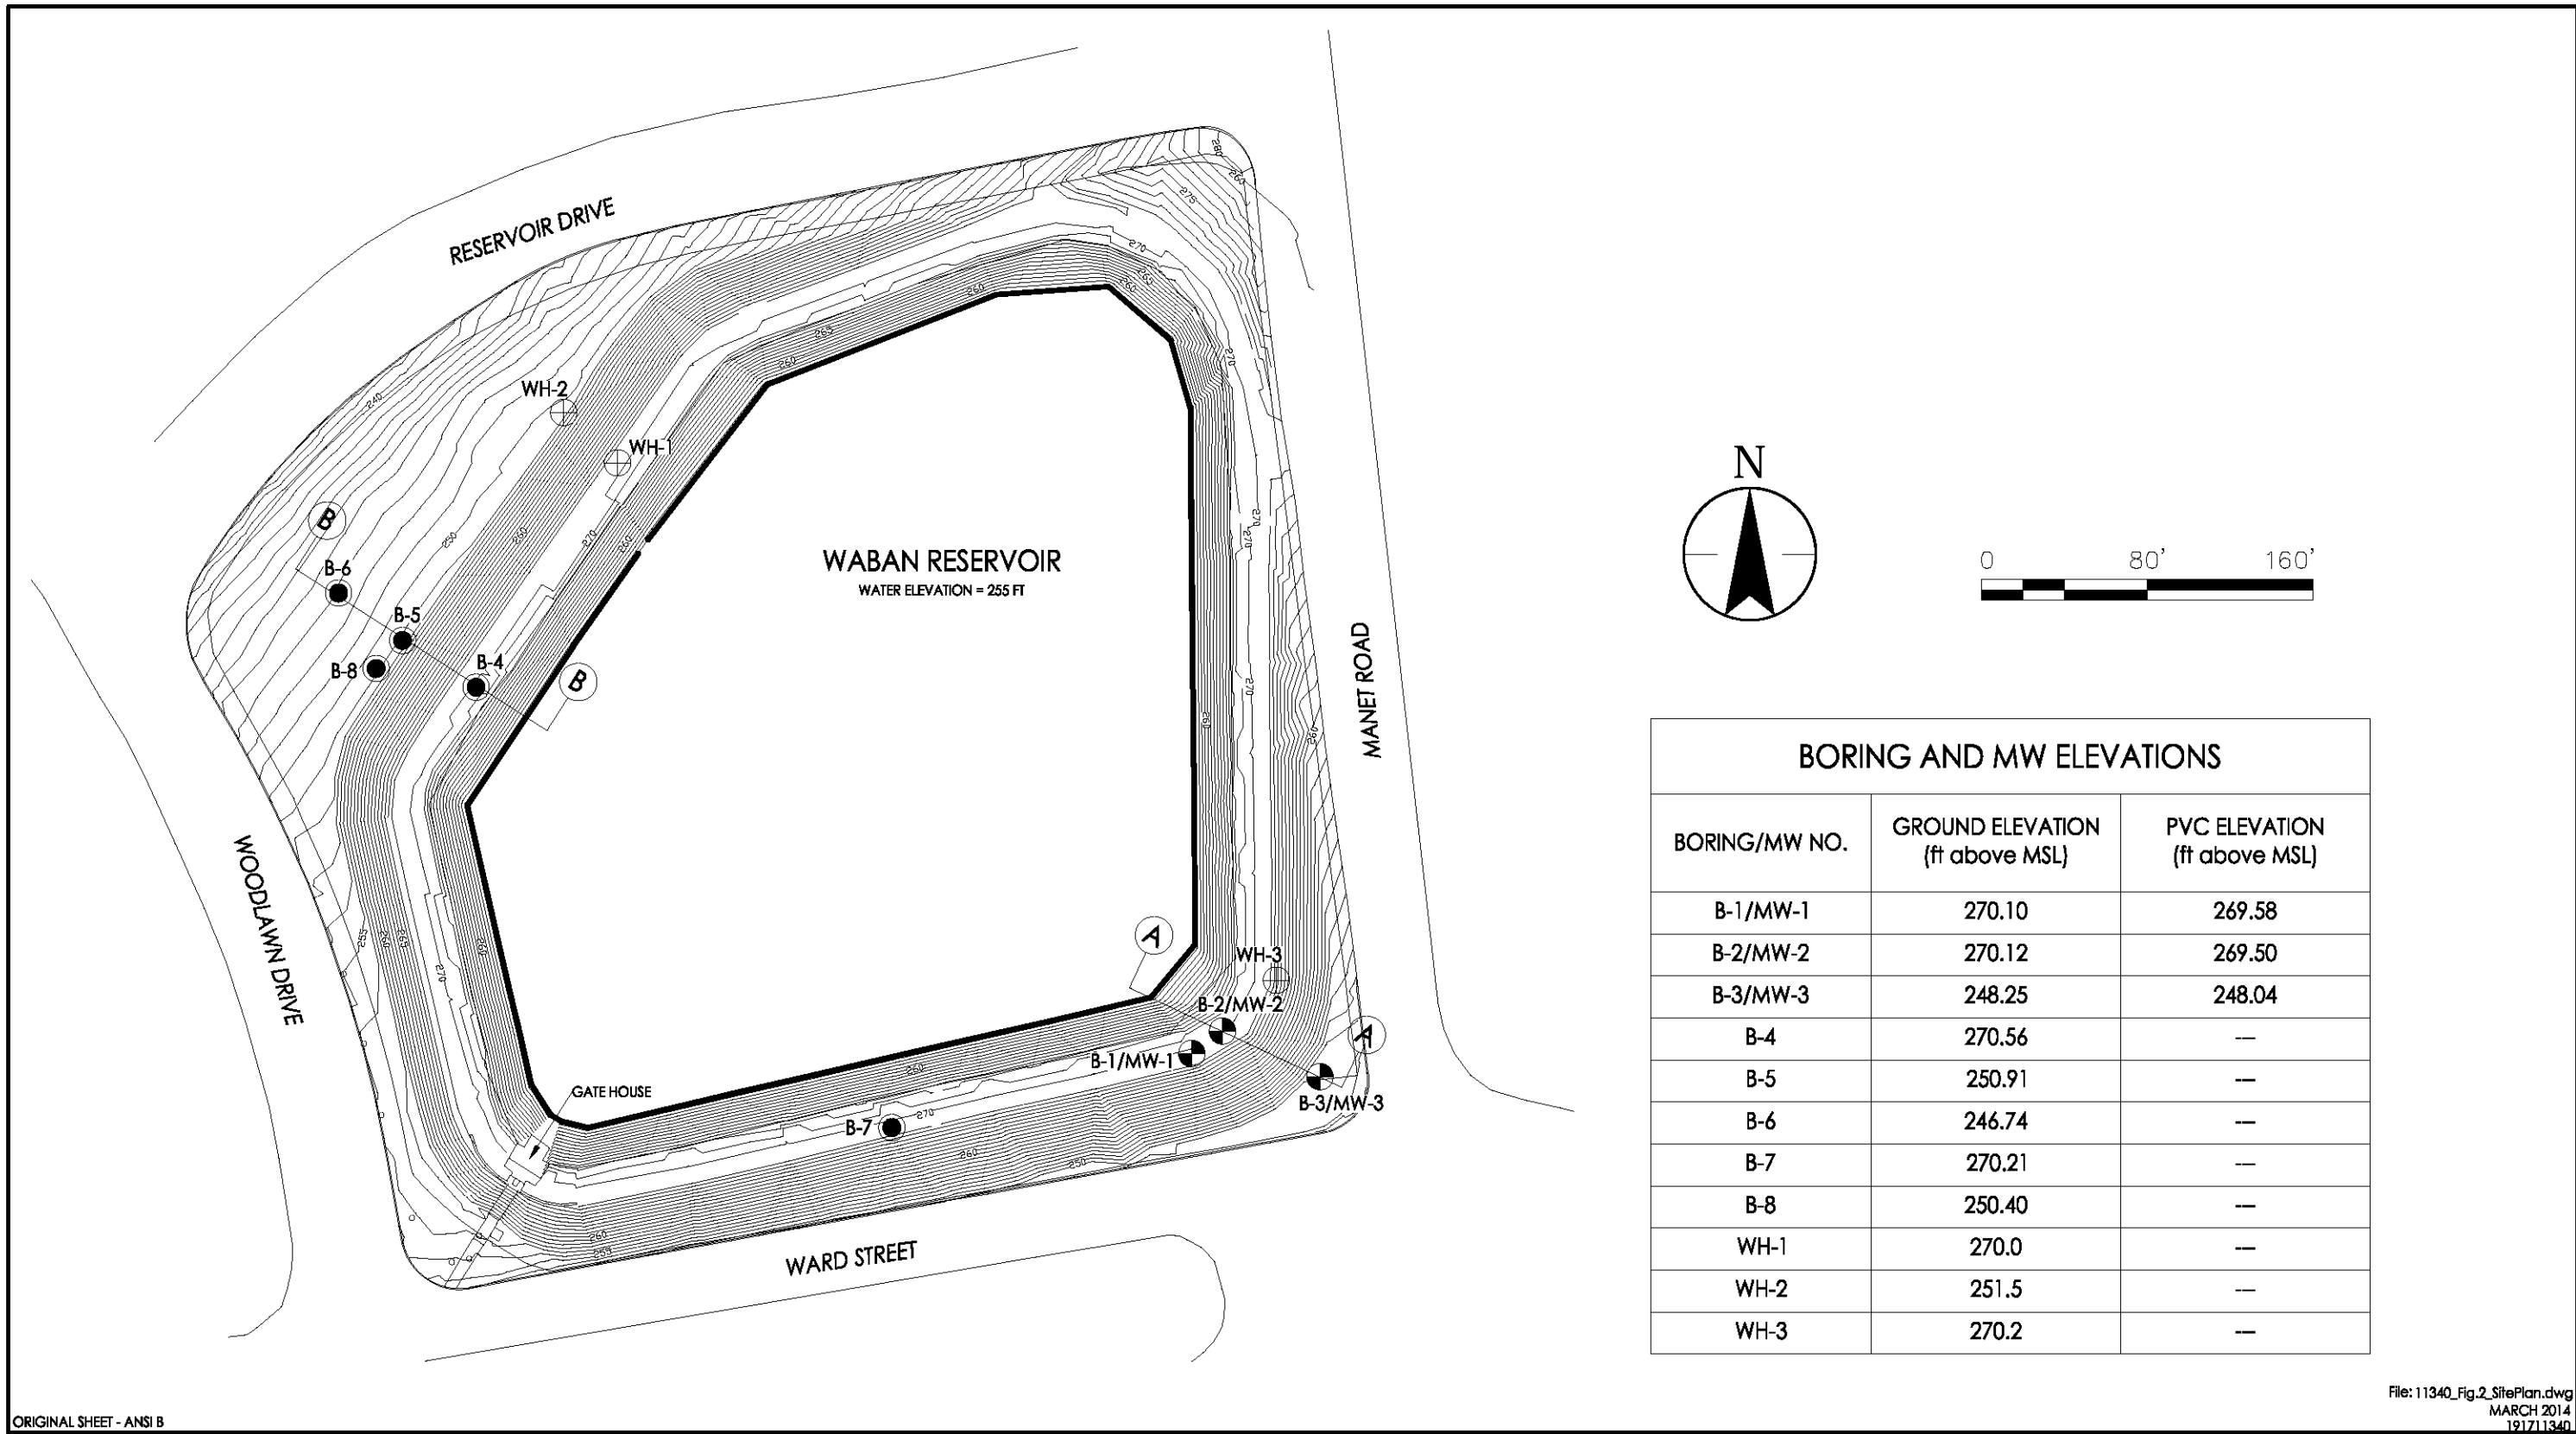
Eight test borings (B-1 through B-8) were drilled to determine the internal makeup of the embankment by New Hampshire Borings, Inc. of Derry, New Hampshire between January 14 and 17, 2014 under contract with Stantec. An all-terrain vehicle (ATV) track mounted (CME 550) drill rig was used to advance the borings. Hollow stem augers with 4-1/4 inch inside diameter were used to advance the borings for the first 8 feet of drilling. Drive and wash drilling methods were then used to advance the borings using 4-inch flush joint casing to the depth of exploration. A roller bit was used to clean out the material within the casing. Three borings (B-1 through B-3) were located along the maximum embankment section at the southeast corner of the reservoir; four borings (B-4 through B-6, and B-8) along the northwest corner adjacent to Woodlawn Drive; and one boring (B-7) was drilled along the top of embankment along the embankment section parallel to Ward Street. The test borings were monitored by a Stantec scientist. The borings were designated B-1 through B-8 and the borehole logs are included in Appendix A. The locations of both borings are shown on Figure 3.1 – Boring Location Plan.

Three groundwater observation wells were installed at the southeast corner of the reservoir in borings B-1, B-2, and B-3 to determine the water level through the embankment along the maximum cross section of the embankment.

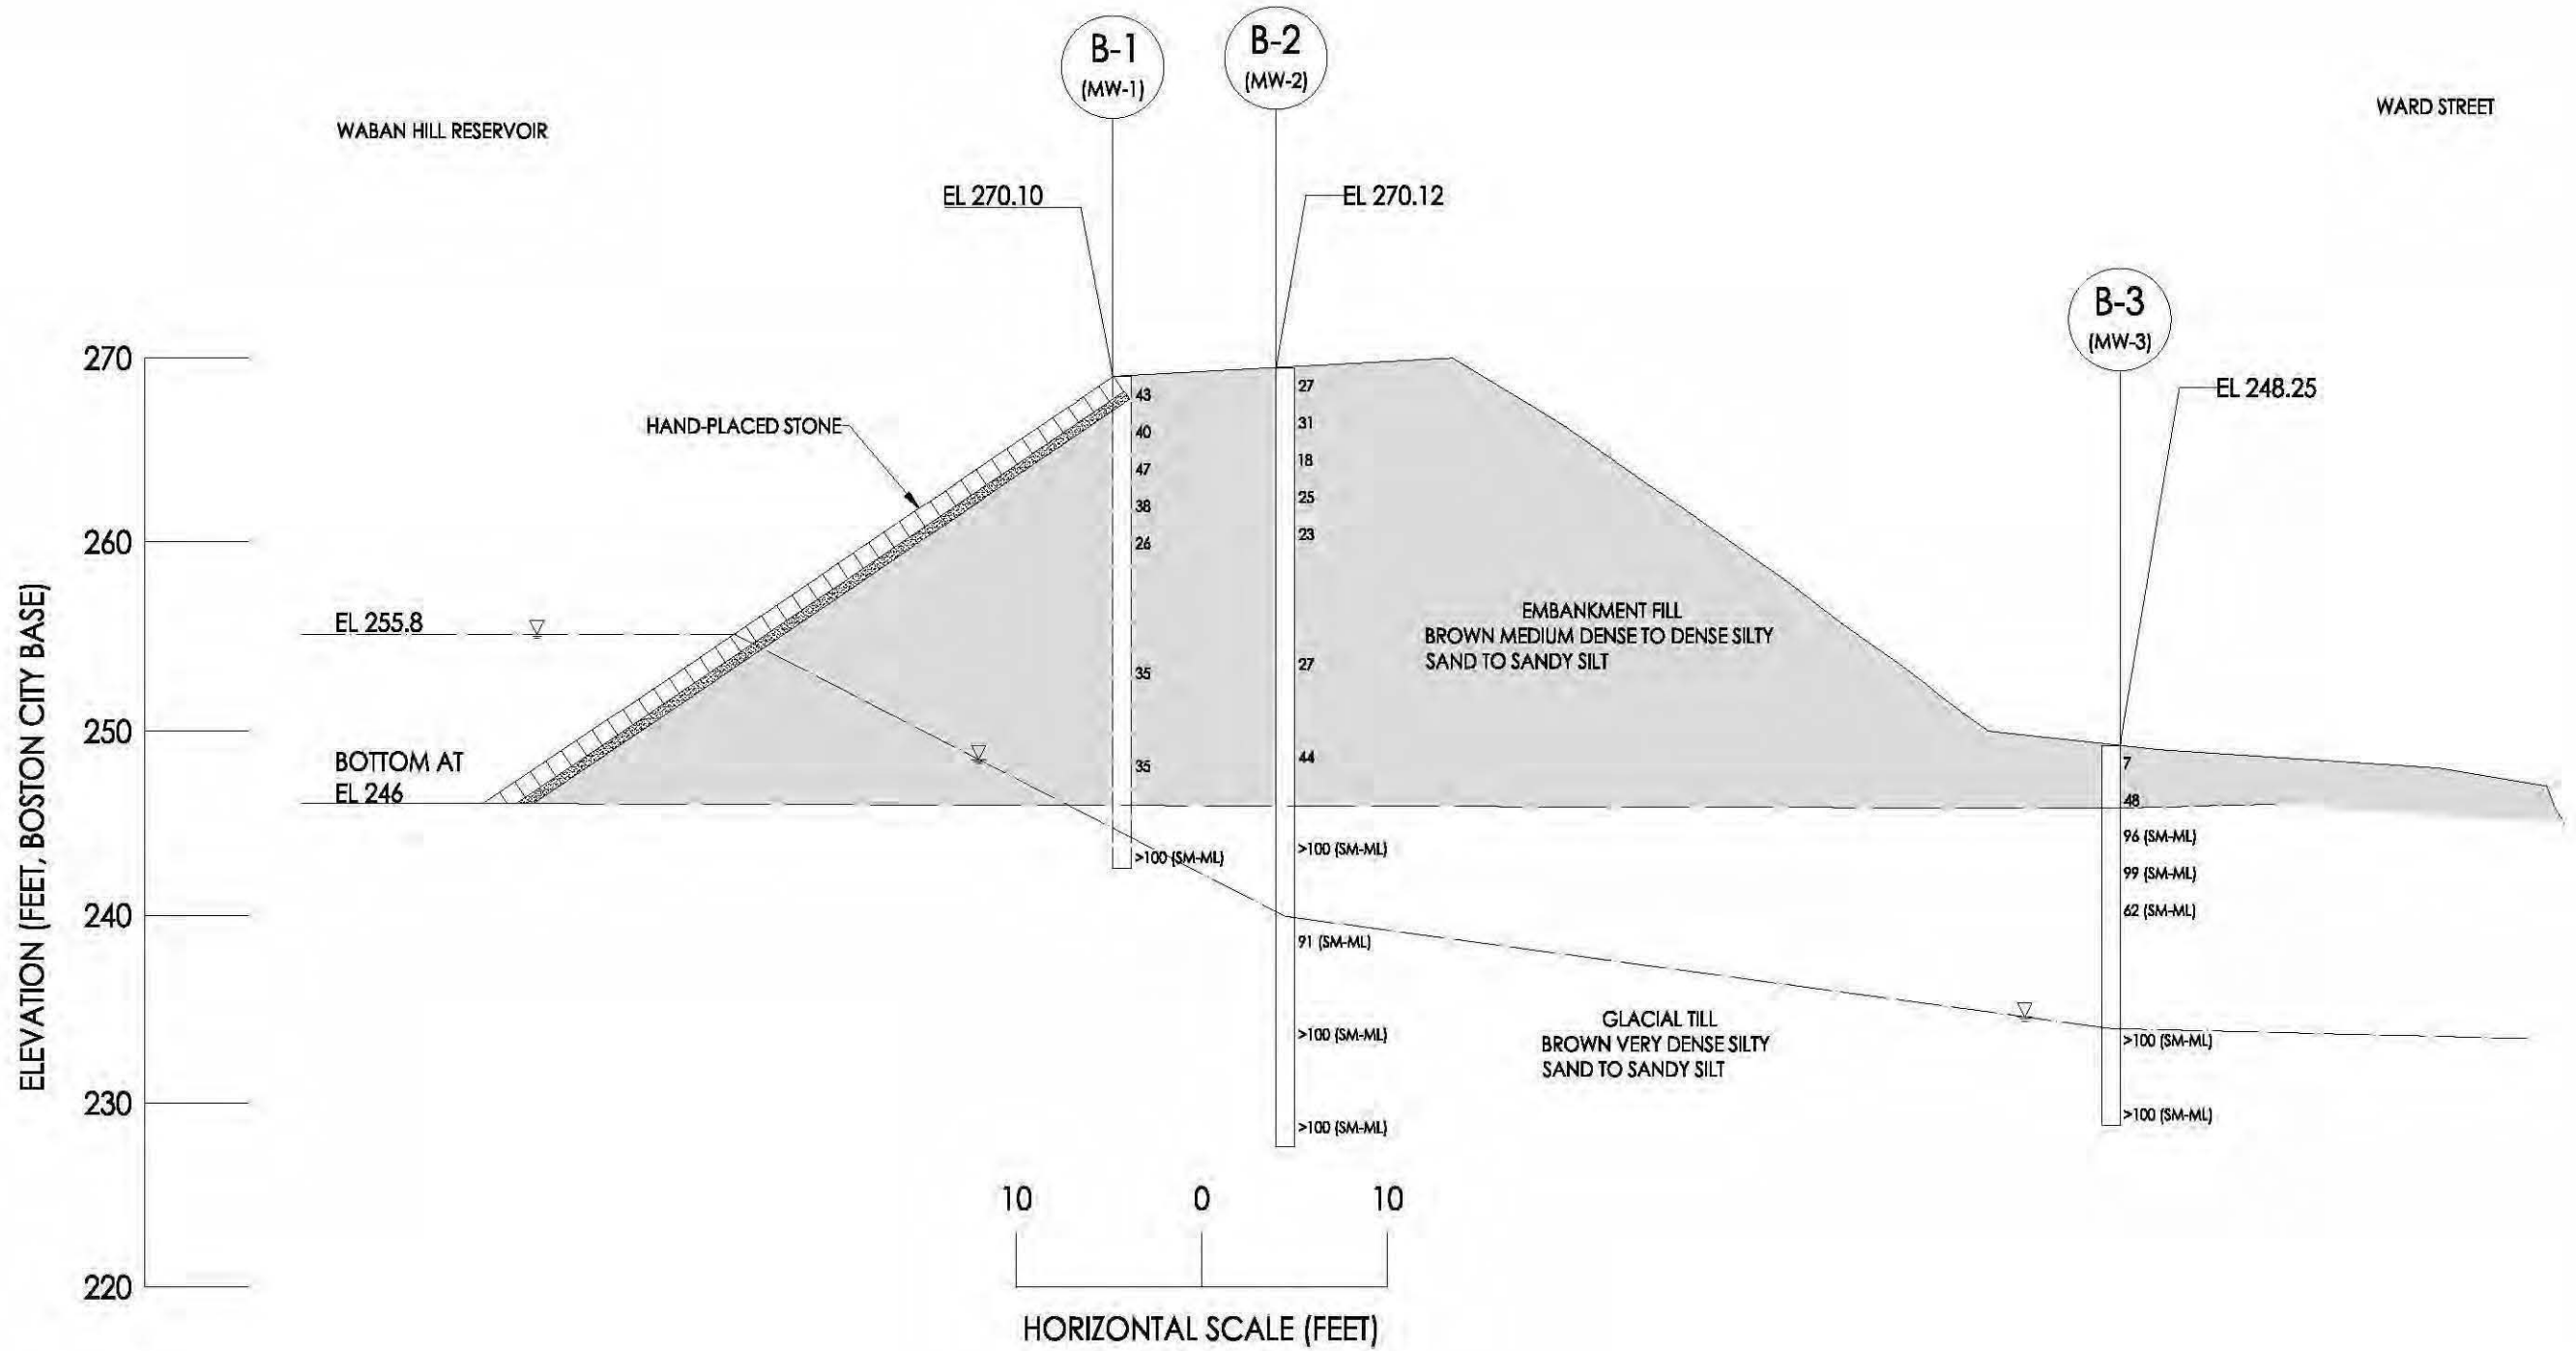
Figure No.
 4.1

Slope /Condition Evaluated	Factor of Safety	
	Steady State Seepage	Earthquake
Southeast Corner – Subsurface Profile A-A		
Downstream Slope	1.480	1.181
Upstream Slope	1.327	1.038
Northwest Corner – Subsurface Profile B-B		
Downstream Slope	1.599	1.267
Upstream Slope	1.376	1.070
