## EXISTING CONDITIONS AND RECOMMENDATIONS

## NEWTON CENTRE PLAYGROUND

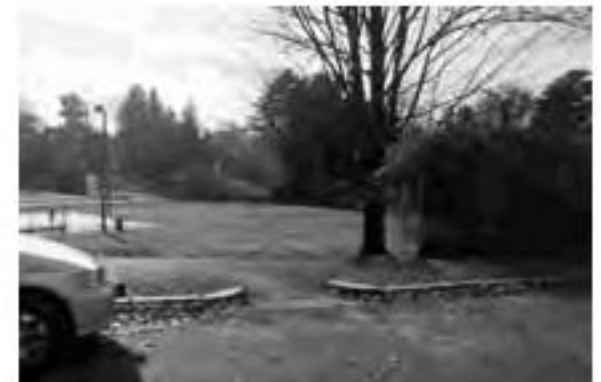
A sidewalk was added along the edge of Bowen Street in the late 1980s to discourage angular parking and the resulting lawn deterioration. Installation of the walk resulted in steep adjacent side slopes.

*Path from Bowen Street, 2005*

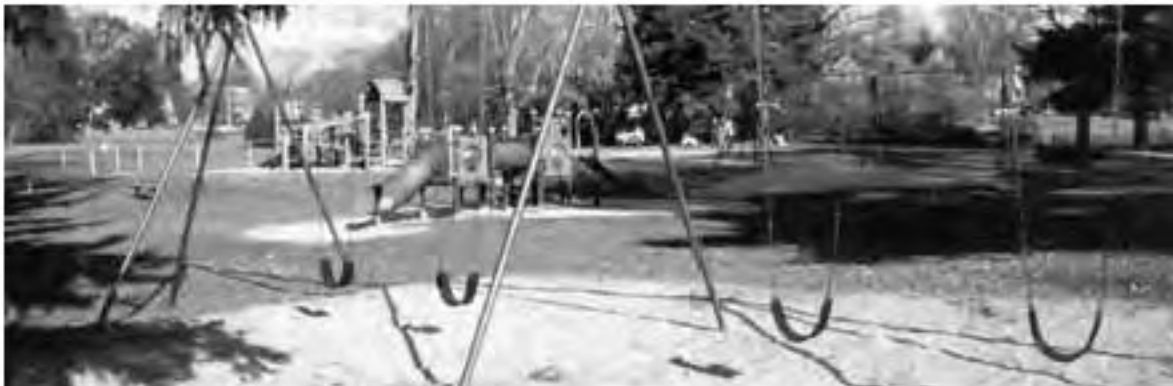
Apparatus in the play structure area, which is about 1/2 acre in size, includes 2 swing sets with 4 belt type seats each, 1 swing set with 2 toddler bucket type seats, 2 pieces of climbing apparatus [one of wood and one of metal, each with plastic slide components], a wood “car” and a wood balance beam. All are in good to fair condition although there have been complaints of splinters related to the wood apparatus. A concrete pad has been reported at the base of one of the slides. Most of the apparatus appears to have been selected for preschool and early elementary school use. The ground surface is sand in and around each piece of apparatus with turf in between.

While safety zones between each piece of equipment appear to be sufficient, sand is not an accessible surface nor is it appropriate as an impact attenuating material. Current apparatus is not compliant with the 2002 Guidelines for Play Areas prepared by the Access Board of the ADA. Additions or alterations to the apparatus should comply with these guidelines.

*Play structure area, 2005*

With private contributions, this facility is scheduled for replacement in place in 2006. While the selection of the site was completed and approved prior to the initiation of this plan, the play structures are being placed in a historically appropriate location even though it is remote from perimeter access points.

While the specific details of this replacement facility have not been examined, from a historic perspective, play equipment components inside the park should be metal with recessive colors. The use of primary colors, and roofs that would attract too much attention to themselves is discouraged. While wood might also be an appropriate material choice for some of the new equipment from a historic perspective, it is not recommended because it is less durable and has higher maintenance requirements.

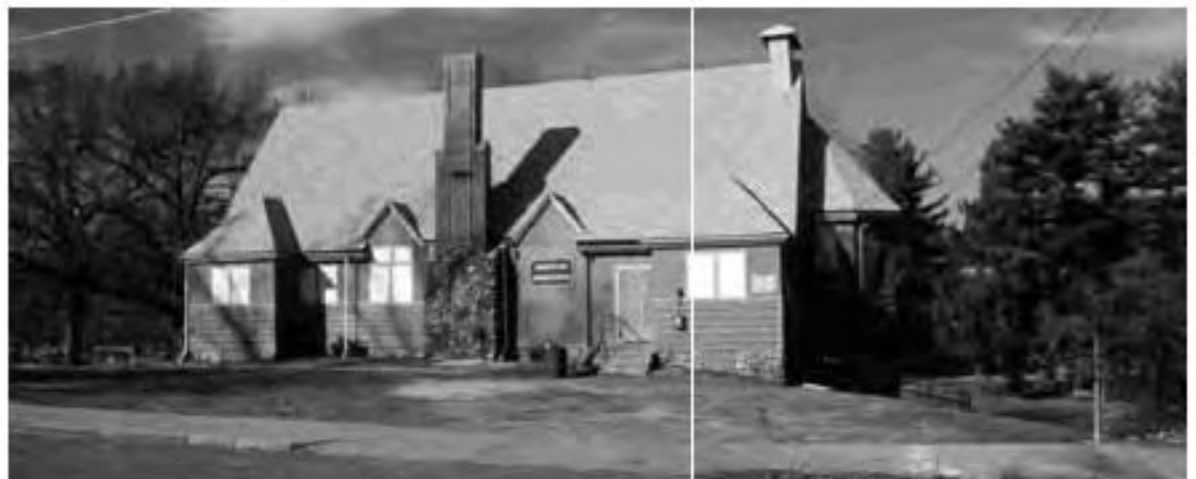
Only the exterior condition of the Jeannette West Recreation Center [the Hut] was examined. The interior was not evaluated, as it was beyond the scope of this endeavor. The building has green painted wood shingle siding and gray asphalt roof shingles. It appears to be in good condition. With wood shutters covering the windows facing Tyler Terrace and metal fabric covering windows facing Hammond Brook, the building is not welcoming and gives the impression of being in disrepair. It contains the only sanitary facilities in the playground. It has been suggested that additional sanitary facilities closer to the ballfields would be desirable.

*Recreation Center, south side, 2005*

Make the Recreation Center accessible. Defer accessibility improvements to the building until appropriate improvements are made inside the Recreation Center. Continue to provide periodic maintenance to the Recreation Center. No additional buildings should be added to the playground.

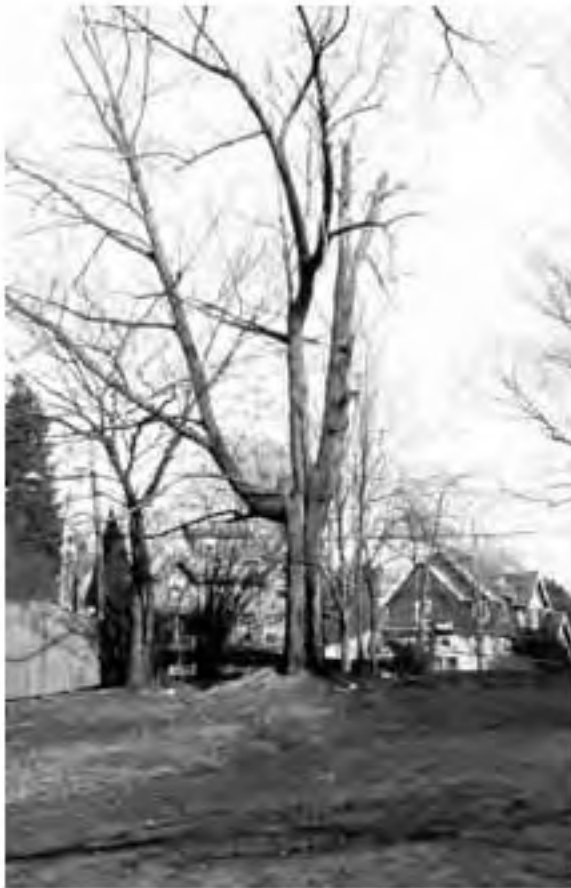
*Tree in poor condition, 2005*

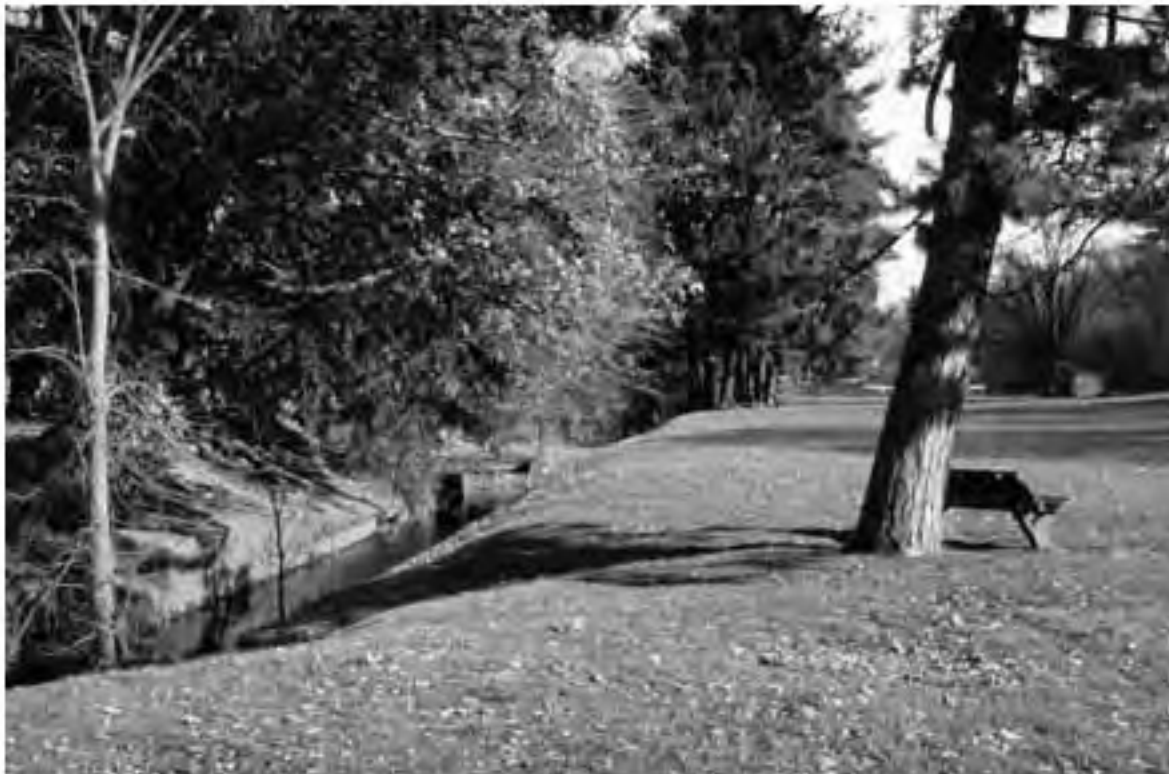
*Hammond Brook below Recreation Center, 2005*

The brooks are contained within stone masonry walls with a stone drainageway base that has stones set in cement. Walls at the brook from Homer Street are 2' high while those along Hammond Brook are 3' high with 1.5 to 1 adjacent side slopes. Most of the walls have a cement parge coat cap and some have parging on the vertical face of the wall. A portion of the wall is collapsing between the play structure area and basketball court. The drainageway floor has collapsed above the bridge. Another portion of the wall is collapsing near the bridge next to the Mason-Rice school play structure area. Numerous volunteer trees are growing out of the walls. They have and will continue to contribute to failure of the walls.

The 4 bridges to remain over Hammond Brook should be reconstructed in a similar style as such time as they need structural repairs. Existing deteriorated sections of the remaining channels should be repaired as soon as possible.

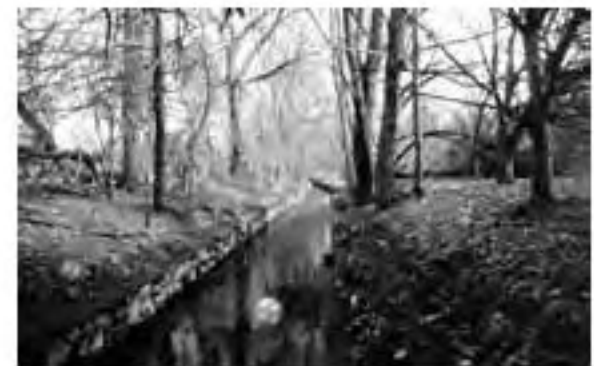
*Hammond Brook below Mason-Rice School, 2006*

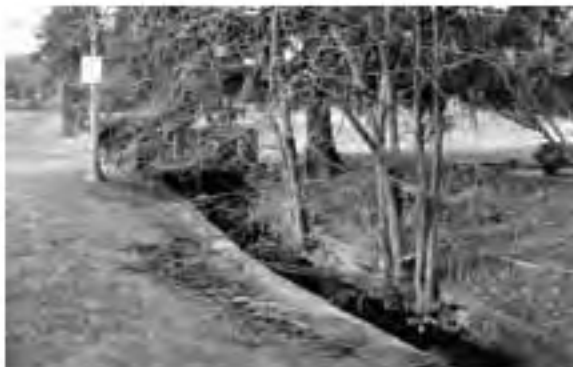
*Volunteer trees growing in Hammond Brook channel walls, 2006*

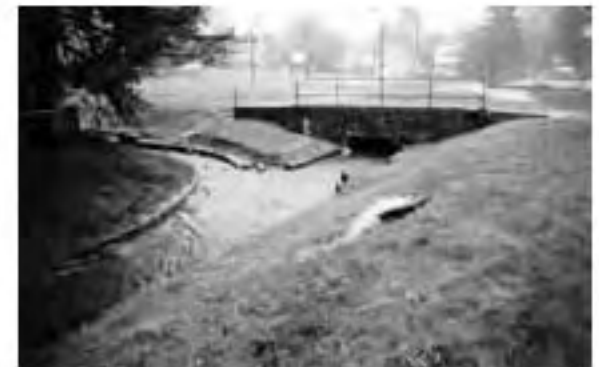
*Hammond Brook during a rain event, 2006*

The flooding issue should be resolved downstream of the site to reduce the impact of providing flood storage capacity inside the playground.

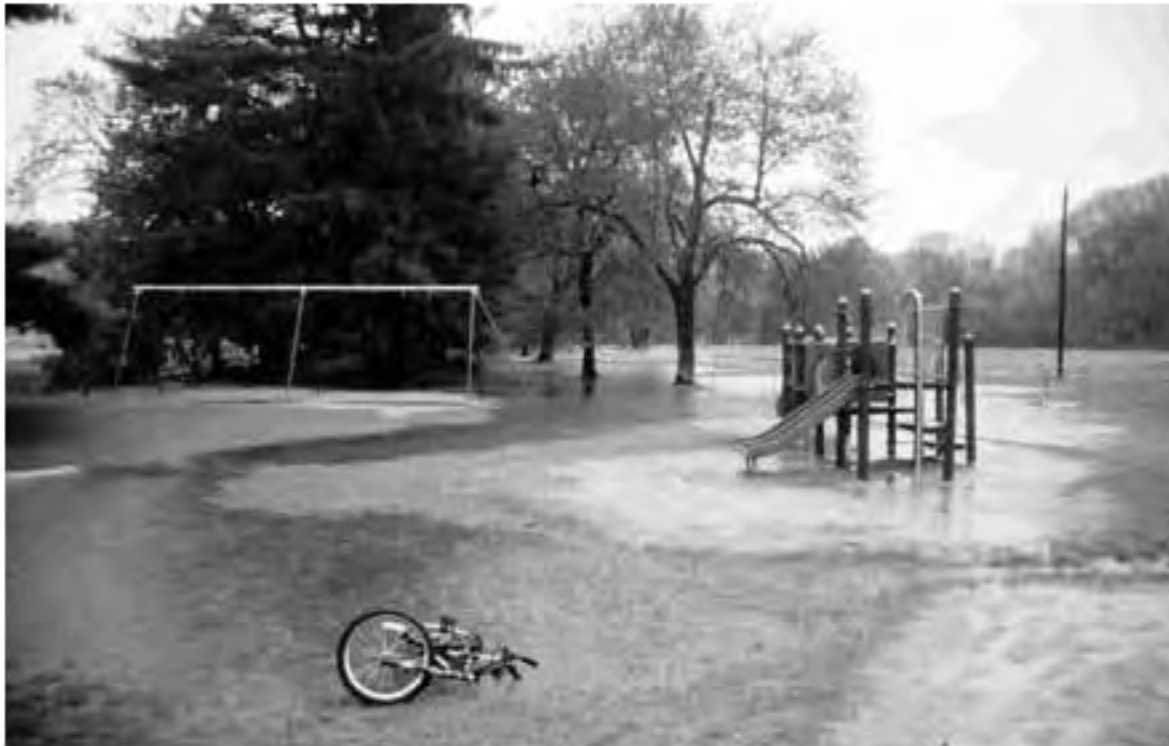
Many areas below elevation 129 have very shallow slopes, ranging from 0.5% to 1.5% which is generally insufficient for positive drainage in lawn areas. An extensive area of standing water does occur in and west of play structure area and east of the Mason-Rice play structure area, and there is a wet area southwest of basketball court because of shallow slopes. Standing water also occurs north of the Little League field and southeast of the basketball court in an isolated depression where a clump of Willows once stood. A tile underdrainage system, north of Hammond Brook is assumed to still be intact although it is not known if it still functions.

*Standing water in play structure area and soccer field beyond, 2006*

Utilize excess excavated material, including topsoil, from the various implementation projects to fill in depressions and erosion areas. Provide proper and ongoing maintenance to eliminate concentrated overland flows.

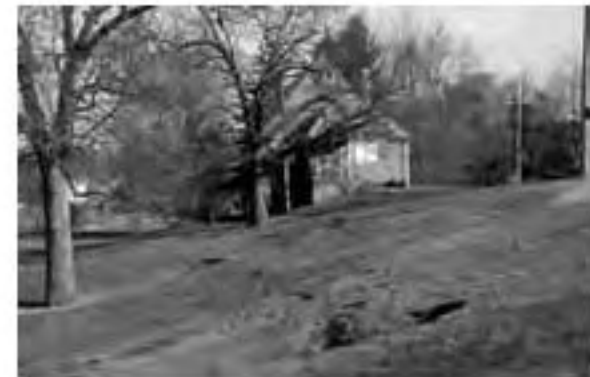
*Erosion near Recreation Center, 2005*
